January 8, 2019

Subject: Harbor Loop Preliminary Design

Field Notes
September 26, 2018
Harbor Loop Sewer Preliminary Design
Manchester-by-the-Sea, MA

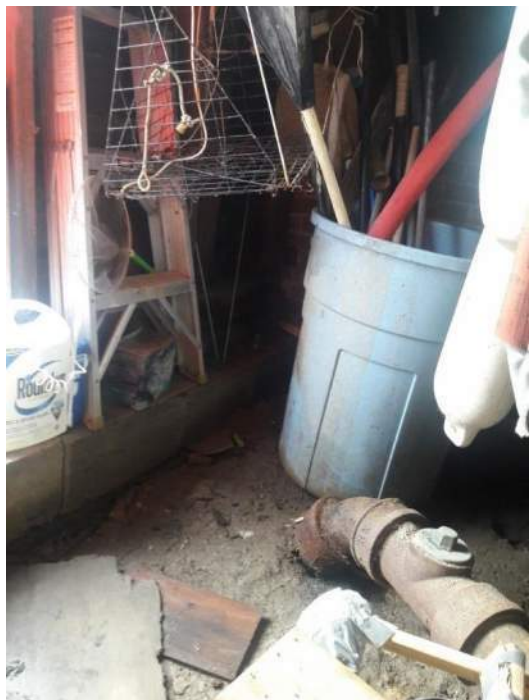
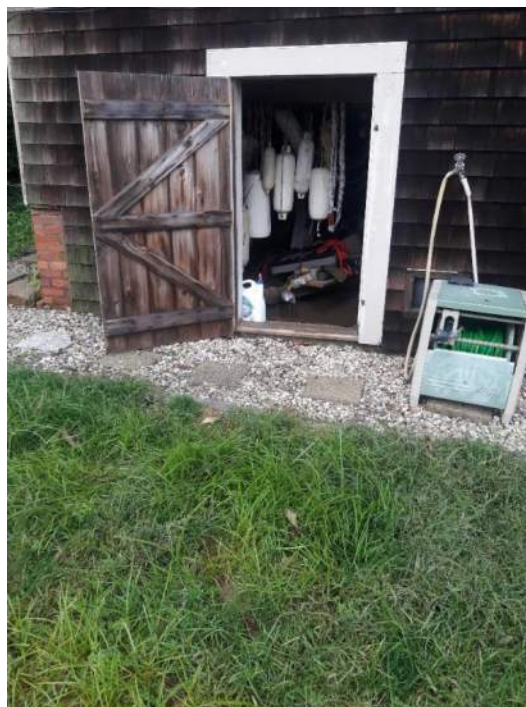
2 Bridge Street

- Service lateral is located in crawl space under house at ground level. Approximately 4' from edge of building as shown on sketch.
- Unable to see elevation of pipe as it goes directly into ground at its furthest point visible.
- On east side of home there is a fence that leads up to a 7' wall to Bridge Street.
- On the west side of the house there is very little space as it borders the shoreline.

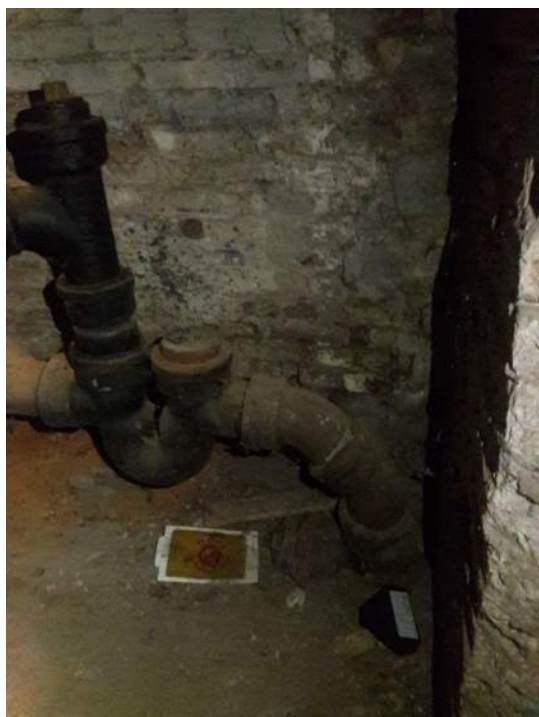
6 Bridge Street

- Lateral can be seen in walkout basement. Located back about 14' from the back of the home where it enters straight into the ground. Approximately 3" from the inside east wall.
- The east side of the home contains a shed. Ground elevation slopes up toward street with steps along the way.
- West side of the home has a 9' wall and stair case to Bridge Street.

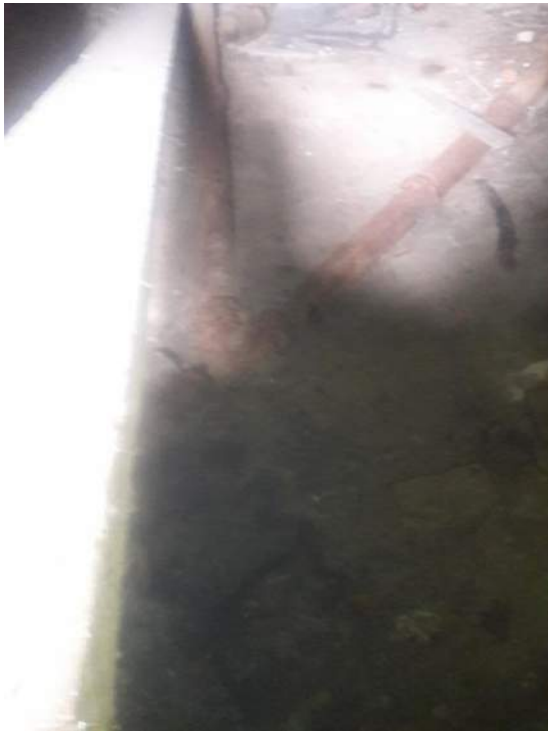
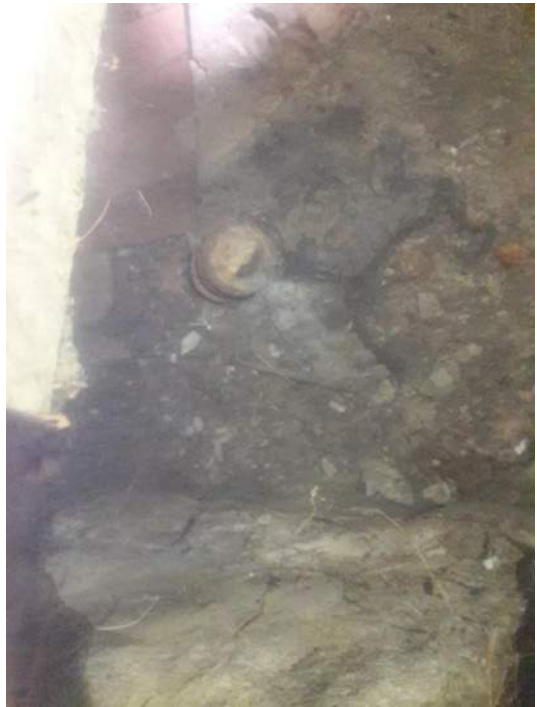
10 Bridge Street

- Small hatch in back of home contained visible sewer lateral. Appears to come straight out of home.
- Right outside of area where lateral exits home is a patio/deck and 10" tree. On east side of home walkway with stairs and 9' wall.

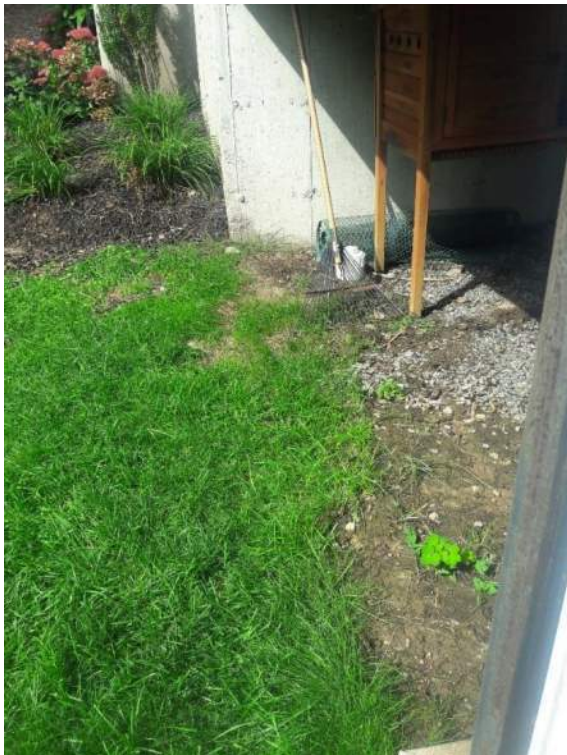
16 Bridge Street

- Located cleanout for sewer outside of home 2' from building corner.
- On east side of home 7'-4" wall to Bridge Street.
- Yard is separated into two sections by 3'-9" stone wall.
- MH123 is located in the south east corner.

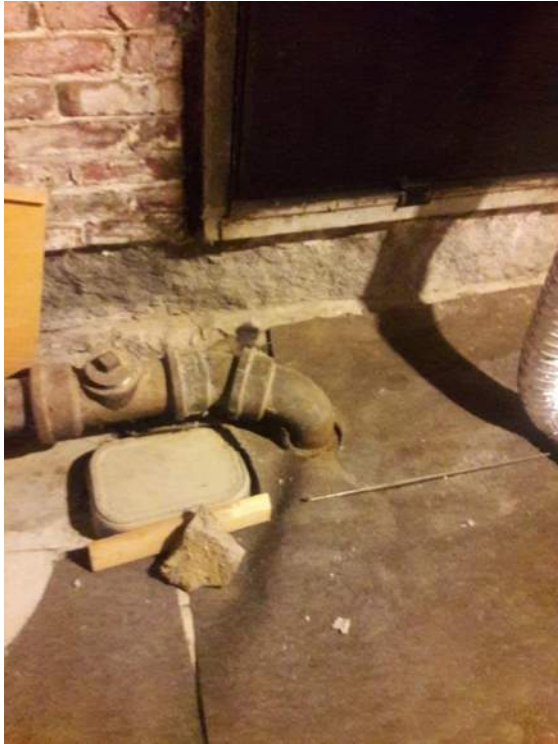
10 Ashland Avenue

- Inspection and tie card information indicated that this service is connected to sewer on Ashland Ave.

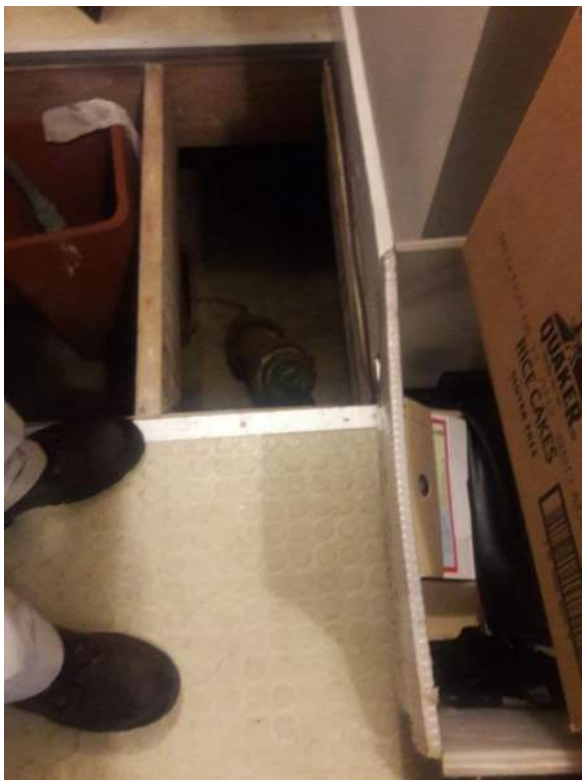
12A/12B Ashland Avenue

During inspections for 12A and 12B Ashland Avenue, the owner reported that the sewer service for the building is submerged during high tide. Upon visual inspection, the service appeared to be in poor and brittle condition which was confirmed by the owner. This could be a potential source for salt water intrusion in the system and should be addressed. Additionally, the service at 12C Ashland Avenue is also submerged during high tide, however, this service has been replaced recently and has a protective barrier around it as shown in the 12C Ashland Avenue photo in Appendix C. The home inspections completed provide some information as to where the service lateral exited the home, however, the elevation of the service laterals could not be determined. All services located went directly into the ground to an unknown depth. From survey information provided, however, it is assumed at this time that the service laterals are located approximately 4

- Service lateral located in apartment under hatch in closet. Located about halfway mark of building.
- Runs out to line to MH 126A.
- Noted that service cleanout/pipe is in poor condition and should be replaced soon.
- Service was reported to be underwater during high tide.

As part of the design, a plan should be developed in the event that there is a collapse of the pipe during installation. Additionally, special attention should be made for the lateral connections located in the tidal plain, specifically at 12A/12B Ashland Avenue. These laterals should be inspected to determine if full replacement will be necessary.

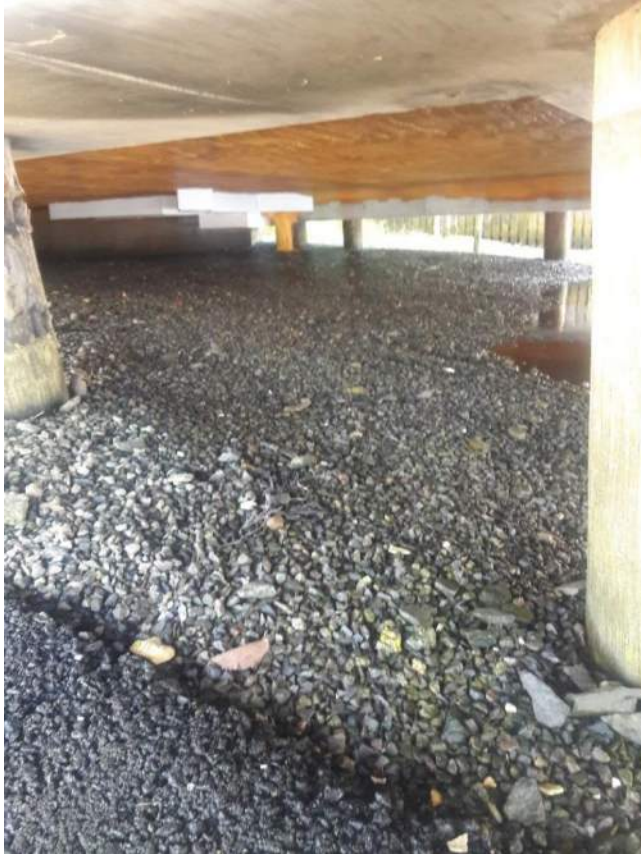
12C Ashland Avenue

- Workshop, newer build. Building extends over the water. Plumbing is located under building encased.
- Plumbing is submerged at high tide, located on north side of building. Plumbing then connects into MH 125 line.
