# Police Department

## Town of Manchester-by-the-Sea ADA Transition Plan

March 2020

Institute for Human Centered Design

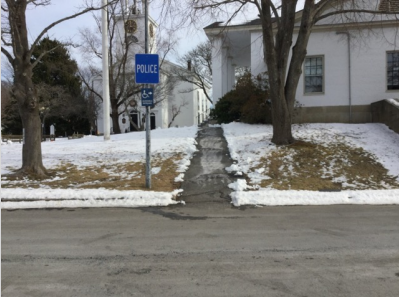
Route not maintained in operable working condition	-	Ensure the accessible route is maintained in operable working conditions.	1	-	\$0
2	Towards Main Entrance	Ext.		Exterior Access Route	Walkway

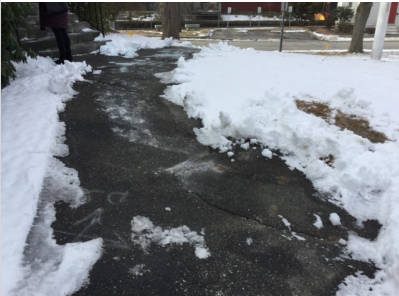
Cross slope > 1:50 (2.00%)	2.7%	Reduce cross slope to be no steeper than 1:50 (2.00%).	1	-	\$0
Entrance												
3	Main Entrance	Ext.		Entrance	Main Entrance

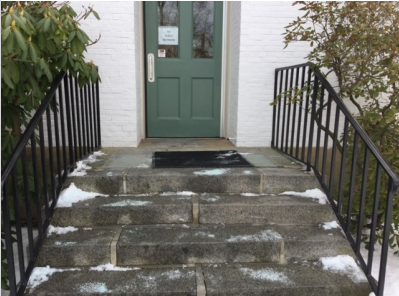
Entrance not on an accessible route Directional sign to accessible entrance not provided Mat not securely attached	<ul style="list-style-type: none"><li>-</li><li>-</li><li>-</li></ul>	Provide a directional sign indicating the location of the nearest accessible entrance. Secure the mat.	1	346	\$346

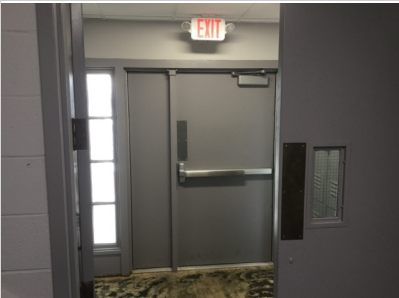
Tactile exit sign not provided Emergency exit not on an accessible route Directional sign to accessible emergency exit not provided	<ul style="list-style-type: none"><li>-</li><li>-</li><li>-</li></ul>	Ensure a tactile exit sign with raised characters and braille is provided at exit door. Mount signs between 48"- 60" above finished floor located on the latch side of the door. Provide a directional sign indicating the location of the nearest emergency exit.	1	232	\$232

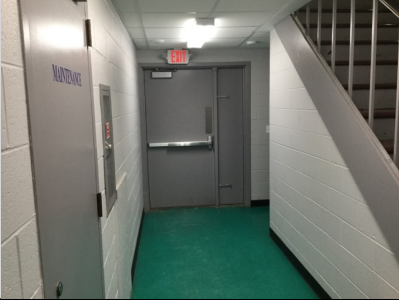
Tactile exit sign not provided Illuminated ISA symbol not provided (MAAB)	- -	Ensure a tactile exit sign with raised characters and braille is provided at exit door. Mount sign between 48"- 60" above finished floor located on the latch side of the door. Provide an illuminated sign with the International Symbol of Accessibility.	1	432	\$432
Interior Access Route												
6	Executive Officer	1		Interior Access Route	N/A

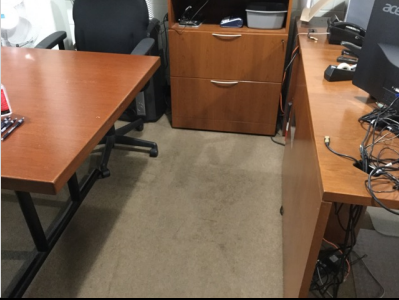
Route < 36" wide	-	Rearrange furniture to ensure that a clear width of 36" min. is maintained at the accessible route.	1	Labor	\$0
7	Police Station - Meeting Room	1		Interior Access Route	N/A

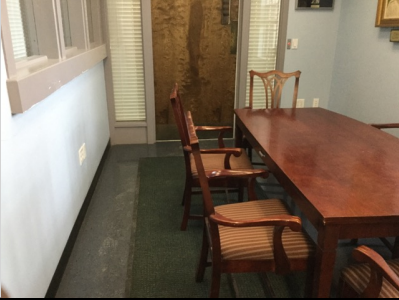
Route < 36" wide	29.5"	Rearrange furniture to ensure that a clear width of 36" min. is maintained at the accessible route.	1	Labor	\$0

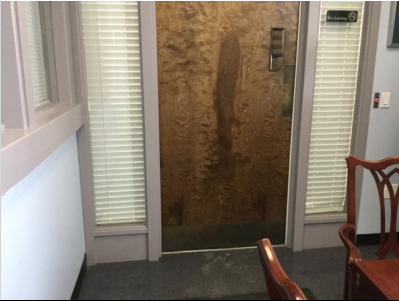
Maneuvering clearance(s) not provided	-	Rearrange furniture to ensure that the maneuvering clearance is maintained at the door.	1	Labor	\$0
9	Police Station - Meeting Room	1		Doors, Doorways, & Gates	Office

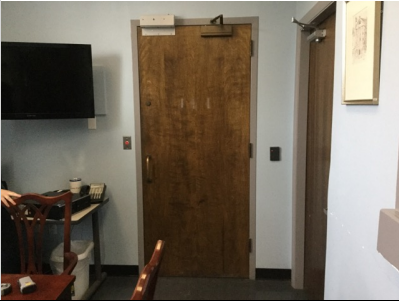
Maneuvering clearance(s) not provided Door requires > 5 lbs. of force to open	- 7 lbs	Rearrange furniture to maintain the maneuvering clearance at the door. Adjust closers so doors do not require more than 5 pounds of force to open.	1	Labor	\$0

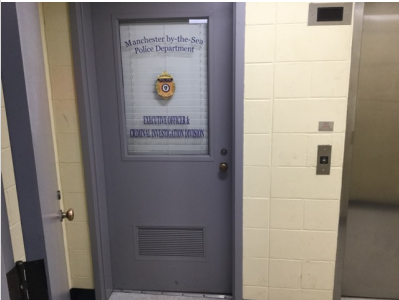
Raised characters not provided on sign Braille not provided on sign Sign not located on the latch side of the door	- - -	Provide text with raised characters duplicated in braille on sign. Locate sign alongside the door on the latch side.	1	232	\$232
11	Towards Holding Cells	G		Signage	Designation

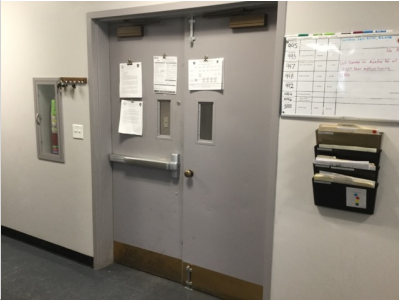
Signage is not provided	-	Locate signage alongside the door on the latch side.	1	232	\$232
12	Female /Juvenile Holding Cell	G		Signage	Designation

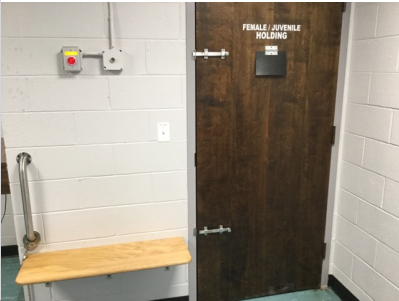
Raised characters not provided on sign Braille not provided on sign Sign not located on the latch side of the door	- - -	Provide text with raised characters duplicated in braille on sign. Provide braille on sign. Locate sign alongside the door on the latch side.	1	232	\$232

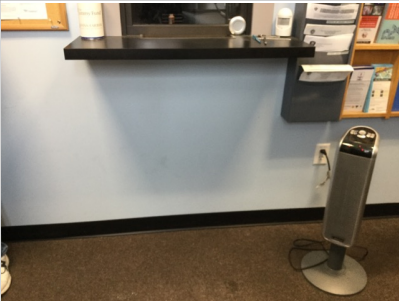
Counter > 36" high	41.5"	Provide a counter that is 36" max. above the finished floor.	1	880	\$880
Detention Facilities												
14	Male Holding Cells	G		Detention Facilities	Men's

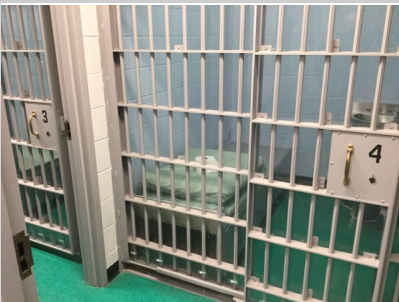
< 3% of holding cells have mobility features	-	Ensure that at least one holding cell has mobility features.	1	-	\$0

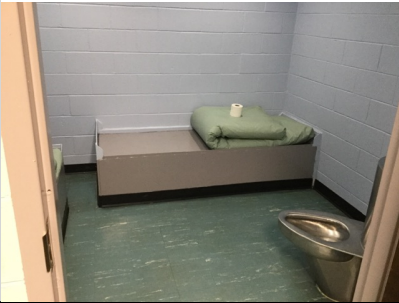
Mobility cell lacks 60" turning space	-	Remove one of the beds to ensure that a 60" turning space is provided.	1	Labor	\$0
16	Female/ Juvenile Holding Cell	G		Detention Facilities	Other

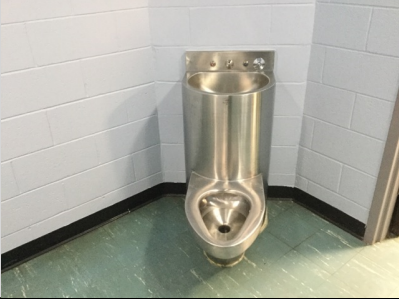
Mobility cell lacks access to accessible toilet/lavatory	-	Ensure an accessible toilet room is provided.	1	10010	\$10010
Toilet & Bathing Rooms												
Overall Access												
17	Bathing Room	G		Overall Access	Bathing Room

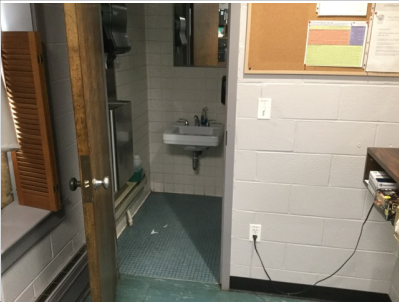
Turning space not provided Accessible plumbing fixtures or stalls not provided	- -	Provide an accessible bathing room.	1	24604	\$24604
