# Town Hall

## Town of Manchester-by-the-Sea ADA Transition Plan

February 2020

Institute for Human Centered Design

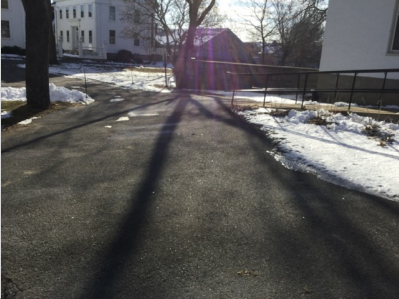
Cross slope > 1:50 (2.00%)		Reduce cross slope to be no steeper than 1:50 (2.00%).  Note: This area is going to be redesigned.	1	-	\$0
2	North Side Main Entrance	Ext.		Exterior Access Route	Walkway

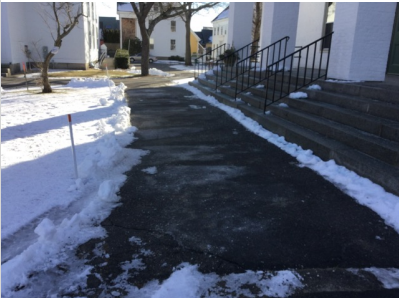
Cross slope > 1:50 (2.00%)	4.2%	Reduce cross slope to be no steeper than 1:50 (2.00%).  Note: This area is going to be redesigned.	1	-	\$0
3	Towards the Police Station	Ext.		Exterior Access Route	Walkway

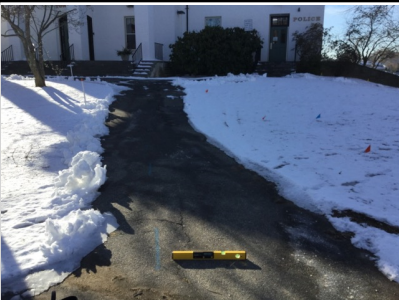
Running slope > 1:20 (5%)	13.3%	Reduce running slope to be no steeper than 1:20 (5%).  Note: This area is going to be redesigned.	1	-	\$0
4	Towards Accessible Entrance - East Side	Ext.		Exterior Access Route	Walkway

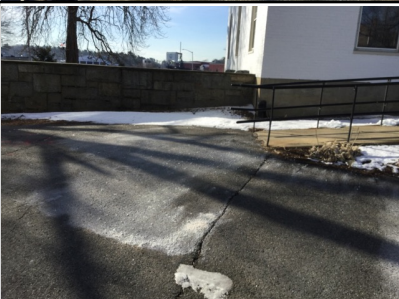
Running slope > 1:20 (5%)	9.5%	Reduce running slope to be no steeper than 1:20 (5%).  Note: This area is going to be redesigned.	1	-	\$0

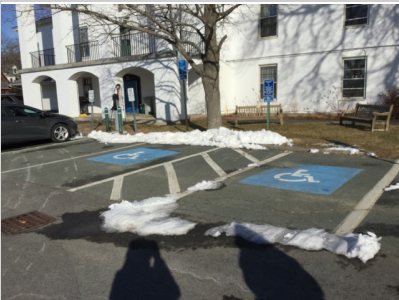
Access aisle < 96" wide at van space	69"	Provide a marked access aisle that is at least 96" wide.	1	300	\$300

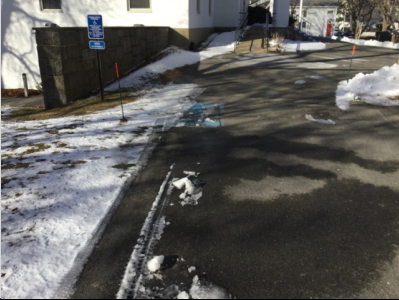
Access aisle not provided	-	Provide a marked access aisle that is at least 96" wide.	1	300	\$300
Exterior Ramp												
7	Towards Accessible Entrance - East Side	Ext.		Exterior Ramp	N/A

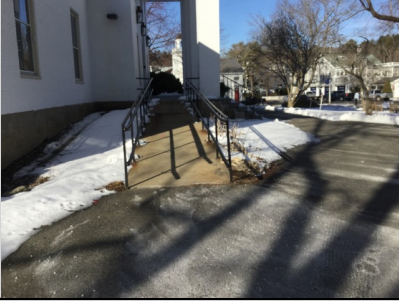
Ramp < 48" wide Running slope > 1:12 (8.3%) Not maintained in operable working condition	44.5" 11.8% -	Widen ramp so that the clear width is 48" min. Reduce running slope to be no steeper than 1:12 (8.3%). Ensure the ramp is maintained in operable working condition.	1	14646	\$14646
Entrance												
8	East Side - Accessible Entrance	B		Entrance	Secondary Entrance

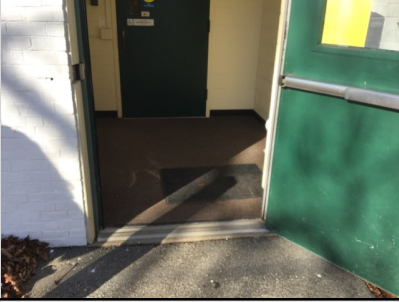
Mat not securely attached Threshold not beveled	- -	Secure the mat. Bevel threshold.	1	150	\$150
Access to Goods and Services												
Means of Egress

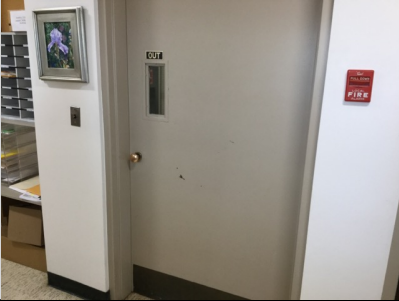
9	Exit - Near Selectmen Town Admin.	1		Means of Egress	N/A

Tactile exit sign not provided	-	Ensure a tactile exit sign with raised characters and braille is provided at exit door. Mount sign between 48"- 60" above finished floor located on the latch side of the door.	1	232	\$232

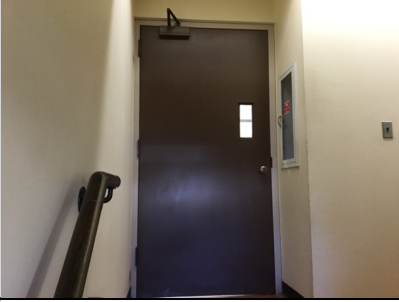
Floor level designation not provided	-	Provide a sign on the interior of the stairway enclosure indicating the floor level.	1	232	\$232
11	Near Town Clerk - Parking Clerk	1		Means of Egress	N/A

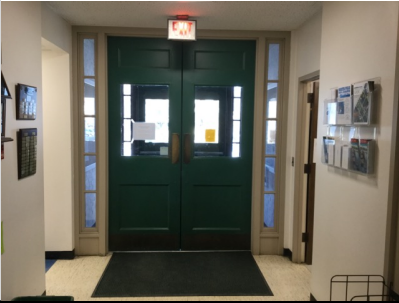
Illuminated ISA symbol not provided (MAAB) Mat not securely attached	-	Provide an illuminated International Symbol of Accessibility. Secure the mat to prevent tripping hazard.	1	200	\$200
12	Egress Near Room 9	2		Means of Egress	111

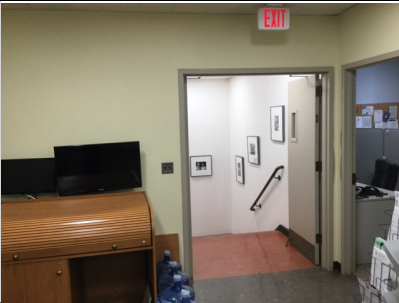
Tactile exit sign not provided	-	Ensure a tactile exit sign with raised characters and braille is provided at exit door. Mount sign between 48" - 60" above finished floor located on the latch side of the door.	1	232	\$232
13	Exit Near Meeting Room	2		Means of Egress	N/A

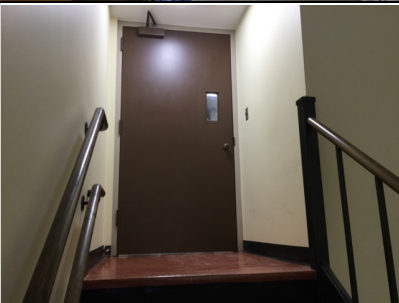
Floor level designation not provided	-	Provide a sign on the interior of the stairway enclosure indicating the floor level.	1	232	\$232

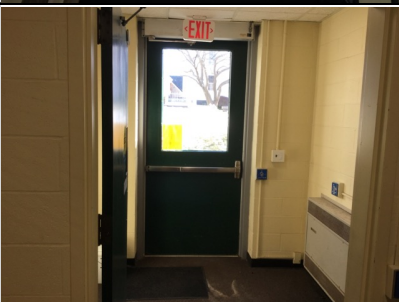
14	Towards Parking Lot	B		Means of Egress	N/A

Illuminated ISA symbol not provided (MAAB)	-	Provide an illuminated International Symbol of Accessibility.	1	200	\$200

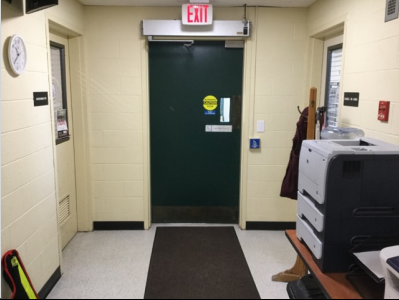
Illuminated ISA symbol not provided (MAAB) Mat not securely attached	-	Provide an illuminated International Symbol of Accessibility. Secure the mat to prevent tripping hazard.	1	200	\$200
Interior Access Route												
16	Town Clerk - Parking Clerk	1	4	Interior Access Route	N/A

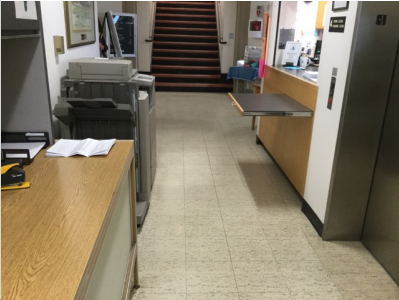
Route < 36" wide	29"	Relocate printer to ensure that a clear width of 36" min. is maintained at the accessible route.	1	Labor	\$0
17	Selectmen's Meeting Room	2	5	Interior Access Route	N/A

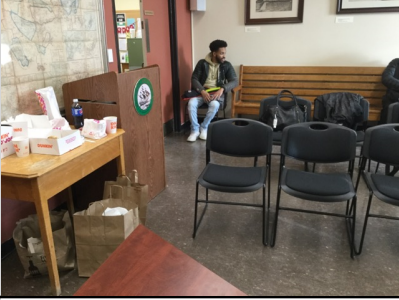
Route < 36" wide	-	Relocate chairs to ensure that a clear width of 36" min. is maintained at the accessible route.	1	Labor	\$0
18	Exit Near the Council on Aging	B		Interior Access Route	N/A

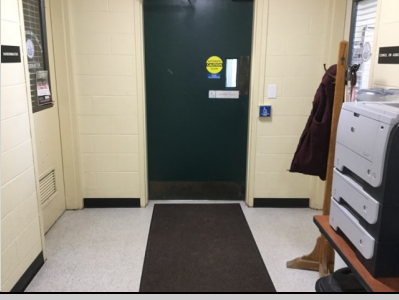
Mat not securely attached	-	Secure the mat.	1	Labor	\$0

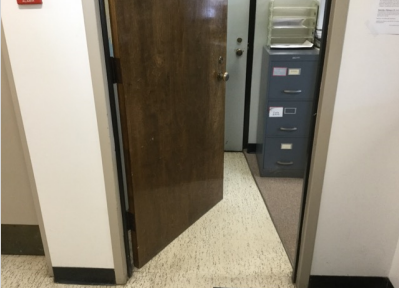
Hardware not operable with a closed fist	-	Provide hardware that can be operable with one hand and not require tight grasping, pinching, or twisting of the wrist.	1	484	\$484

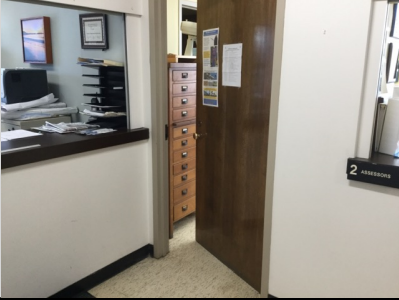
Hardware not operable with a closed fist		Provide hardware that can be operable with one hand and not require tight grasping, pinching, or twisting of the wrist.	1	484	\$484
21	Town Clerk - Parking Clerk	1	4	Doors, Doorways, & Gates	Office

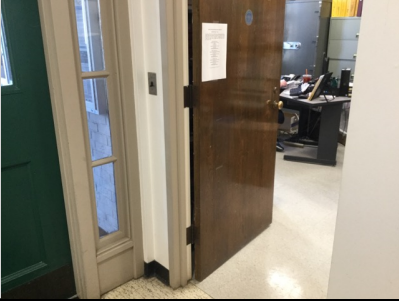
Hardware not operable with a closed fist	-	Provide hardware that can be operable with one hand and not require tight grasping, pinching, or twisting of the wrist.	1	484	\$484
22	Public Works Water & Sewer	2	6	Doors, Doorways, & Gates	Office

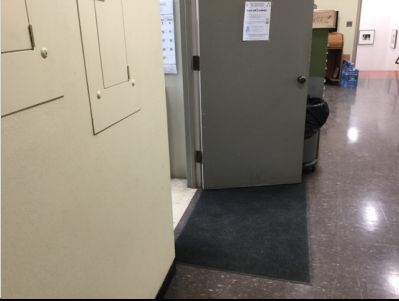
Mat not securely attached Hardware not operable with a closed fist	- -	Install an ADA-compliant walk-off mat. Provide hardware that can be operable with one hand and not require tight grasping, pinching, or twisting of the wrist.	1	484	\$484
23	Meeting Room	2	7	Doors, Doorways, & Gates	Meeting Room

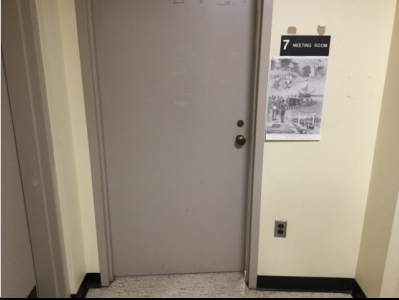
Hardware not operable with a closed fist	-	Provide hardware that can be operable with one hand and not require tight grasping, pinching, or twisting of the wrist.	1	484	\$484

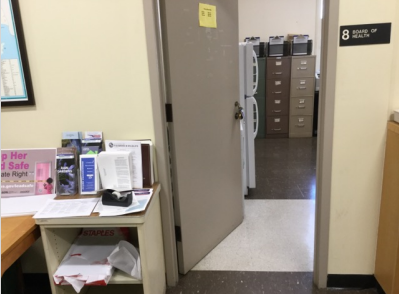
24	Board of Health	2	8	Doors, Doorways, & Gates	Office

Hardware not operable with a closed fist	-	Provide hardware that can be operable with one hand and not require tight grasping, pinching, or twisting of the wrist.	1	484	\$484

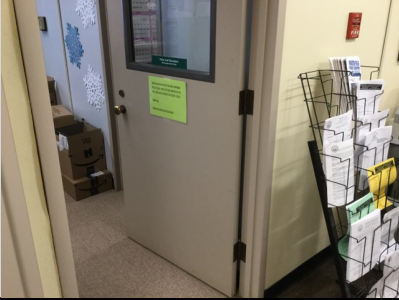
Hardware not operable with a closed fist	-	Provide hardware that can be operable with one hand and not require tight grasping, pinching, or twisting of the wrist.	1	484	\$484
26	Council on Aging	B		Doors, Doorways, & Gates	Office

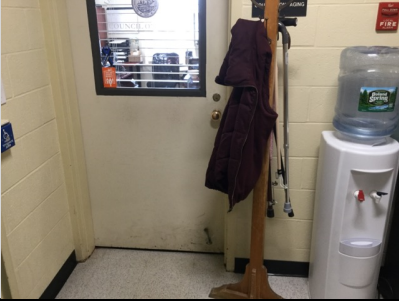
Maneuvering clearance(s) not provided Hardware not operable with a closed fist	- -	Remove coat hook to maintain the maneuvering clearance at the door. Provide hardware that can be operable with one hand and not require tight grasping, pinching, or twisting of the wrist.	1	484	\$484
27	Council on Aging	B		Doors, Doorways, & Gates	Office

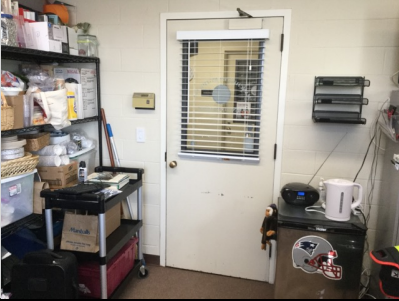
Maneuvering clearance(s) not provided Door requires > 5 lbs. of force to open	- 10 lbs	Relocate table to maintain the maneuvering clearance at the door. Adjust closers so doors do not require more than 5 pounds of force to open.	1	Labor	\$0

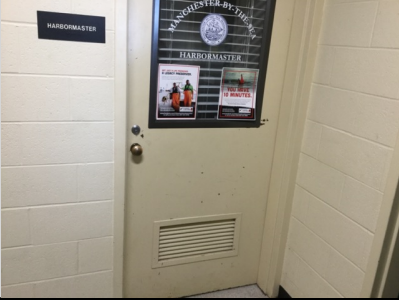
28	Harbormaster	B		Doors, Doorways, & Gates	Office

Hardware not operable with a closed fist	-	Provide hardware that can be operable with one hand and not require tight grasping, pinching, or twisting of the wrist.	1	484	\$484
29	Harbormaster	B		Doors, Doorways, & Gates	Office

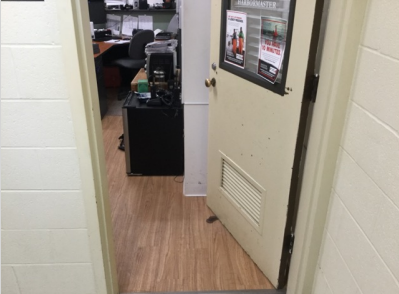
Door requires > 5 lbs. of force to open	10 lbs	Adjust closers so doors do not require more than 5 pounds of force to open.	1	Labor	\$0

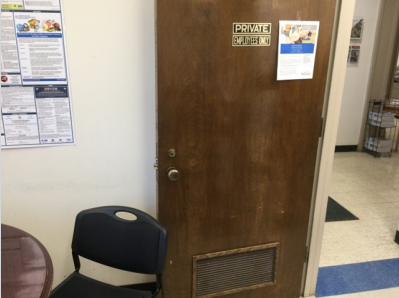
Raised characters not provided Braille not provided Sign not located on the latch side of the door	- - -	Provide text with raised characters duplicated in braille. Locate sign alongside the door on the latch side.	1	232	\$232
31	Selectmen Town Administration	1	3	Signage	Designation

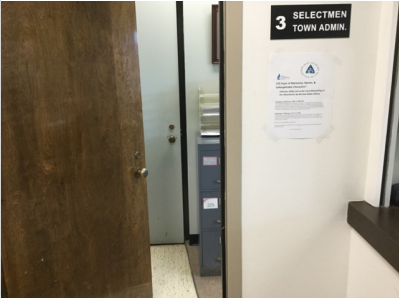
Raised characters not provided on sign Raised characters < 48" or > 60" above ground Braille not provided on sign	- 63.5" -	Provide text with raised characters duplicated in braille on sign. Mount sign so that the baseline of the lowest tactile character is 48" min. above finished floor and the baseline of the highest tactile character is 60" max. above finished floor.	1	232	\$232
32	Assessors	1	2	Signage	Designation

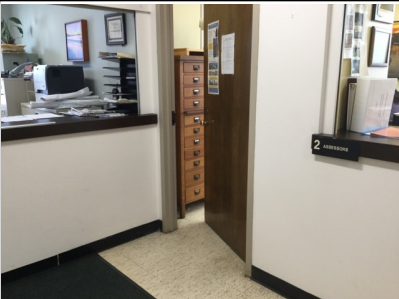
Raised characters < 48" or > 60" above ground Sign not located on the latch side of the door	38.5" -	Mount signs so that the baseline of the lowest tactile character is 48" min. above finished floor and the baseline of the highest tactile character is 60" max. above finished floor. Locate sign at permanent rooms alongside the door on the latch side.	1	Labor	\$0

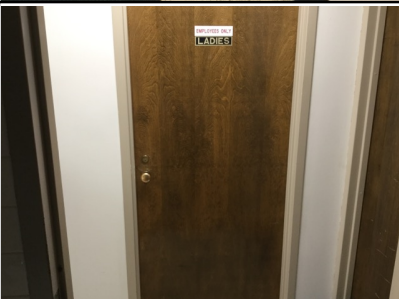
33	Employee Toilet Room	1		Signage	Designation

Sign not located on the latch side of the door Directional sign to access. toilet not provided	- -	Locate sign alongside the door on the latch side. Install a sign indicating the location of the nearest accessible toilet room.	1	232	\$232
34	Men's Toilet Room	1		Signage	Designation

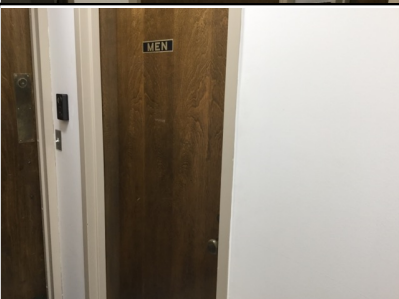
Sign not located on the latch side of the door Directional sign to access. toilet not provided	- -	Locate sign alongside the door on the latch side. Install a sign indicating the location of the nearest accessible toilet room.	1	232	\$232

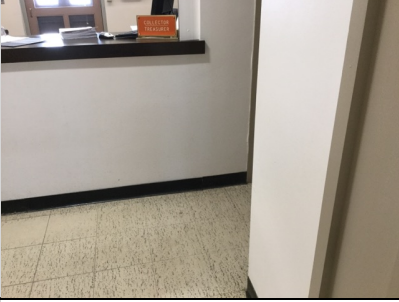
Non glare finish and contrast not provided on sign	-	Install a sign with a non-glare finish with characters that have a high contrast to the background.	1	232	\$232
36	Parks and Recreations	2	9	Signage	Designation

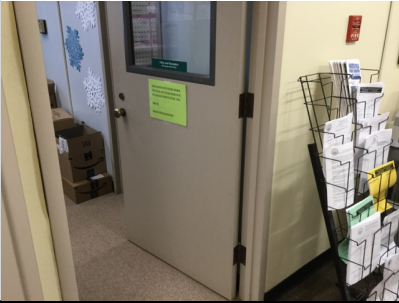
Raised characters not provided on sign Braille not provided on sign Sign not located on the latch side of the door	- - -	Provide text with raised characters duplicated in braille on sign. Locate sign at permanent rooms alongside the door on the latch side.	1	232	\$232
37	Public Works Water & Sewer	2	6	Signage	Designation

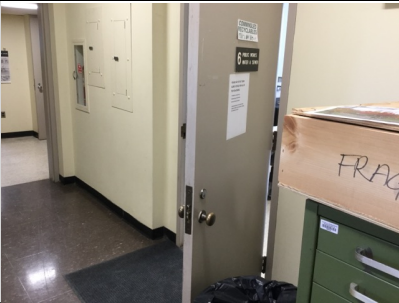
Sign not located on the latch side of the door	-	Locate sign at permanent rooms alongside the door on the latch side.	1	Labor	\$0
38	Selectmen's Meeting Room	2	5	Signage	Designation

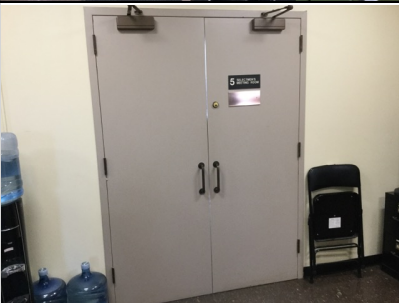
Sign not located on the latch side of the door	-	Locate sign on the inactive door (left hand door).	1	Labor	\$0

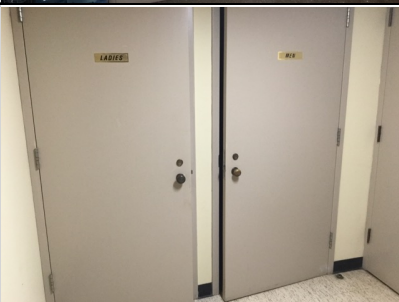
39	Men's and Women's Toilet Rooms	2		Signage	Designation

Sign not located on the latch side of the door Directional sign to access. toilet not provided	- -	Locate signs on the nearest adjacent wall Install a sign indicating the location of the nearest accessible toilet room.	3	232	\$696

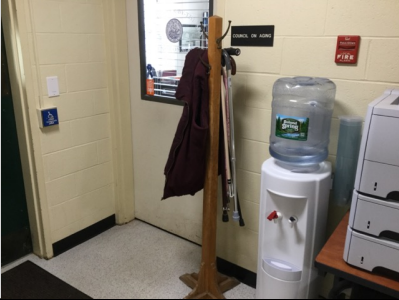
18" by 18" clear space not provided	-	Ensure a clear 18" min. by 18" min. clear floor space is provided. Ensure the clear floor space is centered on the tactile characters	1	Labor	\$0
<b>Service Counter</b>												
41	Assessors	1	2	Service Counter	N/A

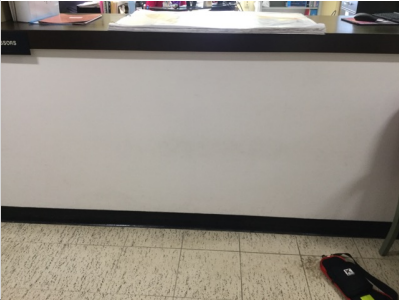
Counter > 36" high	42"	Provide a counter that is 36" max. above the ground or finished floor.	1	880	\$880
42	Collector Treasures	1	1	Service Counter	N/A

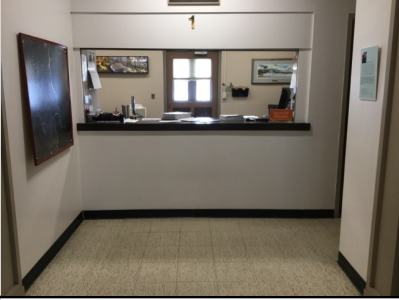
Counter > 36" high	42"	Provide a counter that is 36" max. above the ground or finished floor.	1	880	\$880
43	Selectmen Town Administration	1	3	Service Counter	N/A

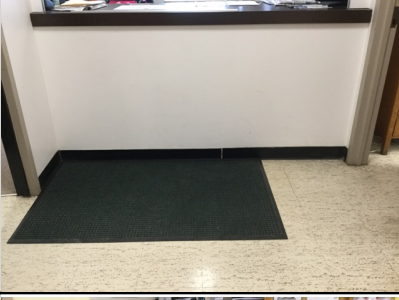
Counter > 36" high Mat not securely attached	42" -	Provide a counter that is 36" max. above the ground or finished floor. Secure the mat to prevent tripping hazard.	1	880	\$880

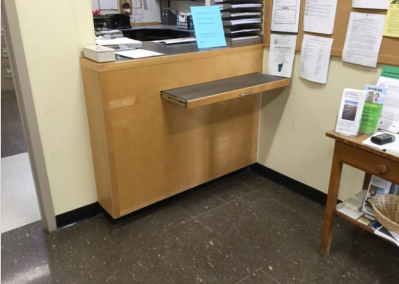
44	Board of Health	2	8	Service Counter	N/A

Clear floor space is not provided	-	Relocate table to maintain the required 30" min. by 48" min. clear floor space at the counter.	1	Labor	\$0

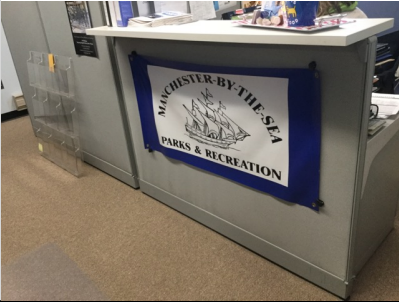
Counter > 36" high	46"	Provide a counter that is 36" max. above the finished floor.	1	880	\$880
Operable Parts												
46	Lobby	1	1	Operable Parts	Other

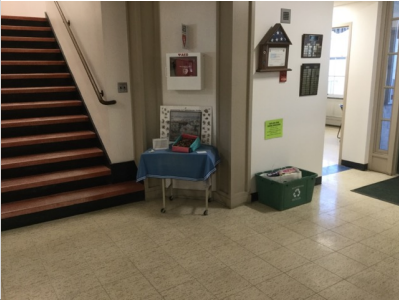
Reach < 15" or > 48"(forward/side approach)	59"	Mount AED cabinet 48" max. above finished floor.	1	256	\$256
47	Hallway	1		Operable Parts	Other

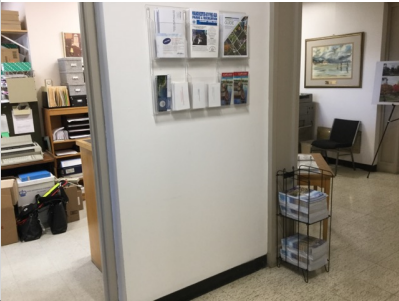
Reach < 15" or > 48"(forward/side approach)	72.5"	Mount flyers rack 48" max. above finished floor.	1	256	\$256
Dining or Work Surfaces												
48	Hallway	B		Dining or Work Surfaces	Work Surface

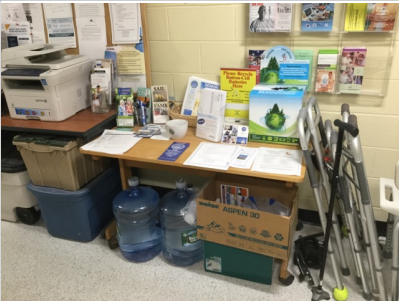
Knee or toe clearance not provided	-	Remove items to maintain knee and toe clearance at the work surface.	1	Labor	\$0
Assembly Area												
49	Meeting Room	2	7	Assembly Area	N/A

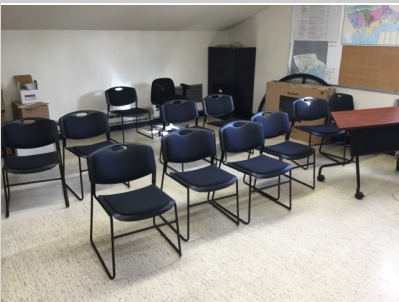
Assistive listening devices not provided	-	If audible communication is integral to the use of the space, provide an assistive listening system.	1	1214	\$1214

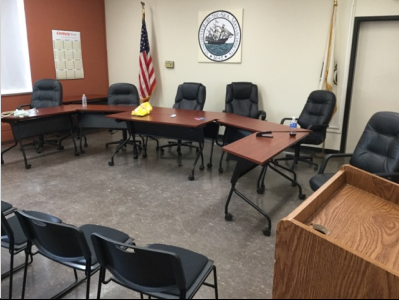
Assistive listening devices not provided	-	If audible communication is integral to the use of the space, provide an assistive listening system.	1	1214	\$1214
Toilet & Bathing Rooms												
Overall Access												
51	Men's and Women's Toilet Rooms	2		Overall Access	Toilet Room

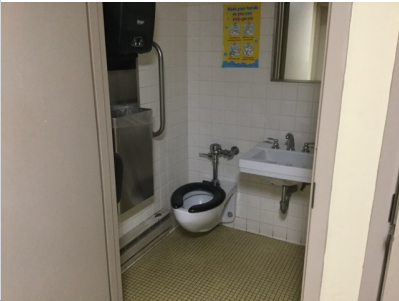
Turning space not provided Accessible plumbing fixtures or stalls not provided	- -	Provide an accessible single-user toilet room.	1	24604	\$24604
Lavatory												
52	Single-User Toilet Room	1		Lavatory	N/A

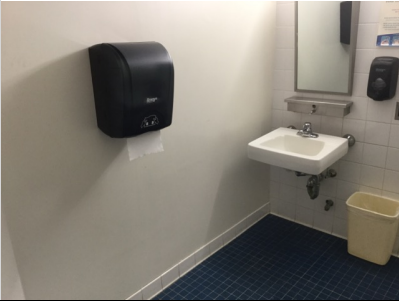
Plumbing underneath is exposed Mirror above lavatory w/reflective surface > 40"	- 42.5"	Insulate or otherwise configure pipes to prevent contact, for at least one lavatory. Lower mirror so that the bottom surface is at 40" max. above finished floor.	1	348	\$348

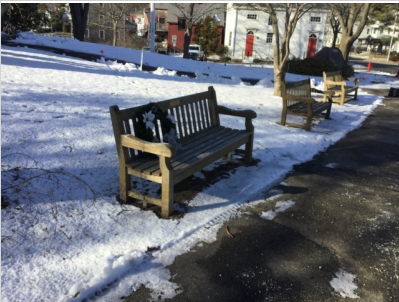
Recommend providing a 30" by 48" clear floor space adjacent to the benches.	1	-	\$0

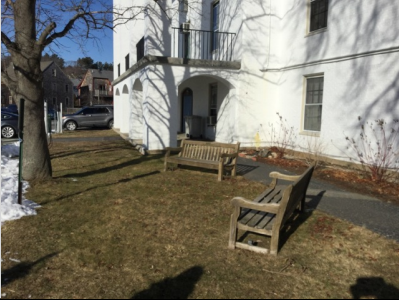
Recommend providing a 30" by 48" clear floor space adjacent to the benches.	1	-	\$0
Directory												
55	Lobby	1	1	Directory	N/A

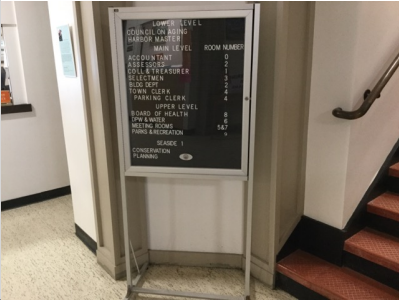
Recommend relocating the directory to avoid glare.	1	-	\$0
56	Across From Elevator	1	1	Directory	N/A

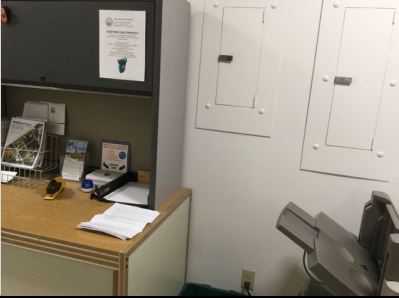
Recommend providing a directory here.	1	-	\$0
57	Across From Elevator	2		Directory	N/A

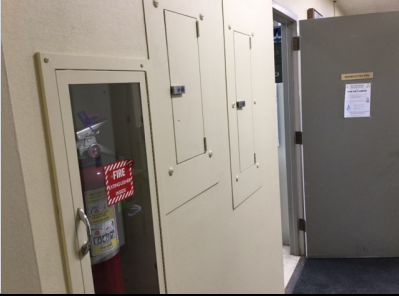
Recommend providing a directory here.	1	-	\$0
EV Parking Space												
58	Parking Lot - Accessible EV Space	Ext.		EV Parking Space	N/A

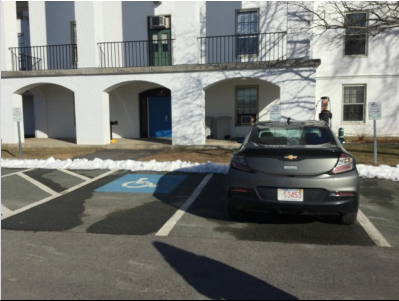
Recommend providing an accessible route on both sides of the vehicle spaces that connects to the charging station.	1	-	\$0

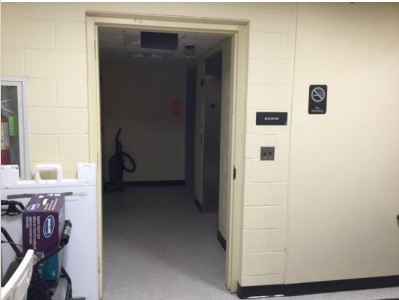
Recommend providing a more visible sign.	1	-	\$0
Stairs												
60	From 1st Floor to 2nd Floor	1		Stairs	N/A

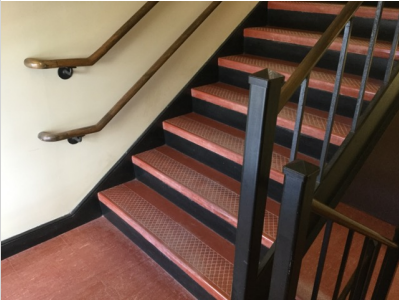
Recommend adding contrasting strips at the edge of each step at interior stairs.	1	-	\$0
61	From 1st Floor to 2nd Floor	2		Stairs	N/A

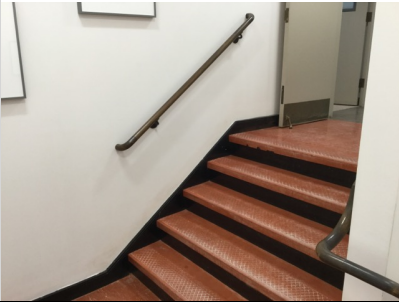
-	Recommend providing handrail extensions at top and bottom of stairs.	1	-	\$0
62	Main Entrance	Ext.		Stairs	N/A

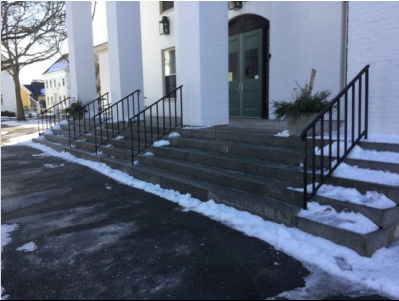
-	Recommend adding contrasting strips at the edge of each step at exterior stairs.	1	-	\$0
