Wastewater Treatment Plant

Town of Manchester-by-the-Sea ADA Transition Plan

March 2020

Town of Manchester-by-the-Sea
Water Treatment Plant

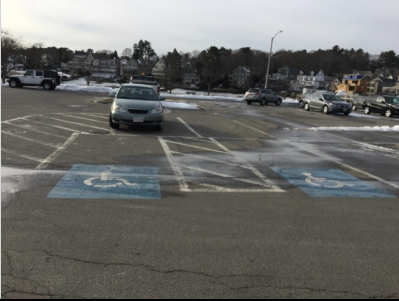
Total # of parking Total # of designated accessible parking spaces Total # of designated van accessible spaces Vehicle space < 96" wide at car space Vehicle space < 132" wide at van space Access aisle < 96" wide at van space Sign not provided Sign does not have the designation "Van Accessible"	75 2 - 88" - 56" - -	Provide a car accessible space 96" wide min. with an access aisle 60" wide min. (re-stripe.) Provide a van accessible space near the ramp to the accessible entrance 96" wide min. with an access aisle 96" wide min. (Relocate one accessible space.) Provide a sign with the International Symbol of Accessibility (ISA) at both spaces. Add the designation "Van Accessible" to the van parking space sign.	1	2950	\$2950

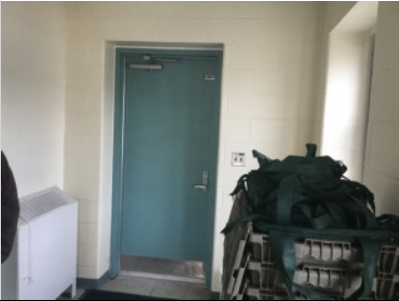
Emergency Exit												
2	Main Entrance Vestibule	1		Emergency Exit	N/A

Tactile exit sign not provided Emergency exit not on an accessible route Directional sign to accessible emergency exit not provided	- -	Ensure tactile exit signs with raised characters and braille are provided at exit doors. Mount signs between 48"- 60" above finished floor located on the latch side of the door. Provide a directional sign indicating the location of the nearest accessible emergency exit.	2	232	\$464
Access to Goods and Services												
Means of Egress												
3	Main Building Path Back Towards Main Entrance and Egress	1		Means of Egress	N/A

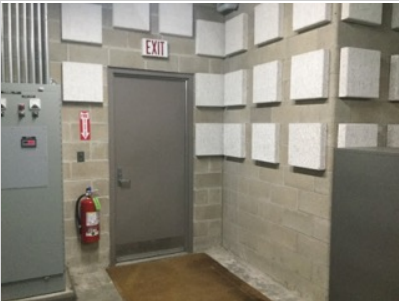
Tactile exit sign not provided	-	Ensure tactile exit signs with raised characters and braille are provided at exit doors. Mount signs between 48"- 60" above finished floor located on the latch side of the door.	1	232	\$232
4	Exit to Vestibule and Ramp			Means of Egress	N/A

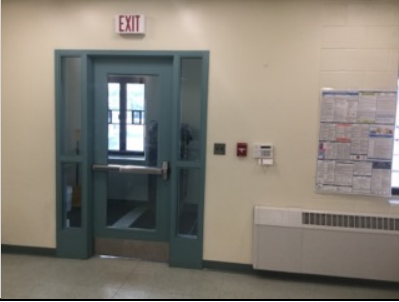
Tactile exit sign not provided	-	Ensure tactile exit signs with raised characters and braille are provided at exit doors. Mount signs between 48"- 60" above finished floor located on the latch side of the door.	1	232	\$232

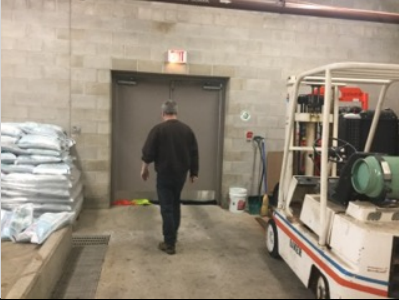
ID	Location	Floor	Room	Element	Type	Photo	Issues	Current Measure	Recommendations	Quantity	Price	Cost Estimation
5	Main Building Emergency Egress	1		Means of Egress	N/A

Tactile exit sign not provided Illuminated Int. Symbol of Acc. not provided (MAAB)	-	Ensure tactile exit signs with raised characters and braille are provided at exit doors. Mount signs between 48"- 60" above finished floor located on the latch side of the door. Provide an illuminated International Symbol of Accessibility.	1	432	\$432
6	Exit to Ramp	1	A	Means of Egress	N/A

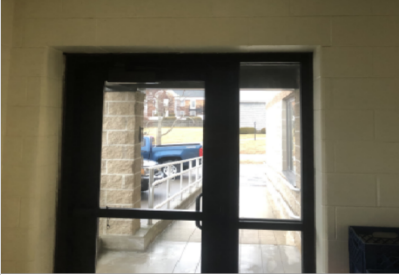
Tactile exit sign not provided Illuminated Int. Symbol of Acc. not provided (MAAB)	-	Ensure tactile exit signs with raised characters and braille are provided at exit doors. Mount signs between 48"- 60" above finished floor located on the latch side of the door. Provide an illuminated exit sign with an illuminated International Symbol of Accessibility.	2	216	\$432

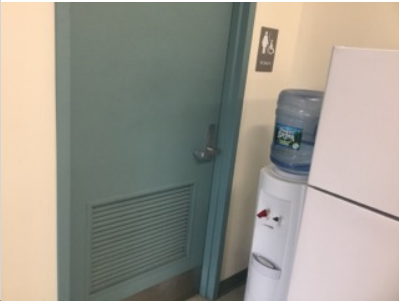
Doors, Doorways, & Gates												
7	Women's Toilet Room			Doors, Doorways, & Gates	Toilet Room

Maneuvering clearance(s) not provided	-	Relocate water cooler and refrigerator so as not to obstruct maneuvering clearance at door.	1	Labor	\$0
8	Men's Toilet Room	1		Doors, Doorways, & Gates	Toilet Room

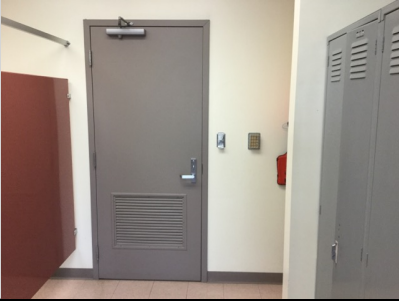
Door requires > 5 lbs. of force to open	10 lbs	Adjust closers so doors do not require more than 5 pounds of force to open.	1	Labor	\$0
Ramps												
9	Main Entrance to Main Building	Ext.		Ramps	Exterior

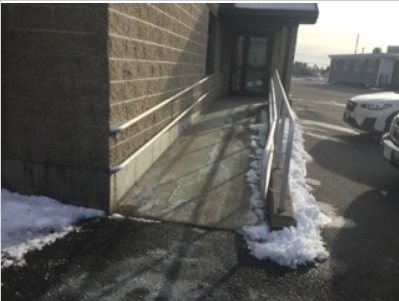
Handrails do not extend 12" past top & bottom Level changes > 1/4"	-	Alter handrails to extend horizontally above the landing for 12" min. beyond the bottom of ramp run on one side. Alter change in level to be 1/4" high max. (Cost based on welding on one rail extension and a 3'x3' asphalt patch at base of ramp.)	1	178	\$178

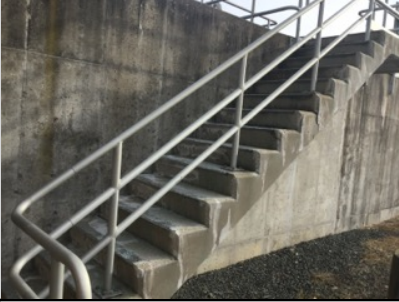
ID	Location	Floor	Room	Element	Type	Photo	Issues	Current Measure	Recommendations	Quantity	Price	Cost Estimation
Stairways												
10	Water Aeration Area	Ext.		Stairways	Exterior

Handrail not provided on both sides Accessible route not provided	-	Provide handrail on one side. During tours, provide information (photos, text) about aeration area at an accessible location. (Cost based on one 30' wall-mounted metal handrail.)	1	2220	\$2220
11	Clarifier Tanks	Ext.		Stairways	Exterior

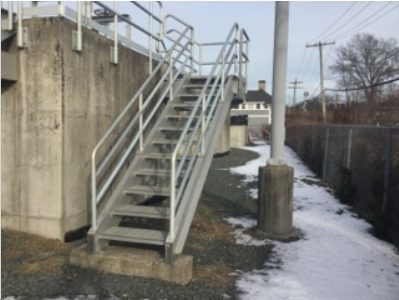
Handrails do not extend 12" from stairs Accessible route not provided	-	Bottom of stairs: Ensure handrails extend to one tread depth beyond the last riser. During tours, provide information (photos, text) about clarifier tanks at an accessible location. (Cost based on welding on rail extensions.)	2	142	\$284
Kitchens and Kitchenettes												
12	Main Building			Kitchens and Kitchenettes	N/A

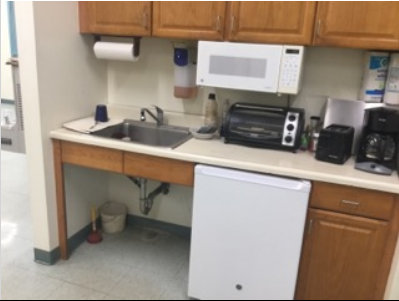
Plumbing underneath is exposed	-	Insulate or otherwise configure pipes to prevent contact.	1	92	\$92

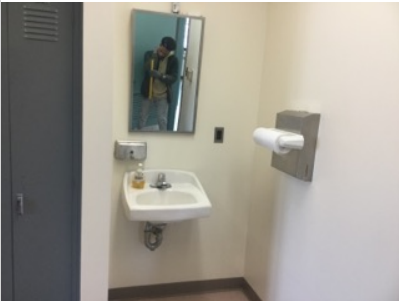
Toilet & Bathing Rooms												
Lavatory												
13	Women's Toilet Room			Lavatory	N/A

Plumbing underneath is exposed Dispenser acts as a protruding object	-	Insulate or otherwise configure pipes to prevent contact, for at least one lavatory. Relocate plastic paper towel dispenser out of the circulation path.	1	798	\$798

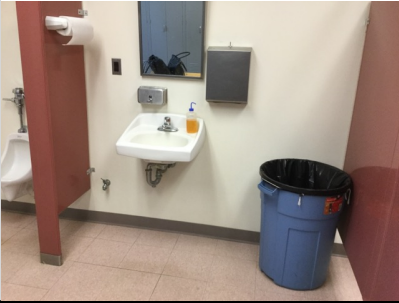
ID	Location	Floor	Room	Element	Type	Photo	Issues	Current Measure	Recommendations	Quantity	Price	Cost Estimation
14	Men's Toilet Room	1		Lavatory	N/A

Plumbing underneath is exposed Mirror above lavatory w/reflective surface > 40" Dispensers not within reach range	- 48" 60"	Insulate or otherwise configure pipes to prevent contact, for at least one lavatory. Lower mirror so that the bottom surface is at 40" max. above finished floor. Relocate dispenser to 42" max. above the floor.	1	1058	\$1058
Toilet Compartment												
15	Men's Toilet Room			Toilet Compartment	Accessible Compartment

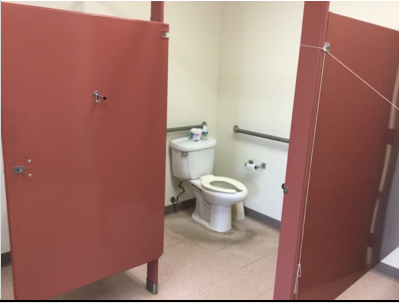
Door has malfunctioning self-closing hinge	-	Repair hinge.	1	Labor	\$0
Best Practice												
Exterior Route to Ramp Landing												
16	Parking Near Exterior Ramp	Ext.		Exterior Route to Ramp Landing	N/A

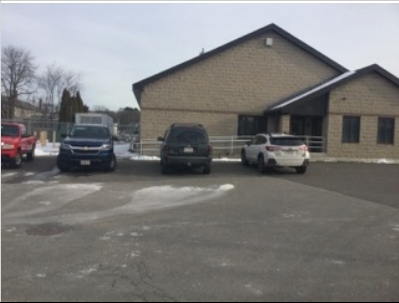
Recommend providing striping by the exterior ramp landing so access to the landing is not obstructed by parked cars.	1	-	\$0
