Tuck's Point

Town of Manchester-by-the-Sea ADA Transition Plan

March 2020

Institute for Human Centered Design

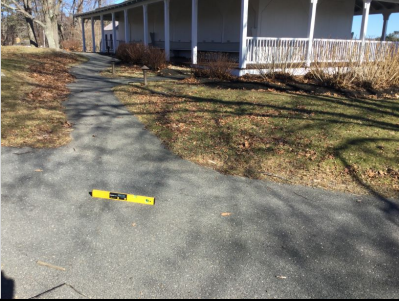
Cross slope > 1:48 (2.08%)	6.1%	Reduce cross slope to be no steeper than 1:48 (2.08%). (Cost based on 6'x4' of asphalt to reduce slope at \$10 a square foot.)	1	240	\$240
2	Towards Toilet Rooms	Ext.		Exterior Access Route	Walkway

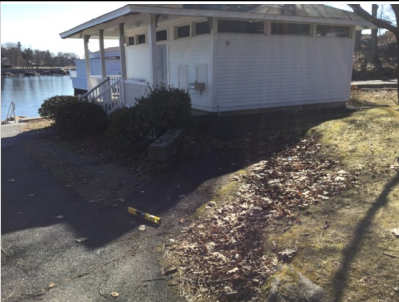
Cross slope > 1:50 (2.00%) (MAAB) Running slope > 1:20 (5.00%)	4.6% 5.5%	Reduce cross slope to be no steeper than 1:50 (2.00%). Reduce the running slope to be no steeper than 1:20 (5.00%). (Cost to reduce excessive running slope not provided.)	1	-	\$0
3	Gazebo Towards Toilets	Ext.		Exterior Access Route	Exterior

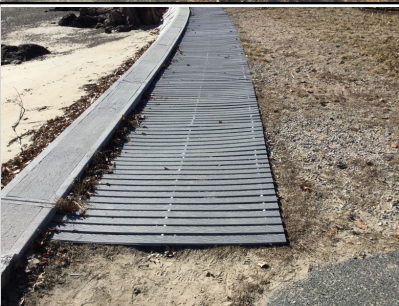
Level changes > 1/4"	2"	Alter change in level to be 1/4" high max. (Cost based on 4'x3' of asphalt to reduce change in level and provide a stable, firm and slip resistant surface between asphalt and mat walkway.)	1	120	\$120

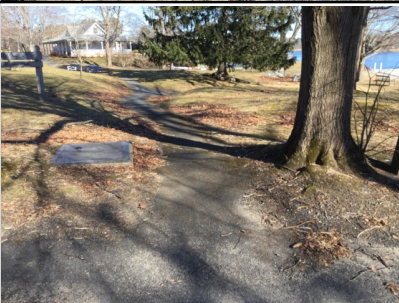
4	Towards Toilet Rooms	Ext.		Exterior Access Route	Walkway

Not maintained in an operable working condition	-	Ensure the accessible route is maintained in operable working condition. Cost based on a 60 ft. long by 4 ft wide asphalt route.	1	2400	\$2400
5	Walkway From Parking Towards Gazebo	Ext.		Exterior Access Route	Walkway

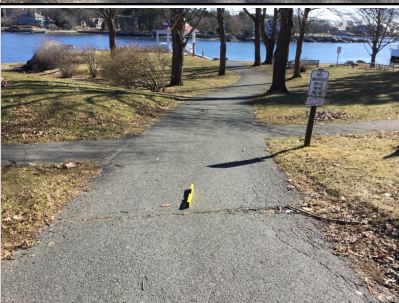
Running slope > 1:20 (5.00%)	8.2%	Reduce the running slope to be no steeper than 1:20 (5.00%). (Cost to reduce excessive running slope not provided.)	1	-	\$0

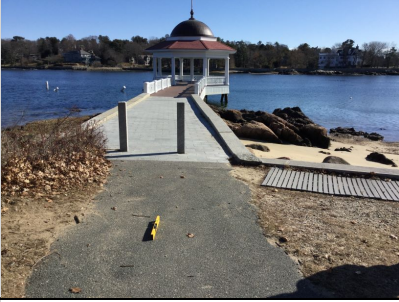
Running slope > 1:20 (5.00%)	8.6%	Reduce the running slope to be no steeper than 1:20 (5.00%). (Cost to reduce excessive running slope not provided.)	1	-	\$0
7	Towards Chowder House	Ext.		Exterior Access Route	Walkway

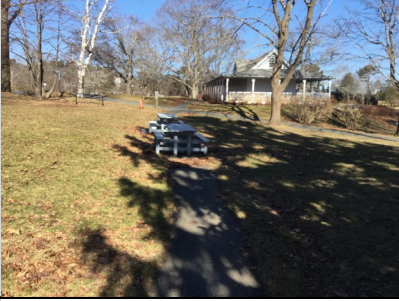
Accessible route not provided	-	Relocate tables to ensure the min. 36' width is maintained at the accessible route.	1	Labor	\$0
8	Horseshoe Pits	Ext.		Exterior Access Route	Exterior

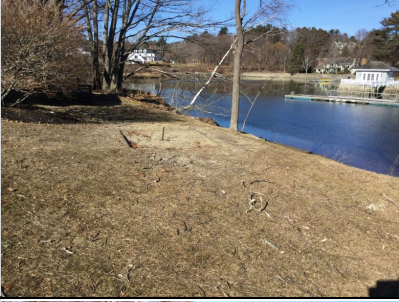
Accessible route not provided	-	Ensure an accessible route is provided to at least one of the horseshoe pits. (Cost based on a 30'x48" wide min. 30' asphalt path to at least one of the horseshoe pits in this area. Ensure walkway has a running slope of 1:20 (5.00%) max. and a cross slope of 1:50 (2.00%) max.)	1	1200	\$1200

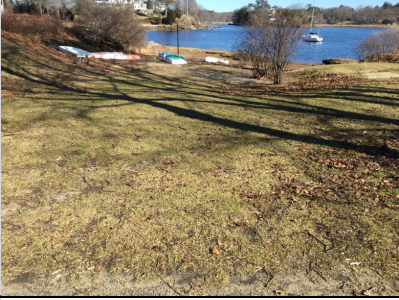
9	Path to Boats	Ext.		Exterior Access Route	Exterior

Accessible route not provided	-	Ensure an accessible route is provided to the area where the boats are stored. (Cost based on a 36'x48" wide min. 60' asphalt path to the accessible picnic table in this area. Ensure walkway has a running slope of 1:20 (5.00%) max. and a cross slope of 1:50 (2.00%) max.)	1	2400	\$2400
10	Life Vest Loaner Station	Ext.		Exterior Access Route	Exterior

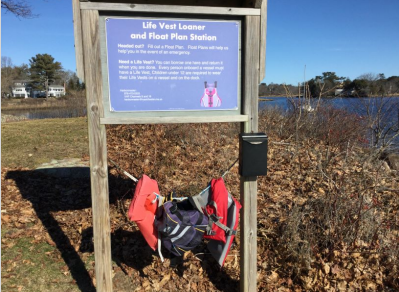
Accessible route not provided	-	Ensure an accessible route is provided to the life vest loaner station. (Cost based on a 30'x48" wide min. 30' asphalt path to at least one of the horseshoe pits in this area. Ensure walkway has a running slope of 1:20 (5.00%) max. and a cross slope of 1:50 (2.00%) max.)	1	1200	\$1200

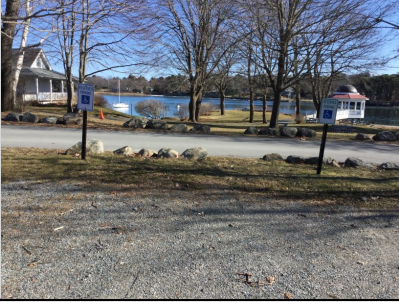
Total # of parking Total # of designated accessible parking spaces Access aisle < 96" wide at van space Sign does not have the designation "Van Accessible" Sign < 60" above finished grade	55 2 - - 38"	Provide a marked access aisle that is at least 96" wide. Add the designation "Van Accessible" to the sign located at the van accessible space. Locate sign with the bottom of the sign 60" above the ground.	1	800	\$800
Access to Goods and Services												
Doors, Doorways, & Gates												
12	Women's Toilet Room	1		Doors, Doorways, & Gates	Toilet Room

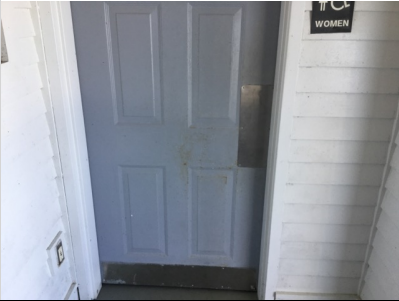
Door requires > 5 lbs of force to open	14 lbs	Adjust closers so doors do not require more than 5 pounds of force to open.	1	Labor	\$0

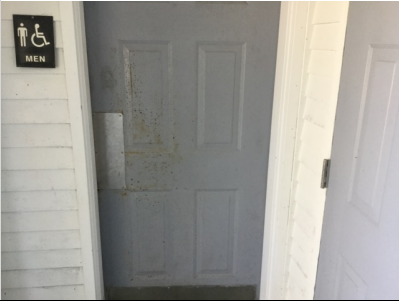
13	Men's Toilet Room	Ext.		Doors, Doorways, & Gates	Toilet Room

Door requires > 5 lbs of force to open	9 lbs	Adjust closers so doors do not require more than 5 pounds of force to open.	1	Labor	\$0
Picnic Tables												
14	Near Parking	Ext.		Picnic Tables	N/A

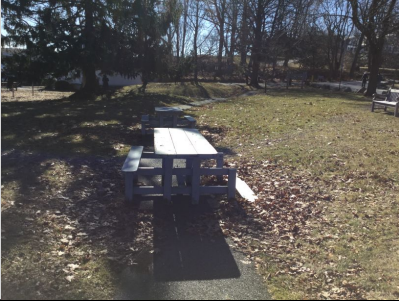
Toe or knee clearance at table not provided	-	Provide at least one picnic table with toe and knee clearance.	1	1400	\$1400

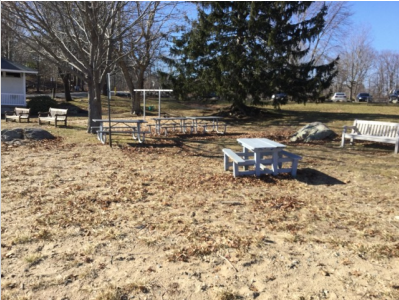
Toe or knee clearance at table not provided Picnic table not on an accessible route	- -	Provide at least one picnic table with toe and knee clearance. Provide an accessible route to at least one picnic table in this area. (Cost based on a 15 ft. long by 4 ft. wide asphalt path.)	1	600	\$600
16	Chowder House Exterior by Ocean	Ext.		Picnic Tables	N/A

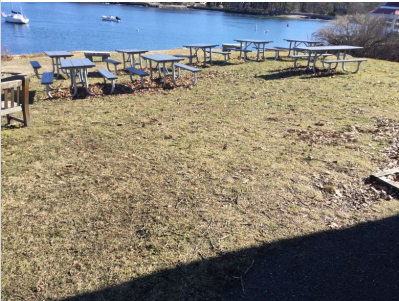
Picnic table not on an accessible route	-	Locate picnic table on an accessible route. (Cost based on a 30'x48" wide min. 30' asphalt path to the accessible picnic table in this area. Ensure walkway has a running slope of 1:20 (5.00%) max. and a cross slope of 1:50 (2.00%) max.)	1	1200	\$1200
17	Near Gazebo	Ext.		Picnic Tables	N/A

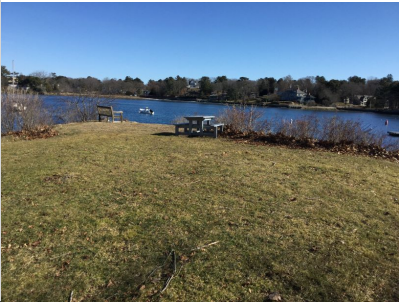
Picnic table not on an accessible route	-	Locate accessible picnic table in this area on an accessible route. (Cost based on a 30'x48" wide min. 30' asphalt path to at least one of the horseshoe pits in this area. Ensure walkway has a running slope of 1:20 (5.00%) max. and a cross slope of 1:50 (2.00%) max.)	1	1200	\$1200

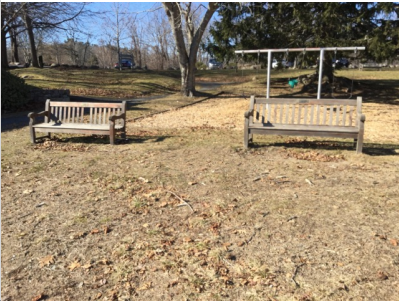
Benches												
18	Near Playground	Ext.		Benches	N/A

No accessible route to one bench in this area	-	Provide an accessible route to at least one bench in this area. Cost based on an 10 ft. long by 4 ft. wide asphalt route.	1	400	\$400
19	Chowder House Exterior by Ocean	Ext.		Benches	N/A

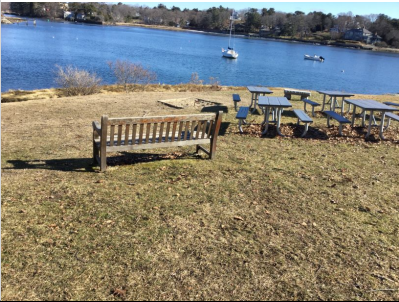
No accessible route to one bench in this area		Provide an accessible route to at least one bench in this area. (Cost based on a 30'x48" wide min. 30' asphalt path to at least one of the benches in this area. Ensure walkway has a running slope of 1:20 (5.00%) max. and a cross slope of 1:50 (2.00%) max.)	1	1200	\$1200

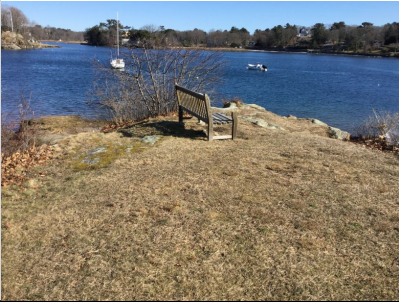
No accessible route to one bench in this area	-	Provide an accessible route to at least one bench in this area. (Cost based on a 30'x48" wide min. 30' asphalt path to at least one of the horseshoe pits in this area. Ensure walkway has a running slope of 1:20 (5.00%) max. and a cross slope of 1:50 (2.00%) max.)	1	1200	\$1200
Bike Racks												
21		Ext.		Bike Racks	N/A

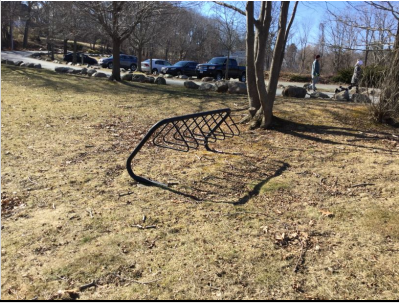
Not connected to an accessible route	-	Ensure bike racks are connected to an accessible route. (Cost based on a 18'x48" wide min. 15' asphalt path to bike rack. Ensure walkway has a running slope of 1:20 (5.00%) max. and a cross slope of 1:50 (2.00%) max.)	1	600	\$600
Toilet & Bathing Rooms												
Lavatory												
22	Women's Toilet Room	Ext.		Lavatory	N/A

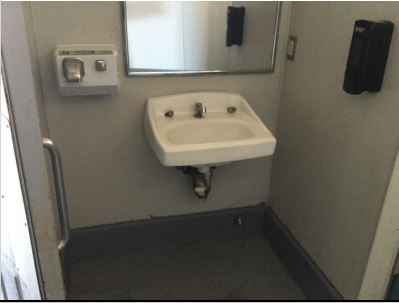
Accessibility issues include flush control not located on the open/transfer side of the toilet (men's toilet room), lack of insulated pipes at lavatory (women's toilet room).

Exposed plumbing underneath	-	Insulate or otherwise configure pipes to prevent contact, for at least one lavatory.	1	92	\$92

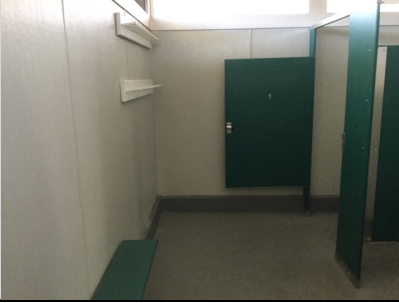
Toilet Compartment												
23	Men's Toilet Room	1		Toilet Compartment	Accessible Compartment

Door with malfunctioning self-closing hinge Coat hook > 48"	- 57"	Repair hinge. Lower coat hook so that it is no higher than 48" above the finished floor.	1	150	\$150

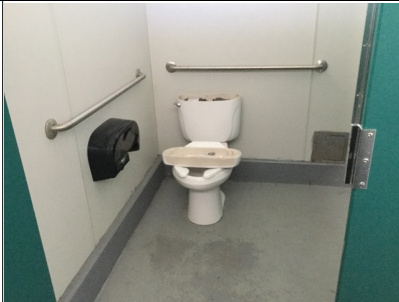
Flush control not on open side	-	Provide the flush control on the open side of the toilet (transfer side).	1	374	\$374	
Urinal													
25	Men's Toilet Room	Ext.		Urinal	N/A

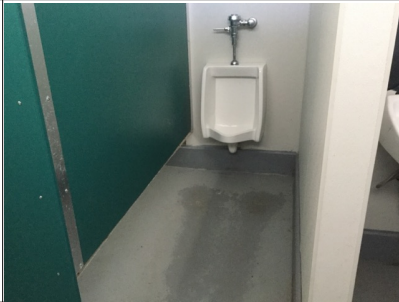
Clear floor space not provided at urinal	-	Remove partition to provide a 30" min. by 48" min. clear floor space positioned for a forward approach.	1	256	\$256	
Additional Access													
Drinking Fountains													
26	By Toilet Rooms	Ext.		Drinking Fountains	Seated

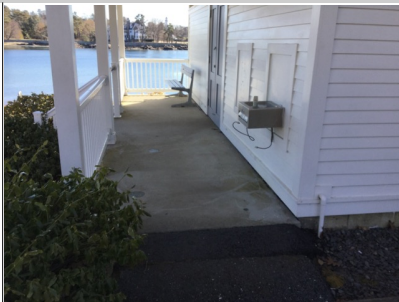
No drinking fountain provided for standing users	-	Provide an additional drinking fountain for standing users or install a Hi-Lo drinking fountain.	1	4028	\$4028	
Sink													
27	Kitchen			Sink	Other

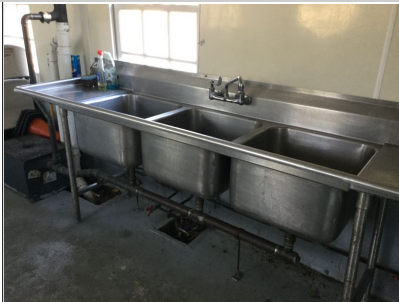
Toe and knee clearances not provided	-	Ensure there is a 27" knee clearance positioned for a forward approach to sink. (Cost based on a sink with the required minimum toe and knee clearance.)	1	1686	\$1686

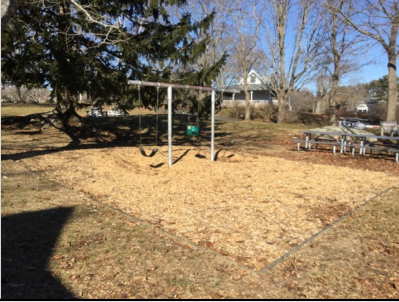
Major accessibility issues include the lack of a compliant accessible route around the playground and lack of an accessible route to each play component.

Note: The Massachusetts Architectural Access Board (MAAB) does not consider engineered wood fiber (EWF) to comply with its regulation requiring an accessible route to each play component and around the playground.

Accessible route not provided to playground Accessible route not provided at play components Surface not stable, firm, and slip-resistant	<ul style="list-style-type: none">---	Provide an accessible route to and around the playground. (30'x48" wide min. asphalt.) Provide an accessible route that is 60" min. wide to each play component in the playground. (Poured-in-place rubber.) Provide a compliant impact-attenuating surface under and around the play components. (25 sq.' poured-in-place rubber.) (Cost includes poured-in-place rubber.)	1	11150	\$11150
Best Practice												
Bench												
29	Women's Toilet Room & Men's Toilet Room	Ext.		Bench	N/A

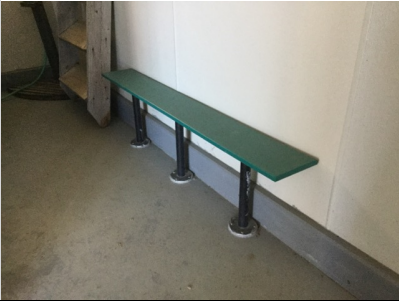
Recommend having a bench that is between 20" and 24" deep.	2	-	\$0

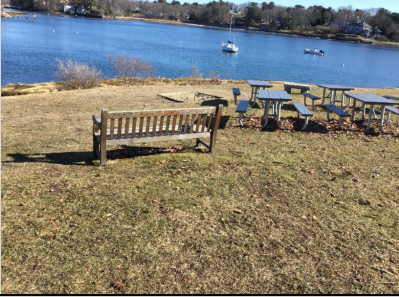
30	Chowder House Exterior by Ocean	Ext.		ench	N/A

Recommend proving a 36"x48" stable, firm and slip resistant surface at the end of at least one bench in each area positioned so that an individual with a wheeled mobility device can have shoulder alignment with a companion seated on the bench.	1	-	\$0
Picnic Table												
31	Near Parking	Ext.		Picnic Table	N/A

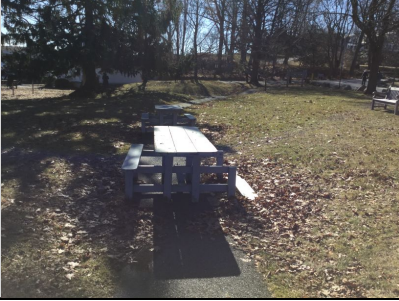
Recommend providing a 48" stable, firm and slip resistant surface around the exterior of all accessible picnic tables.	1	-	\$0
