Manchester-by-the-Sea, Massachusetts

Stream Crossing Evaluation, Sawmill Brook Watershed

Stream Crossing Evaluation in Sawmill Brook Watershed

TO: Mary Reilly, Manchester-by-the-Sea Grants Administrator
FROM: Gabrielle C. Belfit, Janet Moonan; Tighe & Bond
COPY: M. Gregory Federspiel, Town Administrator
David A. Murphy, P.E. Vice President, Tighe & Bond
DATE: July 28, 2015

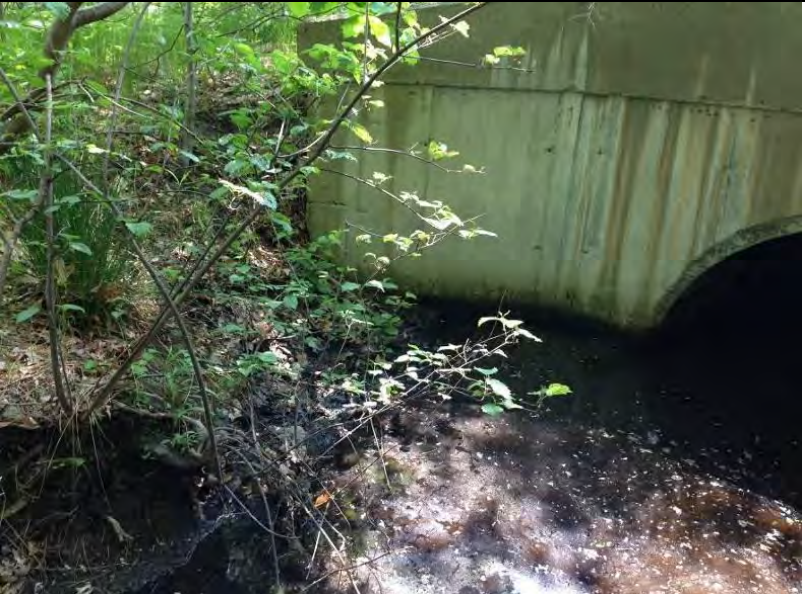
Tighe&Bond		PHOTOGRAPHIC LOG	
Client Name: Manchester-by-the Sea, MA		Site Location: Sawmill Brook Watershed, Millets Ln. Culvert #12	Project No. M-1476
Photo No. 4	Date: 5/30/15

Direction Photo Taken: NW			
Description: Sawmill Brook. View of inlet bank conditions.

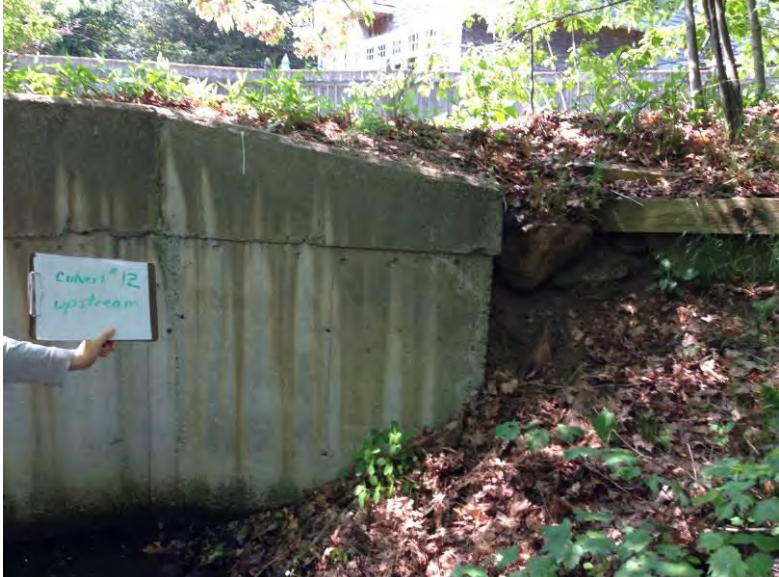
Tighe&Bond		PHOTOGRAPHIC LOG	
Client Name: Manchester-by-the Sea, MA		Site Location: Sawmill Brook Watershed, Millets Ln Culvert #12	Project No. M-1476
Photo No. 5	Date: 5/30/15

Direction Photo Taken: NW			
Description: Sawmill Brook. View of inlet bank conditions

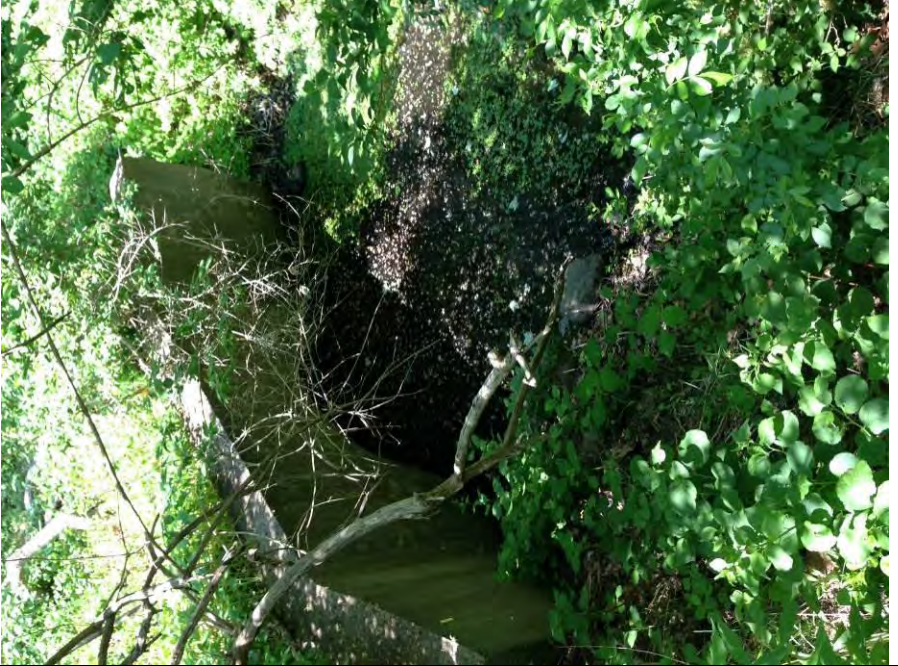
Tighe&Bond		PHOTOGRAPHIC LOG	
Client Name: Manchester-by-the Sea, MA		Site Location: Sawmill Brook Watershed, The Plains Culvert #13	Project No. M-1476
Photo No. 3	Date: 5/30/15

Direction Photo Taken: SE			
Description: Sawmill Brook. View upstream bank conditions.

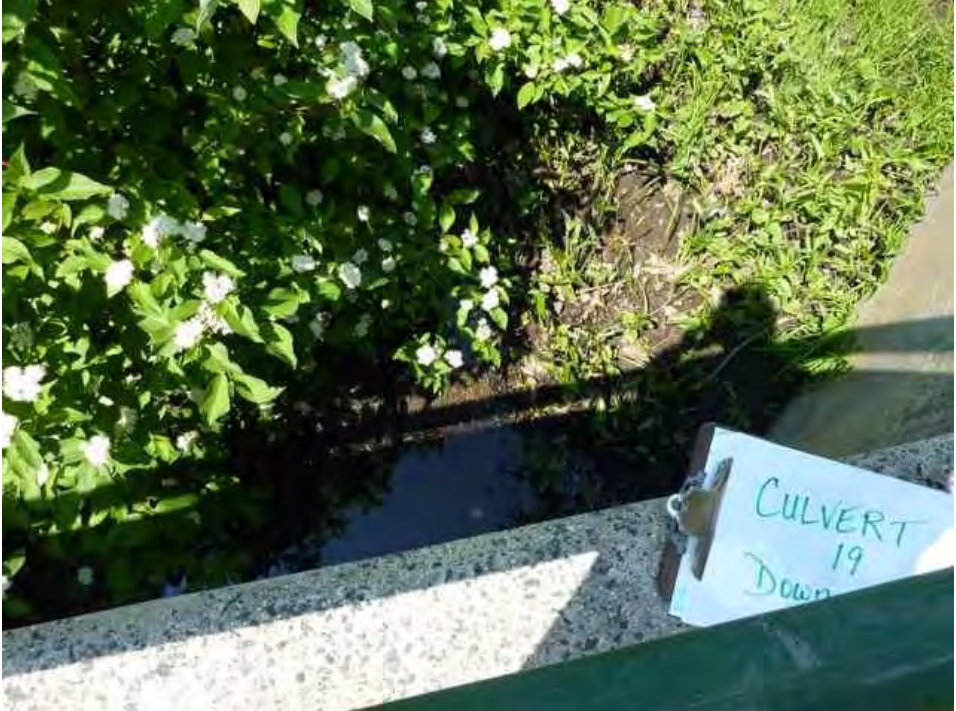
Tighe&Bond		PHOTOGRAPHIC LOG	
Client Name: Manchester-by-the Sea, MA		Site Location: Sawmill Brook Watershed, 153 School St/Golf Course Culvert #19	Project No. M-1476
Photo No. 5	Date: 5/30/15

Direction Photo Taken: NA			
Description: Causeway Brook Overhead view of outlet from the road to show bank growth.

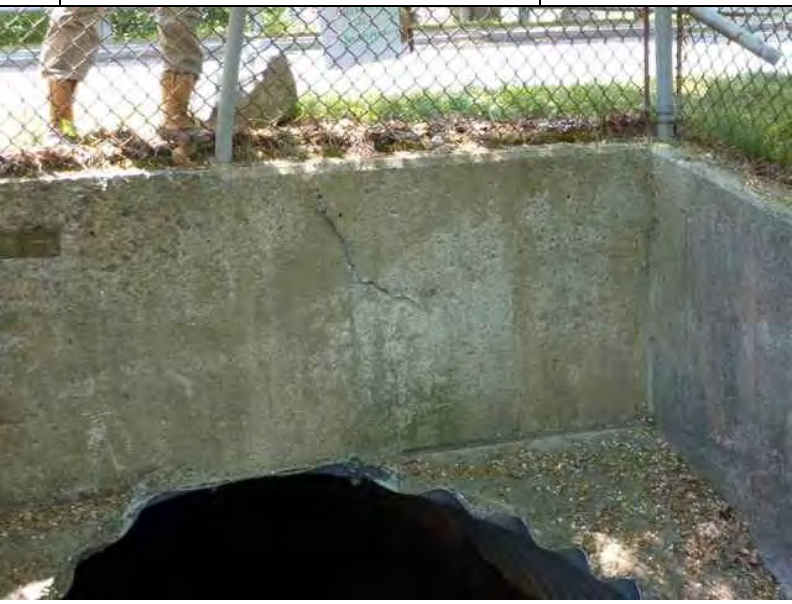
Tighe&Bond		PHOTOGRAPHIC LOG	
Client Name: Manchester-by-the Sea, MA		Site Location: Sawmill Brook Watershed, Summer St. Culvert #20	Project No. M-1476
Photo No. 4	Date: 5/30/15

→ top of concrete above culvert is cracked & photographed

Direction Photo Taken: S			
Description: Causeway Brook. View of outlet, crack in concrete headwall.

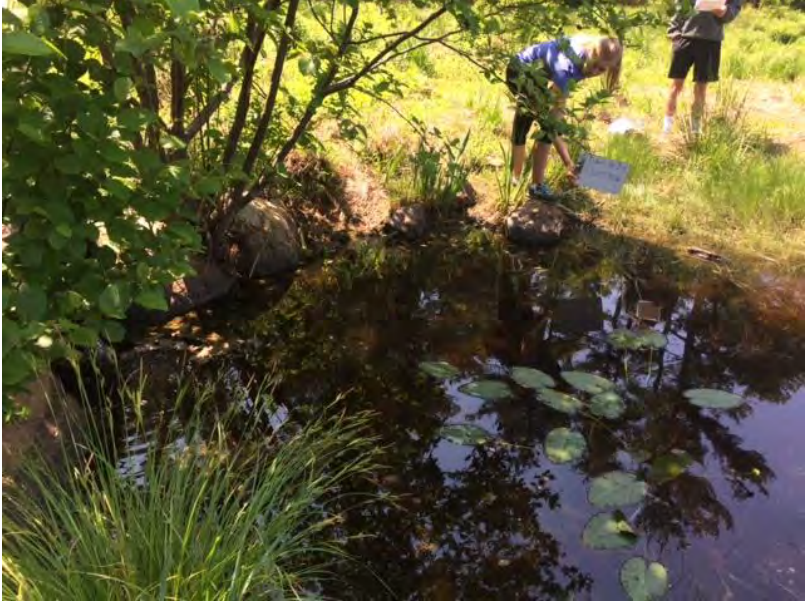
Tighe&Bond		PHOTOGRAPHIC LOG	
Client Name: Manchester-by-the Sea, MA		Site Location: Sawmill Brook Watershed, 185 Summer St. Culvert #24	Project No. M-1476
Photo No. 5	Date: 5/30/15

Direction Photo Taken: SW			
Description: Causeway Brook. View of downstream banks.

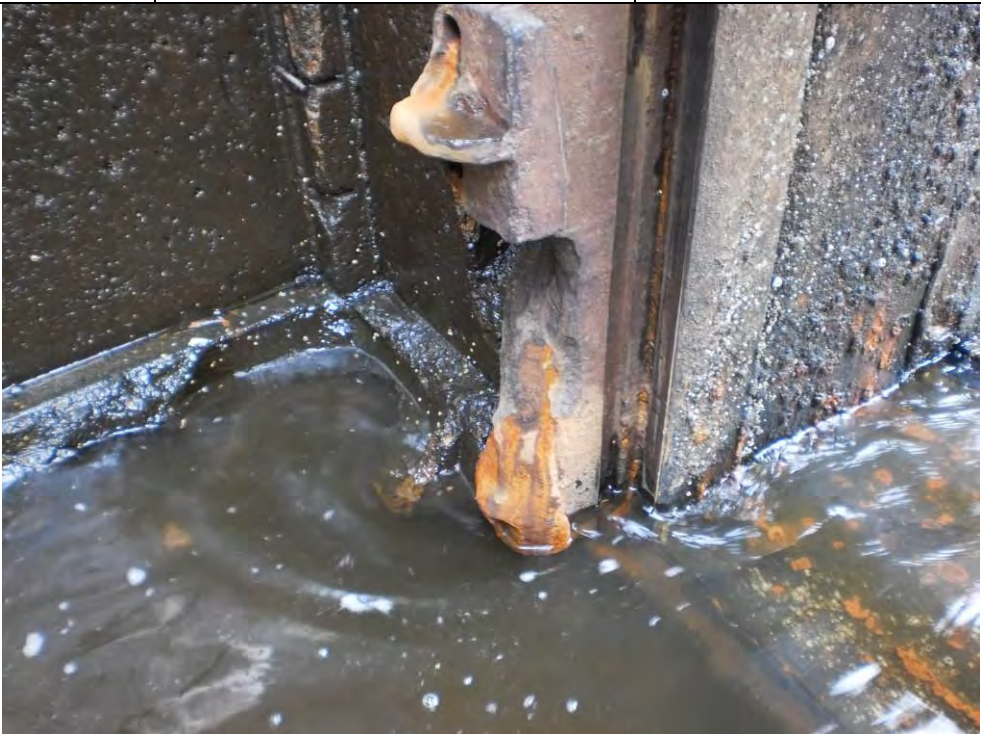
Tighe&Bond		PHOTOGRAPHIC LOG	
Client Name: Manchester-by-the Sea, MA		Site Location: Sawmill Brook Watershed, Sawmill Brook Tide Gate Culvert	Project No. M-1476
Photo No. 7	Date: 6/11/15

Direction Photo Taken: SE			
Description: Gate track near invert with corrosion/erosion

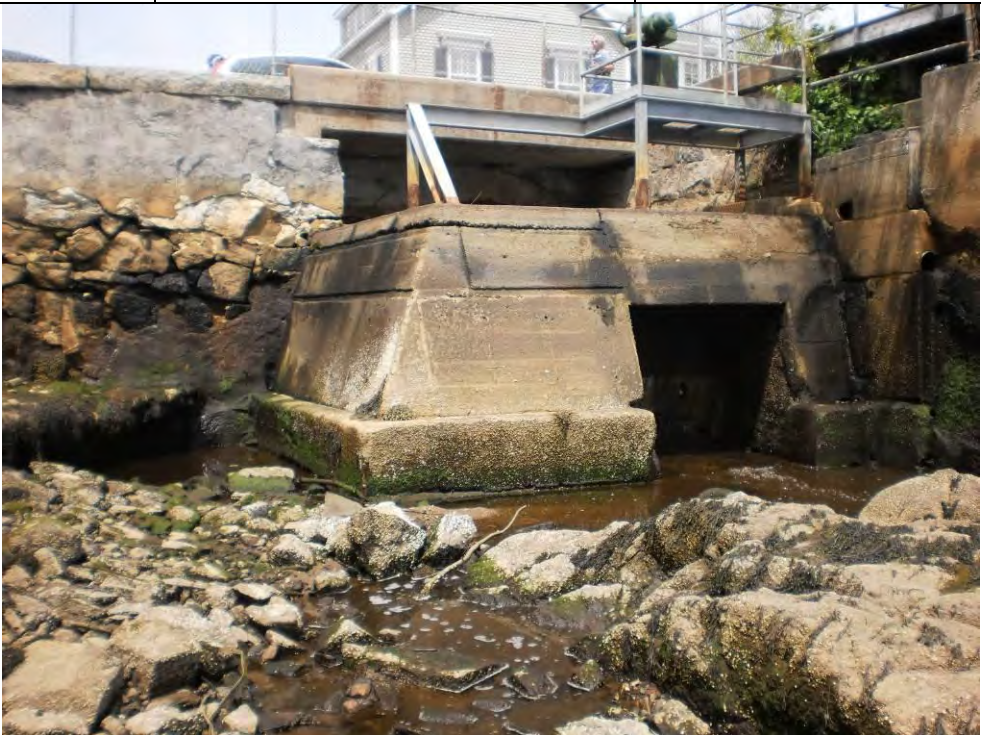
Tighe&Bond		PHOTOGRAPHIC LOG
Client Name: Manchester-by-the Sea, MA		Site Location: Sawmill Brook Watershed, Sawmill Brook Tide Gate Culvert
Project No. M-1476		
Photo No. 9	Date: 6/11/15

Direction Photo Taken: NE		
Description: Tide gate structure, note overlay repair concrete covering original concrete

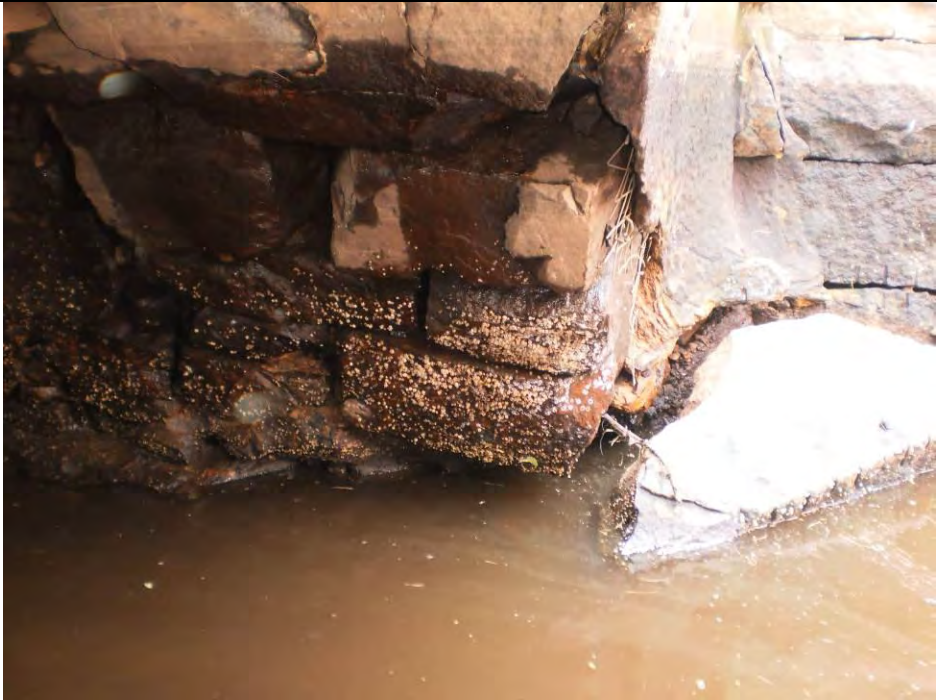
Tighe&Bond		PHOTOGRAPHIC LOG	
Client Name: Manchester-by-the Sea, MA		Site Location: Sawmill Brook Watershed, Sawmill Brook Tide Gate Culvert	Project No. M-1476
Photo No. 12	Date: 6/11/15

Direction Photo Taken: S			
Description: Upstream west entrance corner of stone arch culvert showing unsupported culvert stonework, possibly caused by scour or loss of footing stones – apparent cause of separation in photo 11

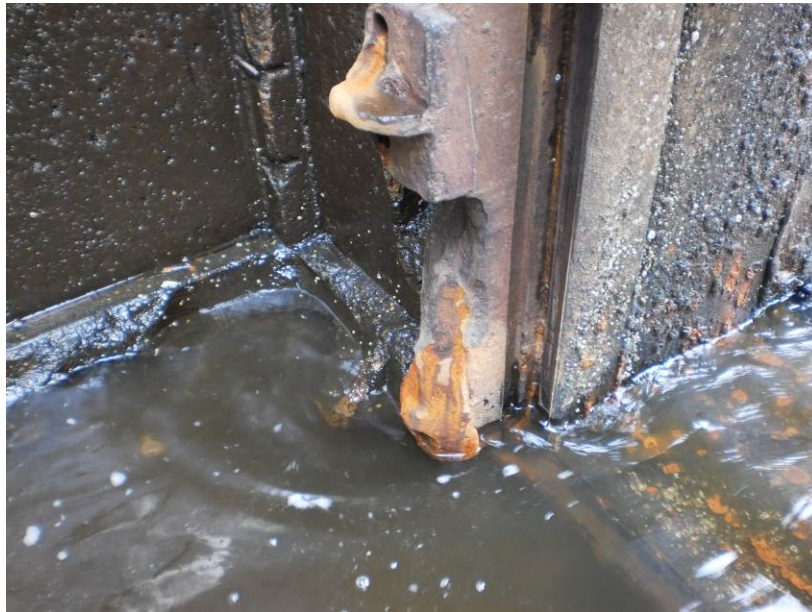
Photo 2 Corrosion/erosion of low tide gate tracks

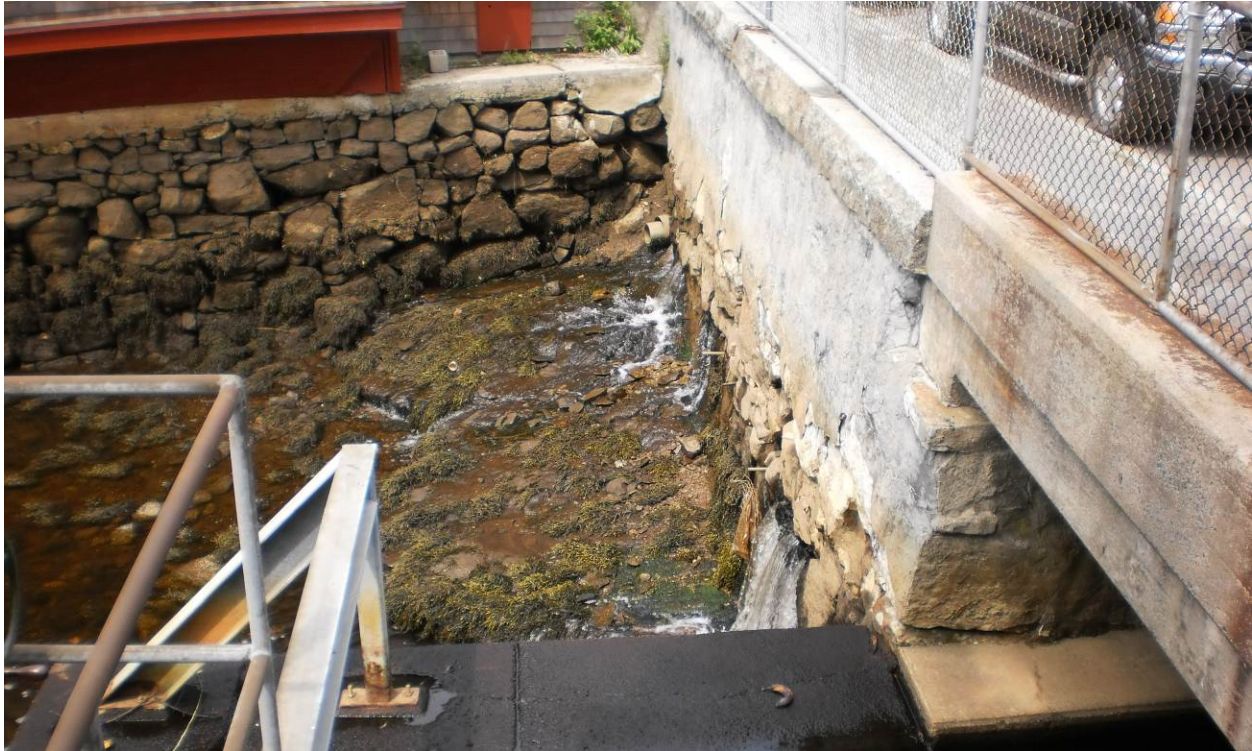
Photo 4 Water seepage (flow) coming from the stone culvert side wall

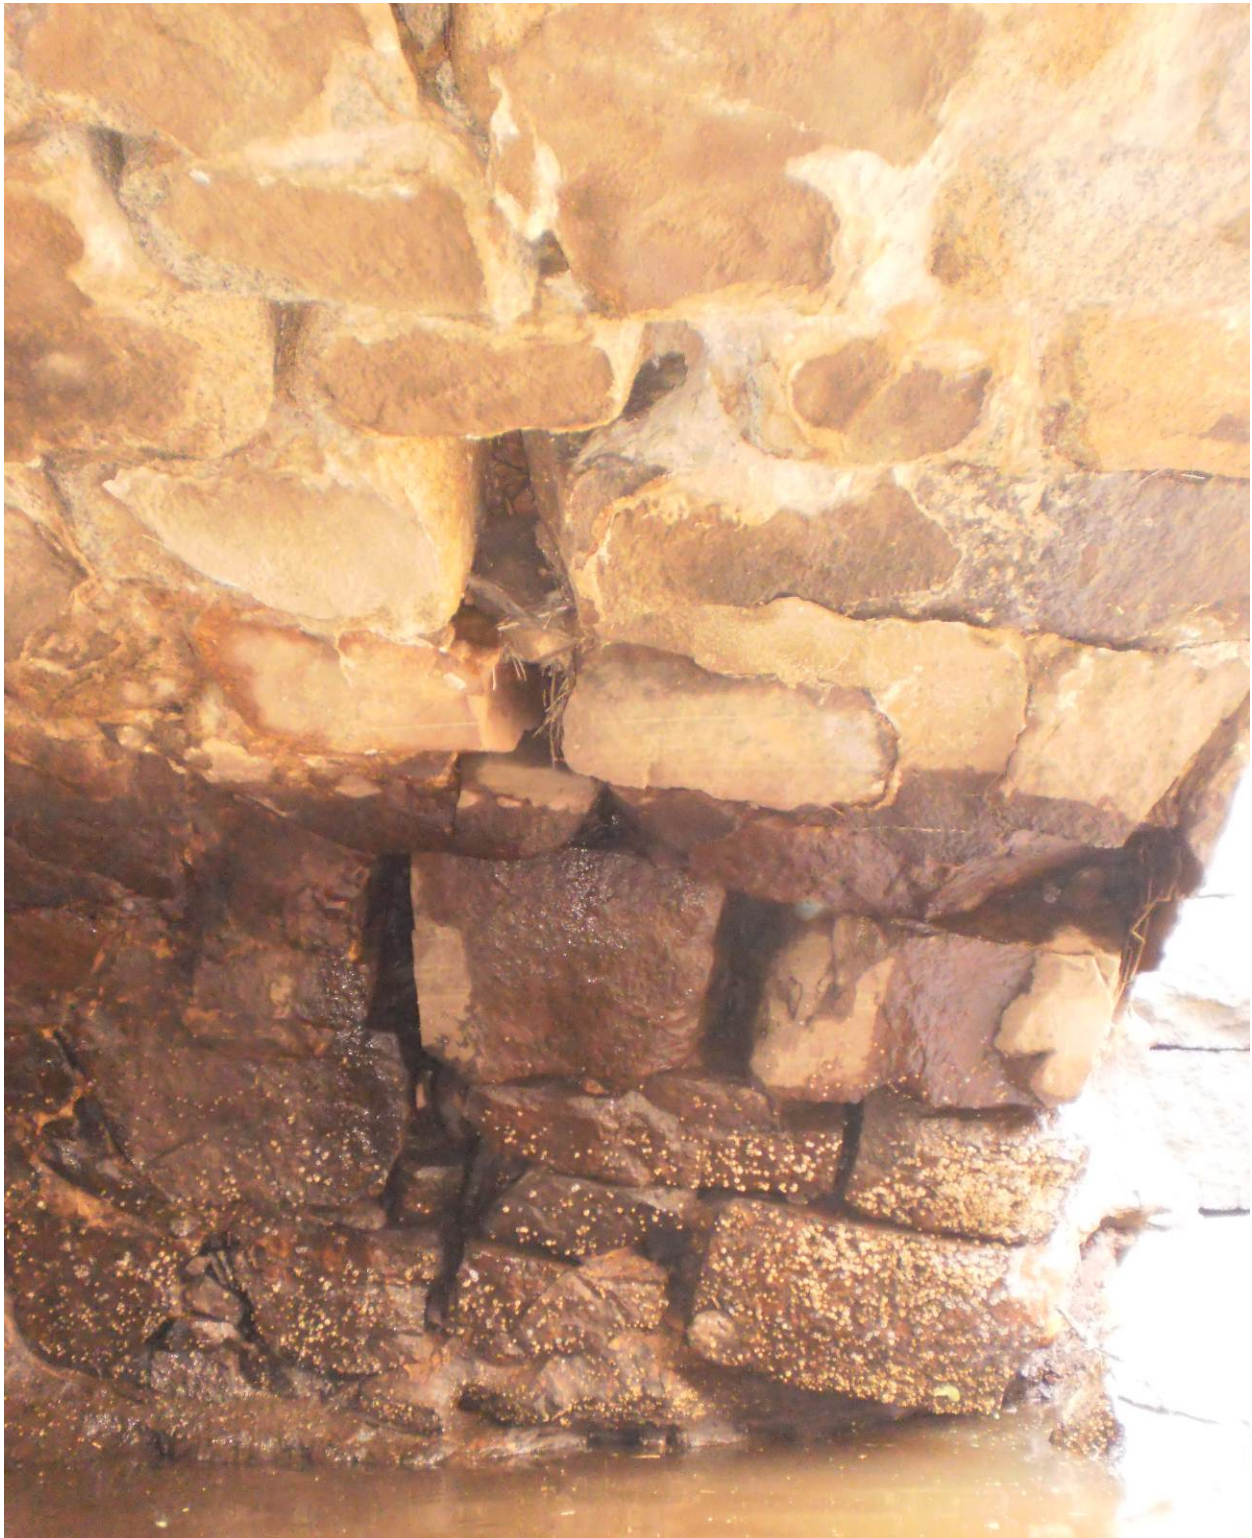
Photo 8 Separation and settlement of culvert arch stones, upstream, northwestern corner

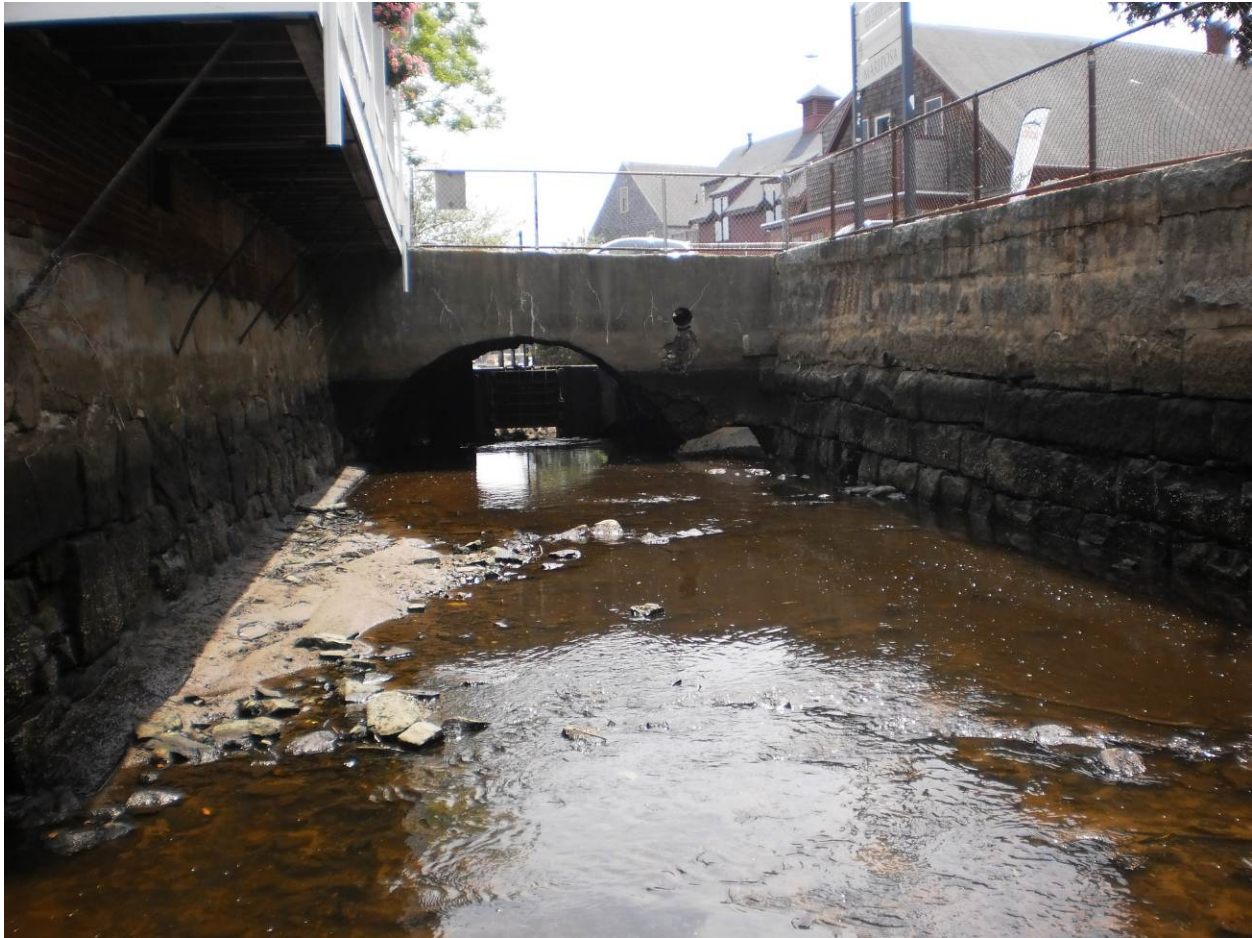
Photo 9 Stream channel upstream from culvert looking south with dark staining on walls indicating normal gate closed high water level

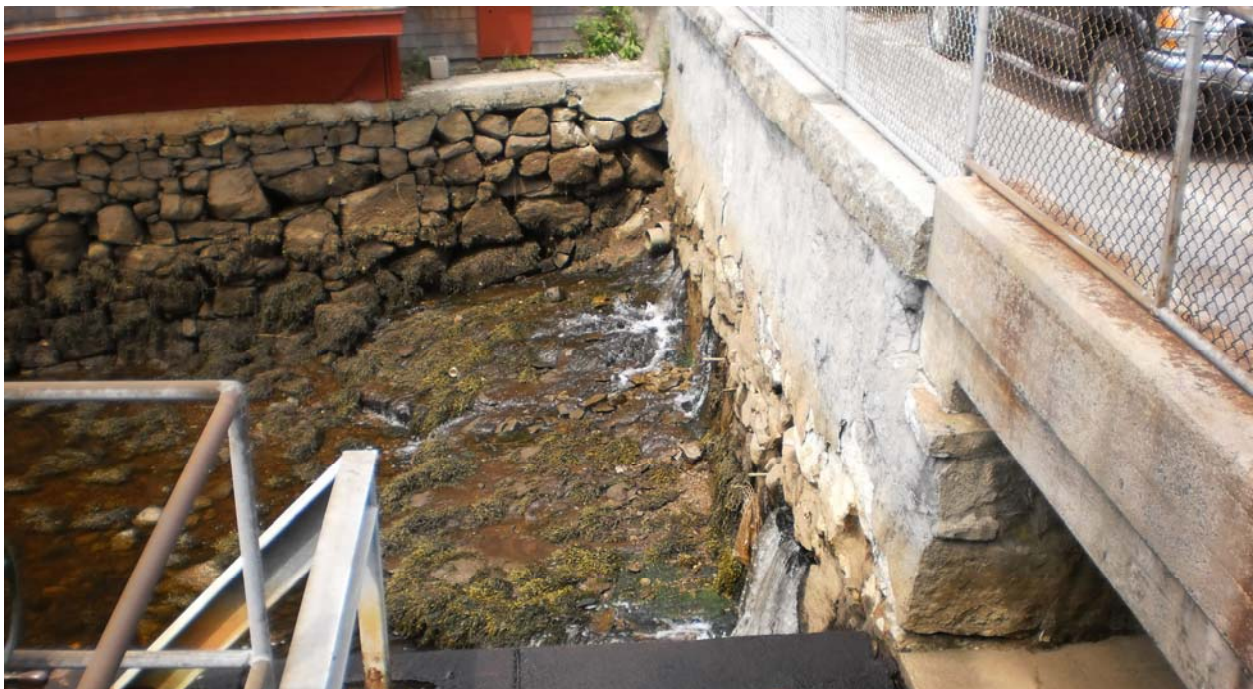
Photo 1 Water seepage (flow) coming from the stone culvert side wall

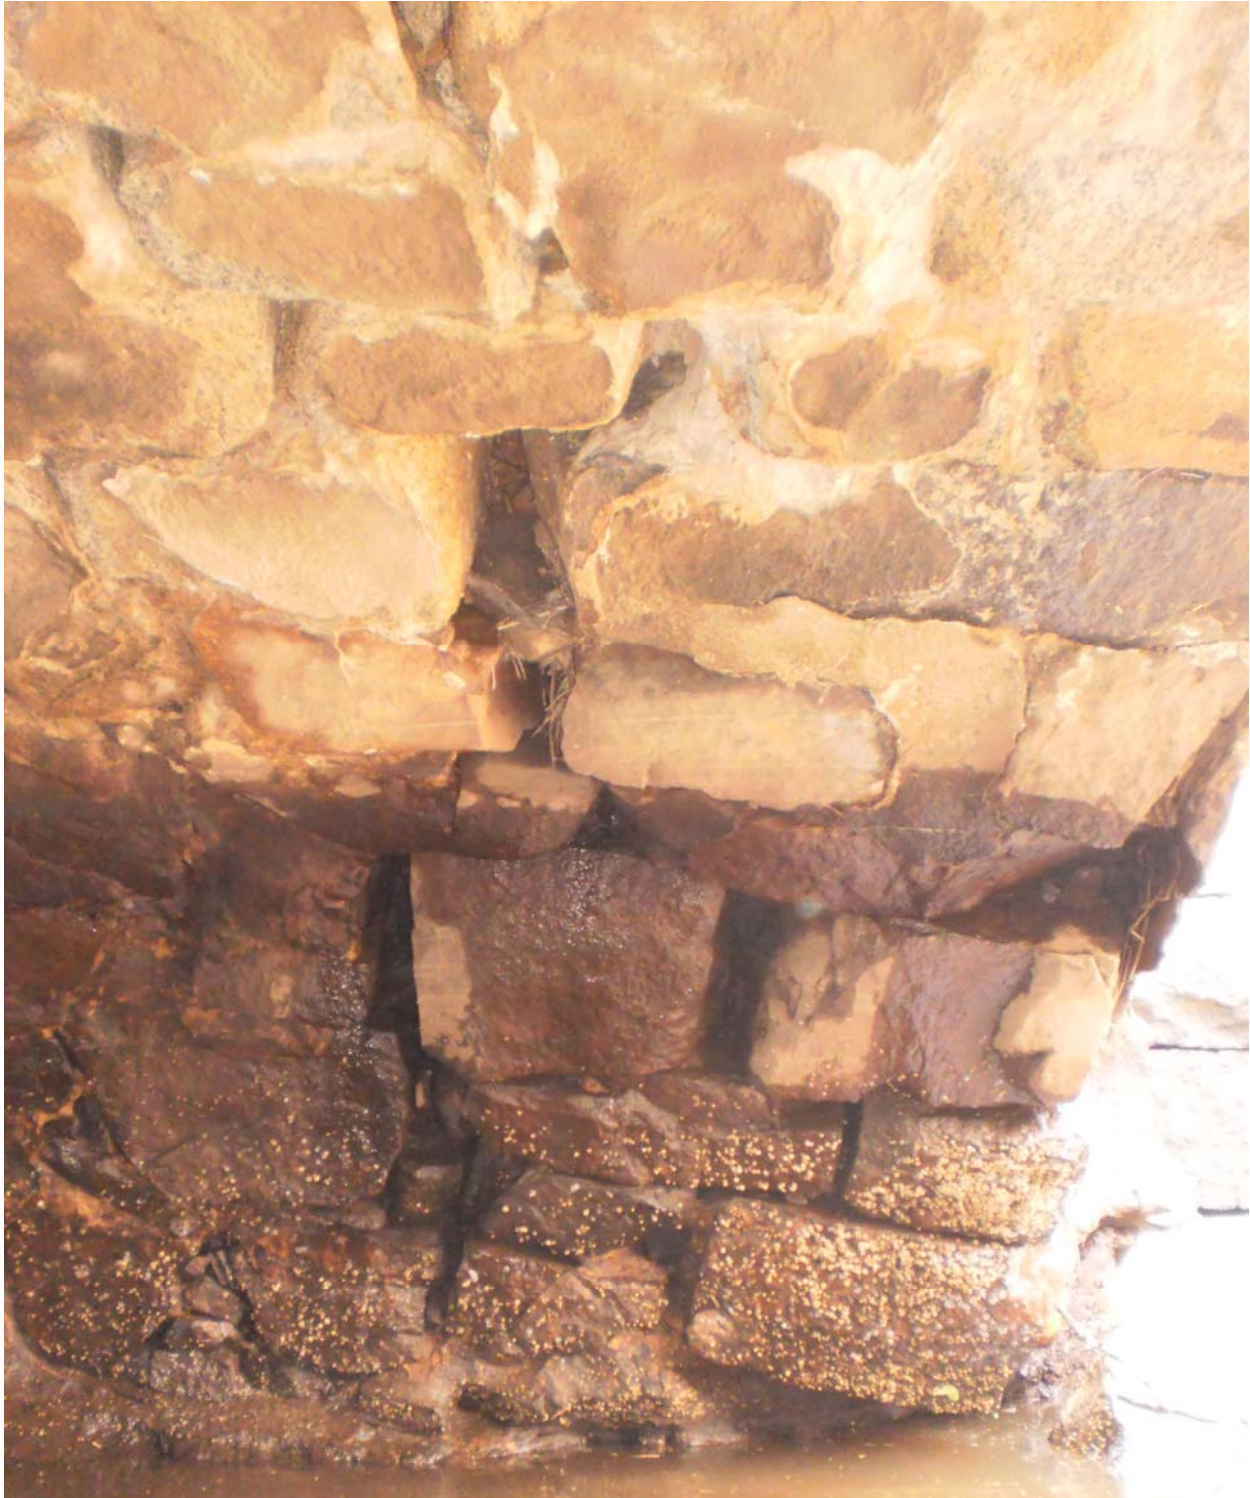
Photo 2 Separation and settlement of culvert arch stones, upstream, northwestern corner

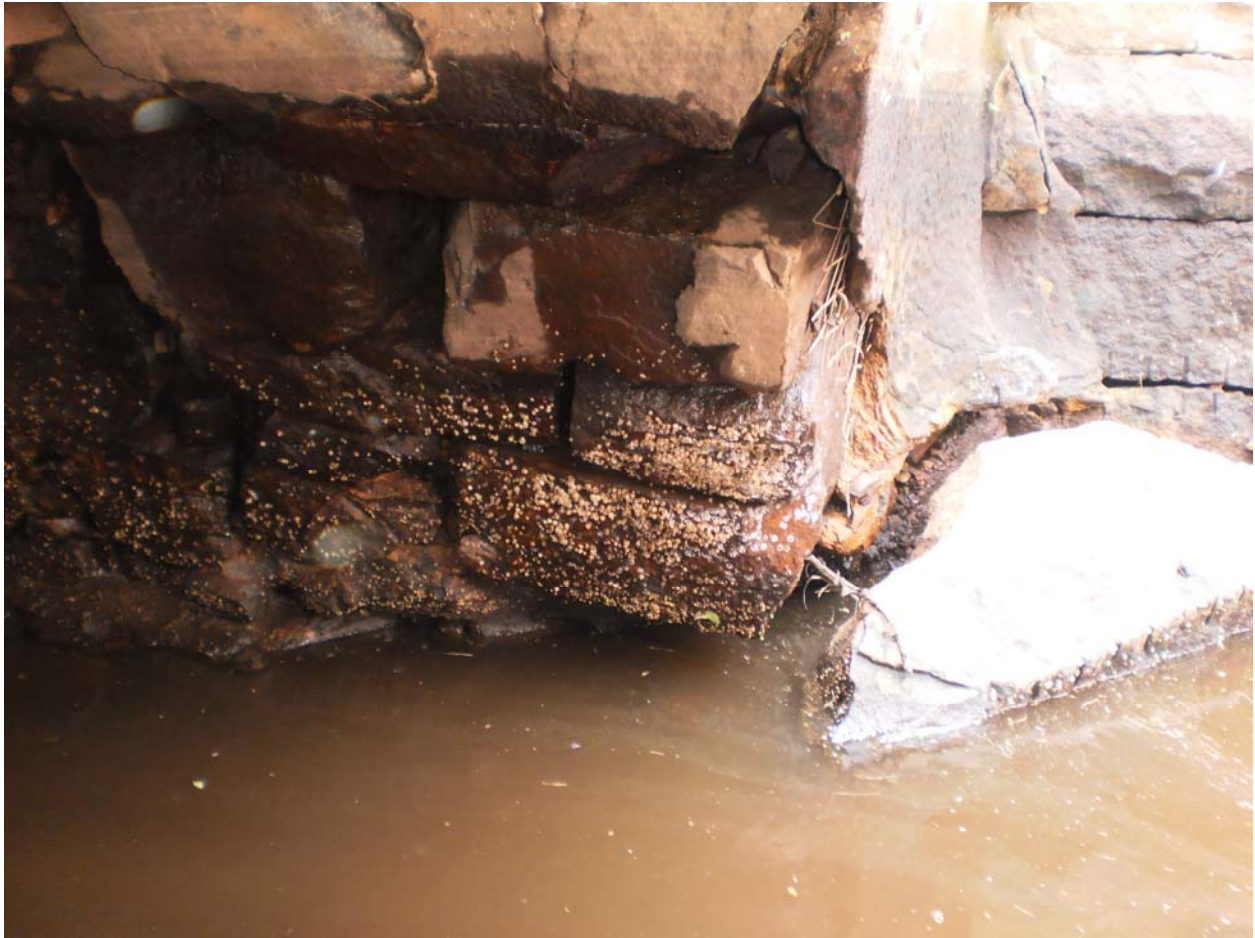
Photo 3 Northwestern corner arch stones unsupported
