STRUCTURES INSPECTION FIELD REPORT

ROUTINE ARCH & SPECIAL MEMBER INSPECTION

BR. DEPT. NO. M-02-001

Bridge M-02-001 (8AM) carries ST-127 (Central Street) over Saw Mill Brook in the town of Manchester, MA. The approaches are east and west and the elevations are south and north. Saw Mill Brook is tidal beneath the bridge, but the brook flows from north to south. **See Sketches 1 and 2.**

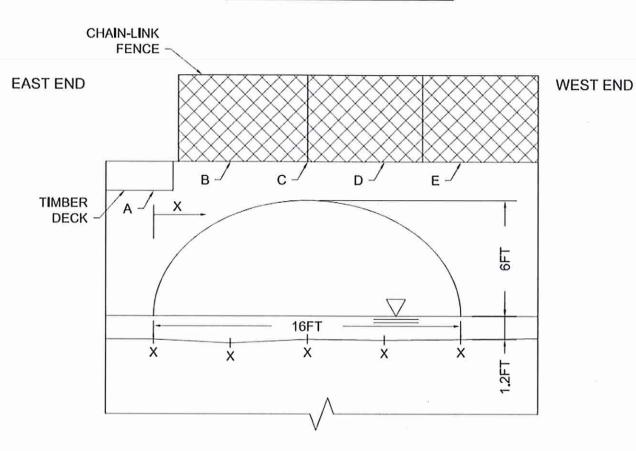
Sketch 2: Upstream Channel Profile.

UPS'	UPSTREAM CHANNEL PROFILE								
LOCATION	DISTANCE X (% SPAN)	VERTICAL MEASUREMENT *							
Α	NE FACE (0%)	9.67FT							
В	4FT-0IN (25%)	11.0FT							
С	8FT-0IN (50%)	11.0FT							
D	12FT-0IN (75%)	11.0FT							
Е	NW FACE (100%)	11.08FT

*ALL MEASUREMENTS ARE 0" to 6" LESS THAN PREVIOUS INSPECTION. THUS, NO SCOUR AND UP TO 6" OF AGGRADATION SINCE PREVIOUS

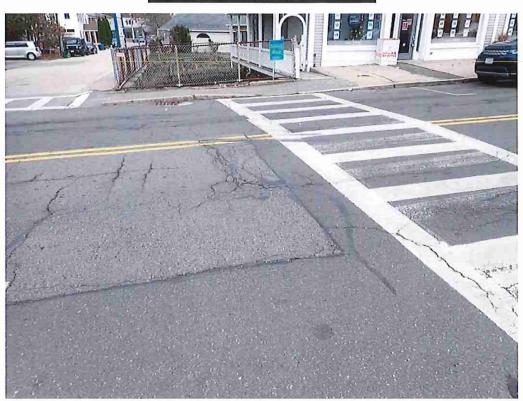
The bituminous concrete wearing surface has numerous areas of minor longitudinal and transverse cracking throughout, up to 1/4" wide, and heaviest in the eastbound lane. The westbound lane has areas of minor raveling and several bituminous patches, up to 2' wide x 8' long. The eastbound lane, near mid-span has a 2' long x 6' wide area of moderate map cracking (cracks up to 1/4" wide). **See Photo 1**. There is a 2' x 18" concrete patch adjacent to the drain along the north curb.

Photo 1: Overview of the wearing surface (view from the south sidewalk).

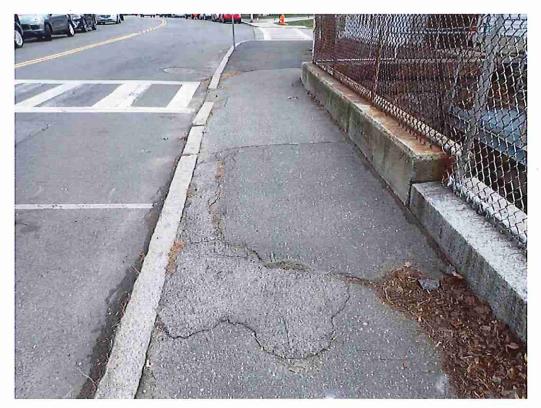
The west 10' of the south sidewalk has random bituminous patches and minor longitudinal cracking, up to 1/4" wide. **See Photo 2.** The underside of the south concrete sidewalk slab has many areas of delamination and shallow spalling with exposed rusted rebar, up to 8' long x 15" wide x 1-1/2" deep near mid-span. **See Photo 3.**

Photo 2: South sidewalk (view from the west end).

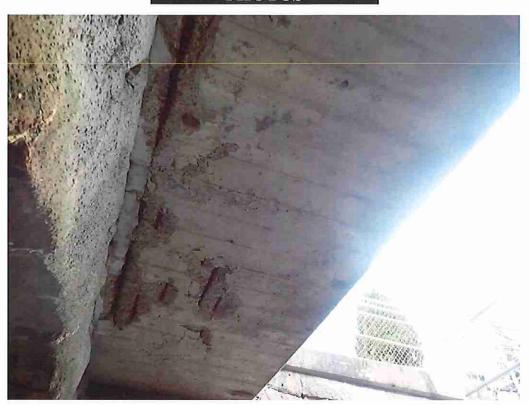
Photo 3: Underside of the south sidewalk slab.

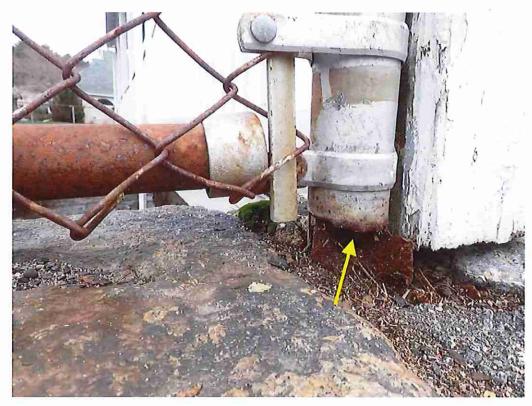
- The fence fabric at the west end has been secured with wire since the previous inspection.
- The first post from the west end and the top rail are bent away from the roadway up to 2".
- The east post has 100% section loss at the base. **See Photo 4.** The post is secured to the adjacent property's wooden fence post only.

Photo 4: 100% section loss to the east post on the north fence.

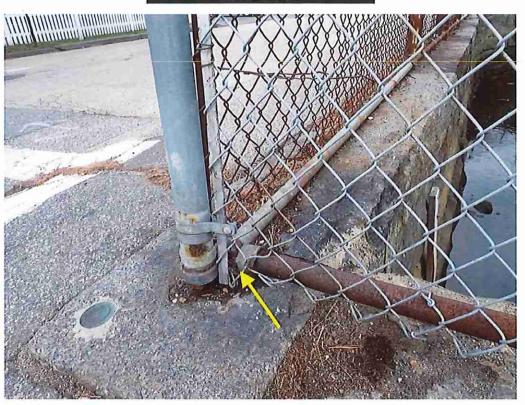
- At the west and east ends, the bottom rail is detached from the posts. See Photo 5.
- The fence fabric is not attached to the bottom rail for the full length of the bridge.

Photo 5: Bottom rail detached from the west post on the north fence.

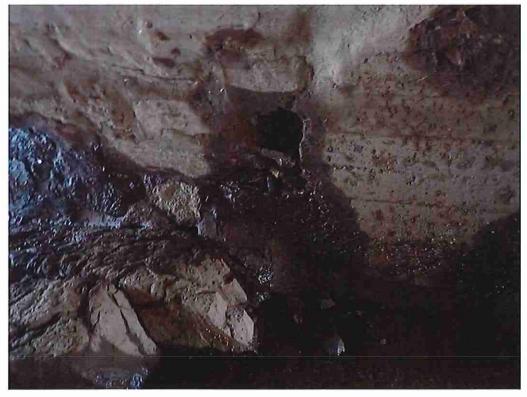
- 14' in from the north fascia: 6" wide x 12" high x 2'-8" deep void located 3' above the west spring line.
- 18' in from the north fascia: 10" diameter x 5' deep void located 3-1/2' above the west spring line. **See Photo 6.**
- 7' in from the south fascia: Full arch length x up to 1/2" wide crack in the shotcrete along arch section interface. **See Photo 7.** At the west spring line, the shotcrete ends resulting in exposed stone masonry with a void between the stones up to 4" wide x 2'-8" deep between the north and south arch sections. **See Photo 8.**

Photo 6: Void in the arch at 18' in from the north fascia, 3-1/2' above the west spring line.

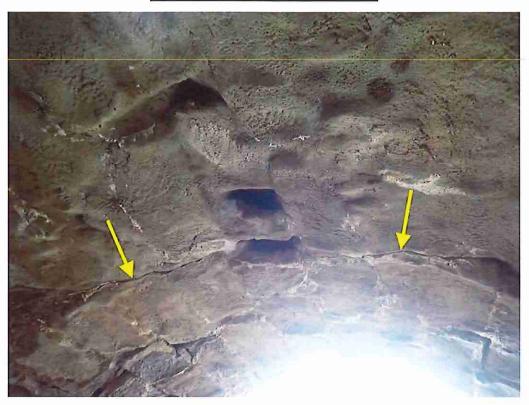
- 2'-6" from north fascia: 2' long x 9" wide x 6" deep void.
- 7' from north fascia: 3' long x 9" wide x 6" deep void.
- 14' from north fascia: 12" long x 9" wide x 6" deep void. Stones surrounding void settled up to 6". **See Photo 10.**
- 18' from north fascia: 6" long x 12" wide x 9" deep void.
- 22' from north fascia: 5' long x 12" wide x 6" deep void.
- 35' to 37' from north fascia: Two 7" long x 11" wide x 8" deep voids. See Photo 7.

Photo 7: Full length crack in the arch at 7' from the south fascia and voids in the keystone area.

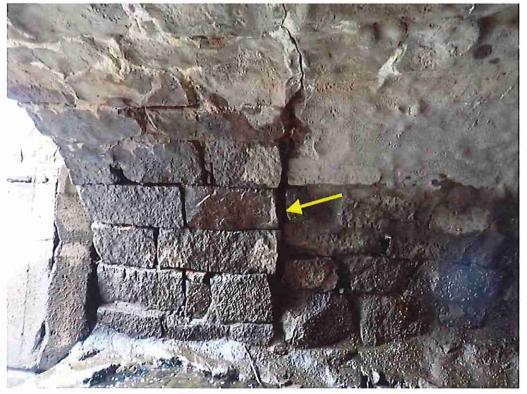
Photo 8: Void above the west spring line at 7' in from the south fascia.

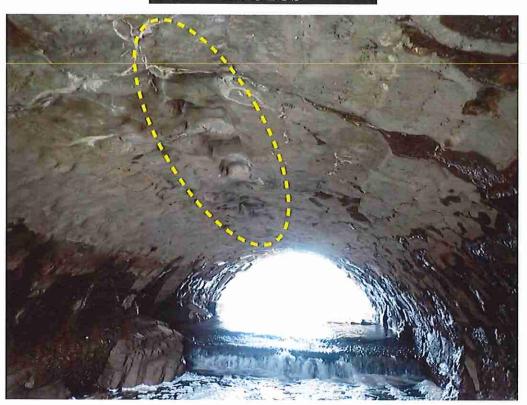
The keystone area, which is covered in shotcrete, has numerous random voids and areas that are uneven, apparently due to broken off and/or missing stones. **See Photo 9.** There has been no change in the appearance of the shotcrete since the previous inspection, indicating no shifting of the keystones. Specific deficiencies are as follows:

Photo 9: Typical voids and unevenness throughout the keystone area.

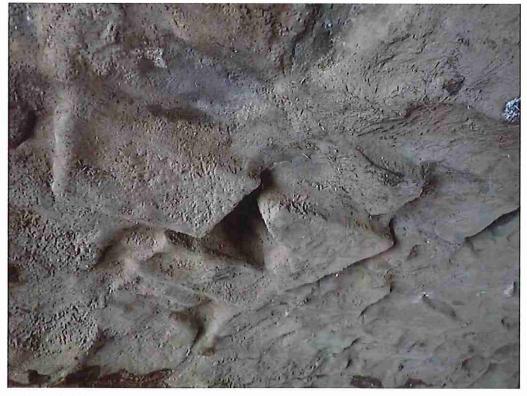
Photo 10: Void in the keystone area at 14' in from the north fascia.

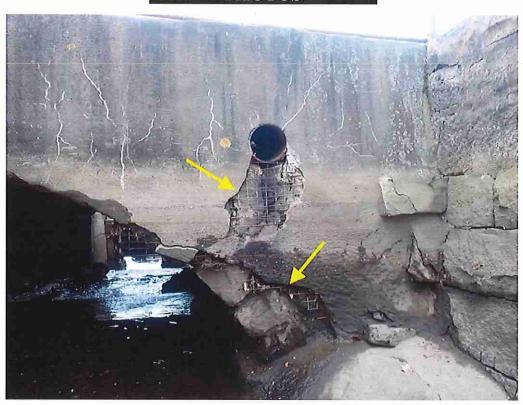
- At the west end, there is a 2' wide x 2-1/2' high x 3-1/2" deep spall below the drainpipe, with exposed rusted wire mesh. See Photo 11.
- Along the west edge of the arch ring, there is a 6' wide x up to 2' high x 3" deep with exposed rusted wire mesh. See Photo 11.
- Above the arch crown, there is a full height crack that is hairline width at the bottom and 9/16" wide at the top. There are several vertical hairline cracks with efflorescence adjacent to this crack. **See Photo 12.**

Photo 11: North spandrel wall at the west end.

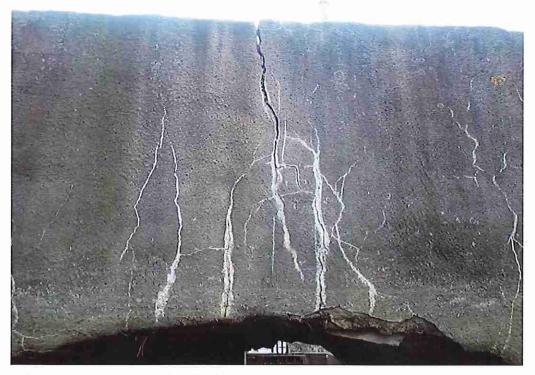
Photo 12: North spandrel wall above the crown area.

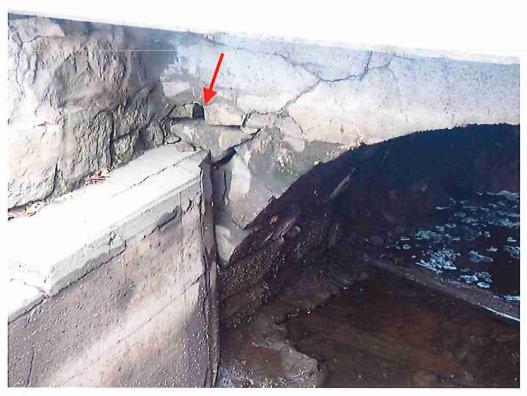
- At the west end, there is a 2' diameter x 2" deep spall exposing the stone masonry with voids up to 21" deep. See Photo 13.

Photo 13: South spandrel wall at the west end.

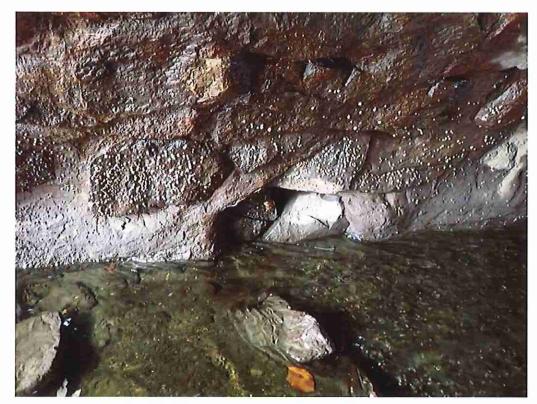
- 9' from the north fascia: 24" wide x 10" high x up to 10" deep void due to a missing stone. See Photo 14.
- 10'-6" from the south wingwall: 4" wide x 18" high x up to 16" deep void between stones.
- 13' from the south wingwall: 5" wide x 8" high x up to 16" deep void between stones.

Photo 14: Void in the east spring line at 9' in from the north fascia.
