# Condition Assessment Report

## Manchester-by-the-Sea Public Library

15 Union Street - Manchester-by-the-Sea - MA 01944

May 25 2024

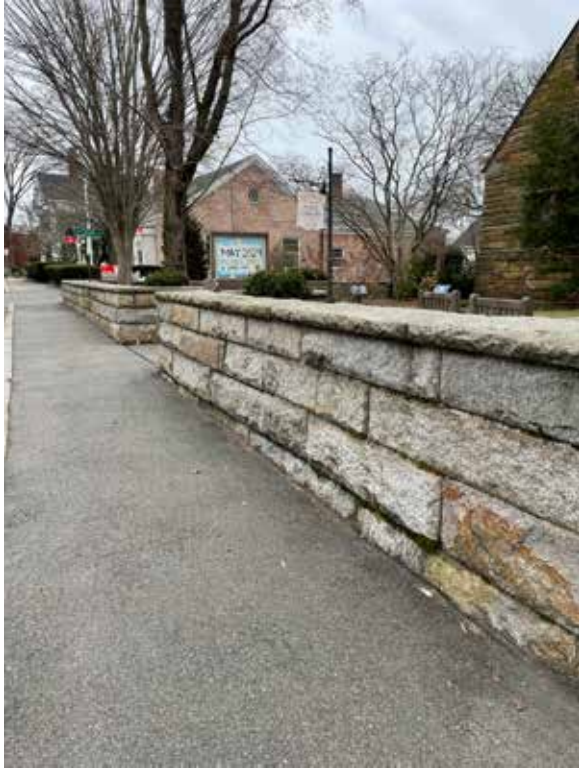
FIGURE 3.3 - Perimeter wall - typical conditions (north elevation)"

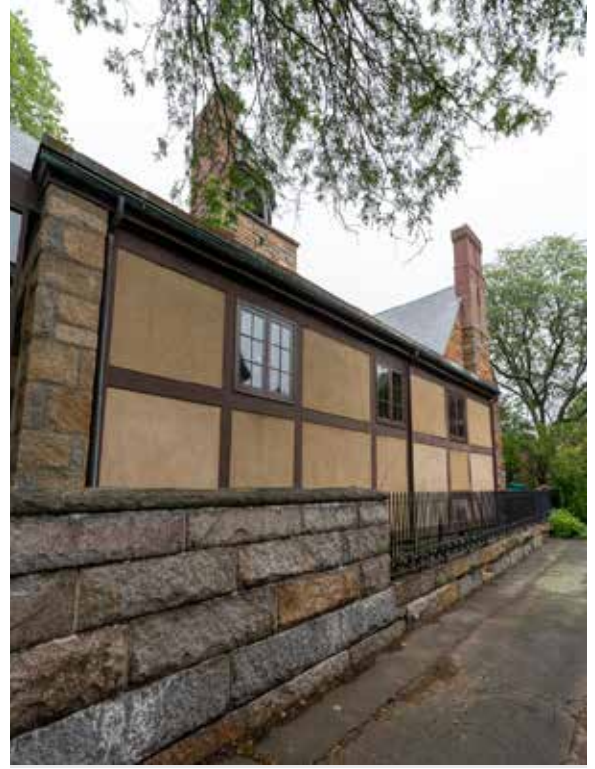
Figure 3.4 - South perimeter wall

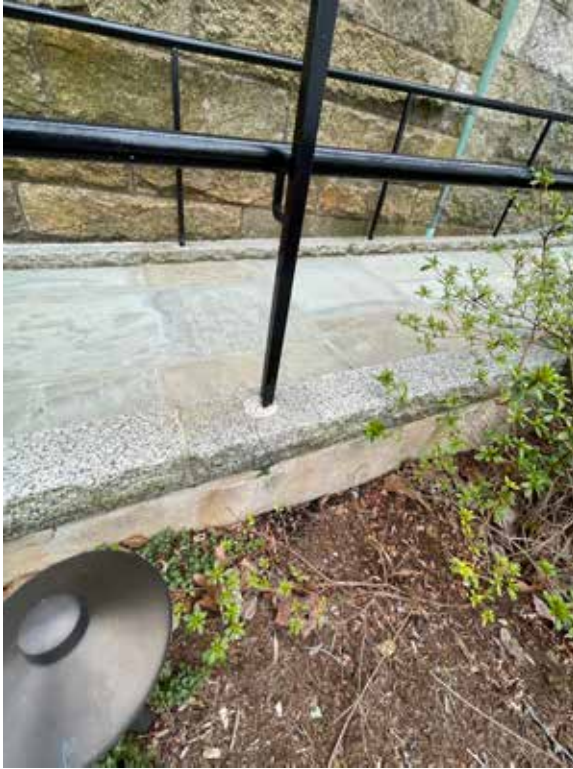
Figure 3.11 Condition at west ramp stone coping.

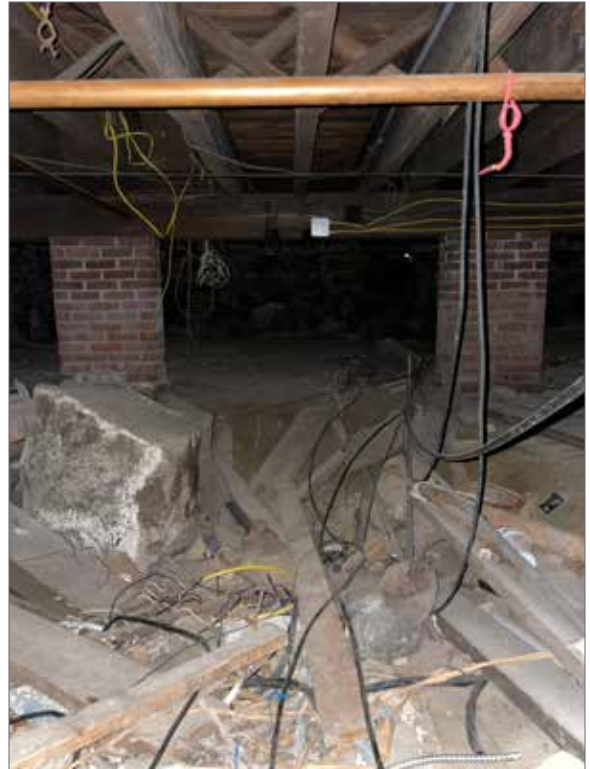
Figure 3.31 Brick piers and first floor wood framing under Library/Reading Room crawlspace - typical conditions

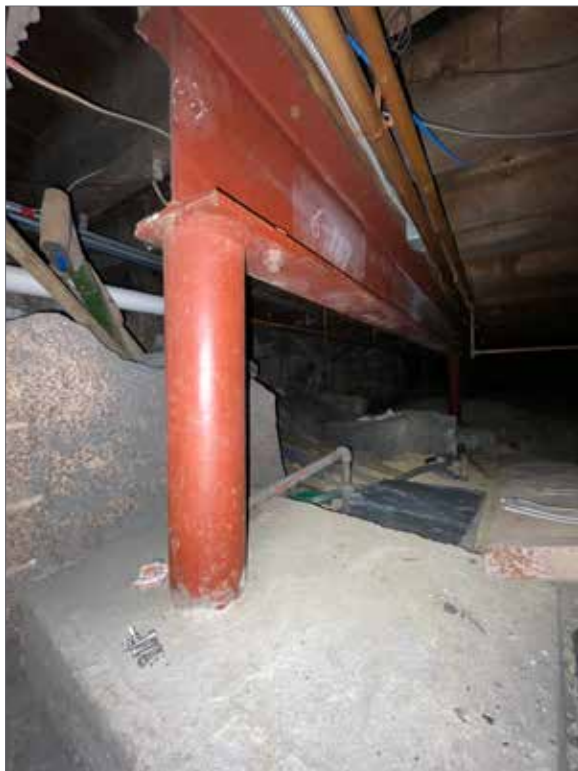
Figure 3.32 Steel structural reinforcement in GAR Hall/Reference Room crawlspace.

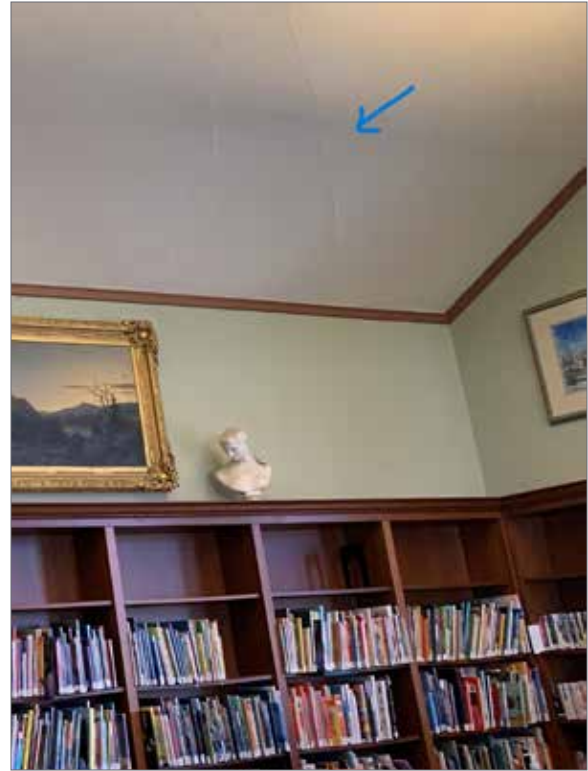
Figure 3.35E cracks in GAR hall/reference3 room ceiling - southwest corner.

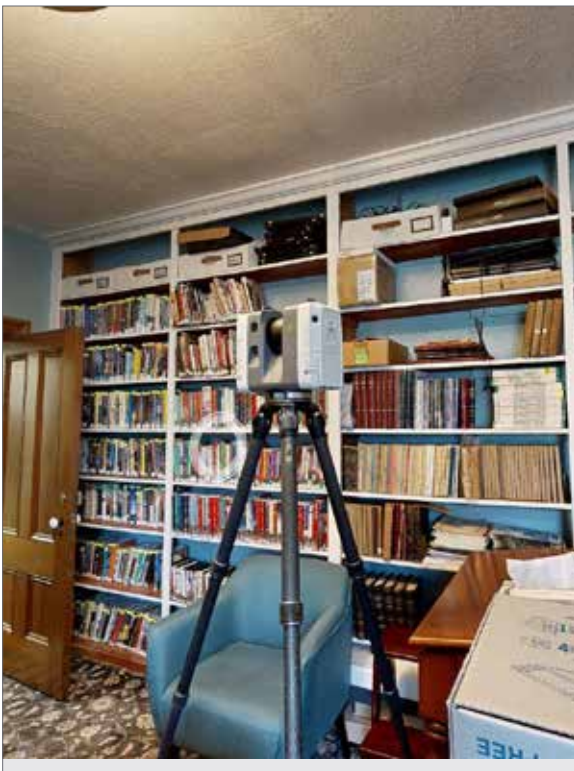
Figure 3.35EF Cracks in ARchives ceiling - above north wall..

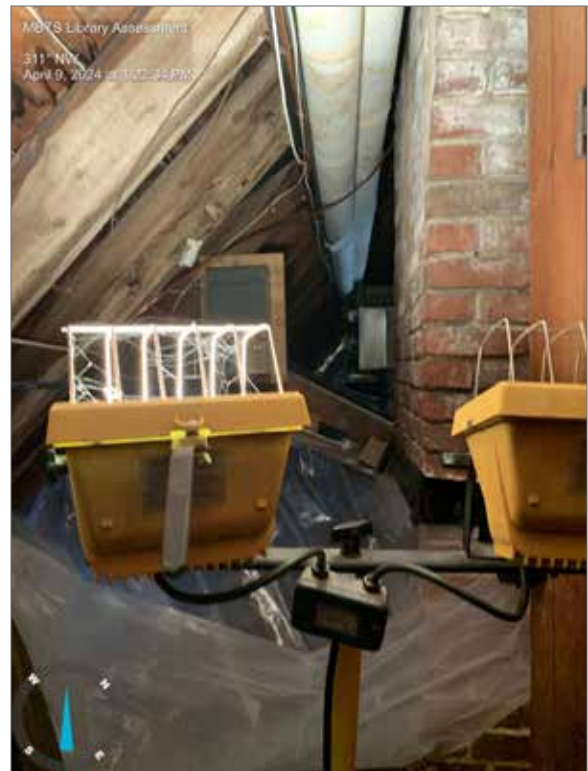
Figure 3.35G Rot damaged rafters in attic.

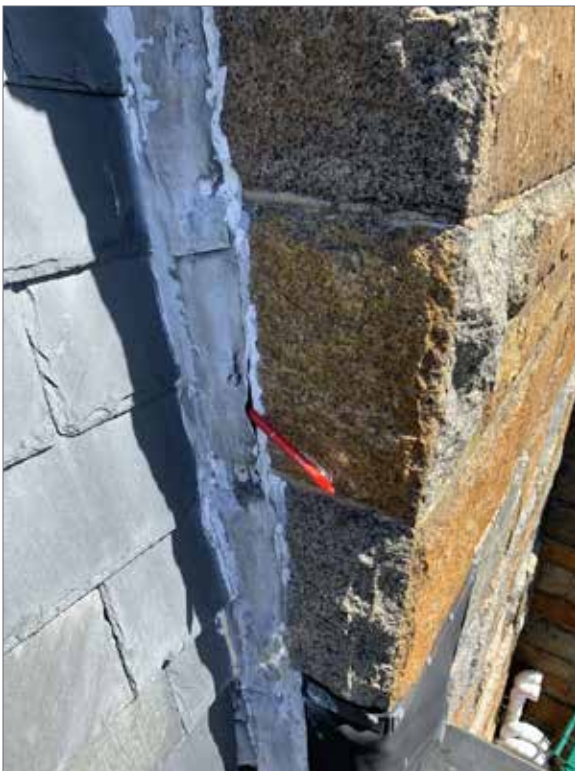
Figure 3.46 Damaged wall copper flashing repair. Note multiple layers of sealant repairs.

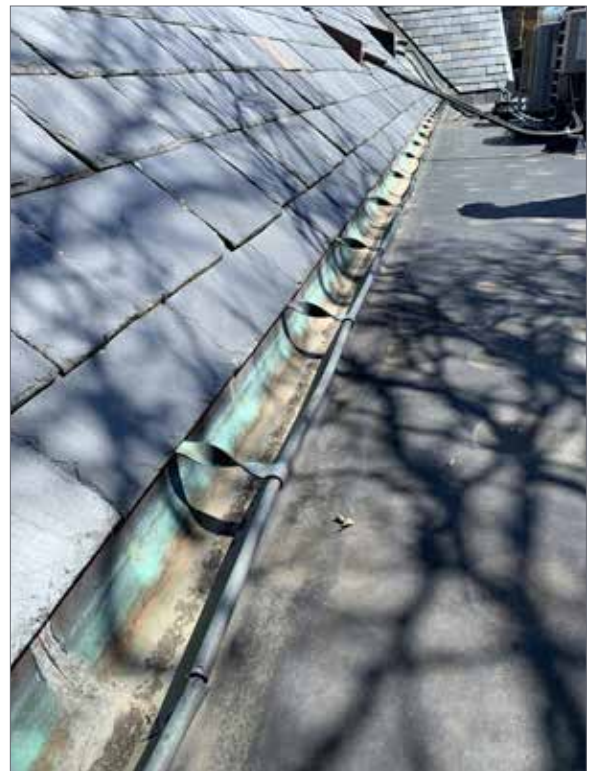
Figure 3.47 Replacement gutter at side gable roof - south elevation.

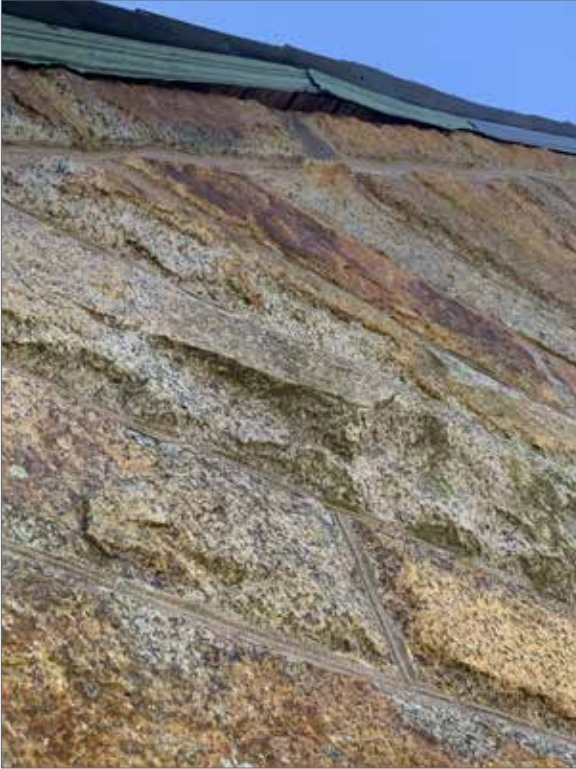
Figure 3.48 End gable rake flashing gaps.

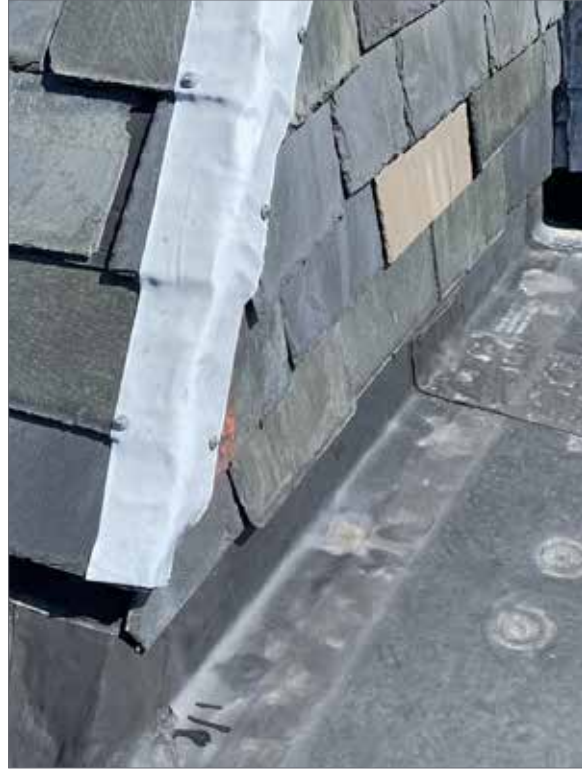
Figure 3.49 Flashing repair at south end of gable wall.

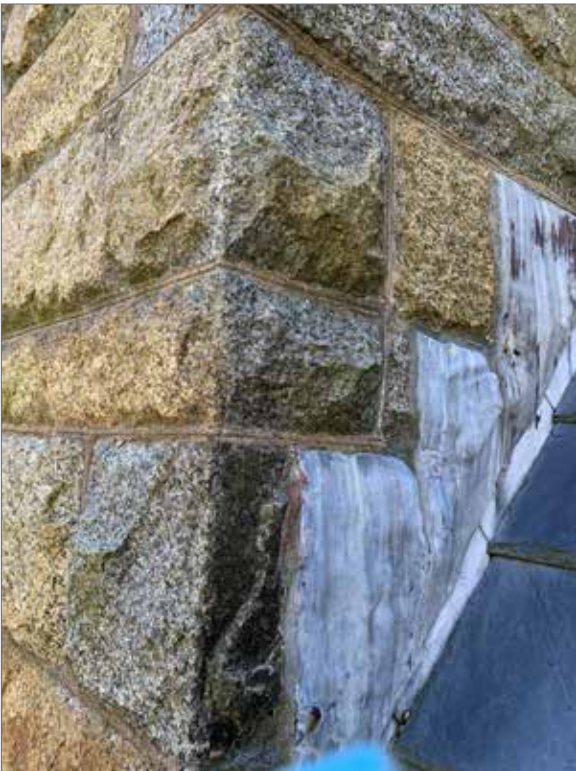
Figure 3.50 Step flashing - typical conditions.

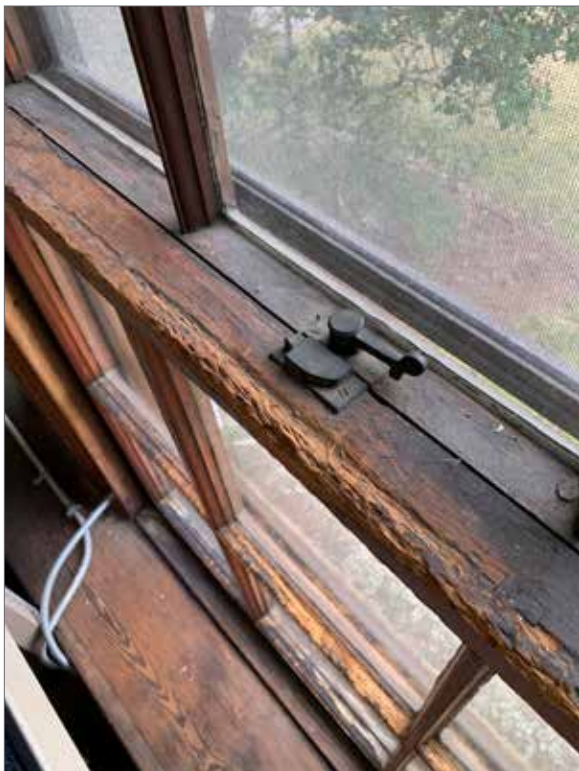
Figure 3.65 Typical single-hung window closing hardware and sash conditions..

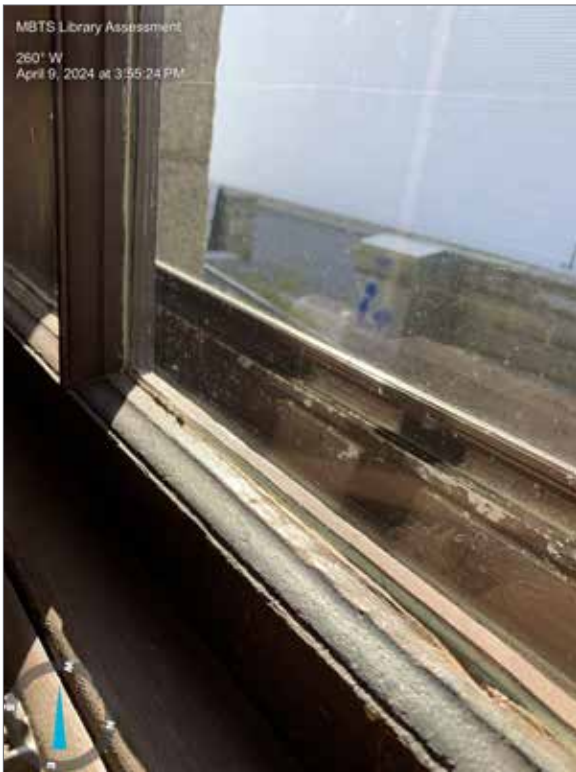
Figure 3.67 Single-hung windows == typical sash conditions.
