Town of Manchester-By-The-Sea Facility Condition Assessment

Town Of Manchester-By-The-Sea

April 02, 2021

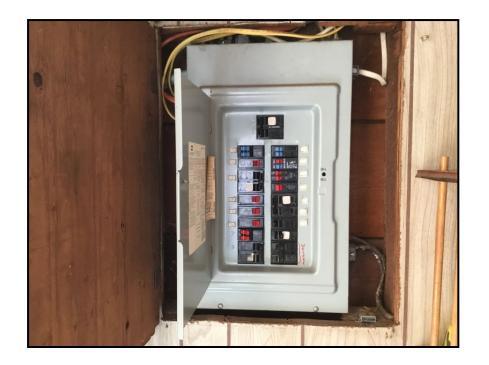
Electrical

The electrical branch wiring is beyond its recommended useful life. The fluorescent lighting was in good condition. The service and distribution system was in poor condition due to observed outdated panels.

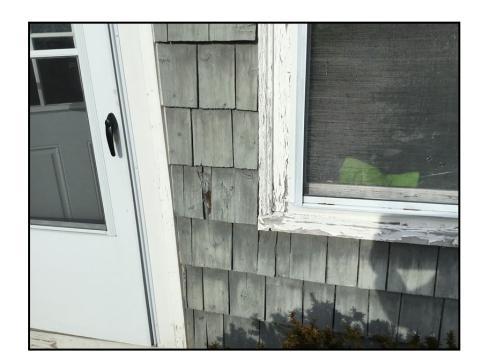
Exterior Enclosure

The wooden doors were in good condition. The single-pane windows were in poor condition due to observed damaged frames. The wood siding walls were in poor condition due to observed damaged finishes.

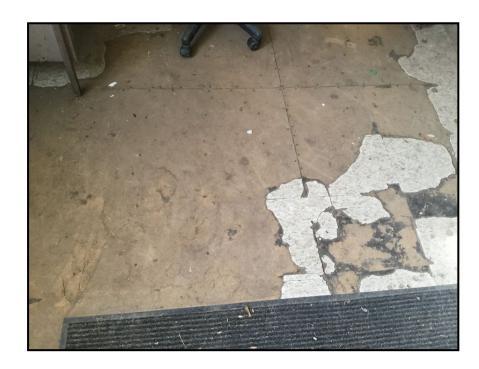
Interiors

The vinyl tile floor finishes were in poor condition due to observed damage. The painted wall finishes were in poor condition due to observed damage. The painted ceiling finishes were in good condition; however, the suspended acoustical tile ceilings were in poor condition due to observed damage.

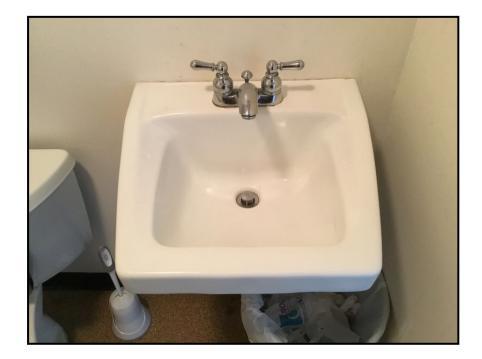
Plumbing

The manual and porcelain plumbing fixtures were in good condition. The domestic water distribution system is beyond its recommended useful life. The sanitary waste system is beyond its recommended useful life.

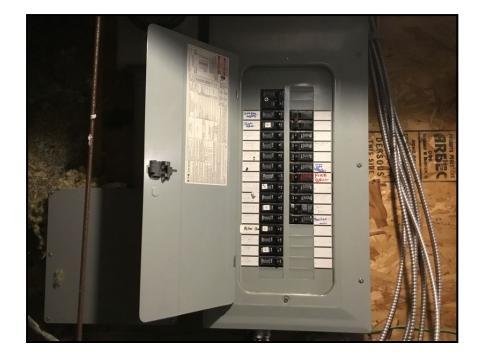
Electrical

The electrical branch wiring is within its recommended useful life. The fluorescent and incandescent lighting was in good condition. The service and distribution system was in good condition. The emergency and exit lighting is within its recommended useful life.

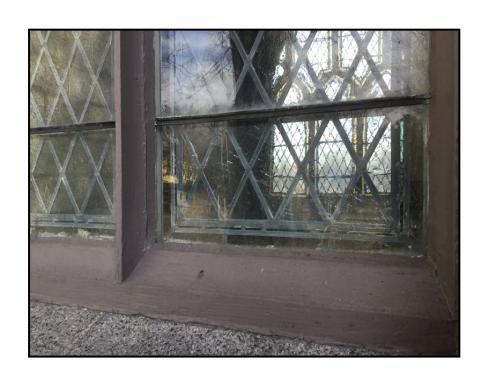
Exterior Enclosure

The wooden doors were in good condition. The single-pane windows were in fair condition due to observed deteriorated window sealant. The split-face stone veneer walls were in good condition.

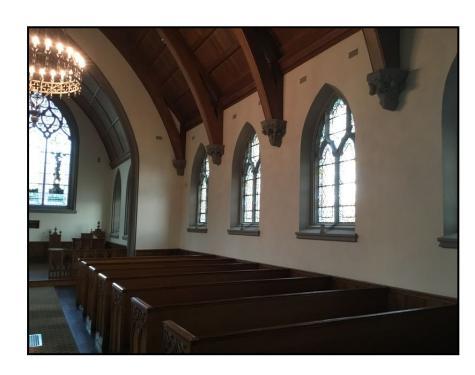
Interiors

The hardwood floor finishes were in good condition. The painted wall finishes were in good condition. The wood ceiling finishes were in good condition.

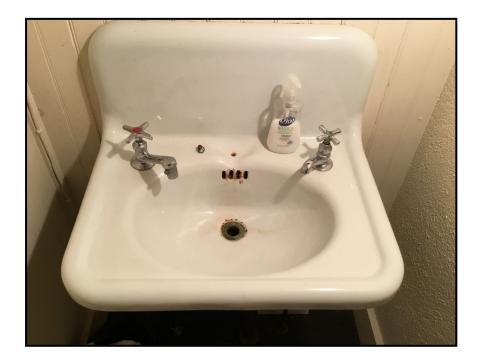
Plumbing

The manual and porcelain plumbing fixtures were in good condition. The domestic water distribution system is within its recommended useful life. The sanitary waste system is within its recommended useful life.

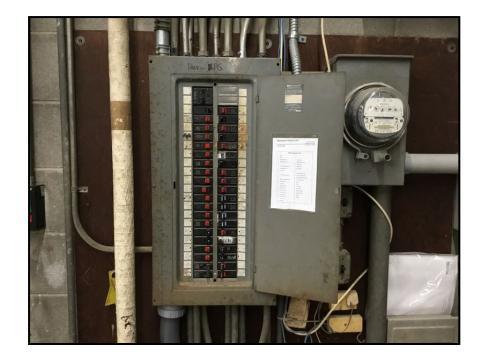
Electrical

The electrical branch wiring is beyond its recommended useful life. The LED lighting was in good condition. The service and distribution system was in poor condition due to observed rusted enclosures. The emergency and exit lighting is within its recommended useful life.

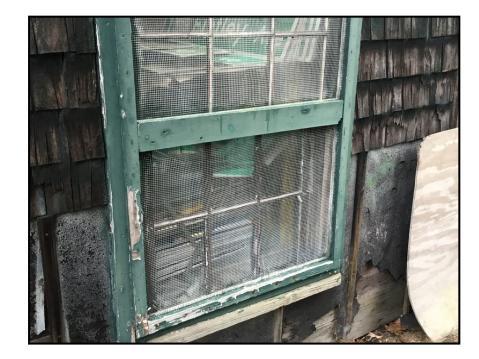
Exterior Enclosure

The metal doors were in good condition. The single-pane windows were in poor condition due to observed damaged frames. A portion of the wood siding walls were in good condition; however, a portion of the wood walls and the CMU walls were in poor condition due to observed stained and damaged finishes.

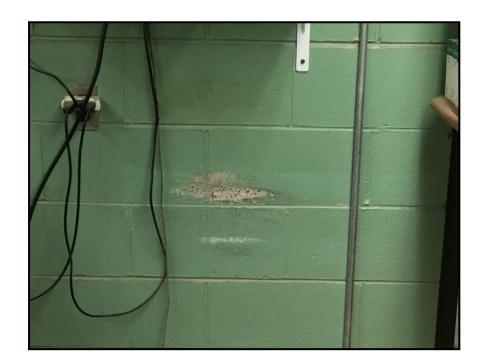
Interiors

The painted wall finishes were in poor condition due to observed stains and damage. The painted ceiling finishes were in good condition.

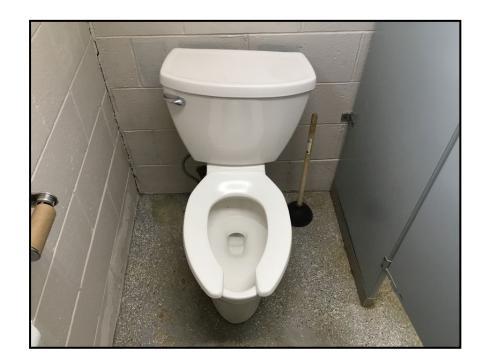
Plumbing

The manual and porcelain plumbing fixtures were in good condition. The domestic water distribution system is beyond its recommended useful life. The sanitary waste system is beyond its recommended useful life.

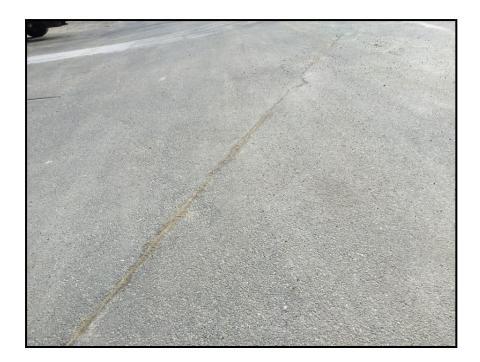
Site Infrastructure

The asphalt pavements were in poor condition and in need of resealing as longitudinal and transverse cracking were observed throughout the pavement.

Asset Description	Corrective Action	Notes	Priority	Current Needs	Year
Vehicular Pavements	Crack Fill, Seal Coat, and Restripe Asphalt Pavements	30000 SF @ \$1.2 Per SF	Low	\$36,000	2021
			Total 2021 Needs	\$36,000

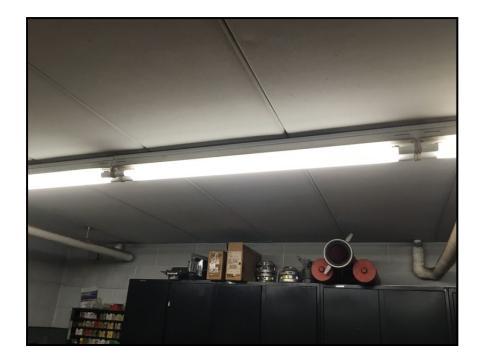
Electrical

The electrical branch wiring is beyond its recommended useful life. The LED lighting was in good condition. The service and distribution system was in good condition. The emergency and exit lighting is within its recommended useful life.

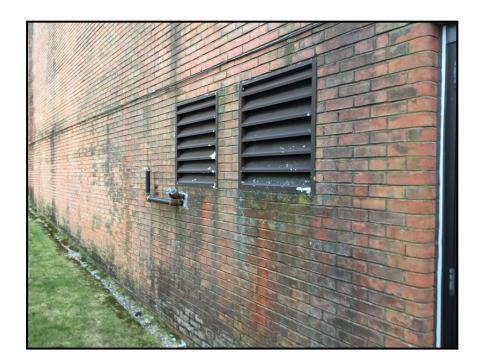
Exterior Enclosure

The metal doors were in good condition. The single-pane windows were in good condition. The brick veneer walls were in poor condition due to observed efflorescence and stained finishes.

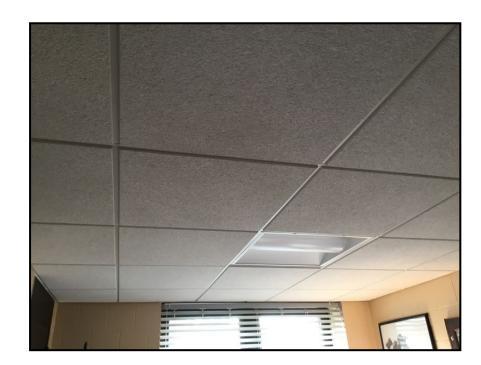
Interiors

The carpet floor finishes were in good condition. The painted wall finishes were in good condition. The cement-fiber panel board and suspended acoustical tile ceiling finishes were in good condition.

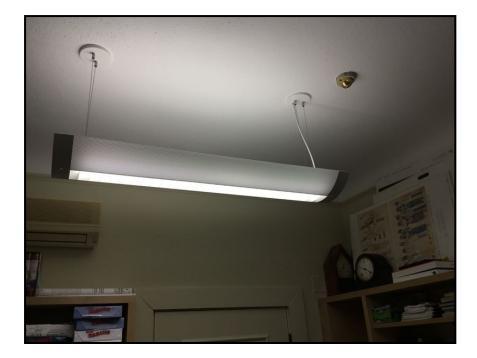
Electrical

The electrical branch wiring is beyond its recommended useful life. The fluorescent lighting was in good condition. The service and distribution system was in good condition. The emergency and exit lighting is within its recommended useful life.

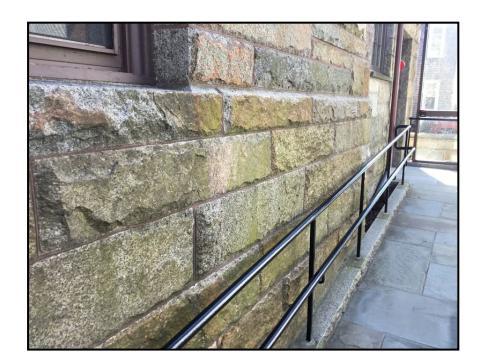
Exterior Enclosure

The wooden and metal doors were in good condition. The singlepane windows were in poor condition due to observed deteriorated window sealant. The split-face stone veneer walls were in poor condition due to observed biological growth.

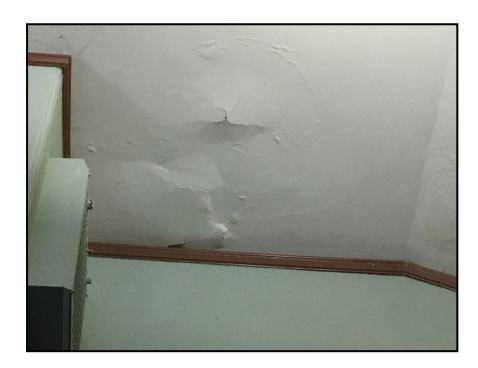
Interiors

The carpet floor finishes were in good condition. The painted wall finishes were in good condition; however, a portion of the walls were in fair condition due to observed damage and cracking above the windows. The wood ceiling finishes were in good condition; however, the painted ceilings were in poor condition due to observed stains and damage.

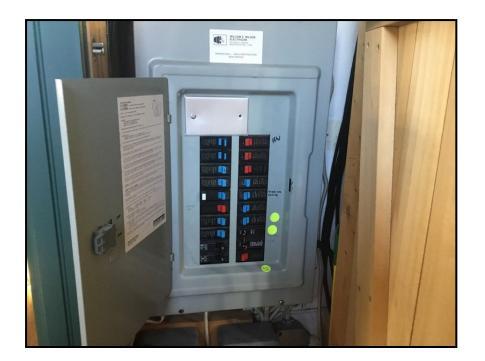
Electrical

The electrical branch wiring is beyond its recommended useful life. The system was observed to contain functioning GFCI plugs. The fluorescent lighting was in good condition. The service and distribution system was in good condition.

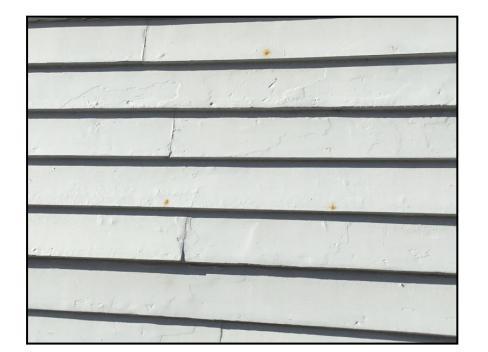
Exterior Enclosure

The wooden doors were in good condition. The single-pane windows were in poor condition due to observed damaged frames and deteriorated window sealant. The wood siding walls were in poor condition due to observed damaged finishes.

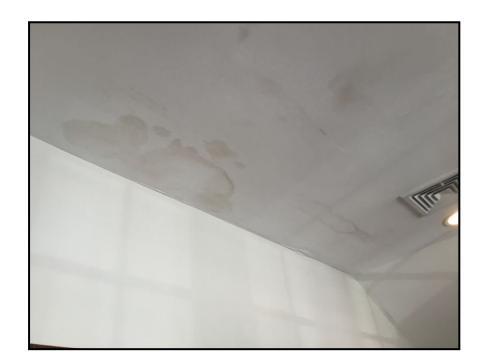
Interiors

The hardwood floor finishes were in fair condition due to observed deterioration. The painted wall finishes were in good condition; however, a portion of the walls were in fair condition due to observed damage. The painted ceiling finishes were in good condition; however, a portion of the finishes were in poor condition due to observed stains.

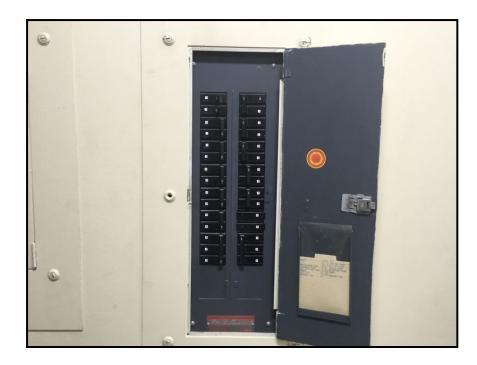
Electrical

The electrical branch wiring is beyond its recommended useful life. The system was observed to contain motion sensor switches and functioning GFCI plugs. The LED lighting was in good condition. The service and distribution system was in fair condition due to observed outdated panels; however, a portion of the system was in good condition. The emergency and exit lighting is within its recommended useful life.

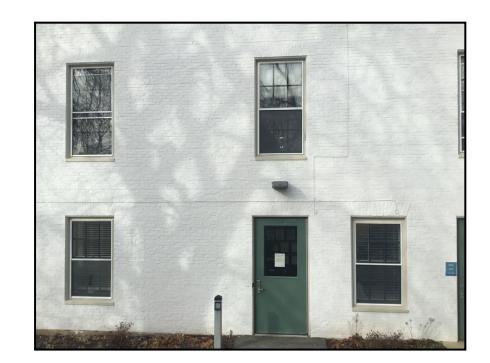
Exterior Enclosure

The metal doors were in good condition. The single-pane windows were in poor condition due to observed deteriorated window sealant. The brick veneer walls were in good condition.

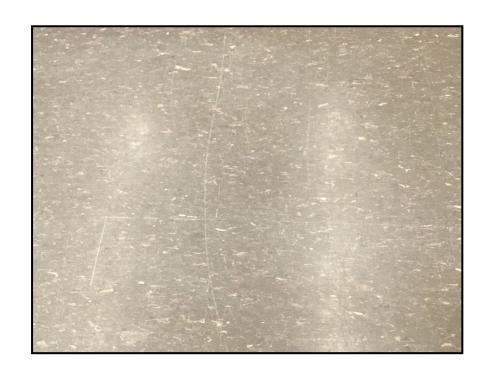
Interiors

The vinyl tile and carpet floor finishes were in poor condition due to observed damage and stains. The painted wall finishes were in fair condition due to observed stains and damage. The suspended acoustical tile and adhered acoustical tile ceiling finishes were in fair condition due to observed deterioration and deterioration.

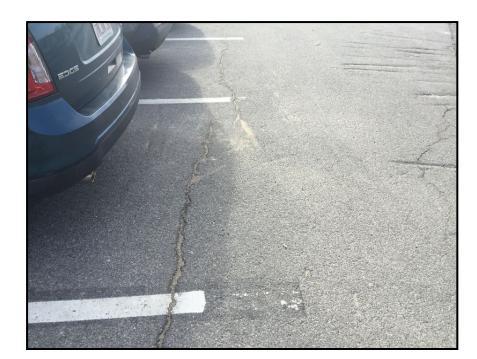
Site Infrastructure

The asphalt pavements were in poor condition and in need of resealing as longitudinal and transverse cracking were observed throughout the pavement.

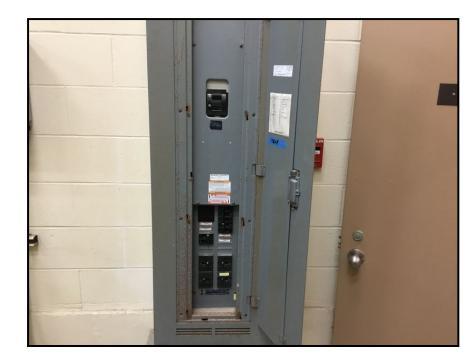
Electrical

The electrical branch wiring is within its recommended useful life. The system was observed to contain functioning GFCI plugs. The LED and fluorescent lighting was in good condition. The service and distribution system was in fair condition due to observed rusted enclosures. The emergency and exit lighting is beyond its recommended useful life.

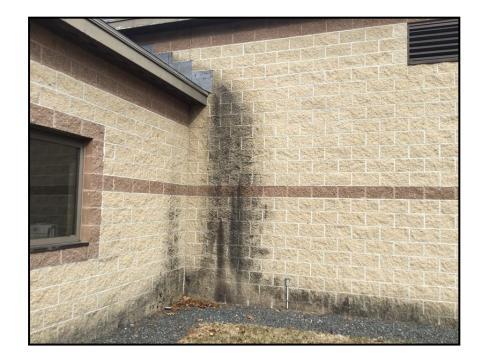
Exterior Enclosure

The metal and glazed doors were in good condition. The doublepane windows were in good condition. The split-face stone veneer walls were in poor condition due to observed stained finishes.

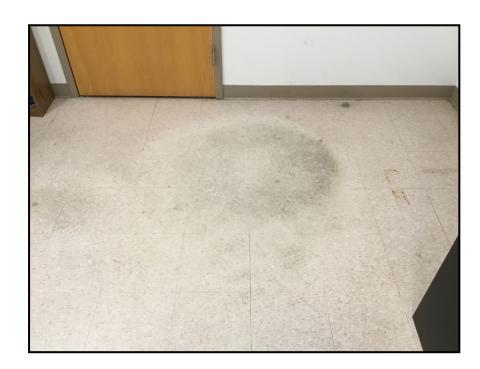
Interiors

The vinyl tile floor finishes were in poor condition due to observed damage and stains. The painted wall finishes were in good condition. The suspended acoustical tile ceiling finishes were in good condition.

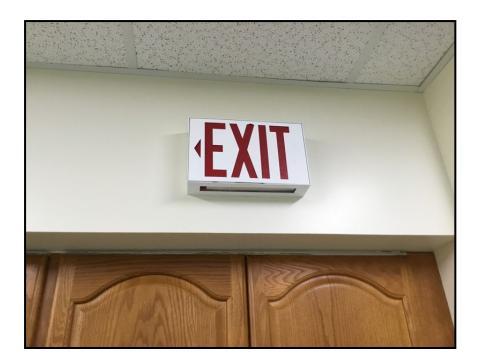
Electrical

The electrical branch wiring is within its recommended useful life. The system was observed to contain functioning GFCI plugs. The LED lighting was in good condition. The service and distribution system was in good condition. The emergency and exit lighting is beyond its recommended useful life.

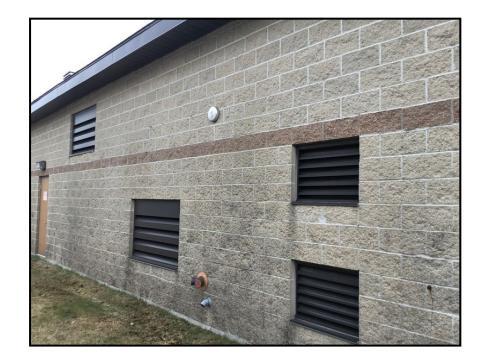
Exterior Enclosure

The metal and glazed doors were in good condition. The triplepane windows were in good condition. The split-face stone veneer walls were in fair condition due to observed stained finishes.

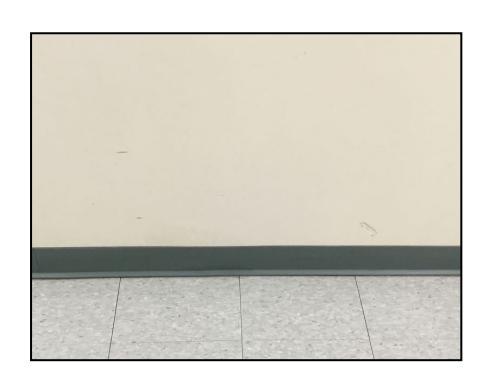
Interiors

The vinyl tile floor finishes were in good condition. The painted wall finishes were in fair condition due to observed damage and stains. The suspended acoustical tile and painted ceiling finishes were in good condition. The cabinets in the lab room have rusted through the bottom.
