Task 2: Hydrologic Monitoring and Flushing Studies - Sawmill Brook Flood Mitigation and Restoration Project

TO: Mary Reilly, Manchester-by-the-Sea Grants Administrator
FROM: Gabrielle C. Belfit, CFM and David Azinheira, P.E., CFM
COPY: David A. Murphy, P.E.
DATE: Jun 18, 2018

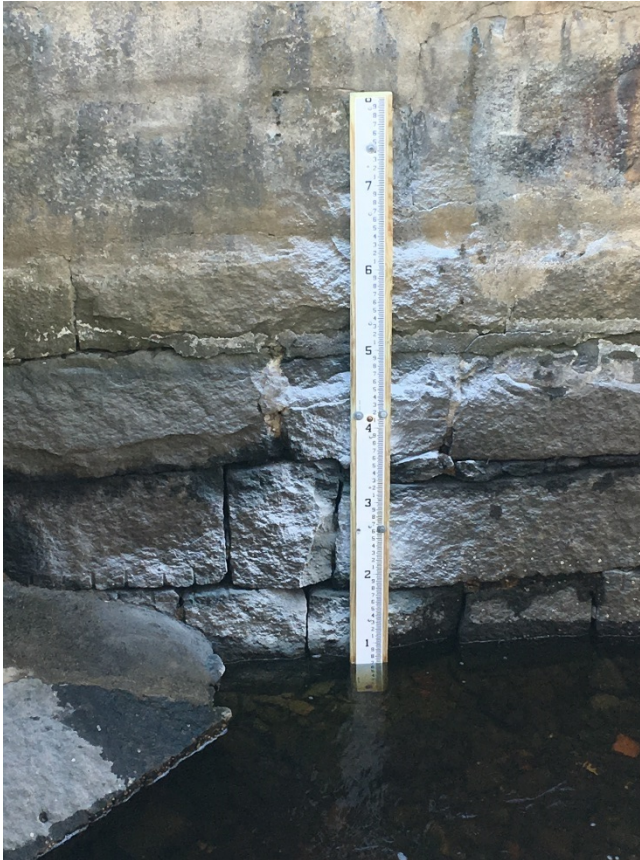
Photo 1: Central Street Bridge Surface Water Level Gage. Fiber glass gage is mounted on pressure treated lumber. Wall mount accomplished with lag bolts drilled into granite blocks.

The Central Street staff gage was dislocated in January due to ice, and was reinstalled 2/28/18 directly onto the granite sidewall just above the bridge (Photo 1) and the bench mark elevation

Non-recording vertical staff gages were installed at the upper and lower extent of the project area to supplement the pressure transducer readings and as a reference backup. The gages are 4-inch wide, fiberglass style A gage with a U.S. scale.

The gages were initially located just below Norwood Avenue and 100 feet above the Central Street Bridge. The gages were mounted on fence post well-hammered into the stream bed, placing the bottom of the gage on the stream bed bottom. The A reference point was marked at the top of the gage plate and tied into the level circuit in November 2017. Volunteers were trained on reading the gages¹ and observations are included in Appendix B surveyed to NAVD88 datum.

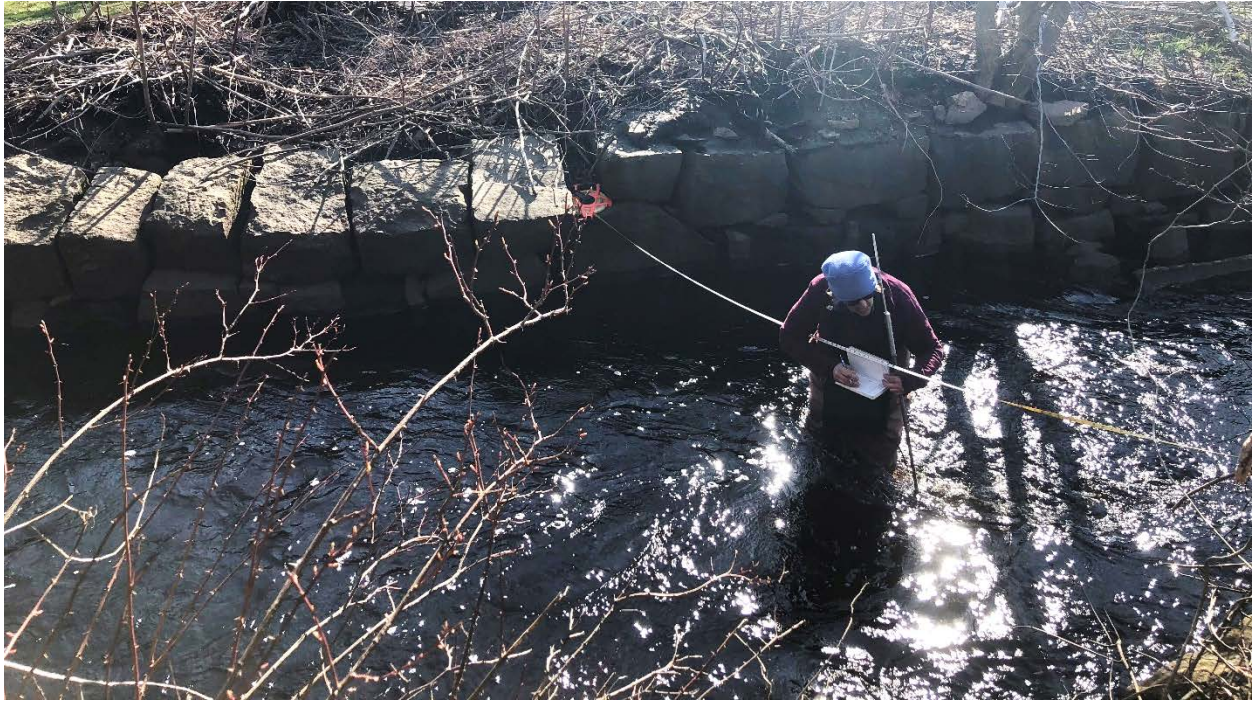
Photo 2: Sawmill Brook Stream Discharge Measuring. Stream velocity in feet/second is measured at discrete intervals across the channel. Stream discharge in cubic feet per second is obtained by multiplying the area for each interval.

2). The measurements were completed on an outgoing tide to capture base flow. The November and April discharge measurements are included in Appendix B.

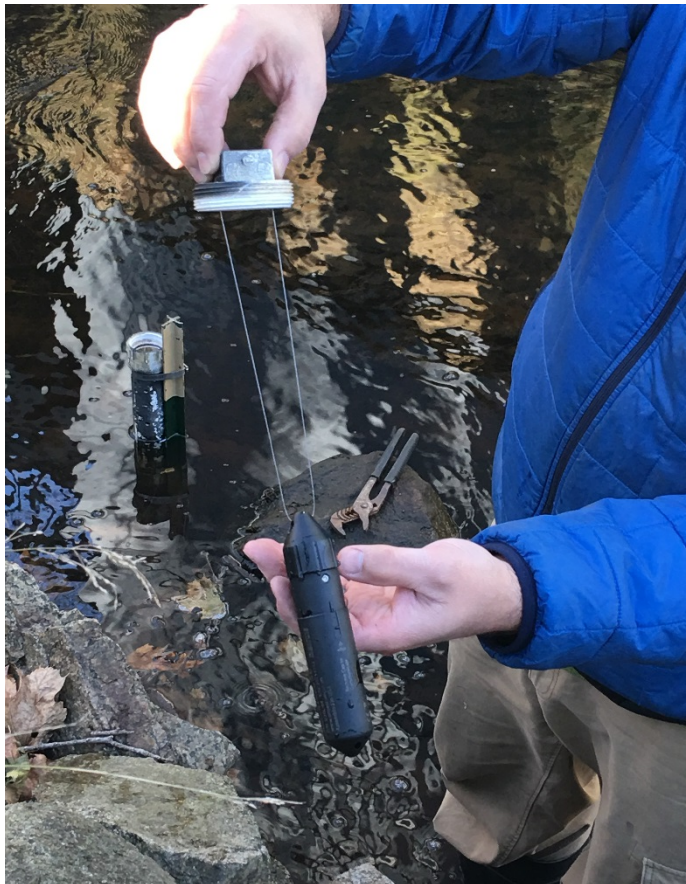
Photo 3: Method to deploy HOB0 water level pressure transducers in stream bed below Norwood Ave. The PVC casing attached to fence post is shown to the left. The PVC was painted black to deter vandalism.

The pressure transducers in Sawmill Brook were installed in 1-foot long, 2-inch diameter PVC pipe sections, that were drilled with holes and capped at both ends. The pipe sections were bolted onto rebar installed hammered in the stream bank. The transducers were suspended from a non-stretchable wire (Photo 3), inside the PVC, as referenced

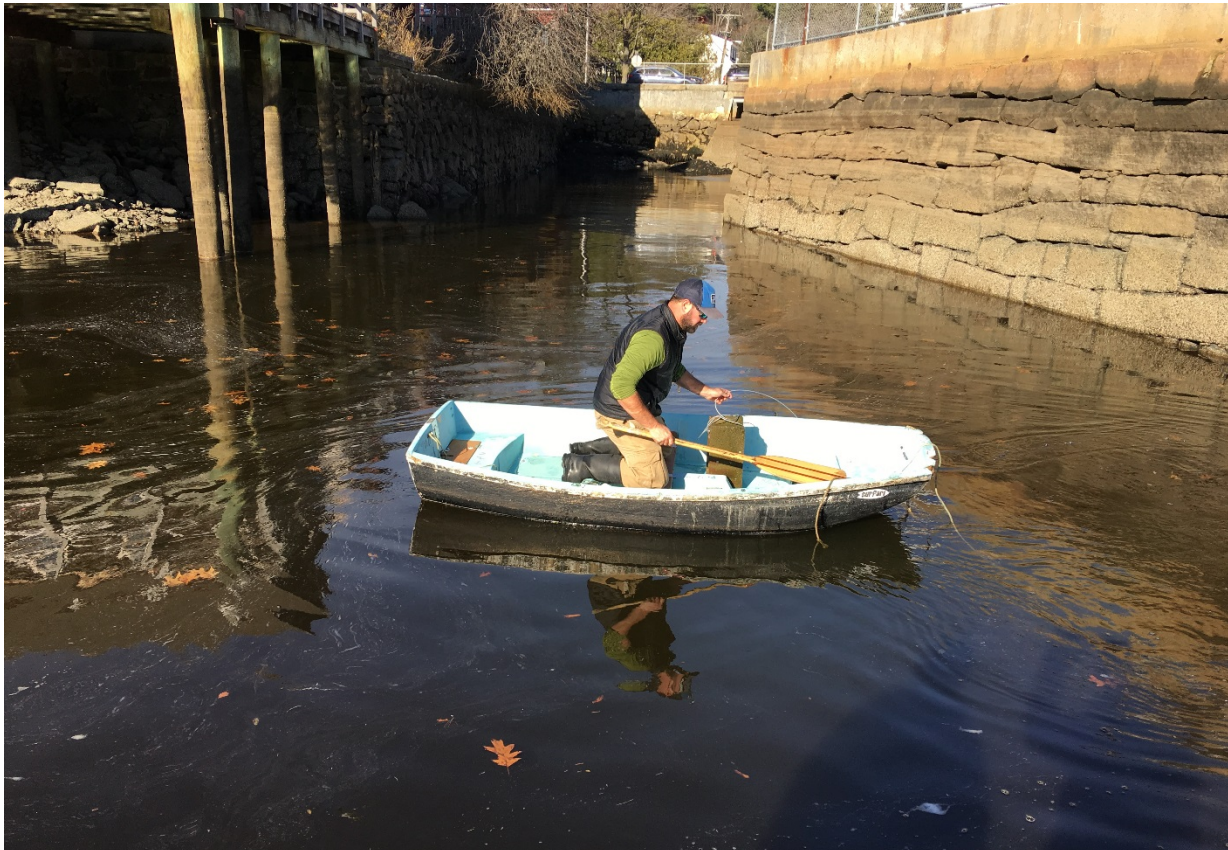
Photo 4: Method to deploy HOB0 water level pressure transducers in Manchester Harbor using granite block and steel cable.

The unit in Manchester Harbor was attach to a concrete cinderblock and secured to the Town Pier with steel cable (Photos 4).

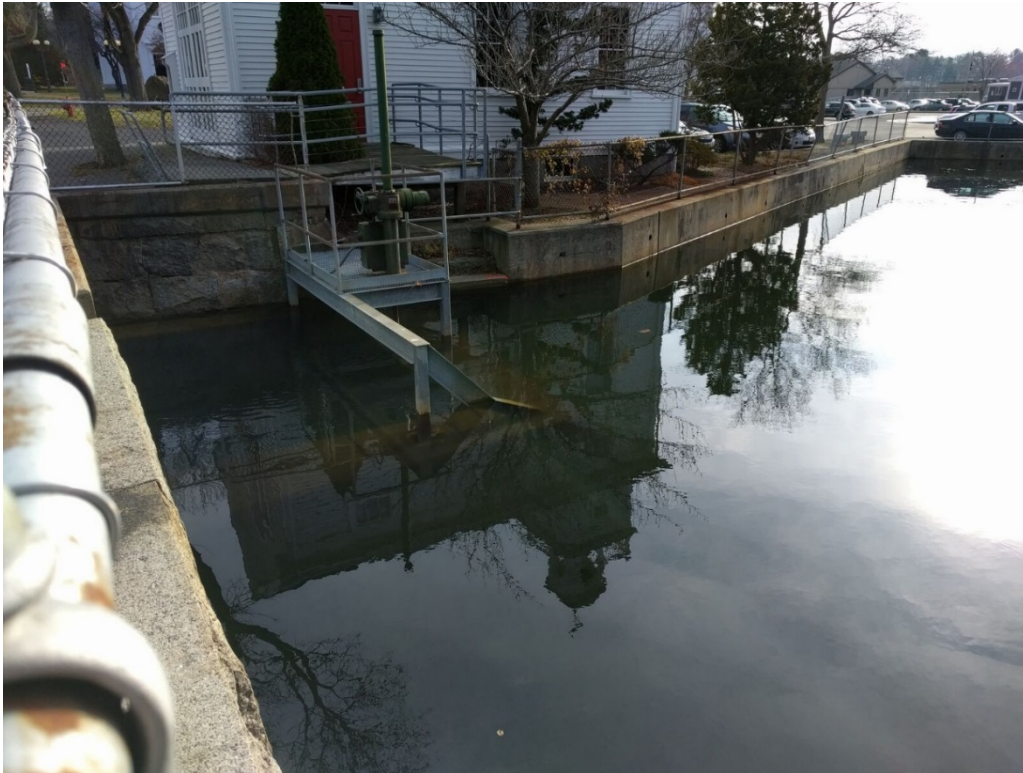
Photo 5: High Tide on December 3, 2017 the tide is well above the top of the tide gate

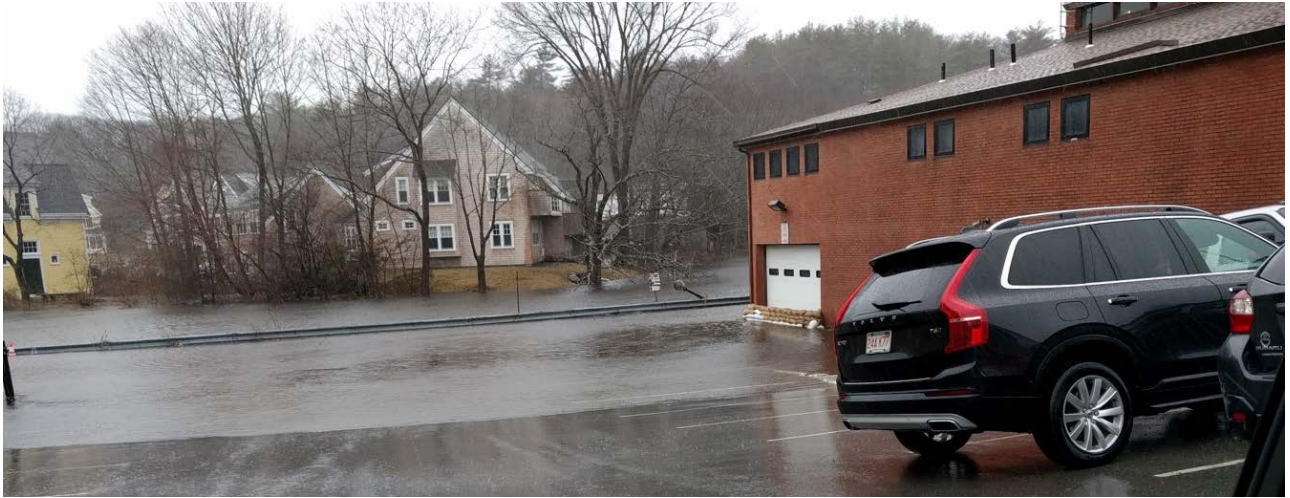
Photo 6: Central Pond adjacent to the Manchester Fire Department shown on 1/4/2018. Rising water levels eventually overtopped the wall (elevation 5.4 ft. NAVD88) flooding the parking area and Fire Department basement and garage area.

high tide and a recorded 0.74 inches of precipitation. Flooding was observed at several locations along Central Pond (Photo 6).

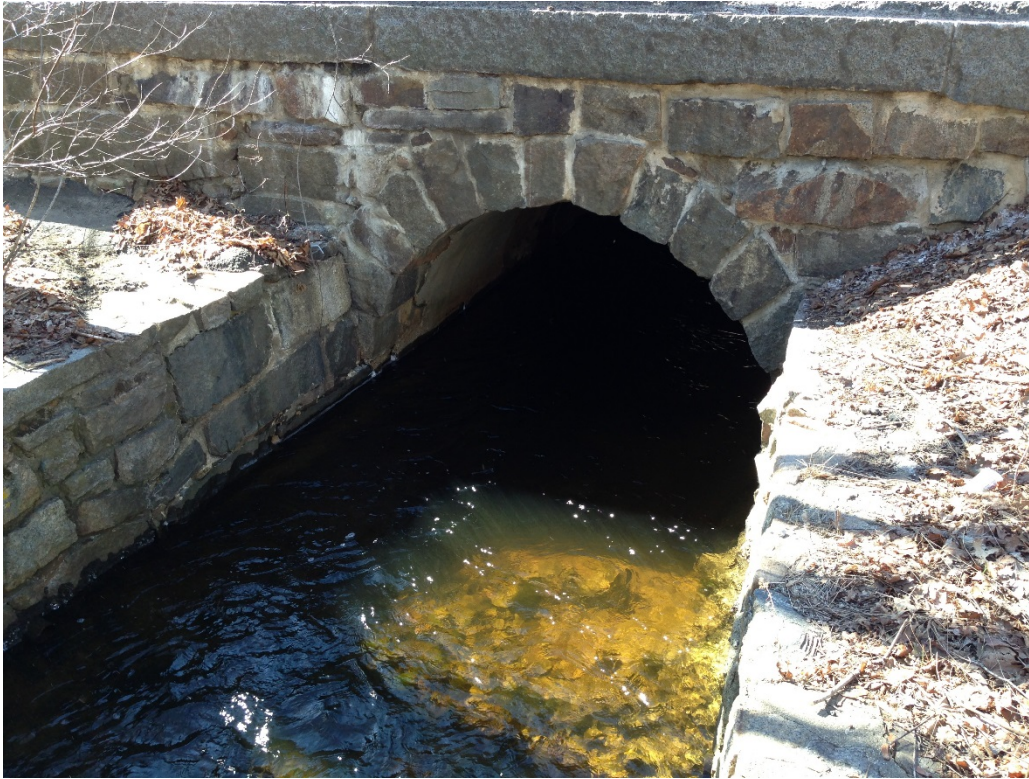
Photo 7: The upstream side of the School Street culvert is an example of the narrow, channelized character of Sawmill Brook. This location overtopped in the 2006 Mother's Day storm, causing extensive damage to adjacent properties. The gravel bottom and location just upstream from Central Pond provides a prime rainbow smelt spawning location.

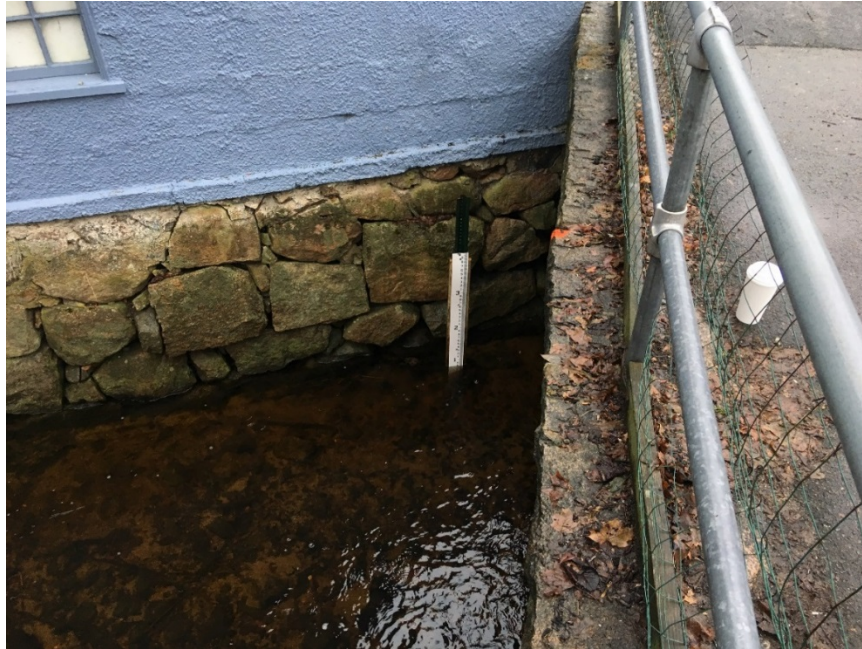
Photo 8: The downstream side of the Norwood Avenue is shown here. Gage A is installed on a heavy-duty fence post, pounded deep into the stream bottom. Volunteers took weekly depth to water measurements at the headwall bench mark location, indicated by the orange mark at the edge of the pavement.

Data obtained from the pressure transducers above and below the Norwood Avenue Culvert, manual measurements at the Norwood Ave culvert headwall, and Staff Gage A were helpful to evaluate conditions under various hydrologic settings (Photo 8). The immediate goal was evaluating if culvert restrictions were evident on the upstream side with a large rainfall event. As with the other sites, the information also provides the data to calibrate the hydrologic model. Hydrologic conditions observed over the five-month monitoring period were sufficient to capture a wide range of conditions. Results at this location are provided in Figures 5 and summarized below.

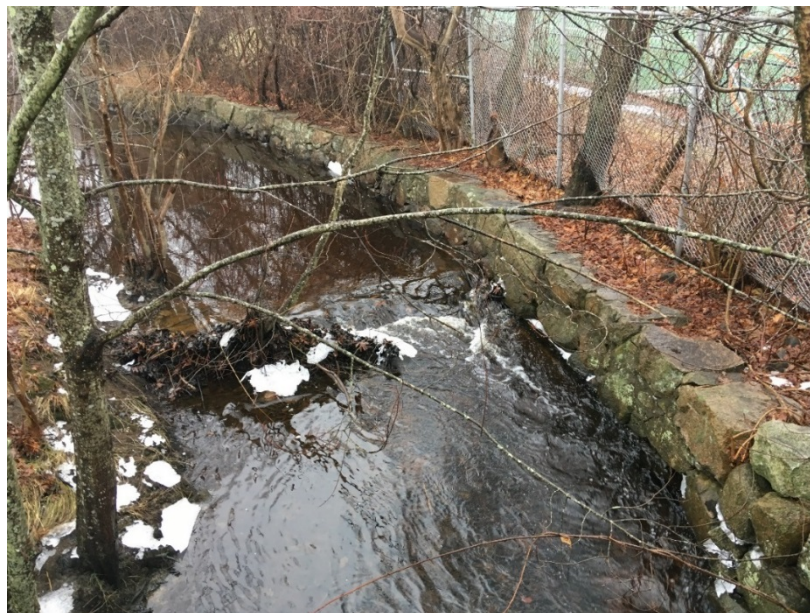
Photo 9 The upstream side of the Norwood Avenue is shown here. The pressure transducer is in the bottom right corner. Just upstream, evidence of recent beaver activity is still causing some backup, an ongoing issue at this location.

- The majority of sudden water level increases are attributed to precipitation events. A few events don't follow this pattern and may be due to rapid snow melt, release of water due to the breaking of an identified upstream beaver dam (Photo 9).
