Task 3: Sediment Characterization and Flushing Studies - Sawmill Brook Flood Mitigation and Restoration Project

TO: Mary Reilly, Manchester-by-the-Sea Grants Administrator
FROM: Gabrielle Belfit, CFM; Gary Hedman, LSP; David Azinheira, CFM, P.E.
COPY: David A. Murphy, P.E.
DATE: June 18, 2018

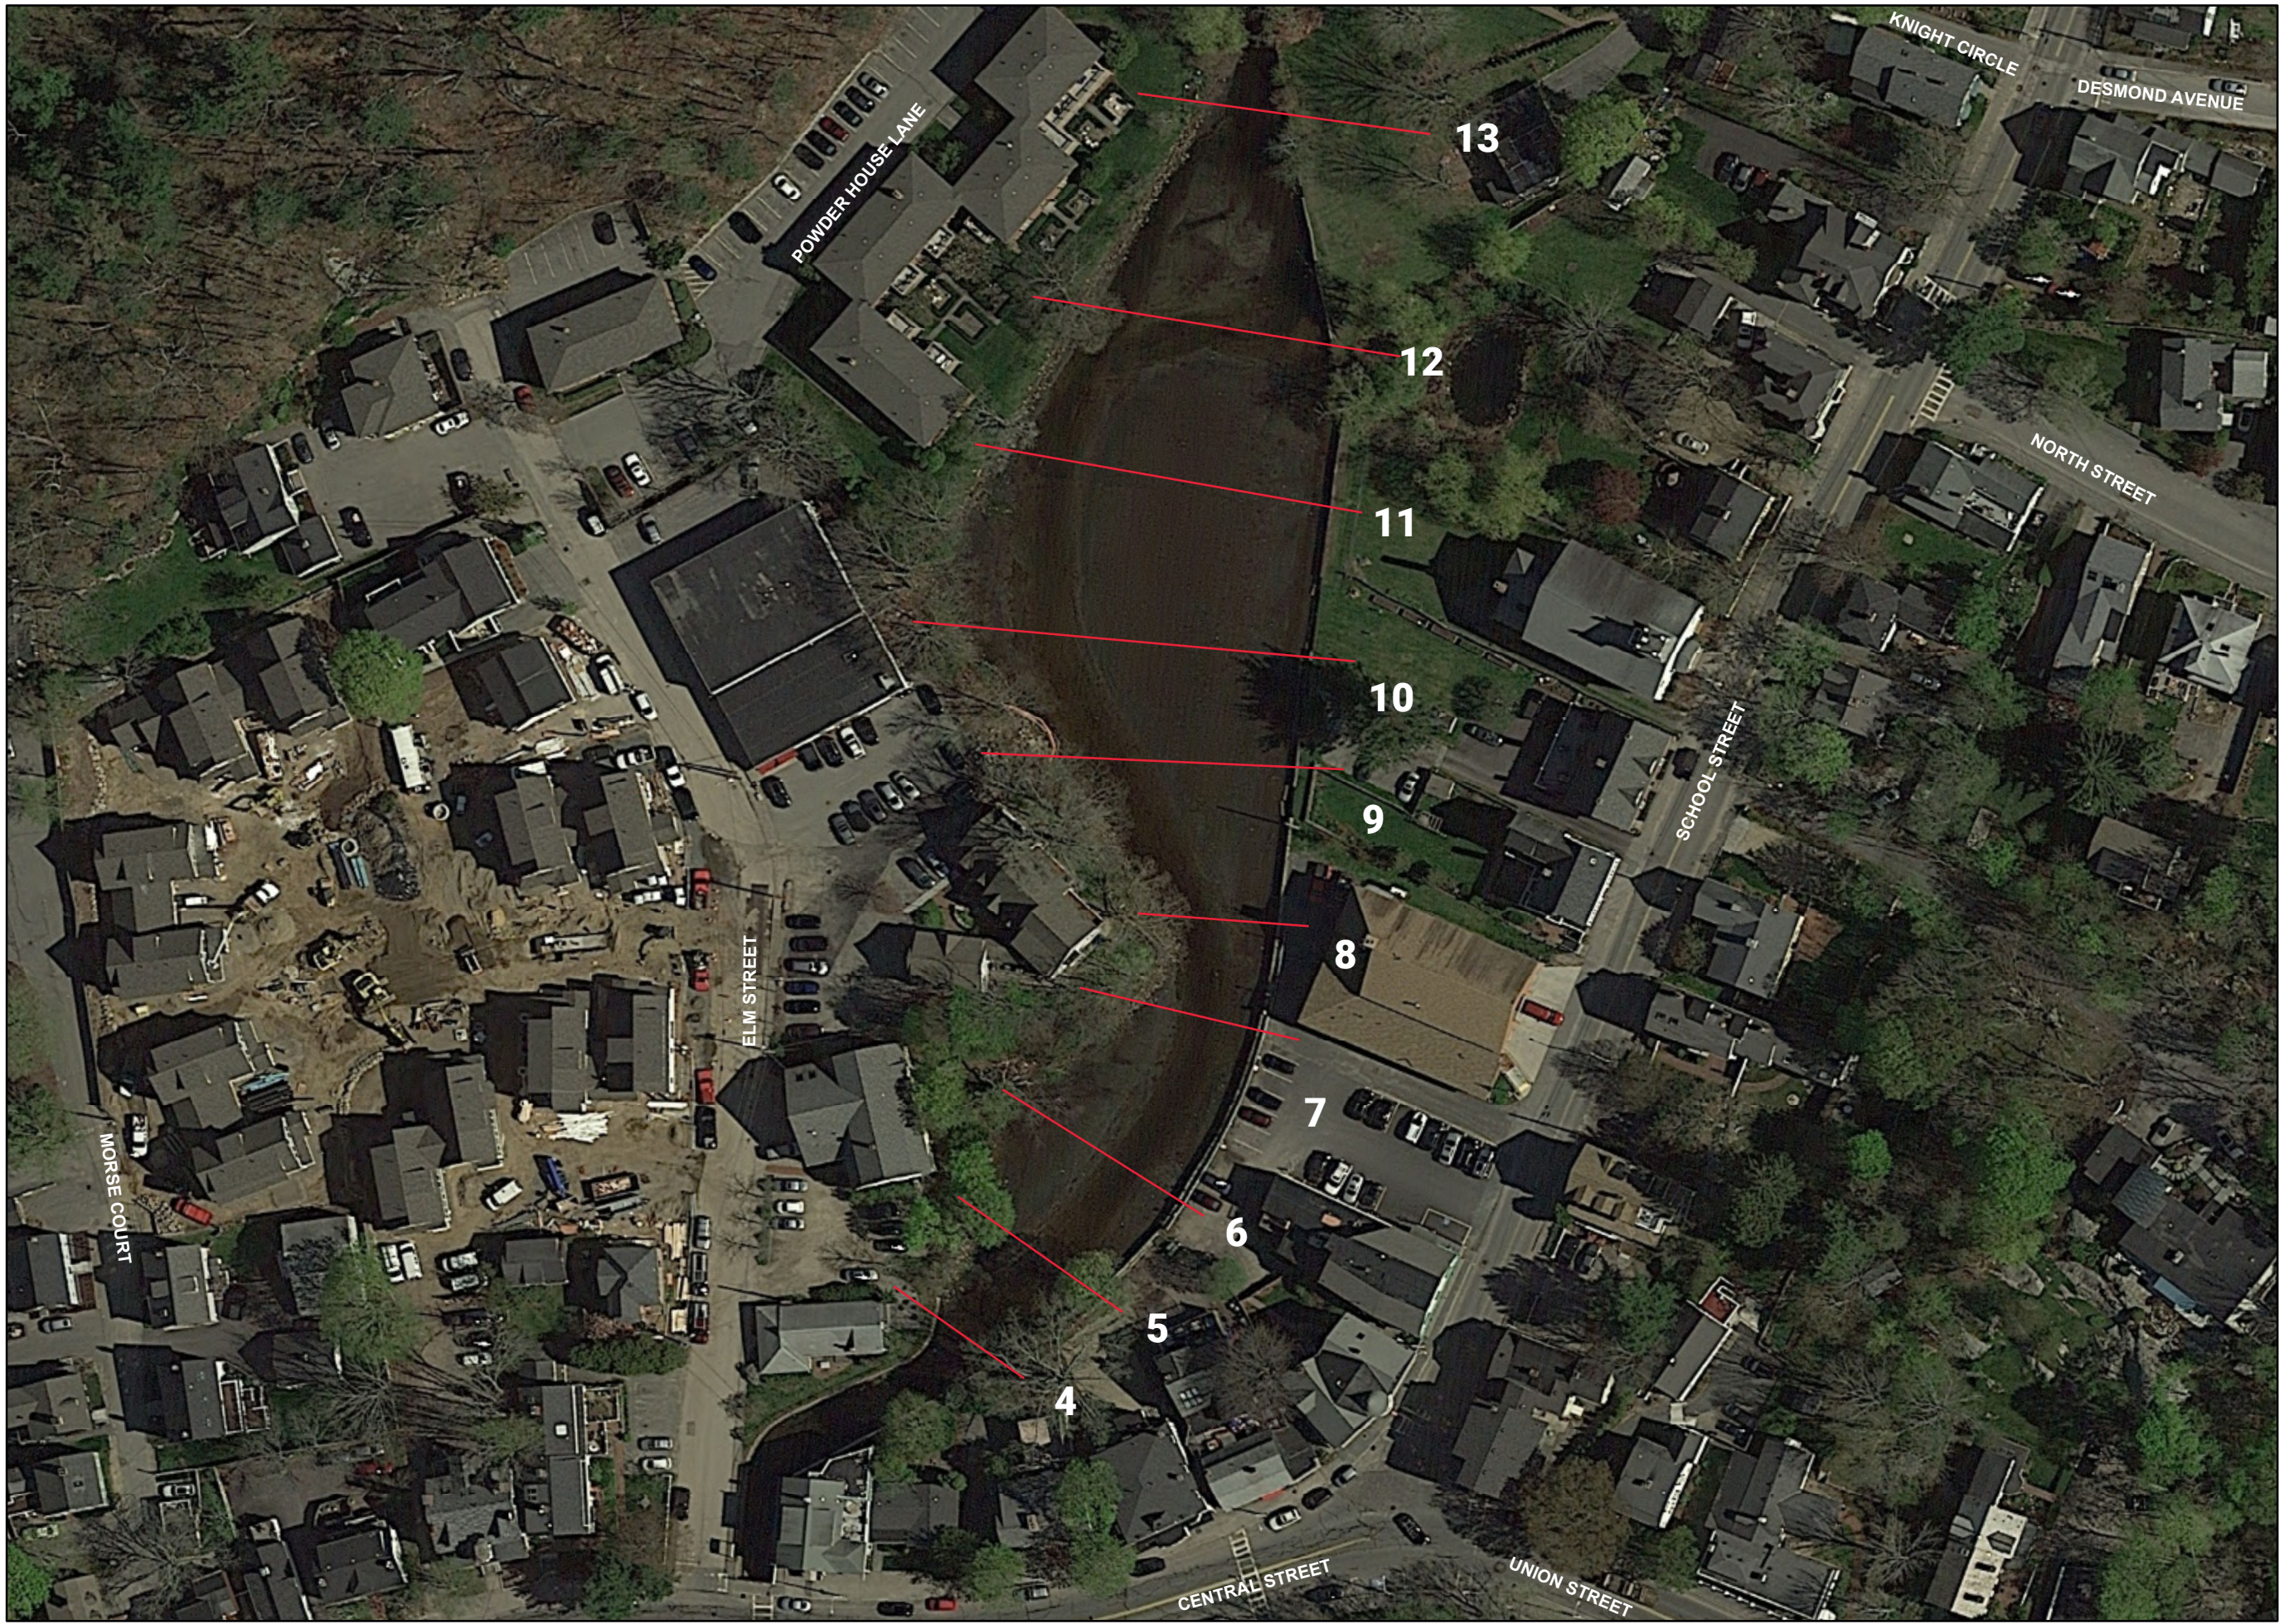
Figure 1
**Sediment Profiles
Transect Locations**

Sediment profiling was conducted in the Central Pond portion of the project area to develop a baseline assessment of sediment depth. A total of nine sediment depth profiles were completed on November 28, 2017 and January 23, 2018, in the same location as the existing conditions plan surveyed cross sections shown in **Figure 1**. Sediment depths were collected by manually advancing a six-foot-long, half inch diameter steel probe to refusal, and recording the measurement. Sediment depths were profiled every 10 feet across each cross section and are summarized in Appendix A, along with sediment profile cross sections, depicted with the existing conditions survey cross section profile.

The sediment depth profiling of Central Pond indicated that accumulations of fine grained sediment and organic muck range from less than one foot to greater than six feet in depth, with the thickest areas of sediment located at Transect 6 and Transect 10. Sediment thickness along these transects was significantly variable, transitioning from approximately two feet to greater than six feet over the course of one profile interval (10 feet). **Inset 1** shows the sediment profiles for Transect 10, stretching out across the widest point of Central Pond. Deposition of sediment in Central Pond is the result of several contributing factors, most notably the dissipation of flow velocity when the Central Street tide gate is closed, impounding water across the Central Pond area. Sources of sediment include streambank erosion within and upstream of Central Pond, and untreated stormwater runoff from the surrounding areas.

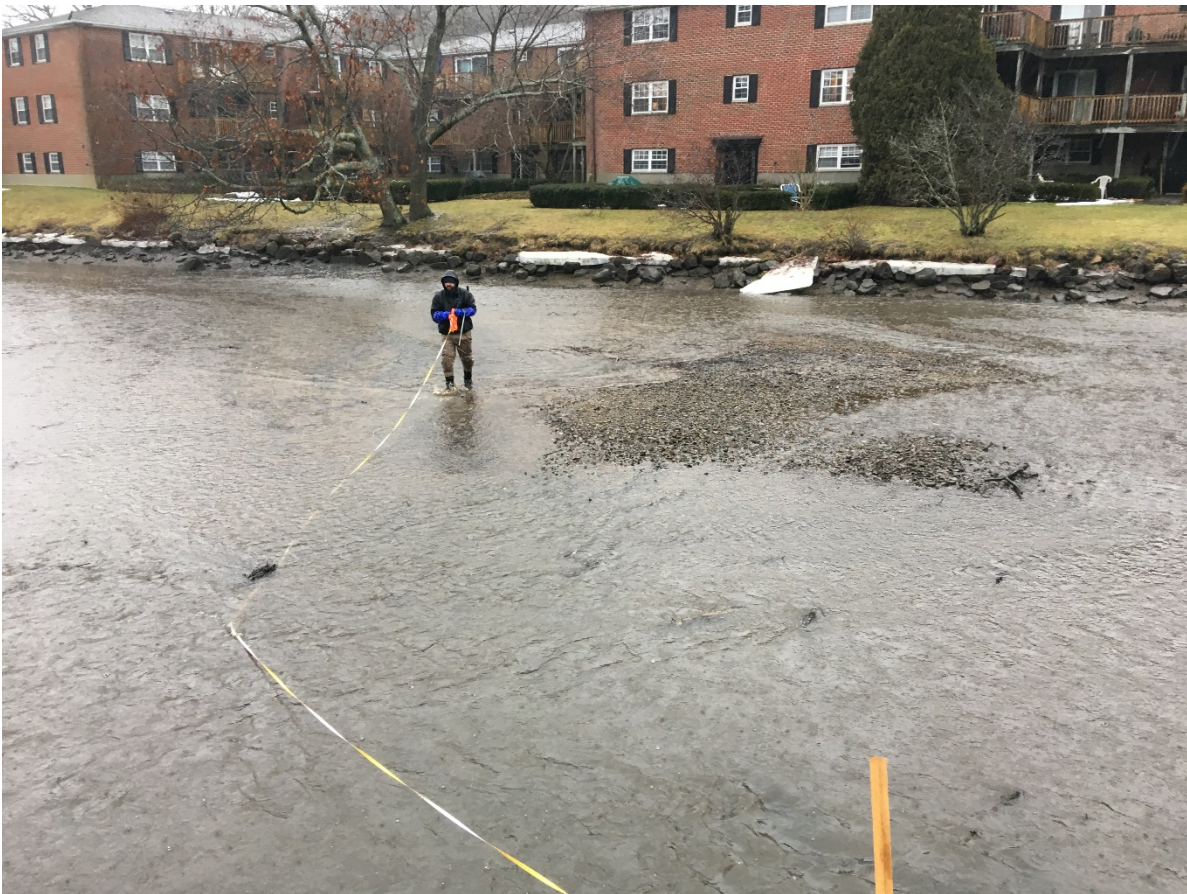
Photo 1: Conducting the sediment depth survey at Transect 11 (January 23, 2018).

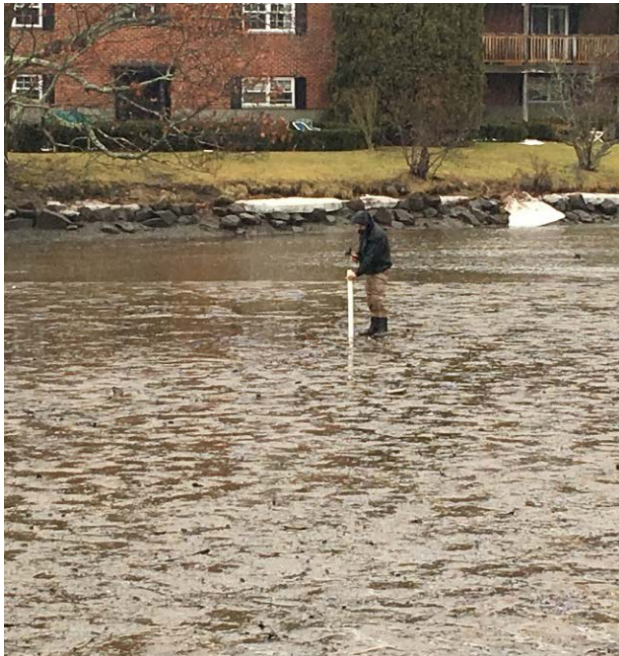
Photo 2: Sediment sample collection at Transect 12 (January 23, 2018).

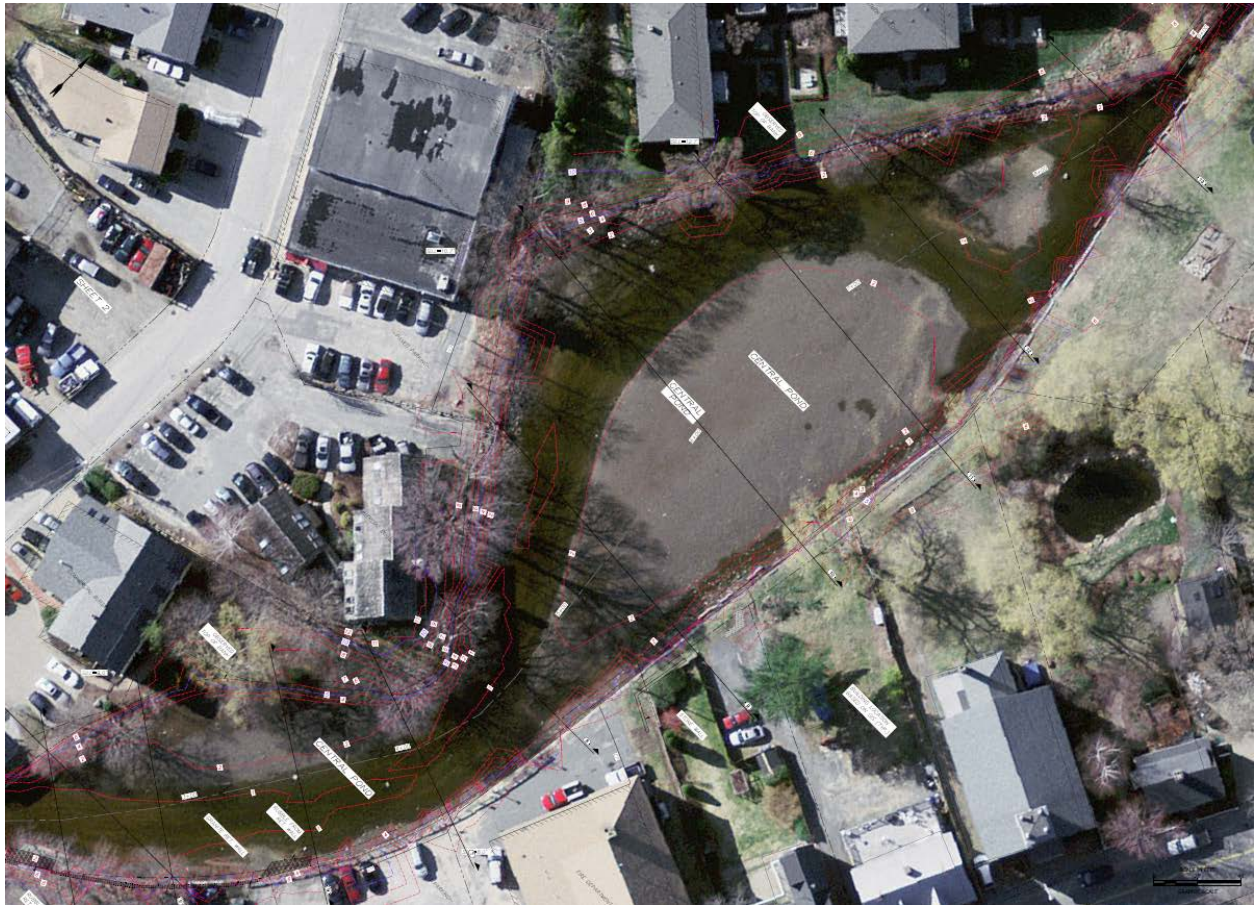
The survey data was used to develop a bathymetric map of the Central Pond surface (Photo 3). The Pond is relatively flat, with a shallow gradient from ranging from 3 feet NAVD88 where Sawmill Brook enters Central Pond to 0.2 feet at the Central Street culvert inlet. Two main "islands" are present at low tide, one triangular feature at the entrance to the pond, and one kidney shaped feature centrally located. The surveyed bathymetry correlates well with orthophotos, considering the contour resolution is only one foot. At low tide, Sawmill Brook

Photo 3- Survey Bathymetry of Central Pond

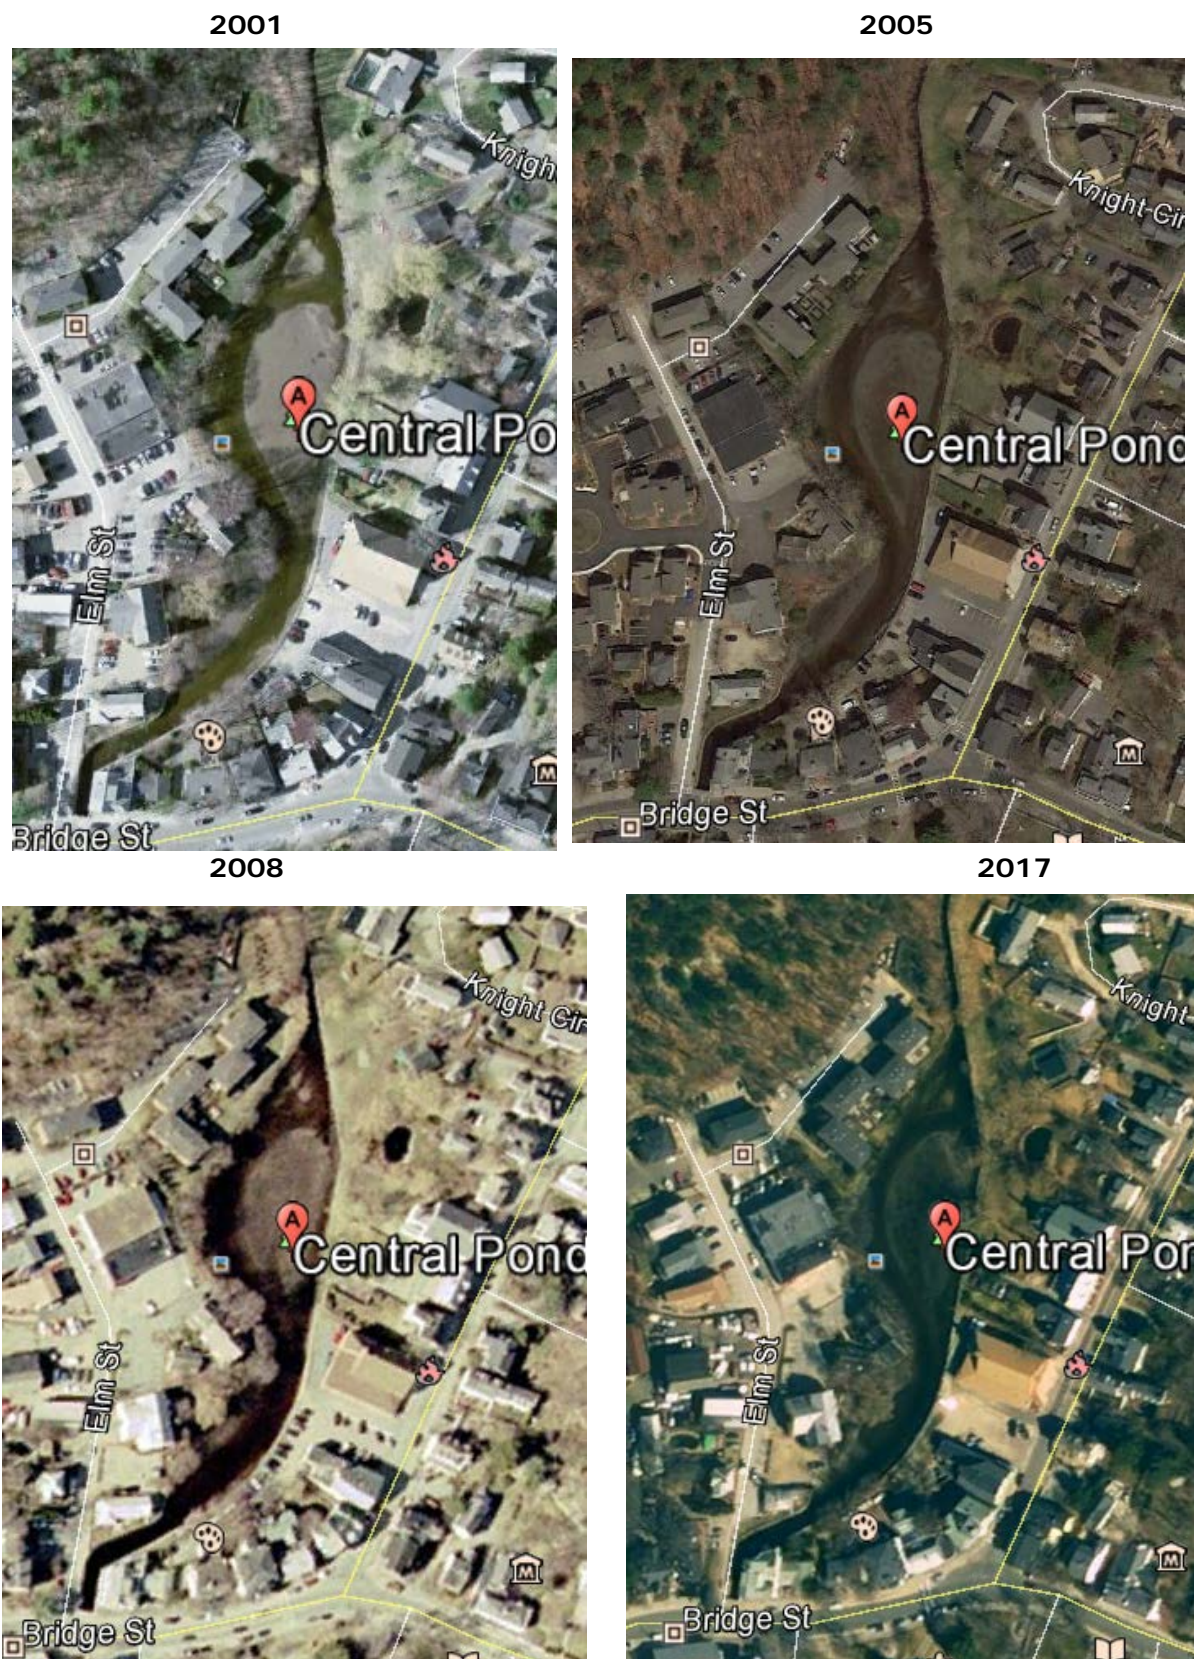
Photo 4: Views of Central Pond 2001-2017

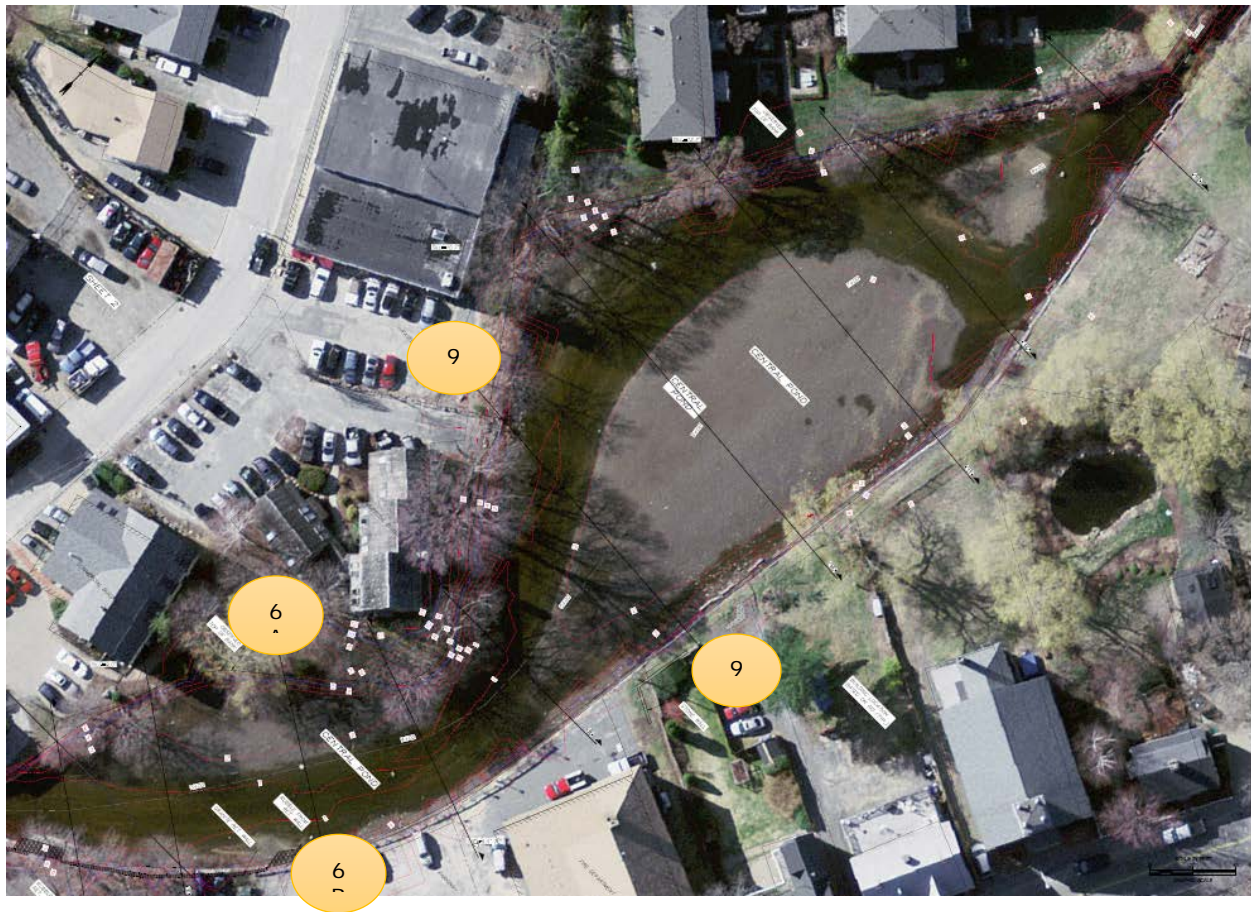
Photo 5
Conceptual Profile for Marsh Restoration- Transect 6 and 9

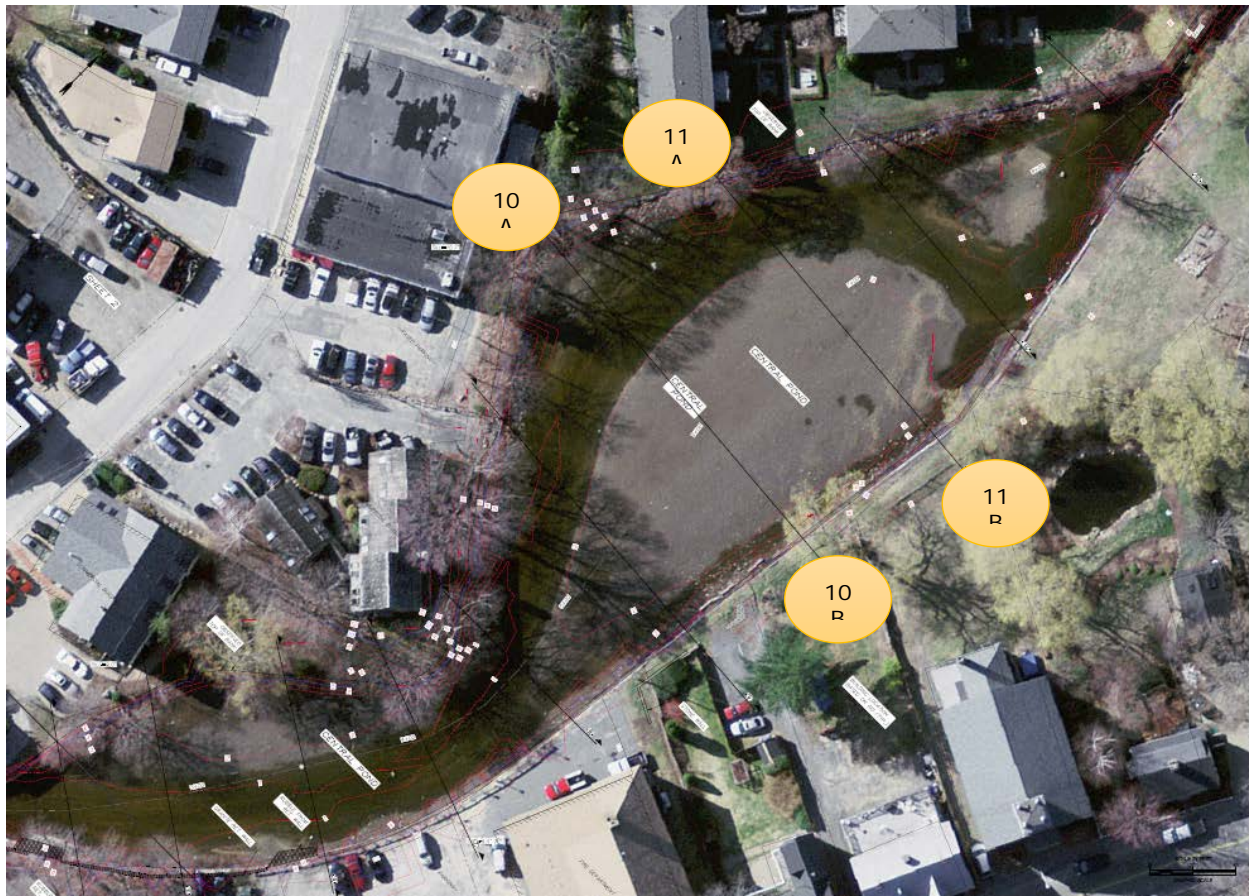
Photo 6
Conceptual Profile for Marsh Restoration- Transect 10 and 11

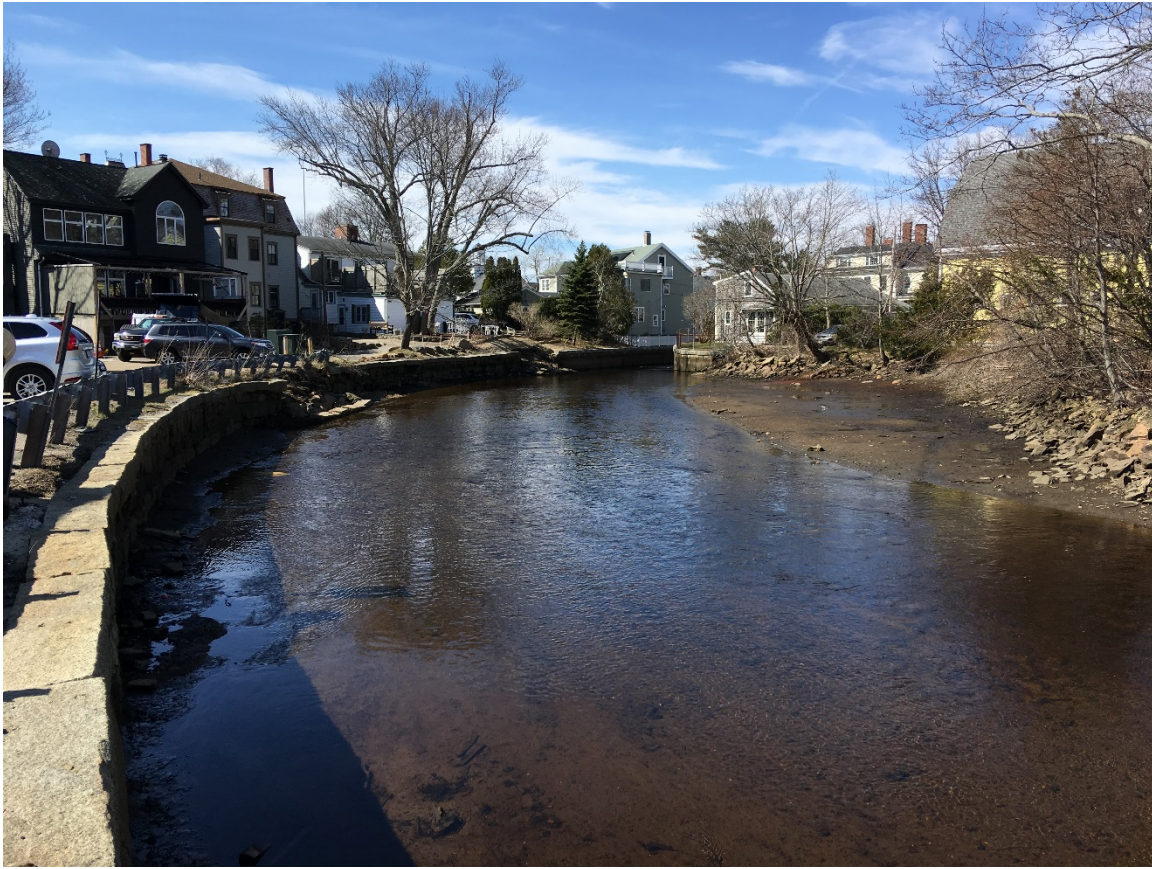
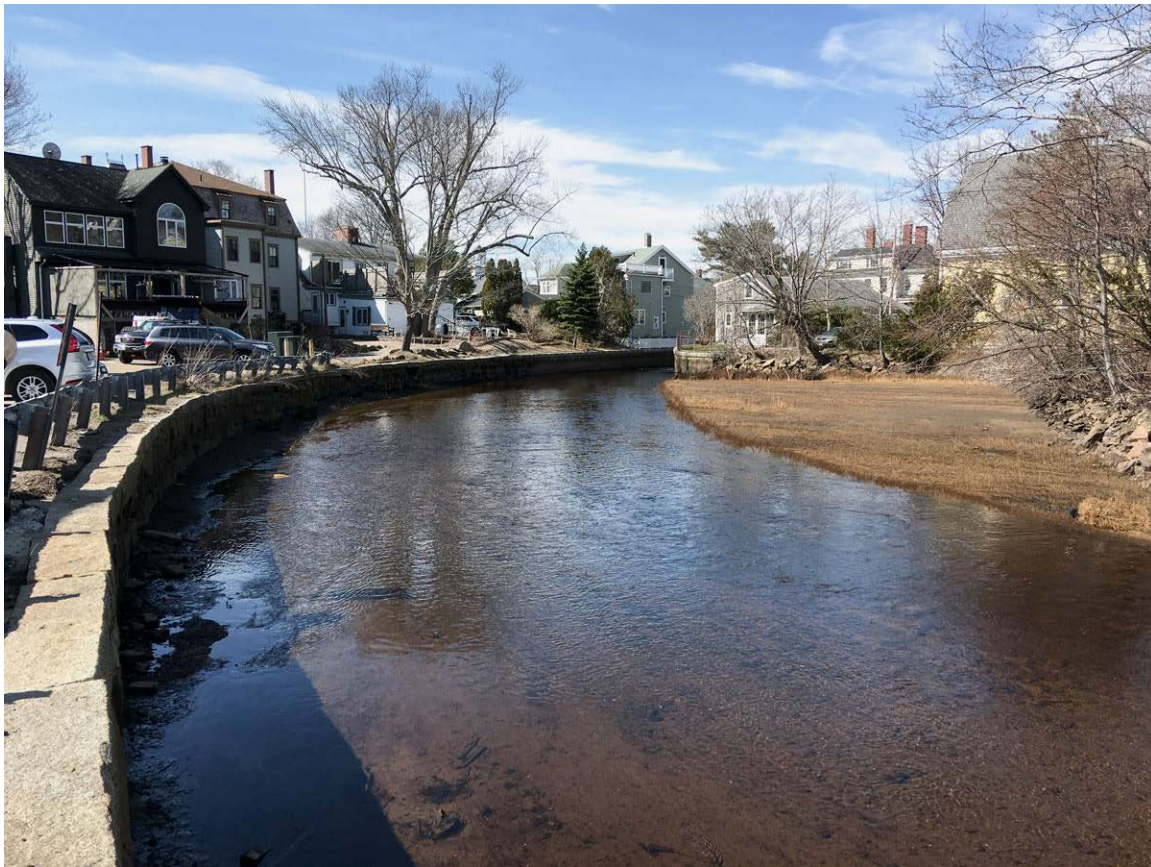
Photo 7
Before and After Restoration- South View

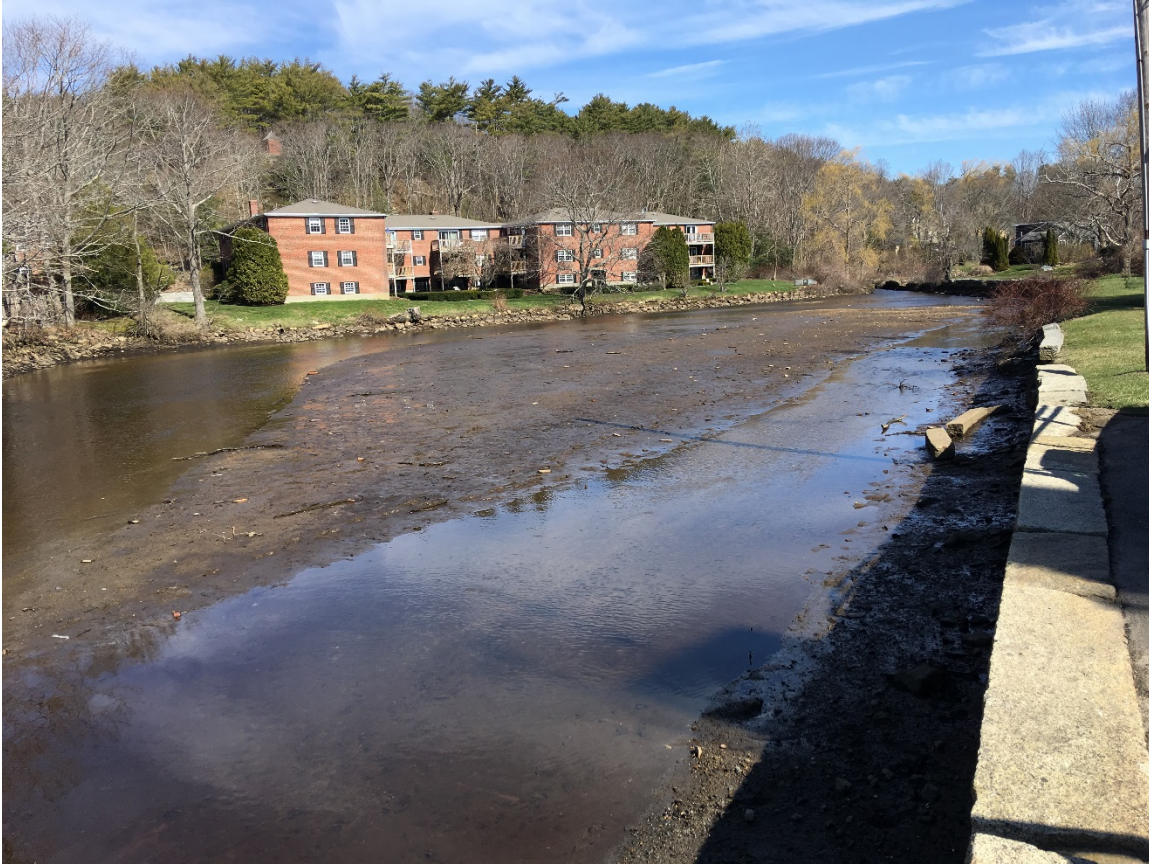
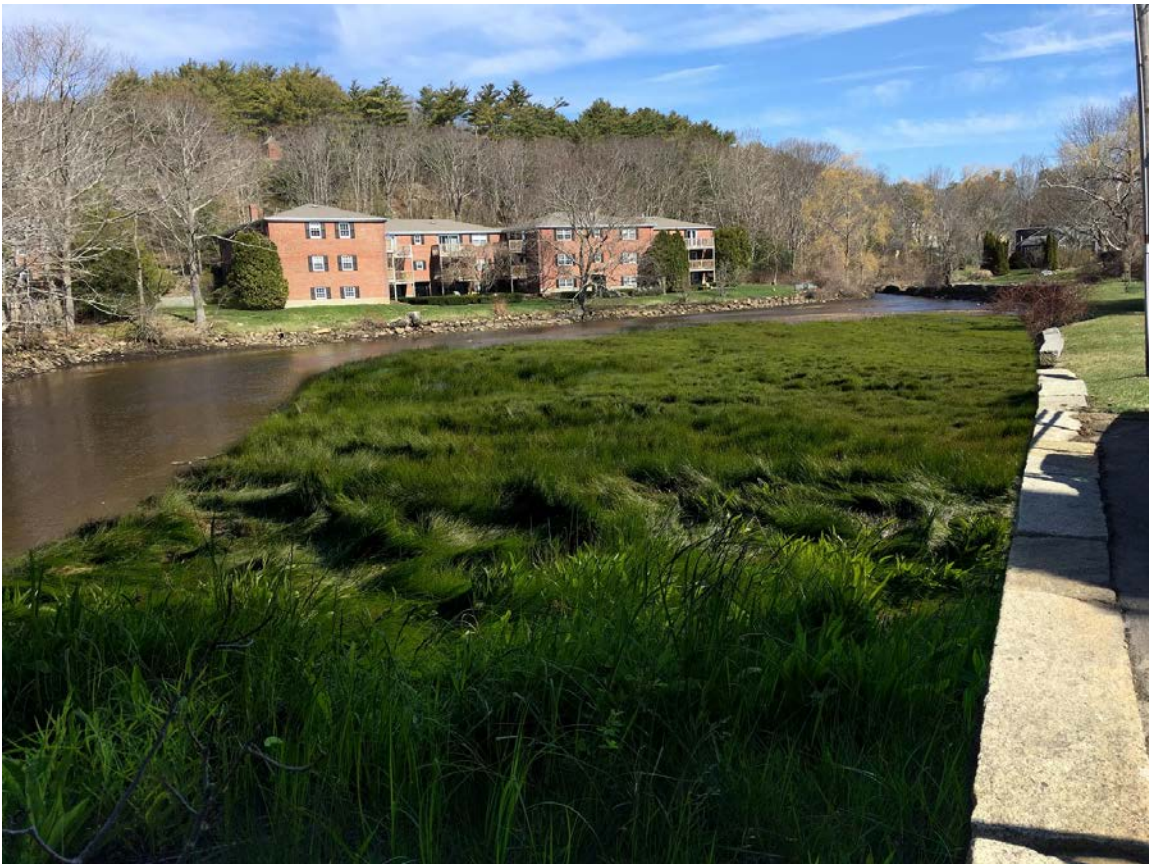
Photo 8
Before and After Restoration-North View

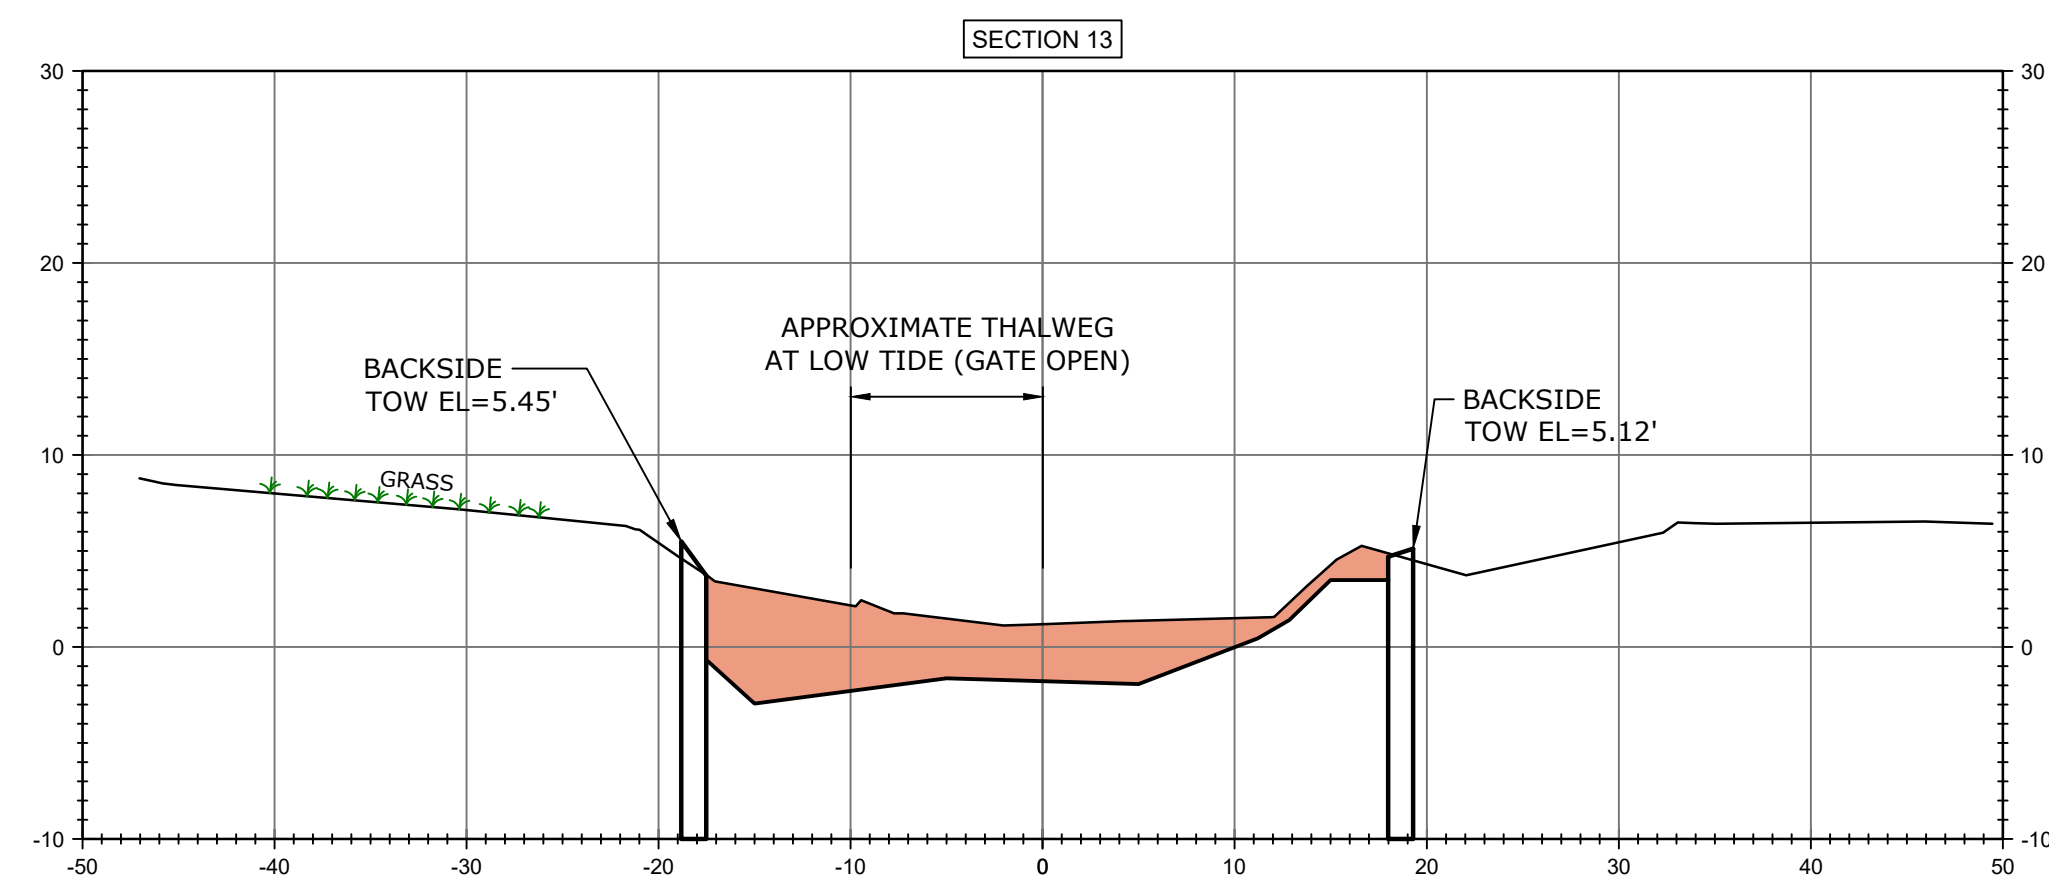
CENTRAL POND
SEDIMENT PROFILES
CROSS SECTION VIEWS
March 2018

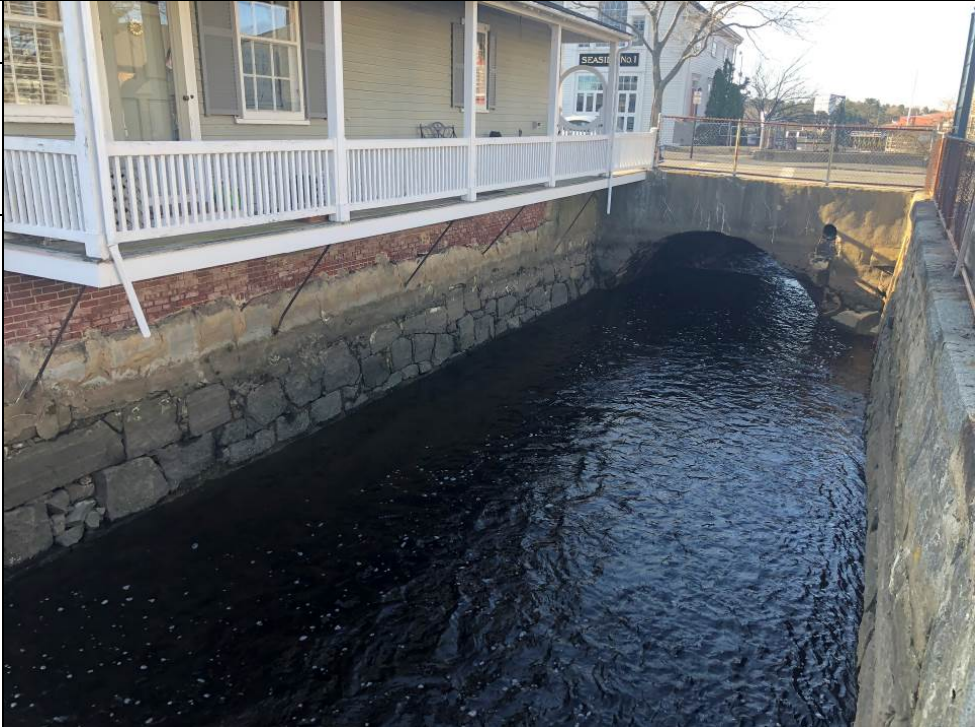
Tighe&Bond		PHOTOGRAPHIC LOG	
Client Name: Manchester-by-the-Sea, MA		Site Location: Central Pond	
Project No.: M-1476-009			
Photo No. 1	Date: 4/18/2018

Direction Photo Taken: South			
Description: Walls adjacent to the Central Street Bridge.

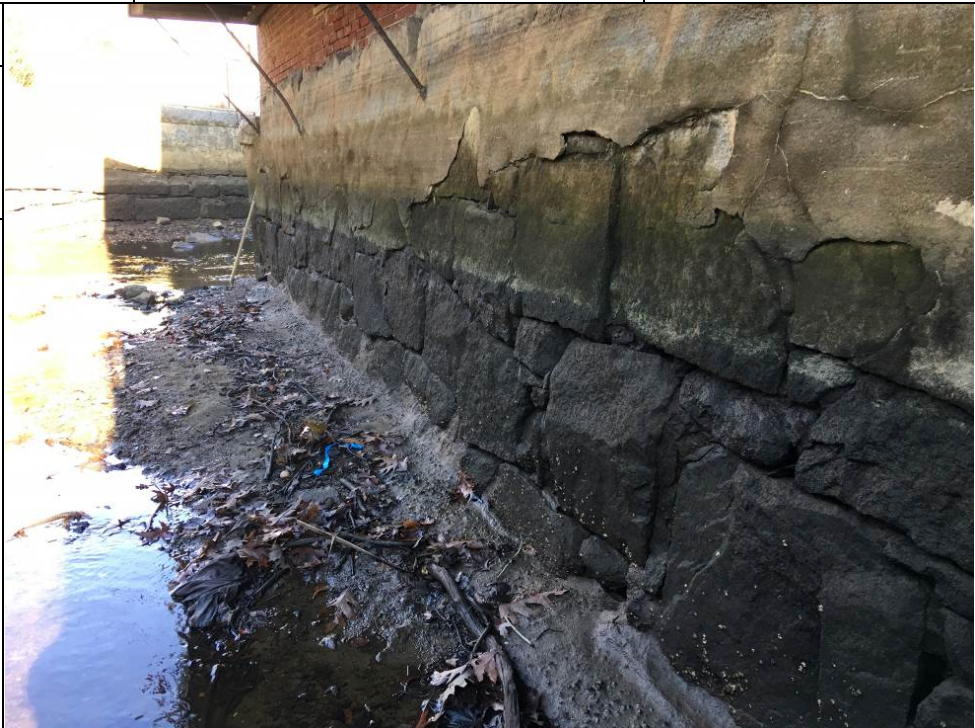
Tighe&Bond		PHOTOGRAPHIC LOG	
Client Name: Manchester-by-the-Sea, MA		Site Location: Central Pond	
Project No.: M-1476-009			
Photo No. 2	Date: 3/28/2018

Direction Photo Taken: North			
Description: Eastern wall segment, concrete overlay on granite blocks.

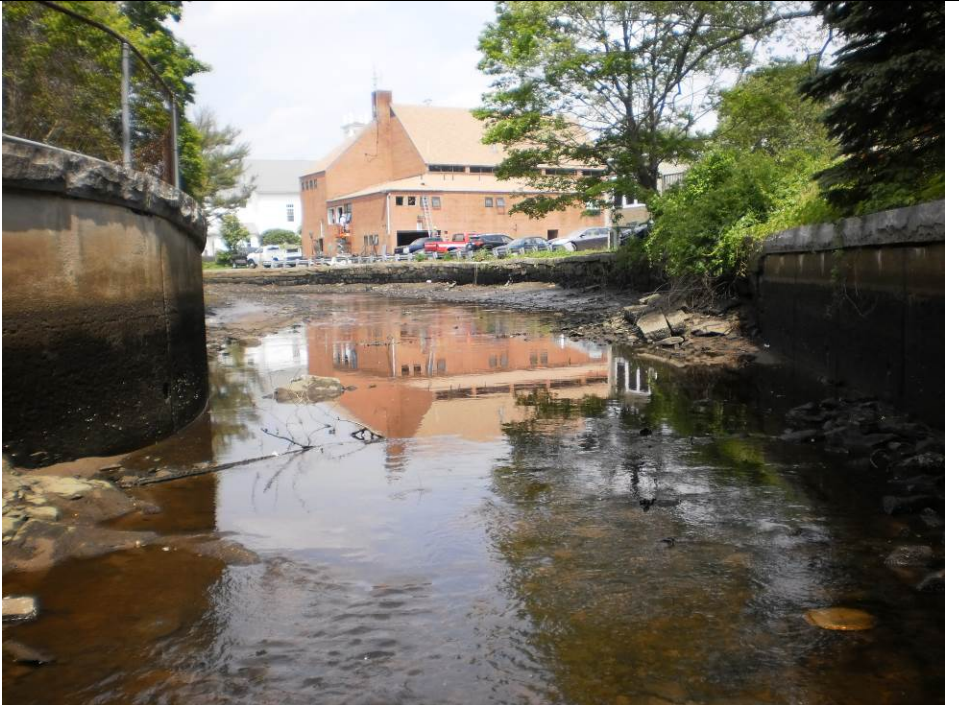
Tighe&Bond		PHOTOGRAPHIC LOG	
Client Name: Manchester-by-the-Sea, MA		Site Location: Central Pond	Project No.: M-1476-009
Photo No. 3	Date: 6/11/2015

Direction Photo Taken: North			
Description: View with tide gate open in 2015 towards Fire station. Wall collapse evident only behind 7 Central Street. Town owned granite/ concrete wall on the left

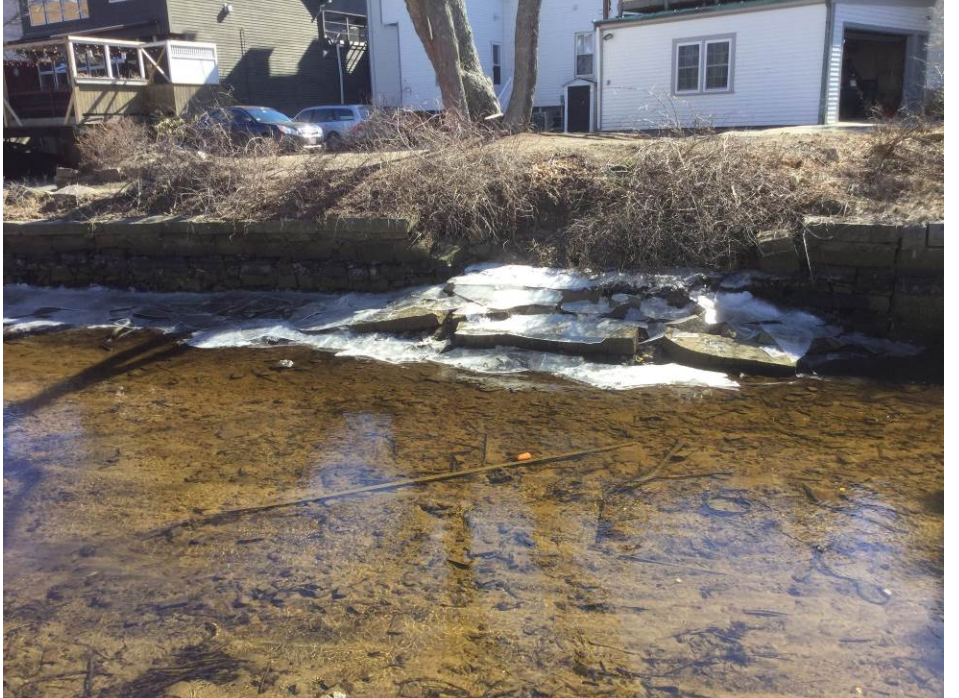
Tighe&Bond		PHOTOGRAPHIC LOG	
Client Name: Manchester-by-the-Sea, MA		Site Location: Central Pond	Project No.: M-1476-009
Photo No. 4	Date: 12/3/2017

Direction Photo Taken: East			
Description: Wall collapse behind 7 Central Street.

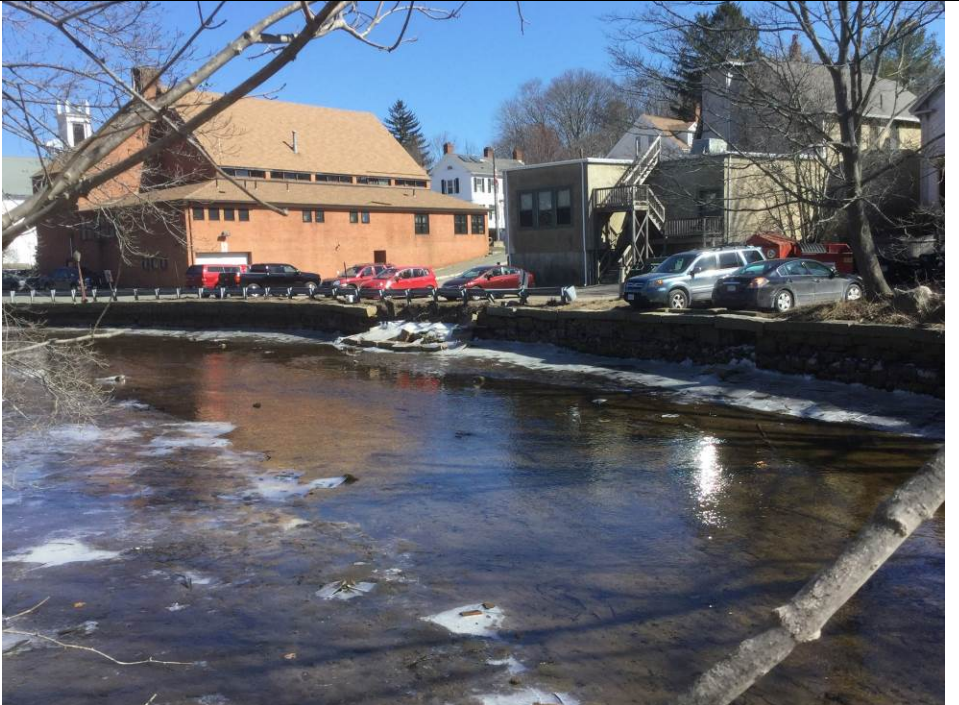
Tighe&Bond		PHOTOGRAPHIC LOG	
Client Name: Manchester-by-the-Sea, MA		Site Location: Central Pond	Project No.: M-1476-009
Photo No. 5	Date: 3/11/2017

Direction Photo Taken: Northeast			
Description: New section of wall collapse behind 6 School Street.

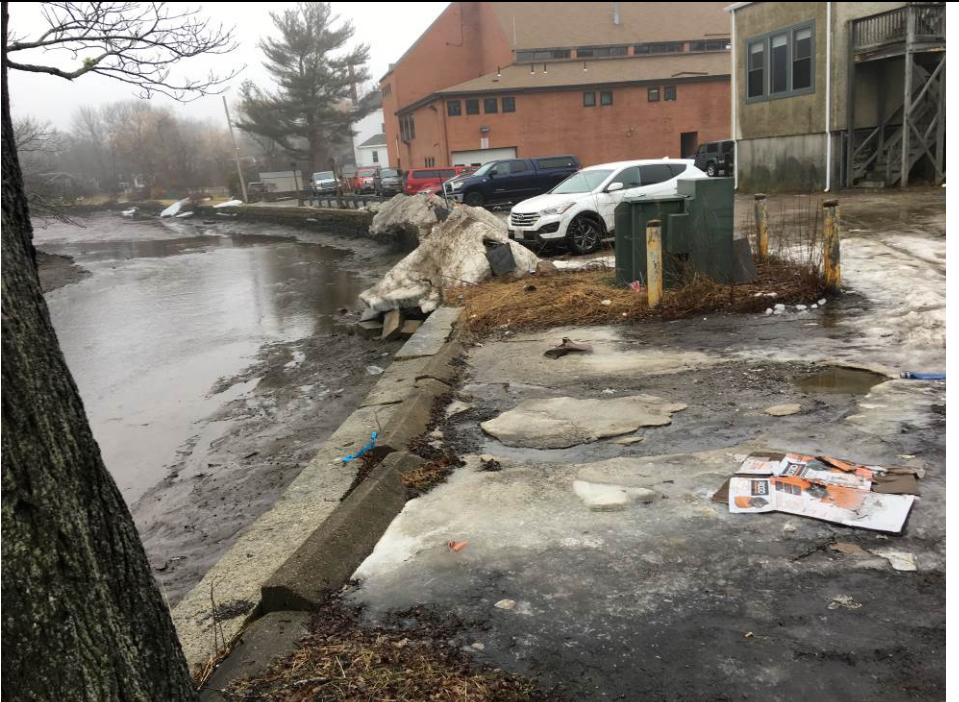
Tighe&Bond		PHOTOGRAPHIC LOG	
Client Name: Manchester-by-the-Sea, MA		Site Location: Central Pond	Project No.: M-1476-009
Photo No. 6	Date: 12/3/2017

Direction Photo Taken: Northeast			
Description: Snow piles on top of wall collapse at 6 School Street. Degraded curb stops in foreground.

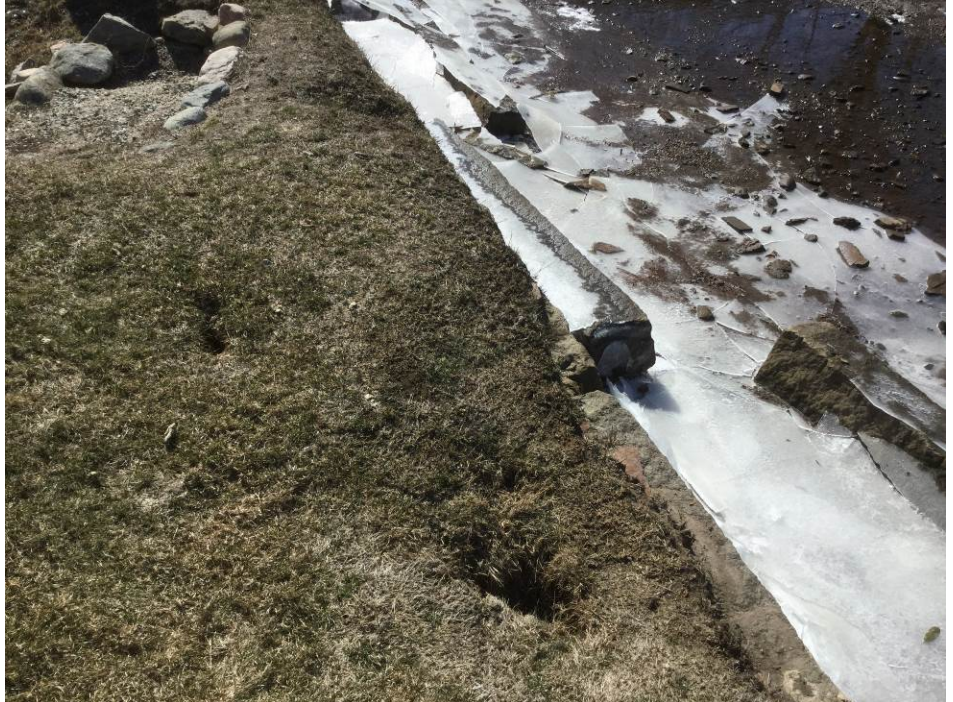
Tighe&Bond		PHOTOGRAPHIC LOG	
Client Name: Manchester-by-the-Sea, MA		Site Location: Central Pond	Project No.: M-1476-009
Photo No. 7	Date: 3/11/2017

Direction Photo Taken: Northwest			
Description: Collapse behind Fire Station and 16 School Street. Drainage issues and land subsidence evident.

The worst wall conditions were observed in the south-eastern section of the Pond (extending from behind 19 Central Street to the Fire Station, where two wall sections have entirely collapsed, and approximately 400 feet is in need of extensive repair. The wall sections above the Fire Station to Knights Circle (approximately 400 feet) have areas that need moderate repairs including replacing cap stones and addressing land subsidence behind the wall.
