Task 3: Sediment Characterization and Flushing Studies - Sawmill Brook Flood Mitigation and Restoration Project

TO: Mary Reilly, Manchester-by-the-Sea Grants Administrator
FROM: Gabrielle Belfit, CFM; Gary Hedman, LSP; David Azinheira, CFM, P.E.
COPY: David A. Murphy, P.E.
DATE: June 18, 2018

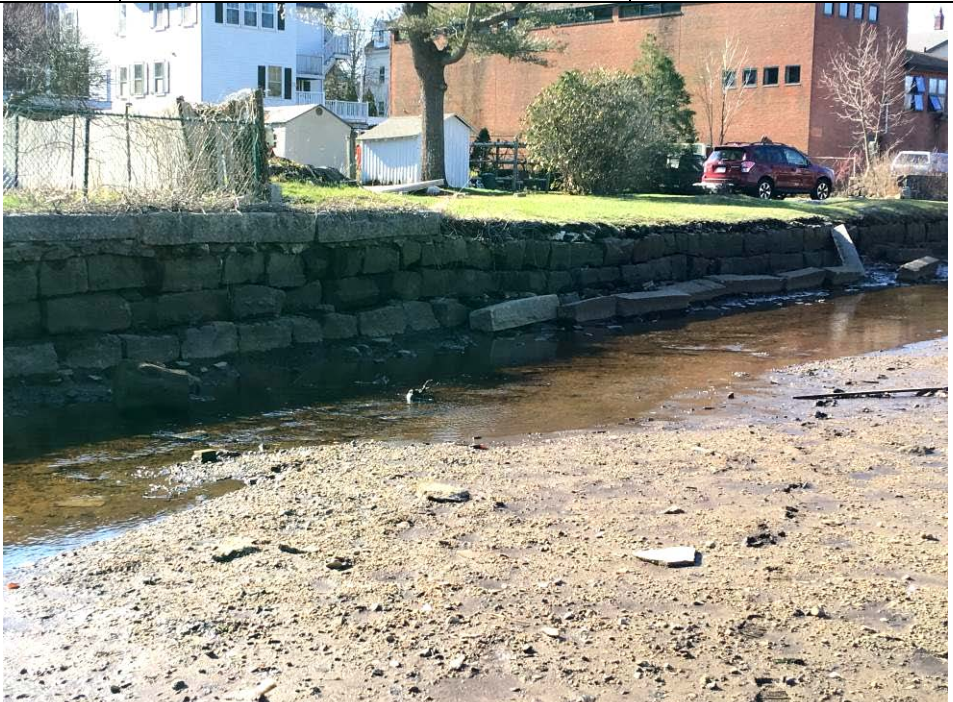
Tighe&Bond		PHOTOGRAPHIC LOG	
Client Name: Manchester-by-the-Sea, MA		Site Location: Central Pond	Project No.: M-1476-009
Photo No. 8	Date: 4/18/2018

Direction Photo Taken: Southwest			
Description: Wall cap collapse behind 16 School Street.

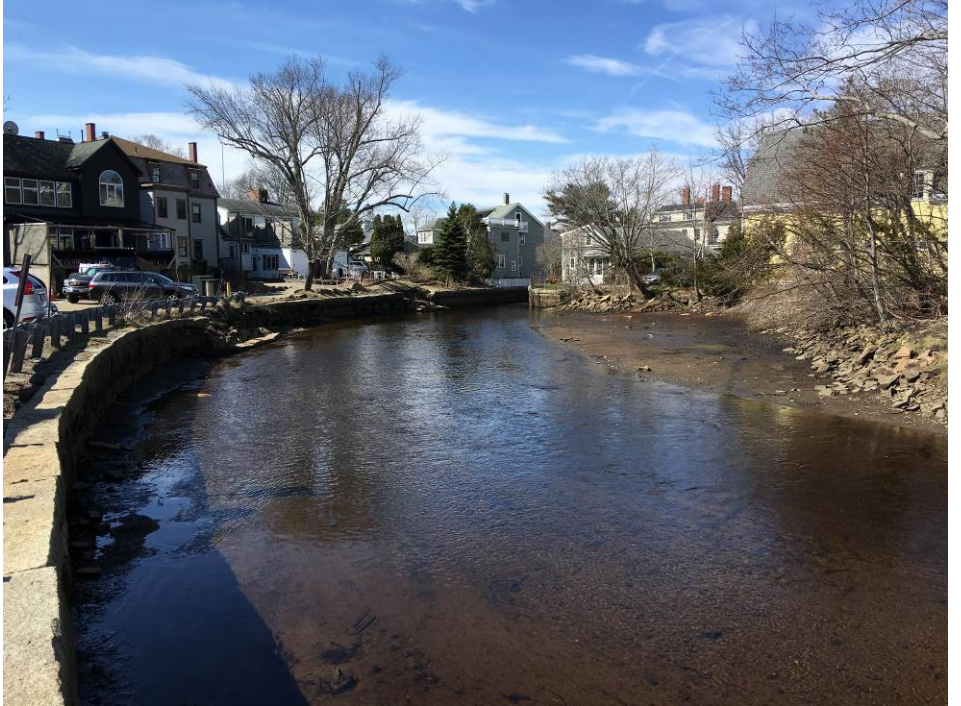
Tighe&Bond		PHOTOGRAPHIC LOG	
Client Name: Manchester-by-the-Sea, MA		Site Location: Central Pond	
		Project No.: M-1476-009	
Photo No. 9	Date: 4/18/2018

Direction Photo Taken: South			
Description: Sections of wall collapse on eastern bank of Central Pond Wall. Over 300 feet of the wall is in poor condition. Western bank includes rock revetment and mud flat behind 5 Elm Street, exposed at low tide.

The worst wall conditions were observed in the south-eastern section of the Pond (extending from behind 19 Central Street to the Fire Station, where two wall sections have entirely collapsed, and approximately 400 feet is in need of extensive repair. The wall sections above the Fire Station to Knights Circle (approximately 400 feet) have areas that need moderate repairs including replacing cap stones and addressing land subsidence behind the wall.

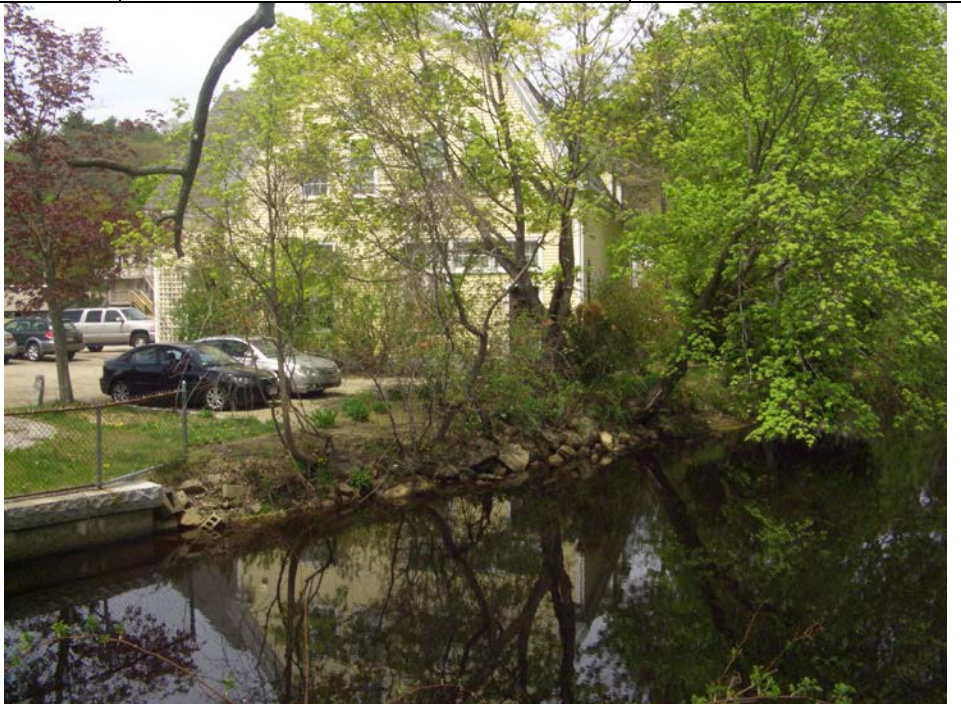
Tighe&Bond		PHOTOGRAPHIC LOG	
Client Name: Manchester-by-the-Sea, MA		Site Location: Central Pond	
		Project No.: M-1476-009	
Photo No. 10	Date: 5/12/2015

Direction Photo Taken: South			
Description: View across Central Pond to end of western wall section at 1 Elm Street.

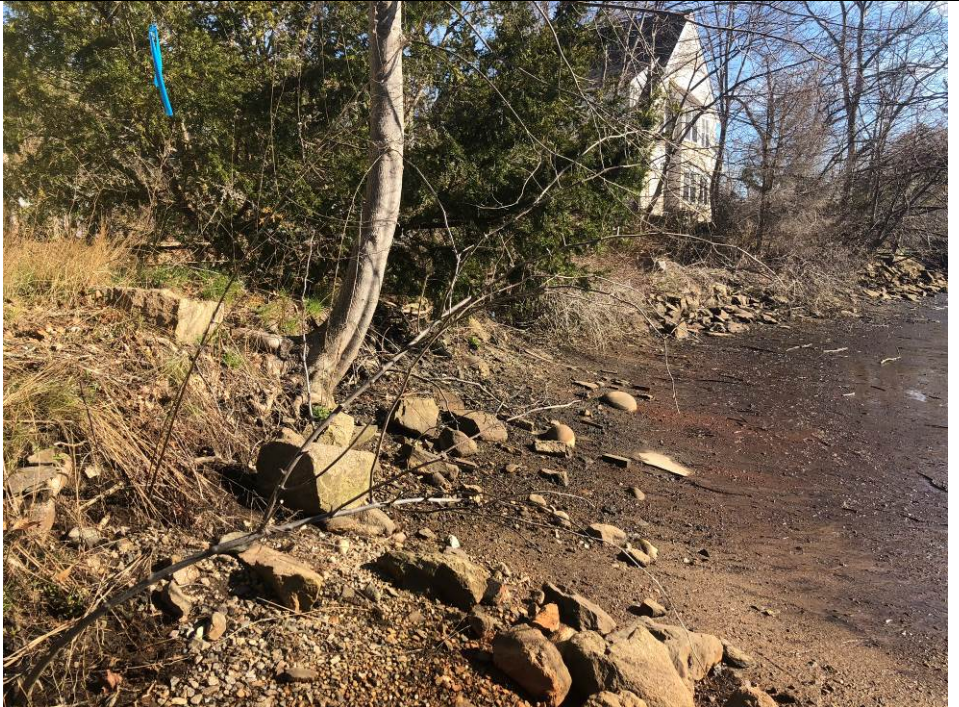
Tighe&Bond		PHOTOGRAPHIC LOG	
Client Name: Manchester-by-the-Sea, MA		Site Location: Central Pond	Project No.: M-1476-009
Photo No. 11	Date: 4/18/2018

Direction Photo Taken: Northeast			
Description: Gravel and rubble western bank in lower Central Pond. Shoreline has a gentle slope.

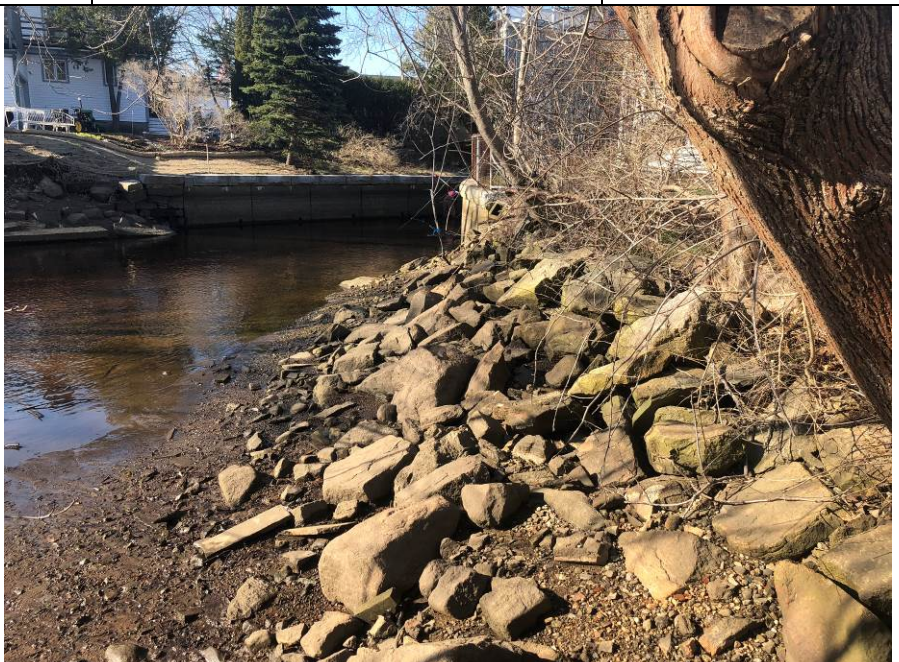
Tighe&Bond		PHOTOGRAPHIC LOG	
Client Name: Manchester-by-the-Sea, MA		Site Location: Central Pond	Project No.: M-1476-009
Photo No. 12	Date: 4/18/2018

Direction Photo Taken: Southeast			
Description: Western shore of Lower Central Pond. Rock revetment intended to stabilize shoreline just before the Town owned granite wall.

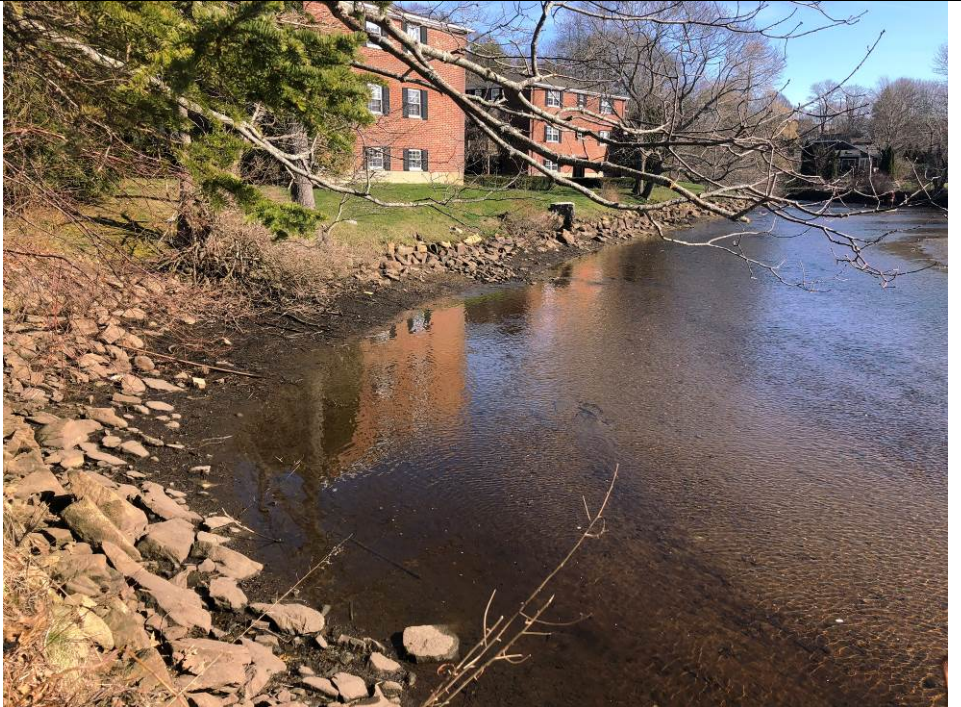
Tighe&Bond		PHOTOGRAPHIC LOG	
Client Name: Manchester-by-the-Sea, MA		Site Location: Central Pond	Project No.: M-1476-009
Photo No. 13	Date: 4/18/2018

Direction Photo Taken: Northeast			
Description: Western shore towards 3 Powderhouse Lane. Gently sloping shoreline stabilized by revetment. The I channel shown in the photos is maintained during low flow/ low tide.

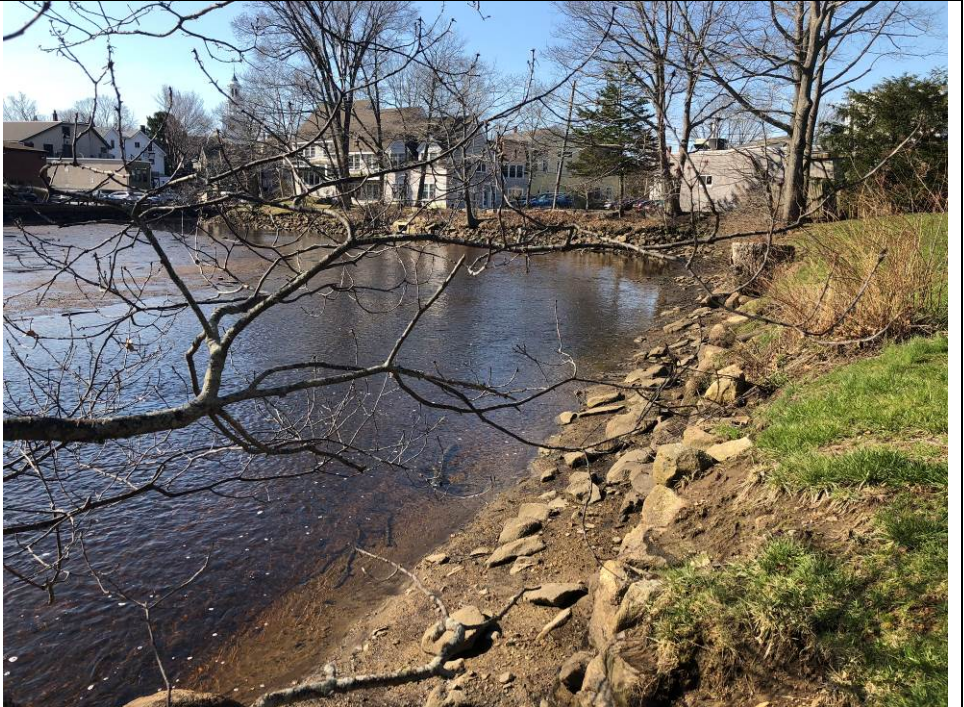
Tighe&Bond		PHOTOGRAPHIC LOG	
Client Name: Manchester-by-the-Sea, MA		Site Location: Central Pond	Project No.: M-1476-009
Photo No. 15	Date: 4/18/2018

Direction Photo Taken: Southwest			
Description: Looking south from the top of Central Pond on the western bank at low tide. Flow is maintained in the western channel. The bottom of the Channel is gravelly in this location. Revetment and grass stabilize the bank.

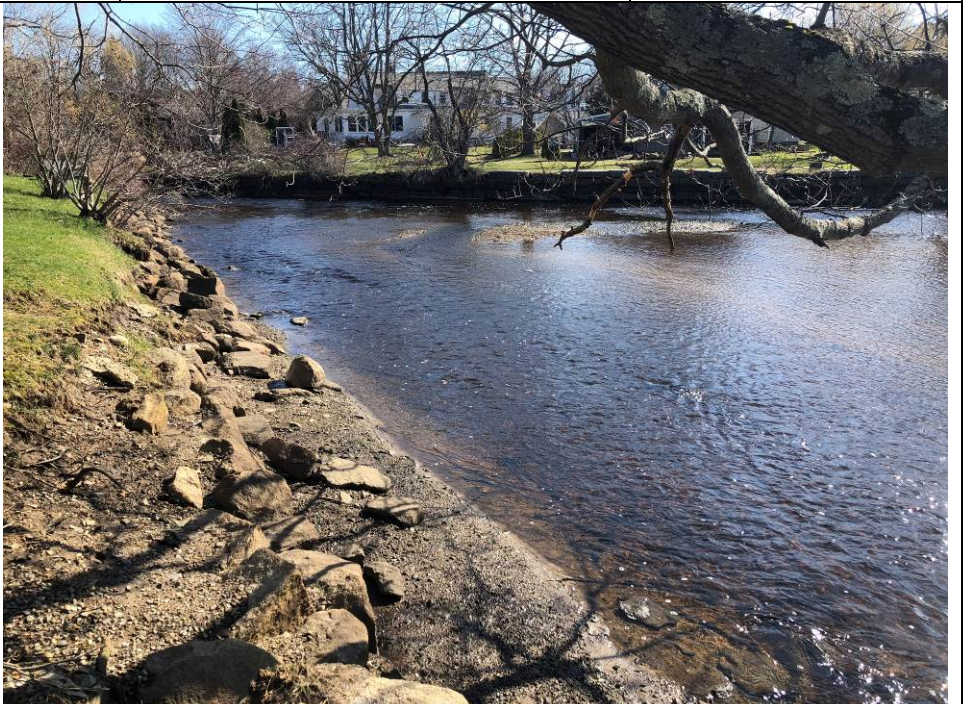
Tighe&Bond		PHOTOGRAPHIC LOG	
Client Name: Manchester-by-the-Sea, MA		Site Location: Central Pond	Project No.: M-1476-009
Photo No. 16	Date: 4/18/2018

Direction Photo Taken: West			
Description: View of the western shore and main channel at low tide. The gravel substrate is carried over to the edge of the bank. The elevated mudflat is shown toward the right.

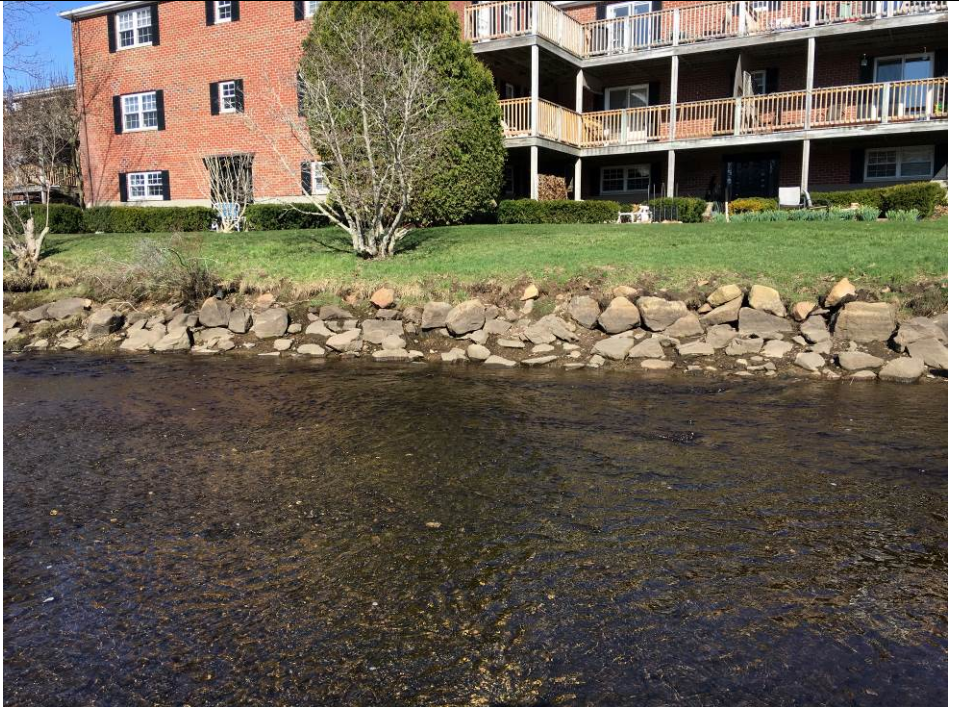
Tighe&Bond		PHOTOGRAPHIC LOG	
Client Name: Manchester-by-the-Sea, MA		Site Location: Central Pond	Project No.: M-1476-009
Photo No. 17	Date: 4/18/2018

Direction Photo Taken: Northwest			
Description: Loose revetment along banks, 3 Powder House Lane.

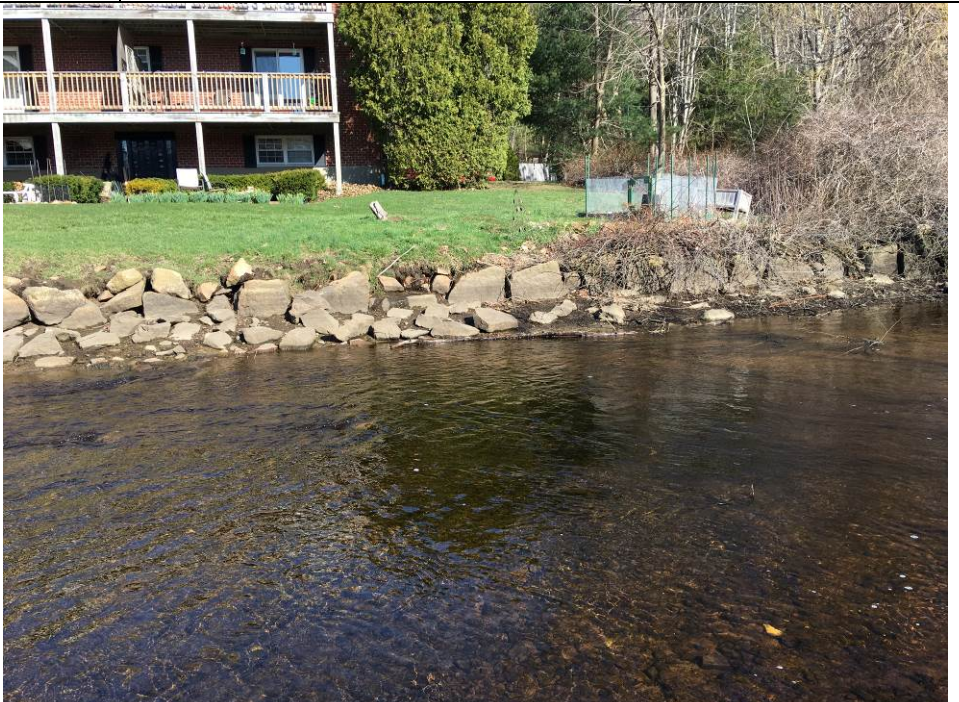
Tighe&Bond		PHOTOGRAPHIC LOG	
Client Name: Manchester-by-the-Sea, MA		Site Location: Central Pond	Project No.: M-1476-009
Photo No. 18	Date: 4/18/2018

Direction Photo Taken: Northwest			
Description: Loose revetment along banks, 3 Powder House Lane. A more structured wall is located at the northern edge, just prior to the entrance of the Sawmill Brook channel

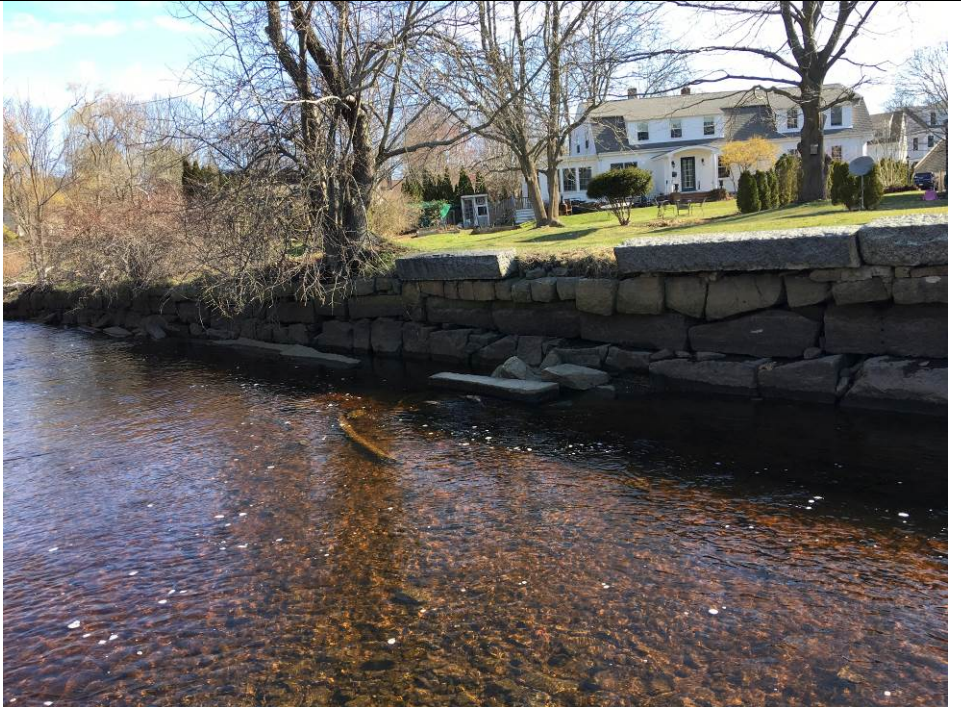
Tighe&Bond		PHOTOGRAPHIC LOG	
Client Name: Manchester-by-the-Sea, MA		Site Location: Central Pond	Project No.: M-1476-009
Photo No. 19	Date: 4/18/2018

Direction Photo Taken: East			
Description: Sections of wall collapse behind 20 Summer Street.

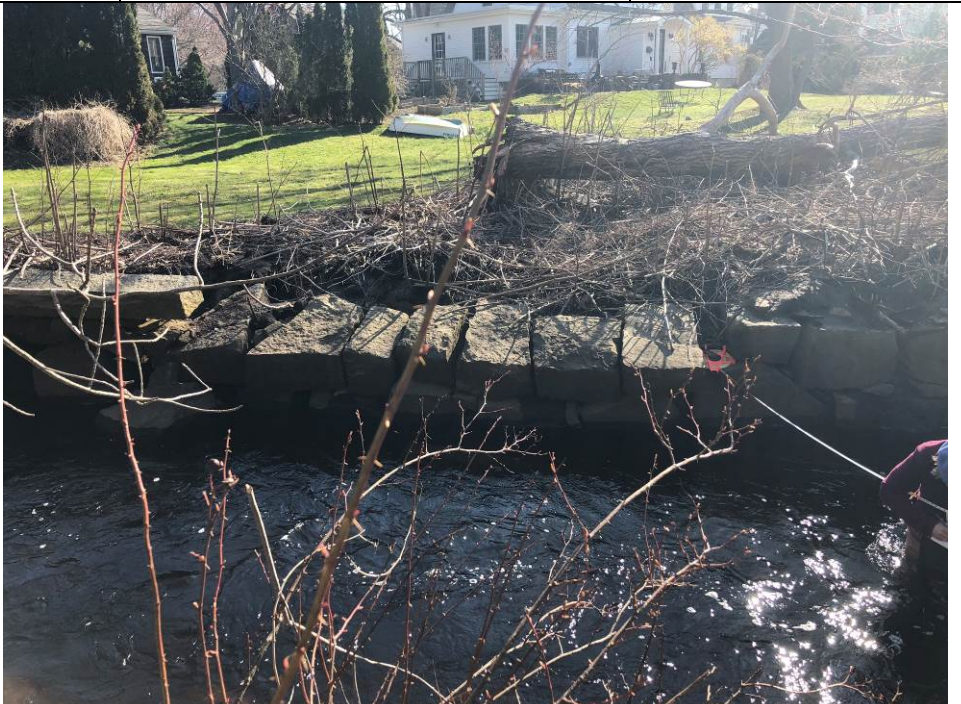
Tighe&Bond		PHOTOGRAPHIC LOG	
Client Name: Manchester-by-the-Sea, MA		Site Location: Central Pond	Project No.: M-1476-009
Photo No. 20	Date: 4/18/2018

Direction Photo Taken: East			
Description: Wall collapse behind 8 Knights Circle.

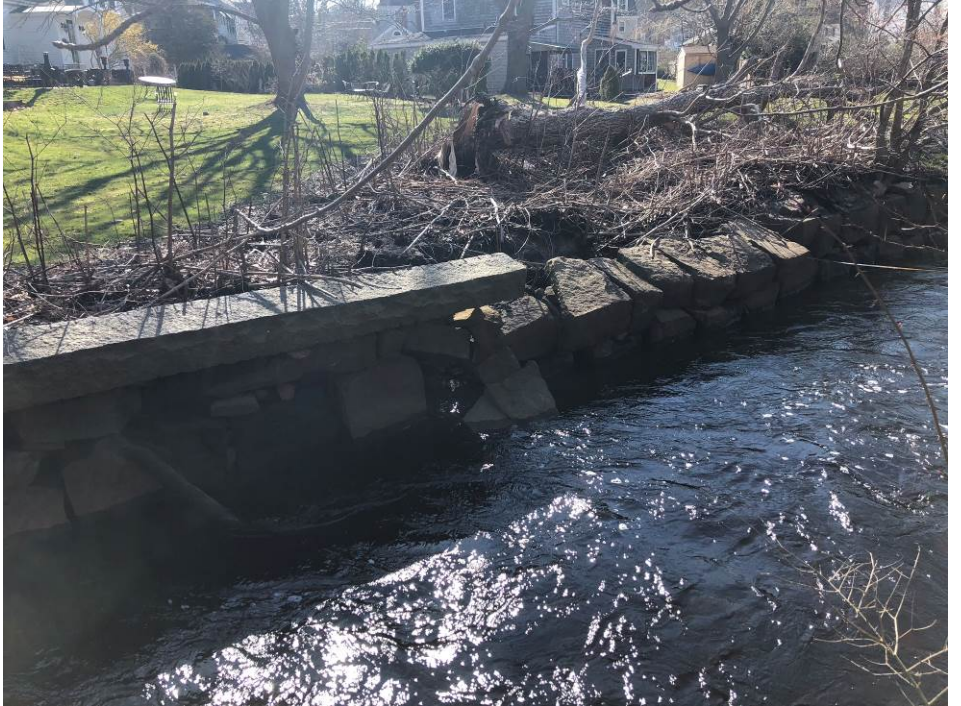
Tighe&Bond		PHOTOGRAPHIC LOG	
Client Name: Manchester-by-the-Sea, MA		Site Location: Central Pond	Project No.: M-1476-009
Photo No. 21	Date: 4/18/2018

Direction Photo Taken: Southeast			
Description: Wall collapse behind 8 Knights Circle.

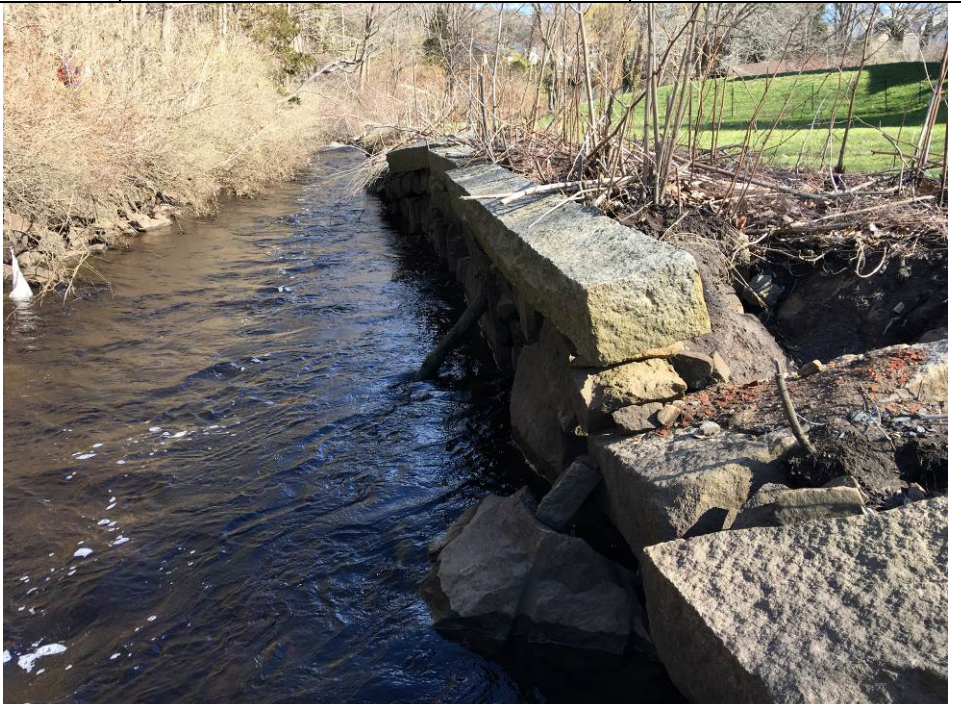
Tighe&Bond		PHOTOGRAPHIC LOG	
Client Name: Manchester-by-the-Sea, MA		Site Location: Central Pond	Project No.: M-1476-009
Photo No. 22	Date: 4/18/2018

Direction Photo Taken: North			
Description: Wall collapse behind 8 Knights Circle.

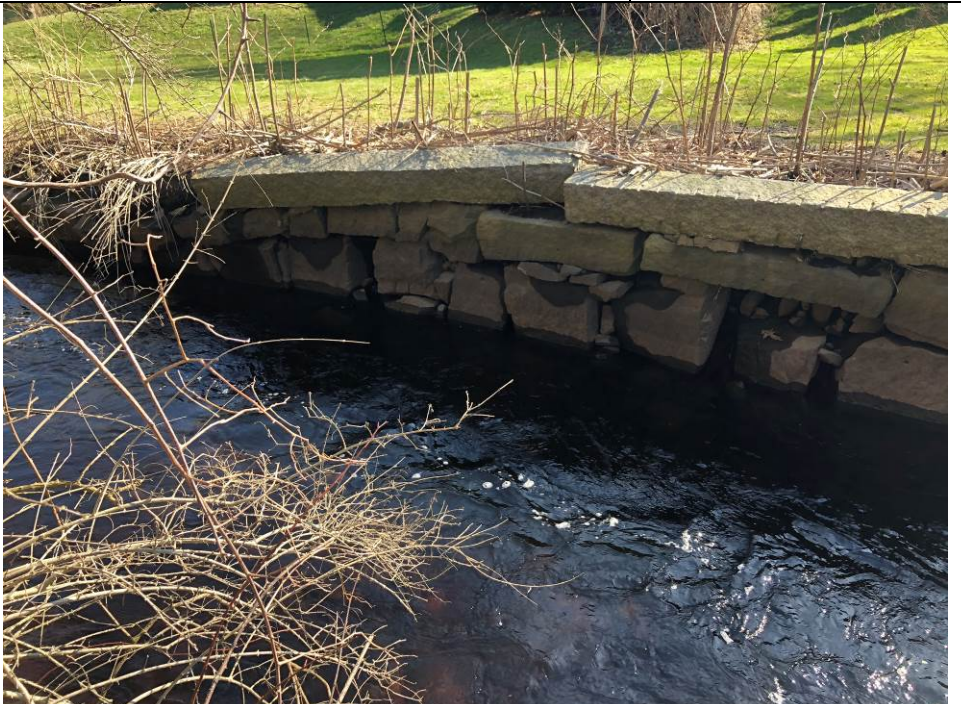
Tighe&Bond		PHOTOGRAPHIC LOG	
Client Name: Manchester-by-the-Sea, MA		Site Location: Central Pond	Project No.: M-1476-009
Photo No. 24	Date: 4/18/2018

Direction Photo Taken: East			
Description: Land subsidence and wall collapse 8 Knights Circle.

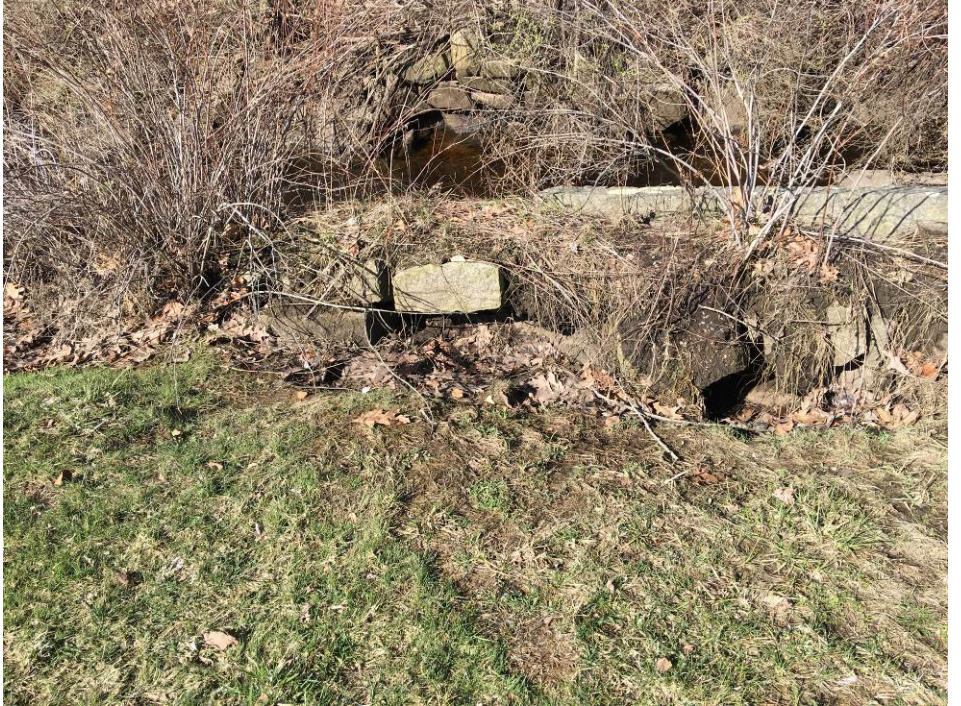
Tighe&Bond		PHOTOGRAPHIC LOG	
Client Name: Manchester-by-the-Sea, MA		Site Location: Central Pond	Project No.: M-1476-009
Photo No. 25	Date: 4/18/2018

Direction Photo Taken: West			
Description: Land subsidence, wall collapse and drainage issues Knights Circle.

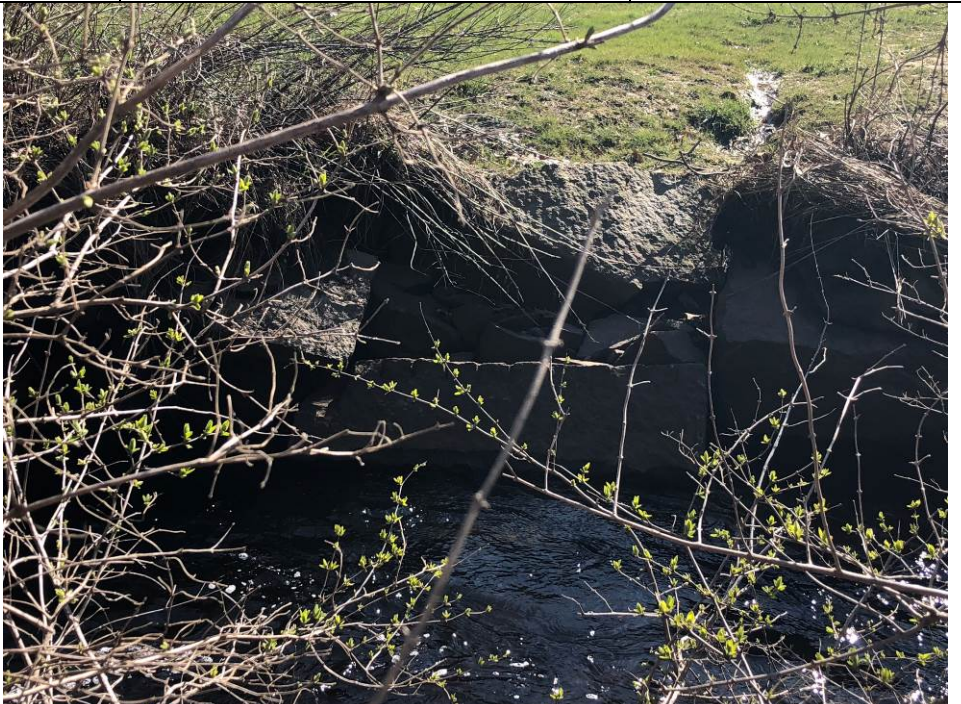
Tighe&Bond		PHOTOGRAPHIC LOG	
Client Name: Manchester-by-the-Sea, MA		Site Location: Central Pond	Project No.: M-1476-009
Photo No. 26	Date: 4/18/2018

Direction Photo Taken: East			
Description: Land subsidence, wall collapse and drainage issues Knights Circle.

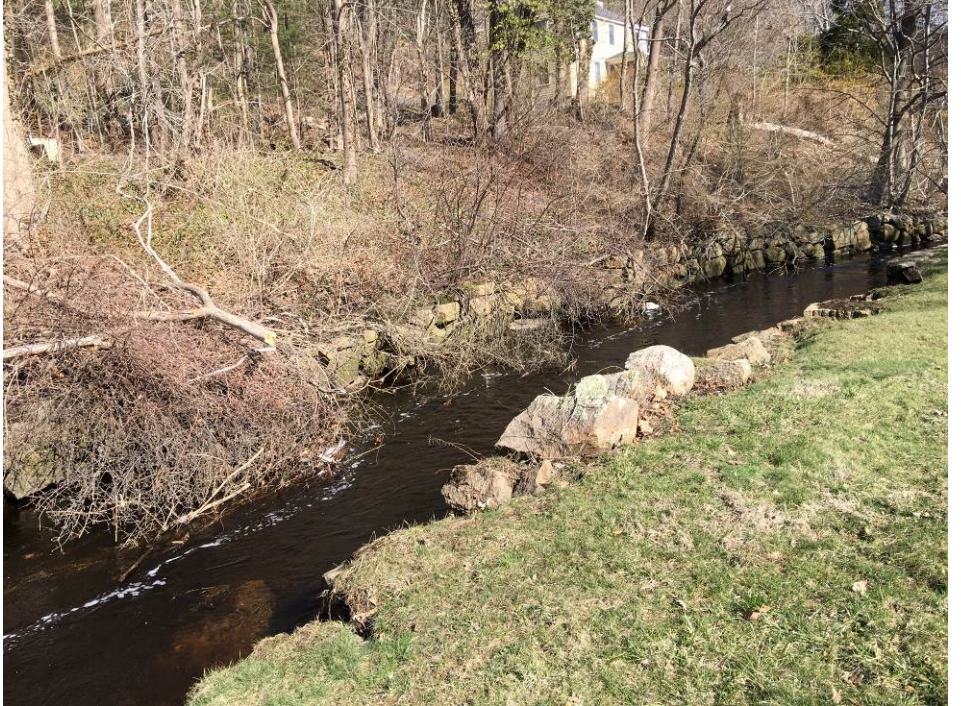
Direction Photo Taken: North			
Description: High flows are near the top of bank behind Knights Circle. Northern bank granite walls are build up higher.

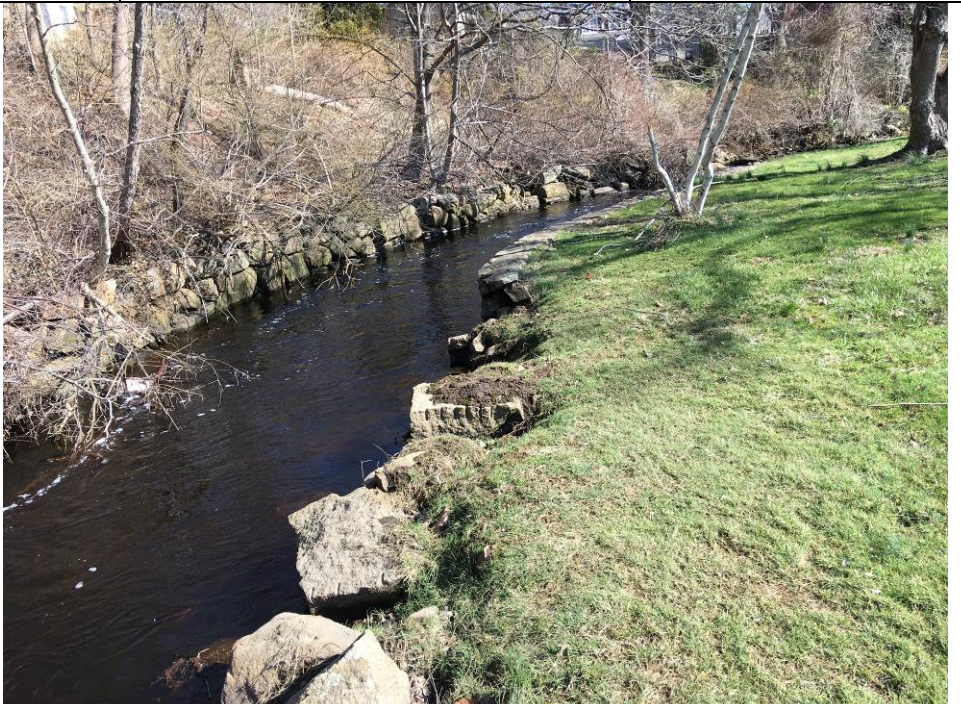
Direction Photo Taken: Northeast			
Description: Land subsidence, wall collapse on south bank Knights Circle. North bank wall is built up higher.

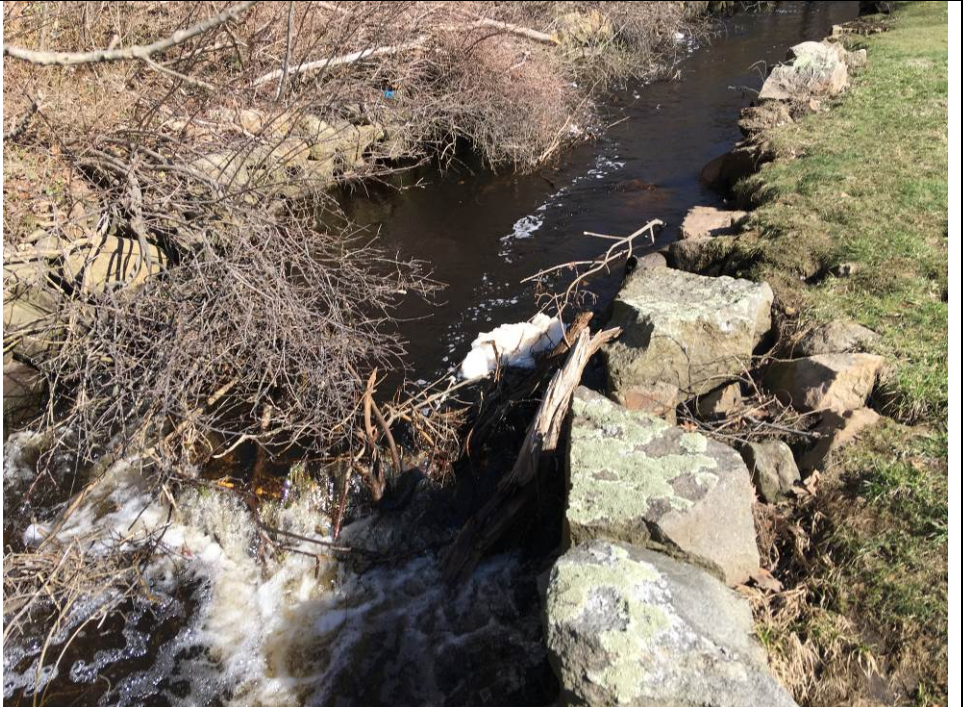
Direction Photo Taken:			
Description: In-stream rock riffle. Debris and vegetation restricting flow.

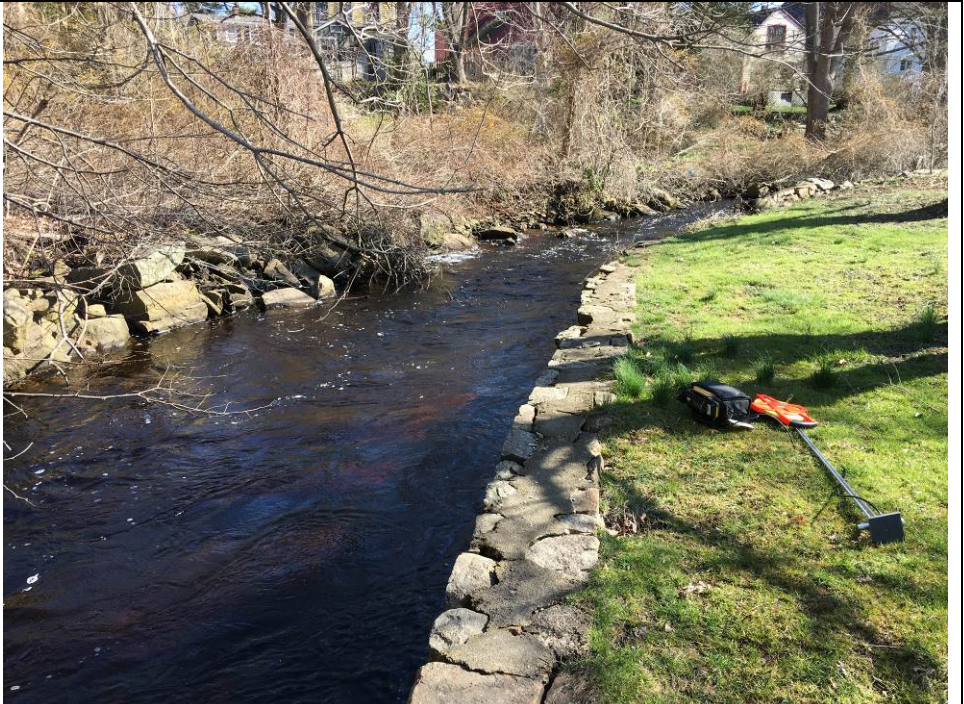
Direction Photo Taken:			
Description: Bend in the Sawmill Brook. Wall is maintained on the south bank and a jumble of granite blocks on the north.

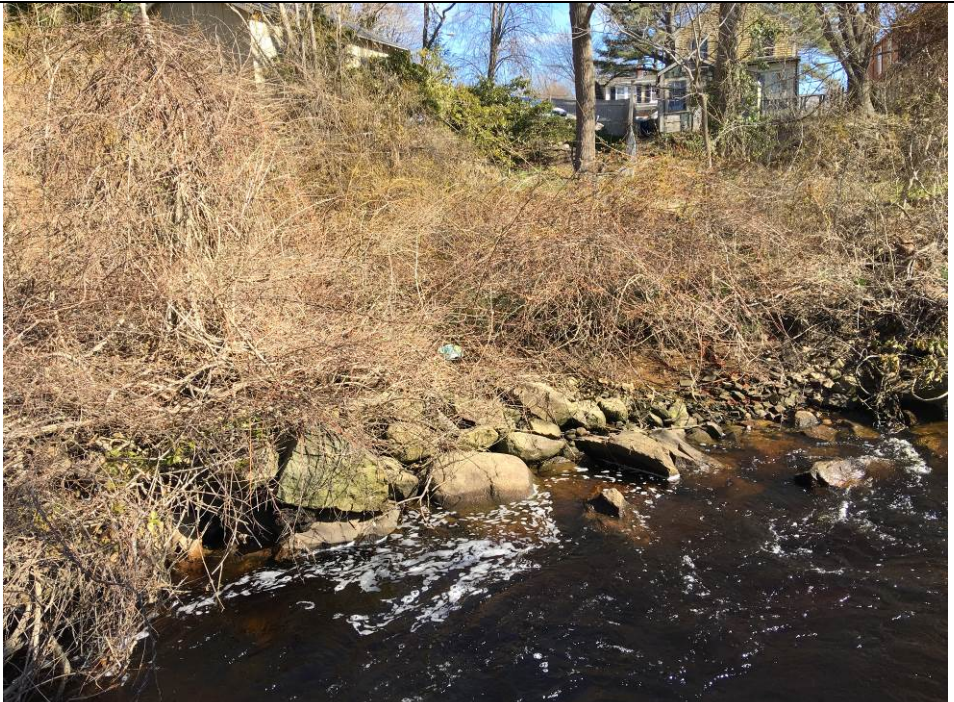
Direction Photo Taken: Northeast			
Description: Loose rocky bank, and invasive covering the shore.

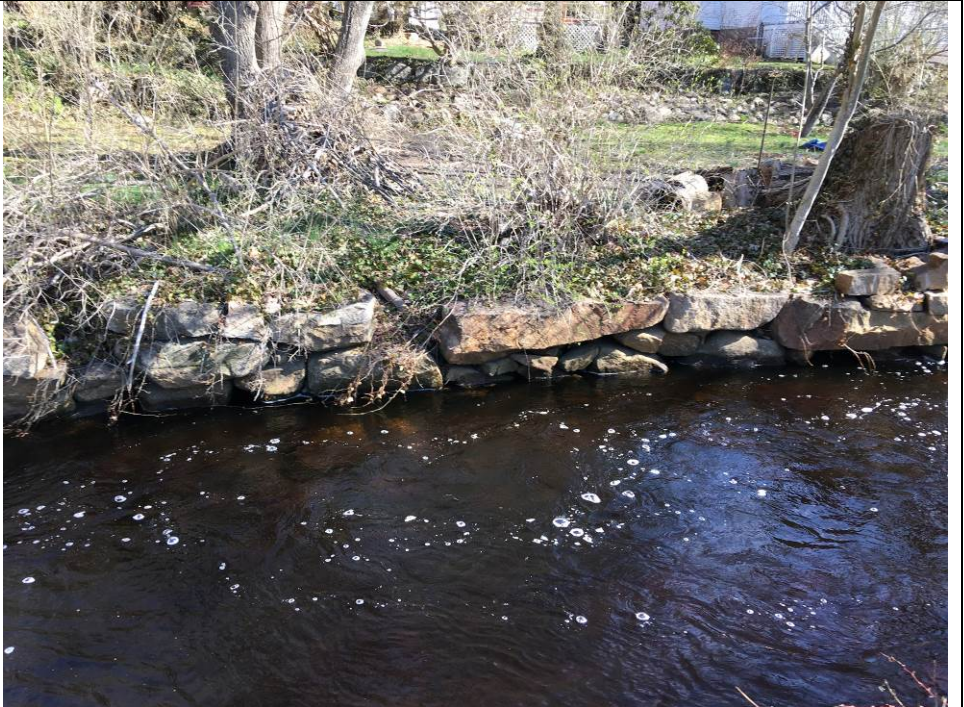
Direction Photo Taken: South			
Description: Section of native fieldstone wall behind Knights Circle.

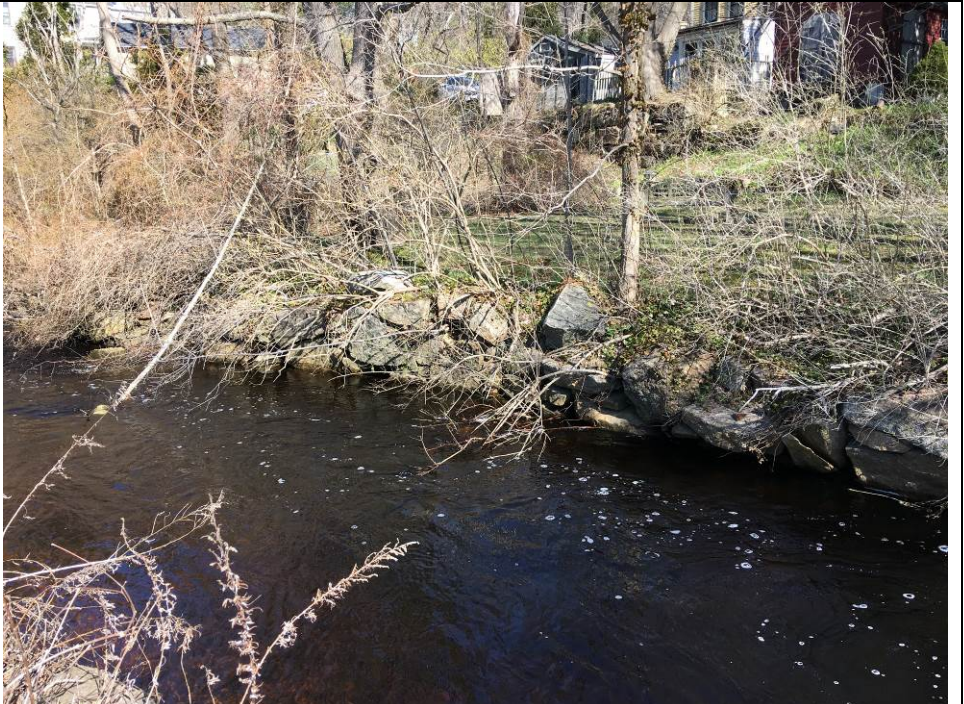
Direction Photo Taken: Southeast			
Description: Native fieldstone wall behind Knights Circle.

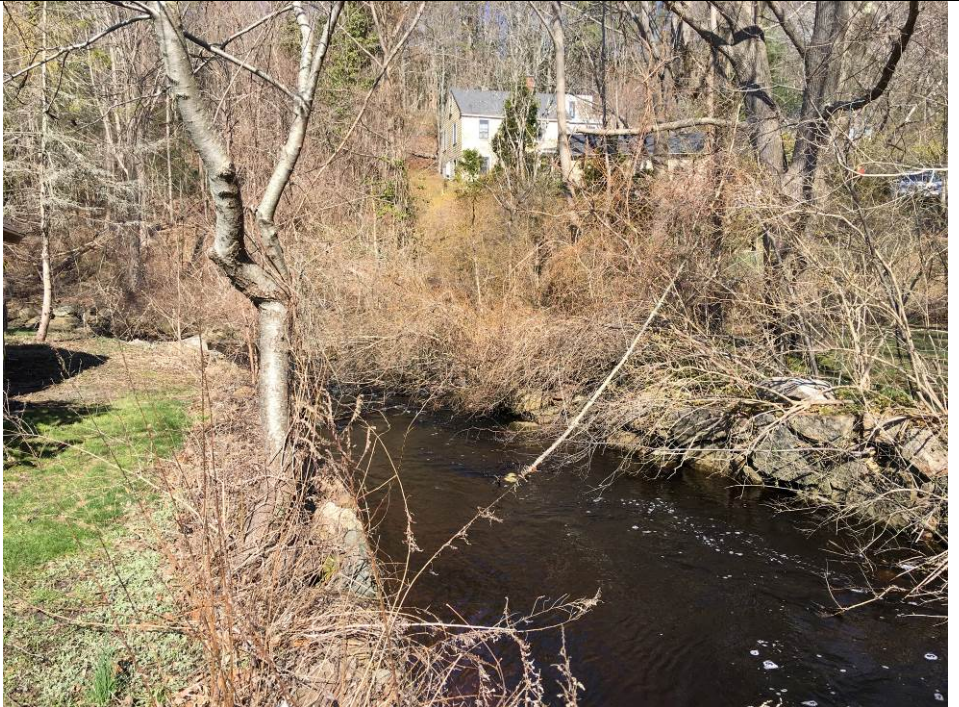
Direction Photo Taken: West			
Description: Native fieldstone wall behind 10 Knights Circle.

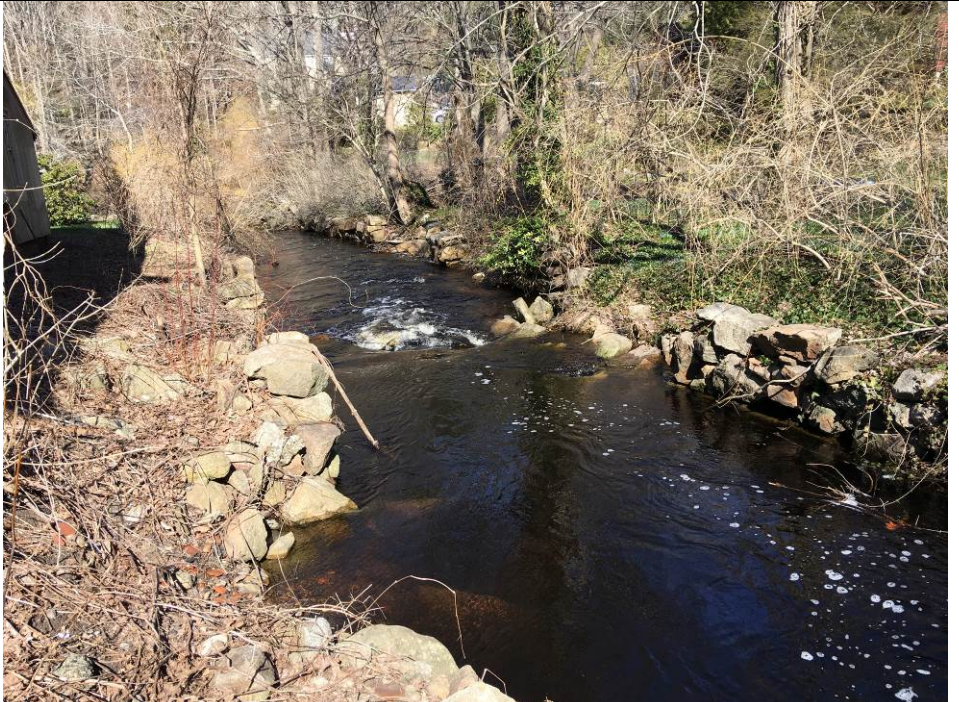
Tighe&Bond		PHOTOGRAPHIC LOG	
Client Name: Manchester-by-the-Sea, MA		Site Location: Central Pond	Project No.: M-1476-009
Photo No. 36	Date: 4/18/2018

Direction Photo Taken: West			
Description: Native fieldstone walls behind 10 Knights Circle.

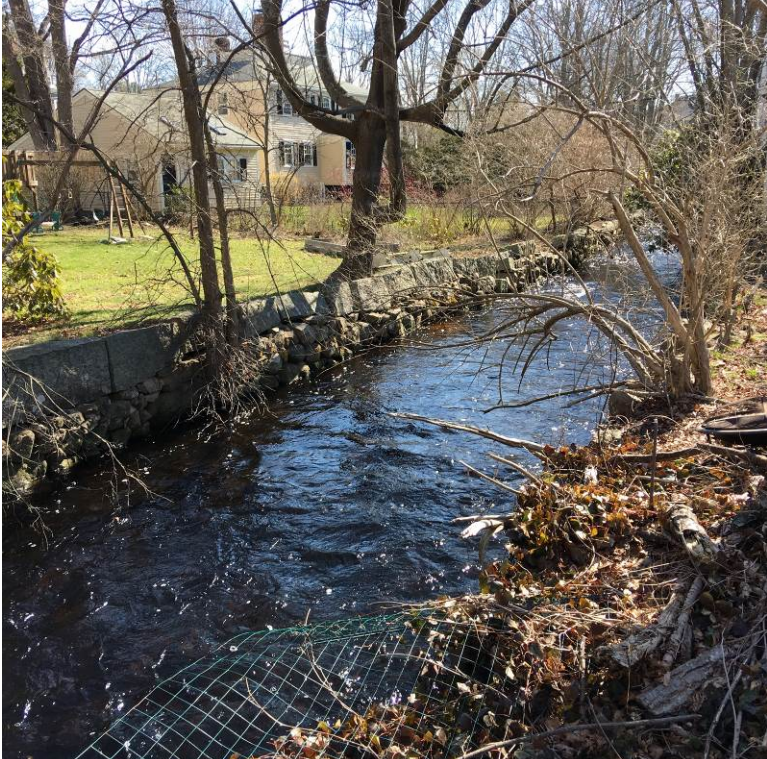
Tighe&Bond		PHOTOGRAPHIC LOG	
Client Name: Manchester-by-the-Sea, MA		Site Location: Central Pond	Project No.: M-1476-009
Photo No. 38	Date: 4/18/2018

Direction Photo Taken: Northeast			
Description: Granite walls behind 6 Friend Street.

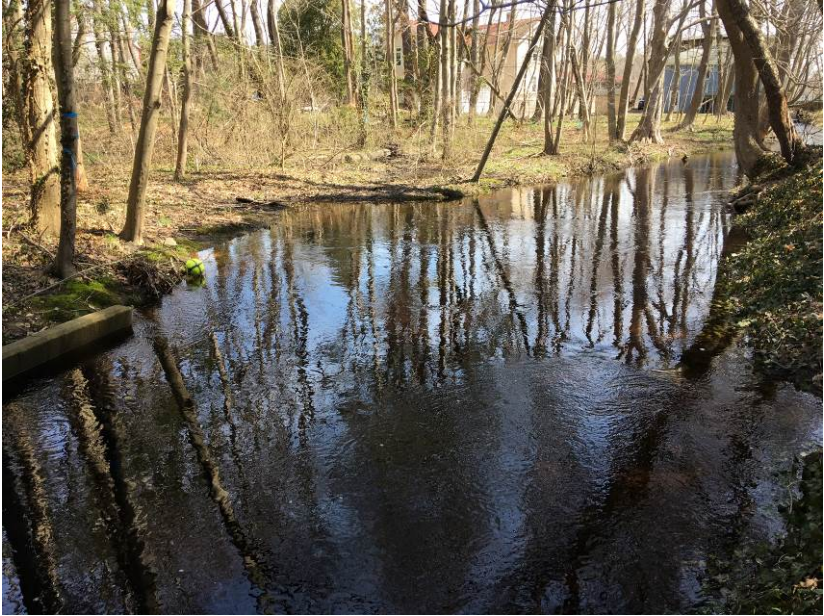
Tighe&Bond		PHOTOGRAPHIC LOG	
Client Name: Manchester-by-the-Sea, MA		Site Location: Central Pond	Project No.: M-1476-009
Photo No. 39	Date: 4/18/2018

Direction Photo Taken: East			
Description: Looking towards Norwood Ave, the Brook widens out overtopping wetland banks on the north.

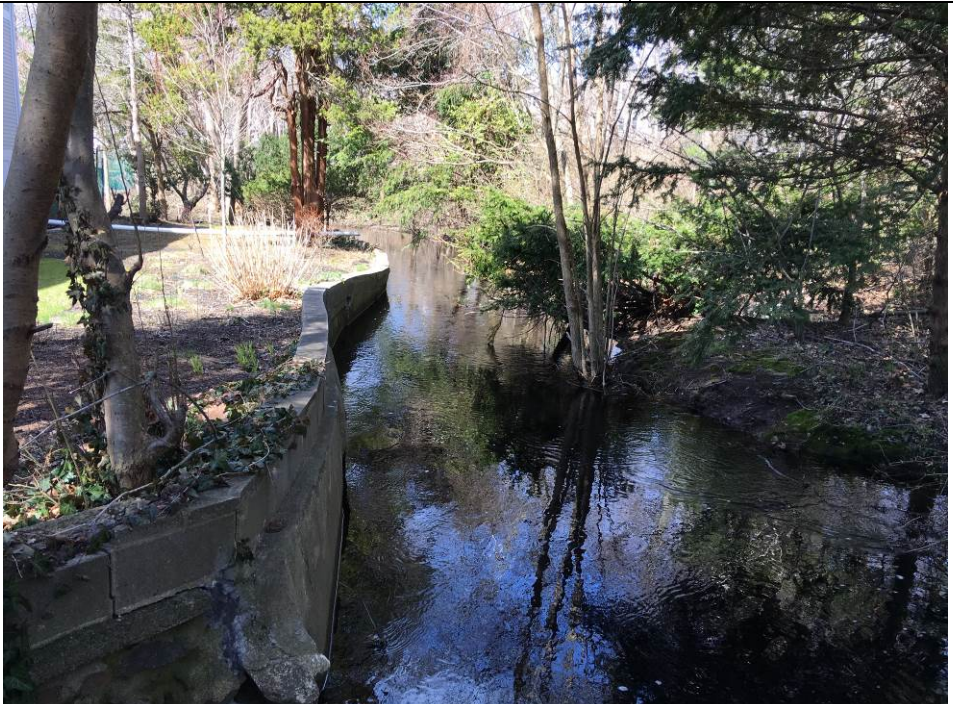
Tighe&Bond		PHOTOGRAPHIC LOG	
Client Name: Manchester-by-the-Sea, MA		Site Location: Central Pond	Project No.: M-1476-009
Photo No. 40	Date: 4/18/2018

Direction Photo Taken: West			
Description: Poured concrete wall with cap behind 6 Putnam Court.

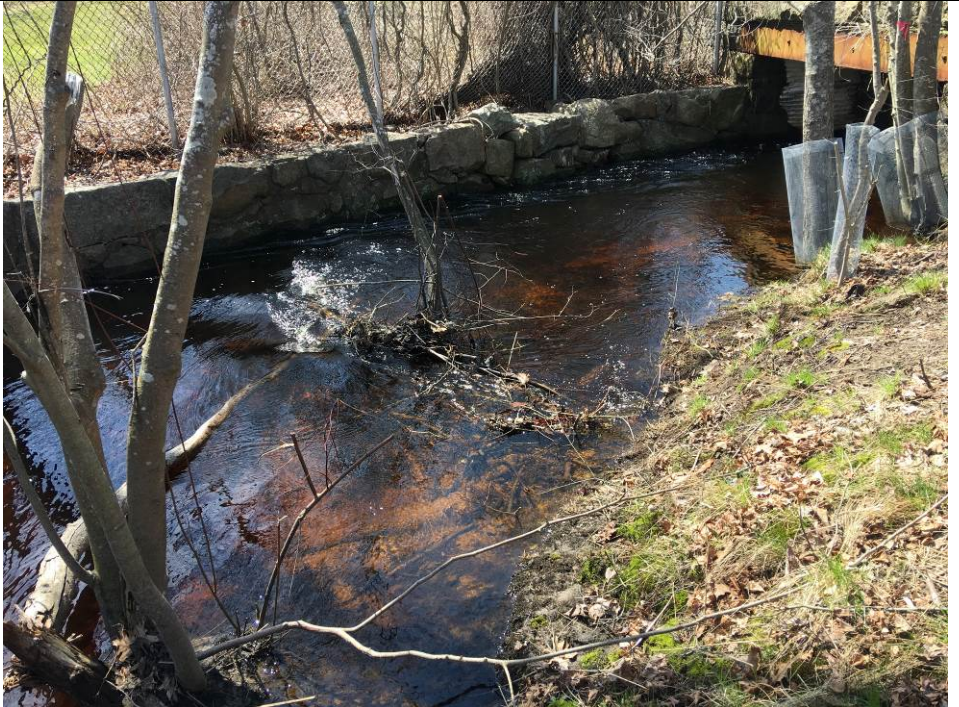
Direction Photo Taken: Southwest			
Description: View towards Coach Fields Park and Norwood Avenue Bridge. Granite and fieldstone walls along the western bank. Remains of beaver dam in center.

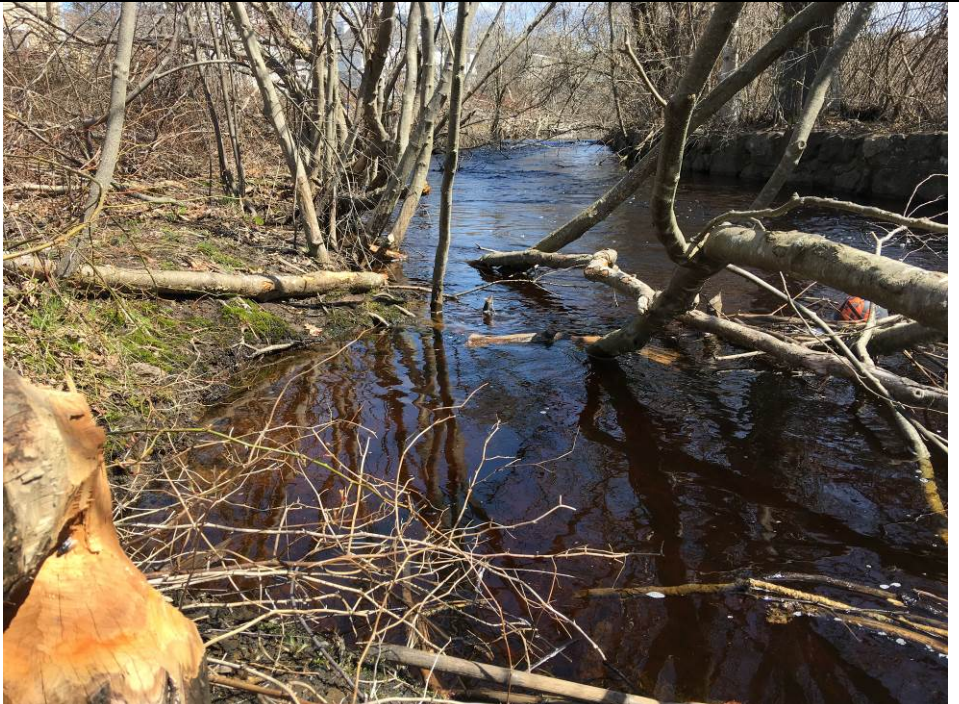
Tighe&Bond		PHOTOGRAPHIC LOG	
Client Name: Manchester-by-the-Sea, MA		Site Location: Central Pond	Project No.: M-1476-009
Photo No. 42	Date: 4/18/2018

Direction Photo Taken: Northeast			
Description: View towards Elementary School. Evidence of west bank overtopping. Beaver activity evident in the foreground.
