Fire Department

Town of Manchester-by-the-Sea ADA Transition Plan

February 2020

Institute for Human Centered Design

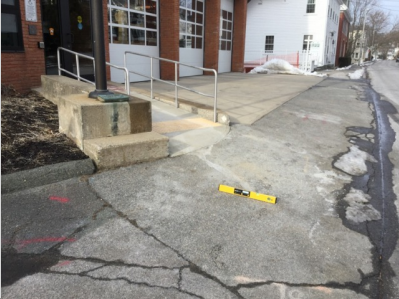
ID	Location	Floor	Room	Element	Type	Photo	Issues	Current Measure	Recommendations	Quantity	Price	Cost Estimation
Approach and Entrance												
Exterior Access Route												
1	Towards Main Entrance	Ext.		Exterior Access Route	Sidewalk

Cross slope > 1:50 (2.00%)	3.3%	Reduce cross slope to be no steeper than 1:50 (2.00%) in all directions.	1	-	\$0
Off-Street Parking Lot or Garage												
2	Parking Lot	Ext.		Off-Street Parking Lot or Garage	Employee

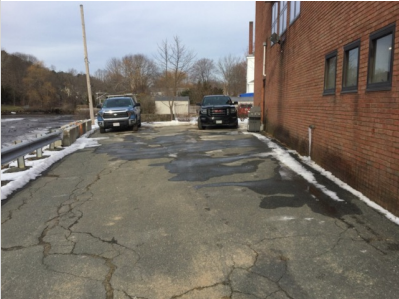
Total # of designated van accessible spaces Vehicle space < 132" wide at van space Access aisle < 60" wide at car/van space Sign not provided Sign does not have the designation "Van Accessible"	-	Provide a van accessible space that is at least 132" wide with an access aisle that is at least 60" wide. Provide a sign with the bottom of the sign 60" min. above the ground and the top 96" max. above the ground. Add the designation "Van Accessible" to the sign.	1	1850	\$1850

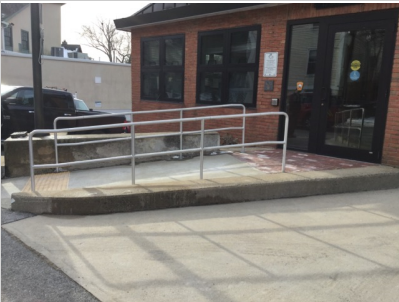
Exterior Ramp												
3	Main Entrance	Ext.		Exterior Ramp	N/A

Handrails do not extend 12" past top & bottom	-	Alter handrails to extend horizontally above the landing for 12" min. beyond the top and bottom of ramp runs.	2	800	\$1600
Entrance												
4	Employee Entrance	Ext.		Entrance	Secondary Entrance

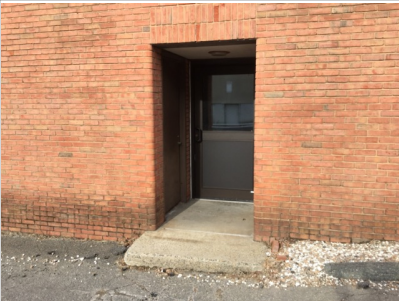
Entrance not on an accessible route Directional sign to accessible entrance not provided	- -	Provide a directional sign indicating the location of the nearest accessible entrance.	1	346	\$346
Access to Goods and Services

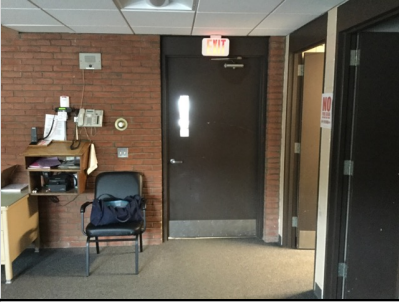
Tactile exit sign not provided	-	Ensure tactile exit signs with raised characters and braille are provided at exit doors. Mount signs between 48"- 60" above finished floor located on the latch side of the door.	1	232	\$232
6	Meeting Room	1		Means of Egress	N/A

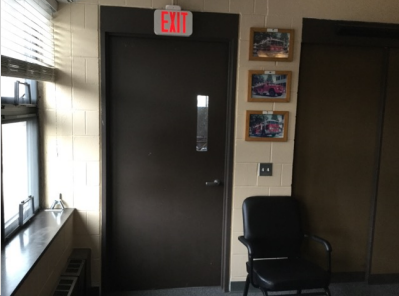
Tactile exit sign not provided Directional sign to accessible emergency exit not provided	-	Ensure a tactile exit sign with raised characters and braille is provided at exit door. Mount sign between 48"- 60" above finished floor located on the latch side of the door. Provide a directional sign indicating the location of the nearest emergency exit.	1	232	\$232
7	Exit to Parking	B		Means of Egress	N/A

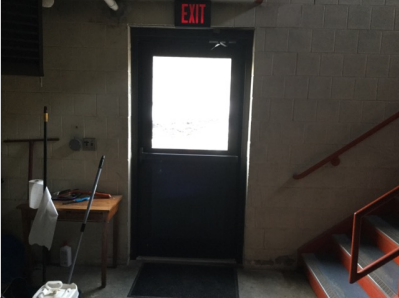
Tactile exit sign not provided Directional sign to accessible emergency exit not provided	- -	Ensure a tactile exit sign with raised characters and braille is provided at exit door. Mount sign between 48"- 60" above finished floor located on the latch side of the door. Provide a directional sign indicating the location of the nearest emergency exit.	1	232	\$232

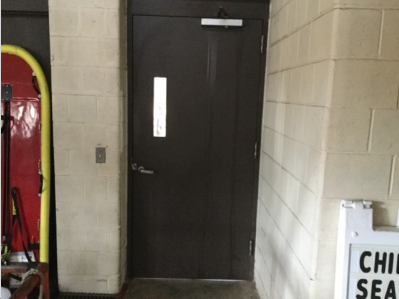
8	Exit to Apparatus	B		Means of Egress	N/A

Tactile exit sign not provided Illuminated ISA symbol not provided (MAAB)	- -	Ensure tactile exit signs with raised characters and braille are provided at exit doors. Mount signs between 48"- 60" above finished floor located on the latch side of the door. Provide an illuminated International Symbol of Accessibility.	1	432	\$432
9	Towards Meeting Room	1		Means of Egress	N/A

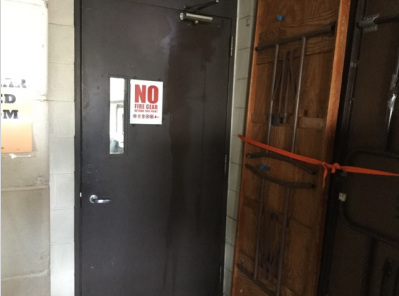
Floor level designation not provided	-	Provide a sign on the interior of the stairway enclosure indicating the floor level.	1	232	\$232

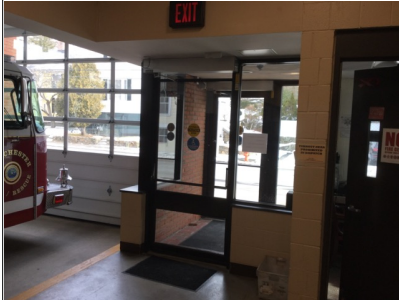
Illuminated ISA symbol not provided (MAAB)	-	Provide an illuminated International Symbol of Accessibility.	1	200	\$200
Doors, Doorways, & Gates												
11	Towards Meeting Room	1		Doors, Doorways, & Gates	Meeting Room

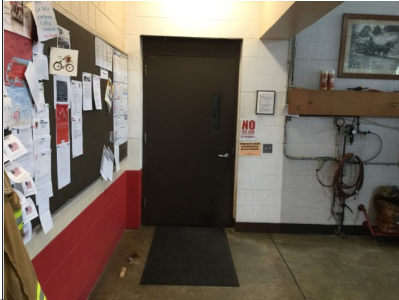
Mat not securely attached Door requires > 5 lbs. of force to open	- 10 lbs	Secure the mat. Adjust closers so doors do not require more than 5 pounds of force to open.	2	Labor	\$0
12	Men's Toilet Room			Doors, Doorways, & Gates	Toilet Room

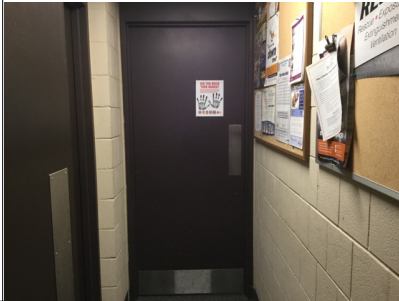
Door requires > 5 lbs. of force to open	-	Adjust closers so doors do not require more than 5 pounds of force to open.	1	Labor	
Signage												
13	Men's Toilet Room	1		Signage	Designation

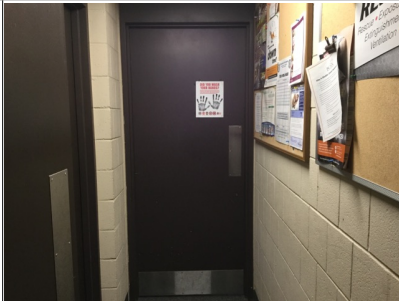
Signage is not provided	- -	Locate compliant signage alongside the door on the latch side.	1	232	\$232

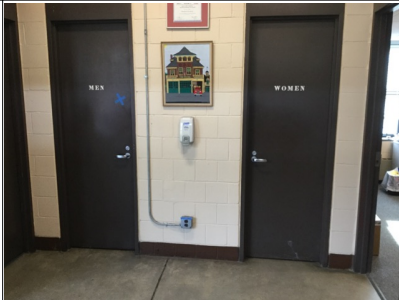
14	Men's and Women's Toilet Room	1		Signage	Designation

Raised characters not provided on sign Raised characters < 48" or > 60" above ground Sign not located on the latch side of the door Directional sign to access. toilet not provided	- - - -	Provide text with raised characters duplicated in braille on sign. Mount signs between 48" min. and 60" max. above finished floor. Locate sign alongside the door on the latch side. Install a sign indicating the location of the nearest accessible toilet room.	3	232	
Toilet & Bathing Rooms

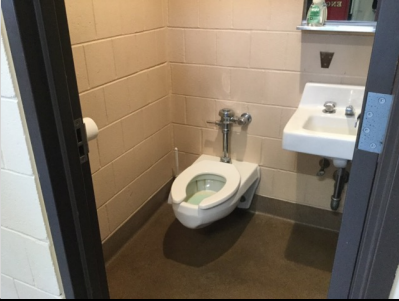
Turning space not provided Accessible plumbing fixtures or stalls not provided	- -	Provide one accessible single-user toilet room.	1	24604	\$24604
16	Men's Toilet Room	1		Overall Access	Toilet Room

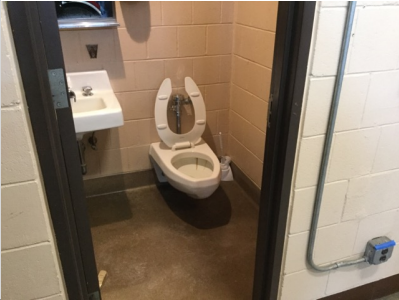
Turning space not provided Accessible plumbing fixtures or stalls not provided	- -	Provide one accessible single-user toilet room. See ID #15.	1	-	\$0
17	Men's Toilet Room	1		Overall Access	Toilet Room

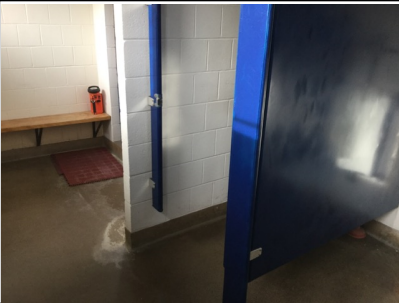
Accessible plumbing fixtures or stalls not provided	-	Provide one accessible wheelchair compartment.	1	6182	\$6182
Lavatory												
18	Men's Toilet Room	1		Lavatory	N/A

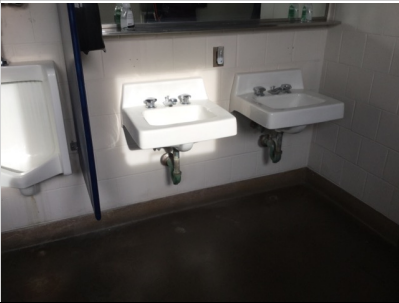
Faucet is not operable with a closed fist Plumbing underneath is exposed Mirror above lavatory w/reflective surface > 40"	- - 48"	Provide a faucet that can be operable with one hand and not require tight grasping, pinching, or twisting of the wrist for at least one lavatory. Insulate or otherwise configure pipes to prevent contact, for at least one lavatory. Lower mirror so that the bottom surface is at 40" max. above finished floor.	1	1334	\$1334

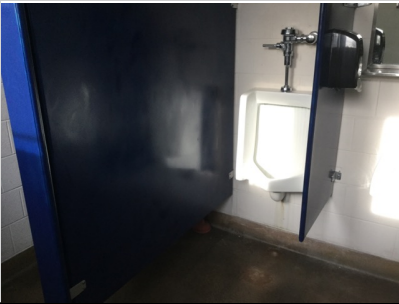
Urinal												
19	Men's Toilet Room	1		Urinal	N/A

Rim > 17" high	-	Provide an urinal with the rim no higher than 17" above the finished floor.	1	3248	\$3248

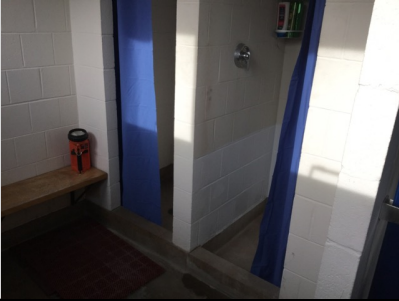
-	Recommend providing an accessible shower.	1	-	\$0
