RE: Geotechnical Reconnaissance  
Proposed MBTS Apartments  
School Street  
Manchester-By-The-Sea, Massachusetts

Project No. 20.119.NH

## GEOTECHNICAL RECONNAISSANCE

Proposed MBTS Apartments  
School Street  
Manchester-By-The-Sea, MA  
July, 2020  
Miller Project No. 20.119.NH

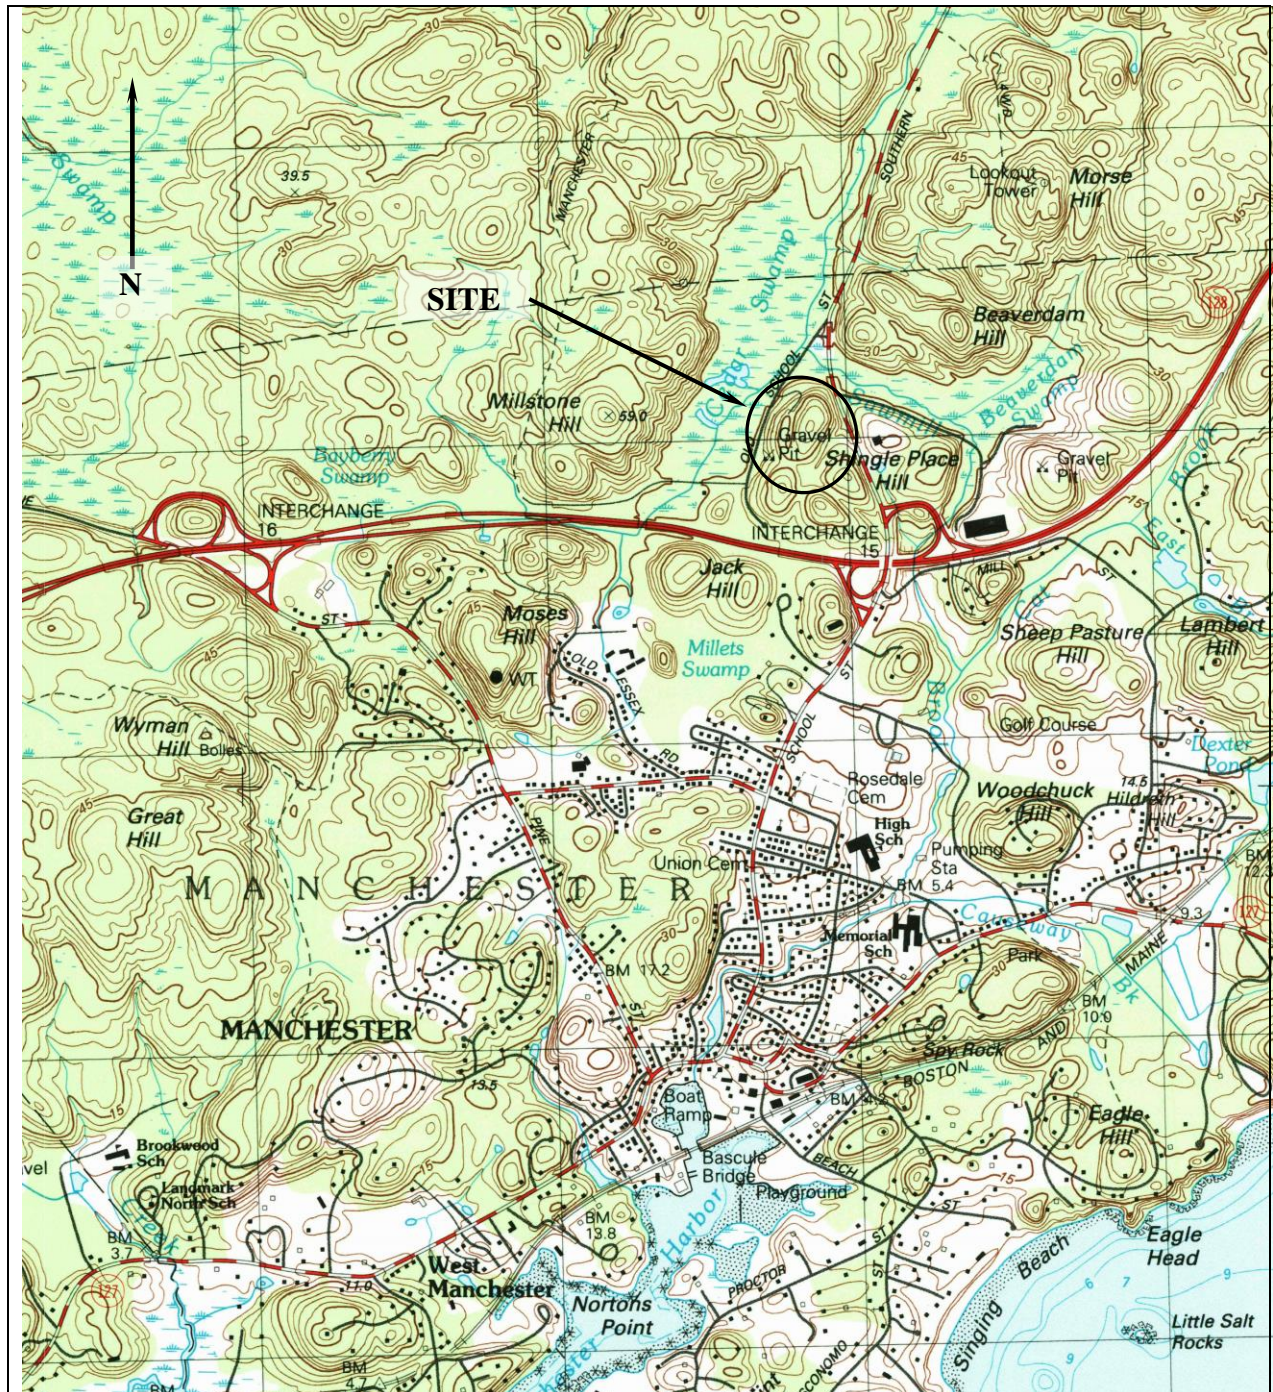
# FIGURE 1

## SITE LOCATION MAP

The MBTS Apartments development is proposed for the northerly portion of Manchester parcel 43-0-18, with a street address of 0 School Street, in the northern side of Manchester-By-The-Sea, Massachusetts. Figure 1 of this report is a Site Location Map depicting the location of the Site on a 7.5-minute topographic quadrangle. Our current understanding of the existing conditions and the proposed Site layout and grades is based on examination of:

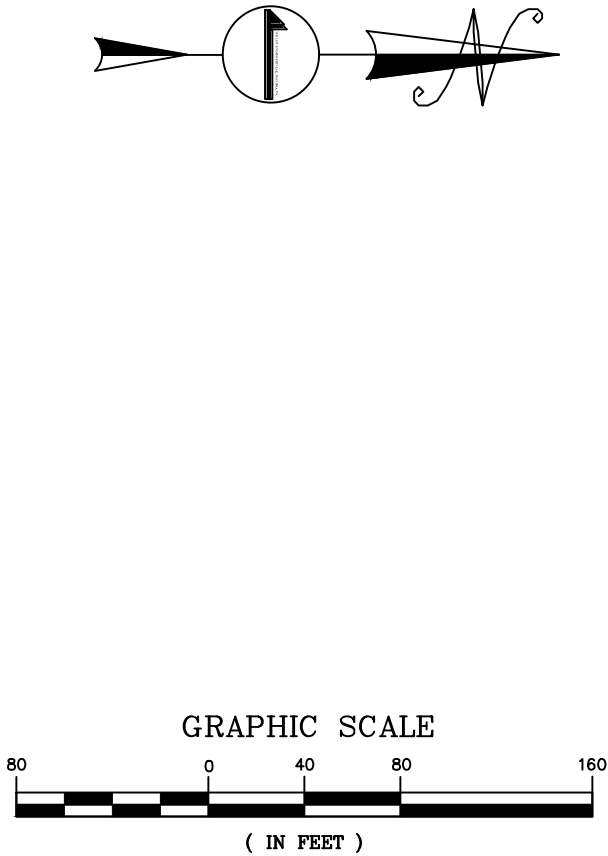
FIGURE No.  
3

Examination of the Site grading plans indicates that cuts into the unconsolidated soil formations and the bedrock will be required to achieve the design elevations (Figure 3):

- Cuts of approximately 25 to 30 feet into the bedrock will be needed within the proposed building footprint.
- Cuts into the Site soil formations appear to be approximately 25 to 45 feet at the access driveway near School Street.
- Fills of up to about 15 feet will be needed to reach the driveway subgrade elevation along the Site westerly side.
- Higher sidehill fills will be needed east and west of the proposed building footprint.

1. This plan is a reproduction of portions of "Grading & Drainage Plan, Manchester, MA", (not dated) by Allen & Major Associates, Inc. of Woburn, MA.

PROPOSED SITE  
LAYOUT

Based on the Allen & Major Grading & Drainage Plan (Sheet C-103), it appears that all, or most, of the building footprint would be founded in bedrock that will have to be blasted to achieve the design grades (Figure 3). These subsurface conditions should be confirmed with test borings advanced during the final design geotechnical investigation. The test borings will be used to determine the bearing capacity for the building foundation design.

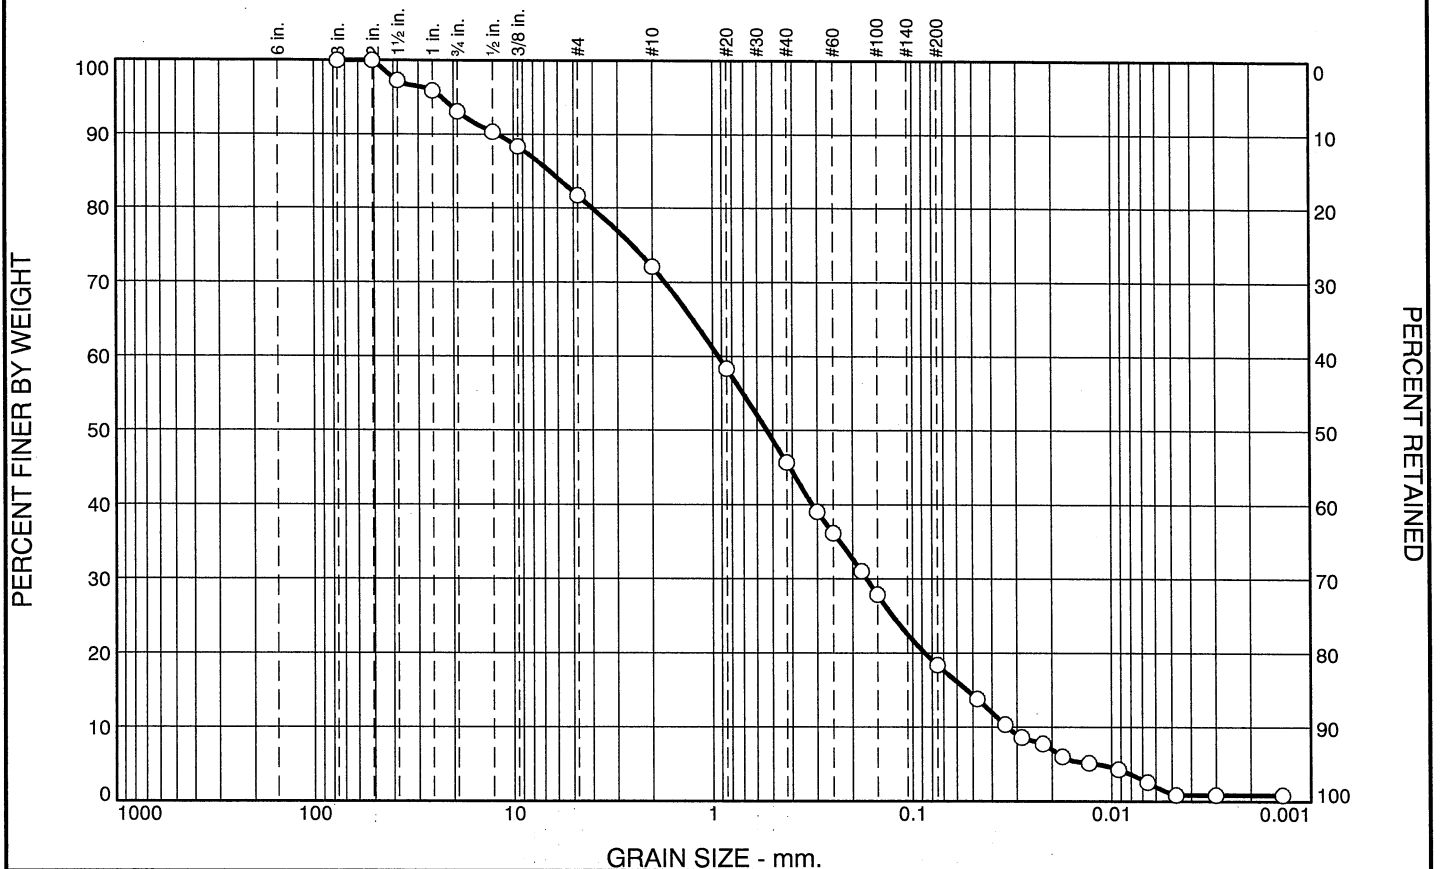
% +3"	% Gravel		% Sand			% Fines	
	Coarse	Fine	Coarse	Medium	Fine	Silt	Clay
0	7	11	10	26	28	17	1

SIEVE SIZE	PERCENT FINER	SPEC.* PERCENT	PASS? (X=NO)
3"	100		
2"	100		
1.5"	97		
1"	96		
.75"	93		
.5"	90		
.375"	88		
#4	82		
#10	72		
#20	58		
#40	46		
#50	39		
#60	36		
#80	31		
#100	28		
#200	18

We collected bulk samples of the sand and gravel deposit soils from two locations at the Site within the former sand and gravel workings. Laboratory analyses indicate that the sand and gravel deposit is a well-graded soil (Unified Soil Classification System designations SP and SW, with a fines content (silt and clay fractions combined) of approximately 18 percent). The soil texture is a gravelly loamy sand, as determined using Natural Resource Conservation Service protocols (Attachment C).

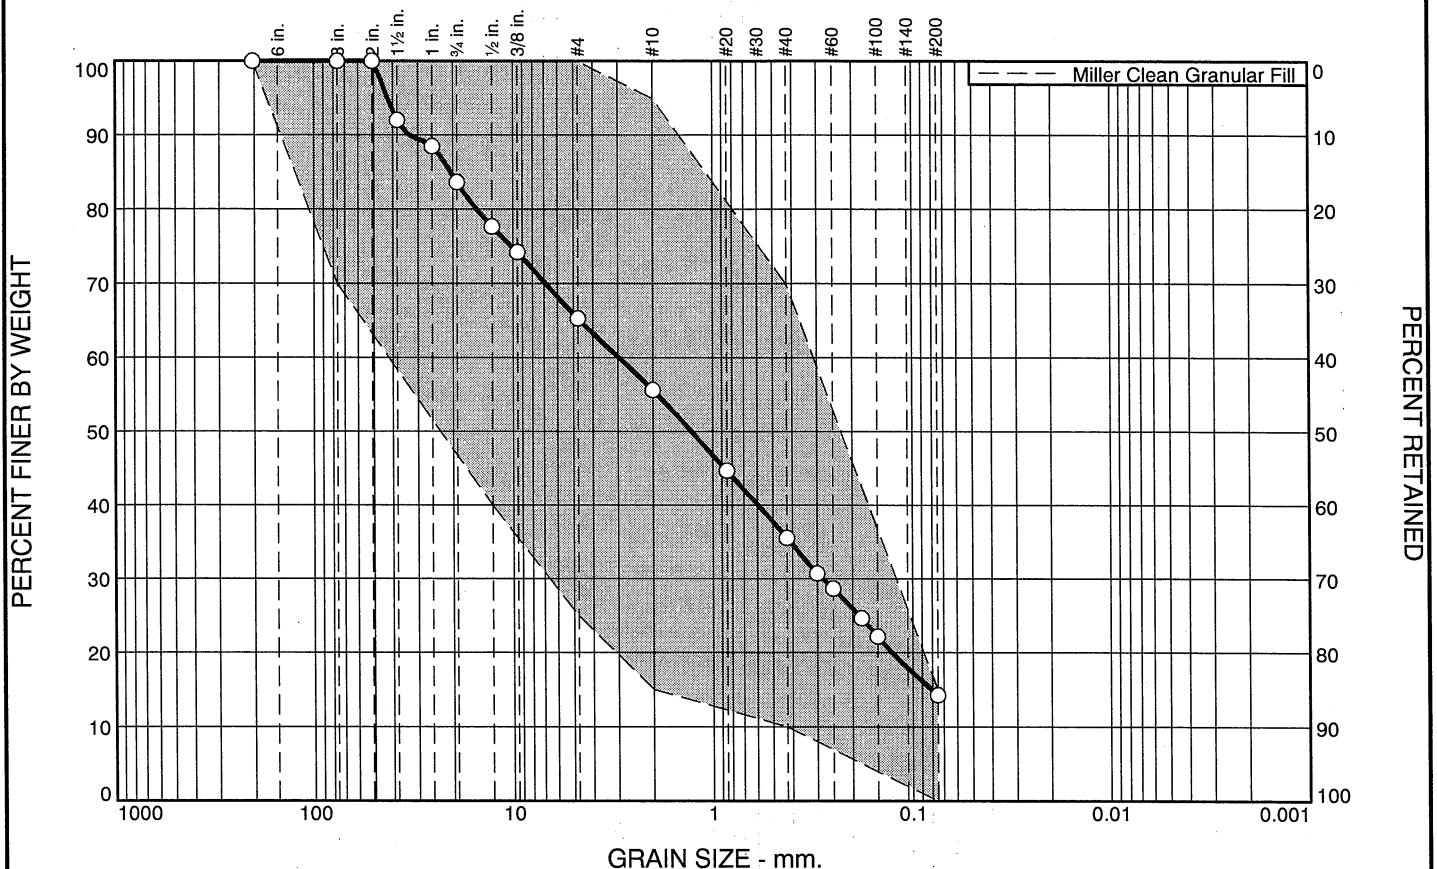
% +3"	% Gravel		% Sand			% Fines	
	Coarse	Fine	Coarse	Medium	Fine	Silt	Clay
0	16	19	9	20	22	14

SIEVE SIZE	PERCENT FINER	SPEC.* PERCENT	PASS? (X=NO)
8"	100	100	
3"	100	70 - 100	
2"	100		
1.5"	92		
1"	88		
.75"	84		
.5"	78	40 - 100	
.375"	74		
#4	65	25 - 100	
#10	56	15 - 95	
#20	45		
#40	36	10 - 70	
#50	31		
#60	29		
#80	25		
#100	22		
#200	14	0.0 - 15

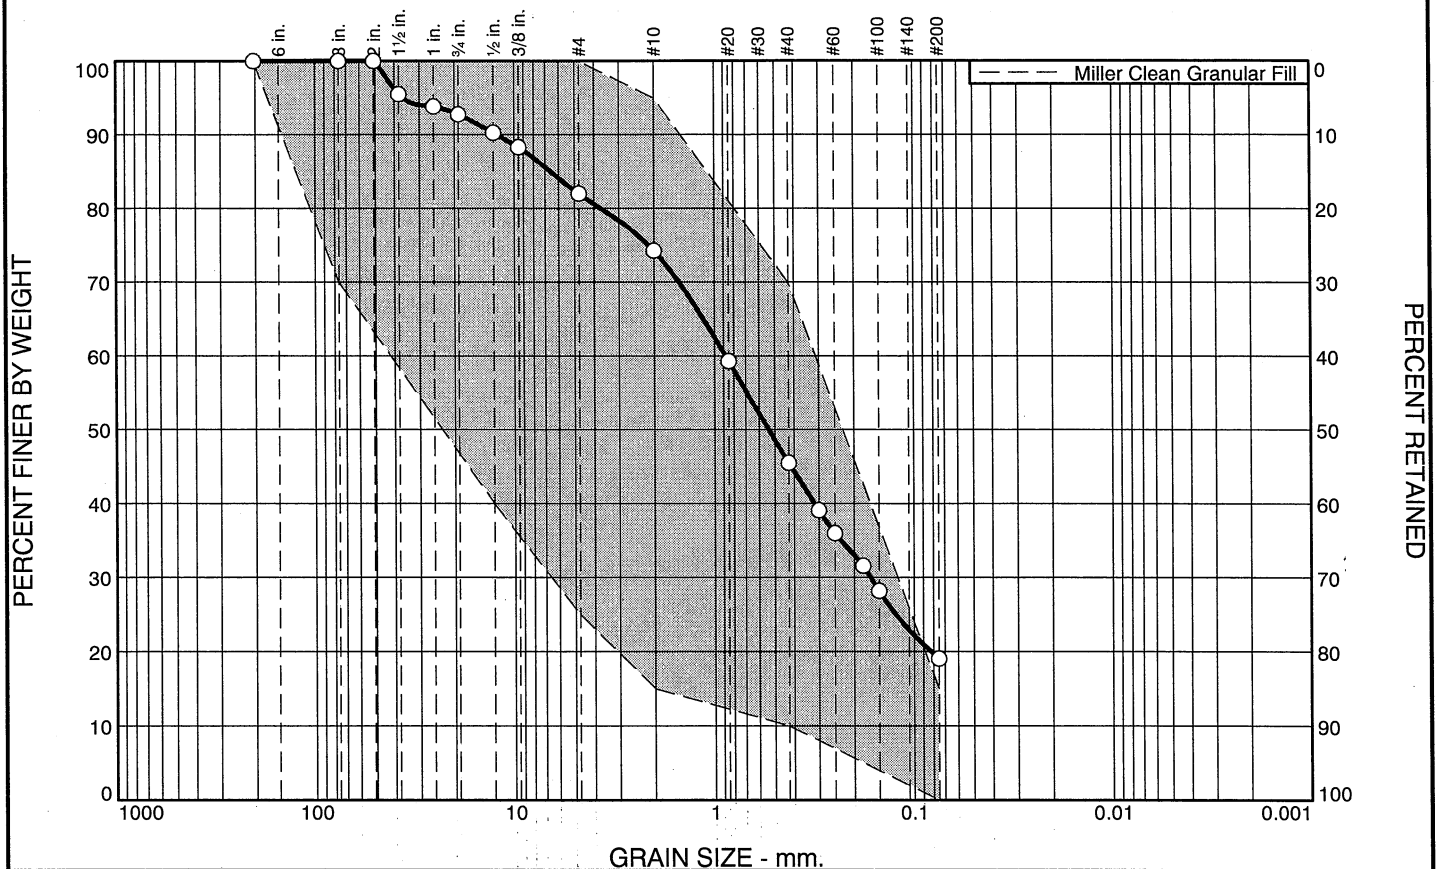
% +3"	% Gravel		% Sand			% Fines	
	Coarse	Fine	Coarse	Medium	Fine	Silt	Clay
0	7	11	8	28	27	19

SIEVE SIZE	PERCENT FINER	SPEC.* PERCENT	PASS? (X=NO)
8"	100	100	
3"	100	70 - 100	
2"	100		
1.5"	96		
1"	94		
.75"	93		
.5"	90	40 - 100	
.375"	88		
#4	82	25 - 100	
#10	74	15 - 95	
#20	59		
#40	46	10 - 70	
#50	39		
#60	36		
#80	32		
#100	28		
#200	19	0.0 - 15	X
