**Re:** MassDEP File # 39-0834  
**ANRAD Supplemental  
Information**  
School Street  
Assessors Map 43, Lots 18  
Manchester by the Sea, MA 01944

**Re: Supplemental Documentation for ANRAD Peer Review  
School Street - Manchester, MA  
DEP File # 39-0834**

Introduction

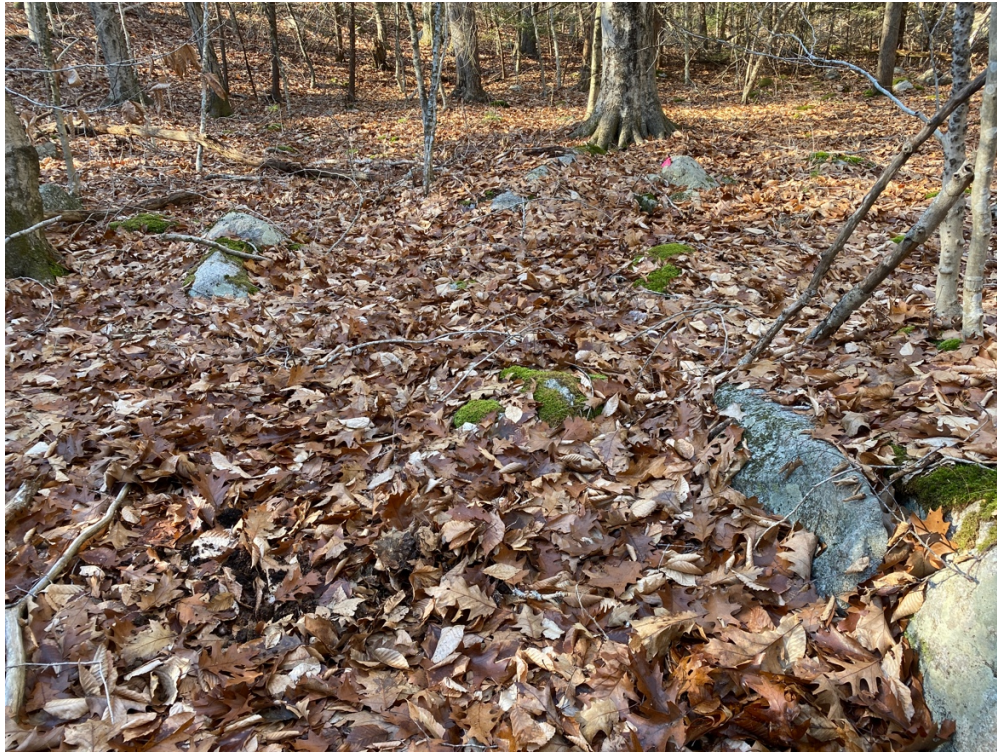
Test Pits 1-3 in the southeast portion of the property confirmed that upland conditions are present, despite the steep topography which creates a potential route for water to drain eastward towards School Street. Although low chroma colors were observed in the B-Horizon at TPs 1 & 2, these soils do not qualify as hydric indicators. No other indicators of the presence of a stream or BVW such as wrack lines, water staining on rocks or trees, or presence of obligate indicator plants such as Sphagnum moss were observed. Further downslope (offsite) to the east (Town of Manchester property) there were no visible wetland conditions present all the way up to School Street.

*Photo 1 - TP #1.*

Horizon	Depth (inches)	Matrix Color	Mottles Color or Texture
A	0-4	10YR 2/1	loam
B	4-9	10YR 3/2	loam
C	9-12+	10YR 3/4	sandy loam

Conclusion: Is soil hydric? ☐ yes ☒ no

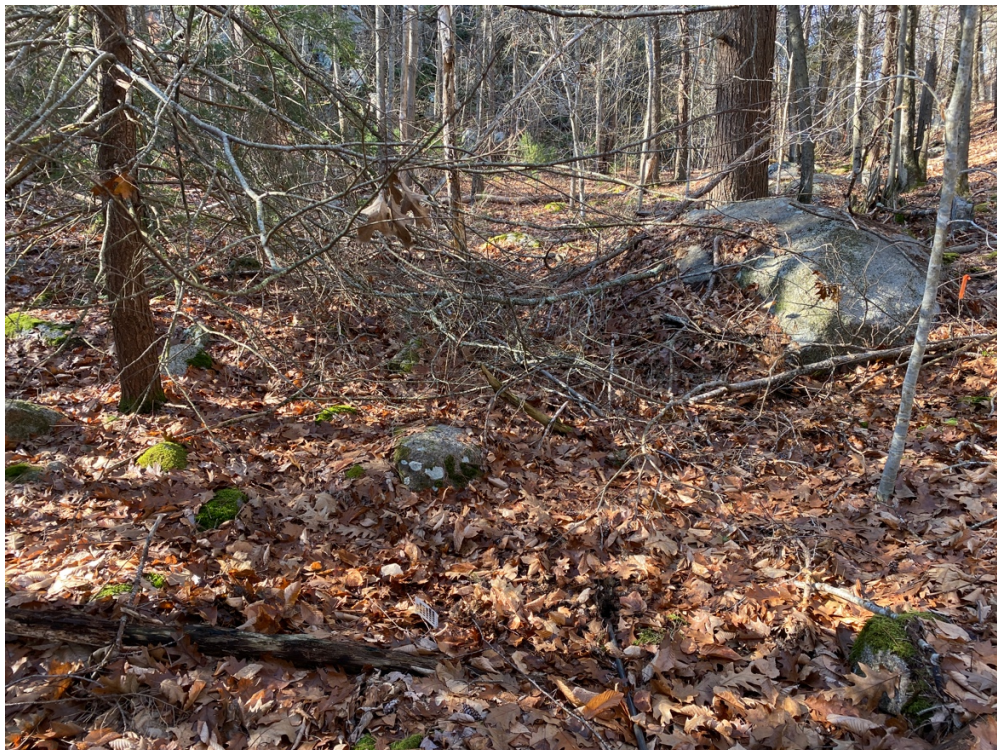
*Photo 2 - TP #2.*

<u>Horizon</u>	<u>Depth (inches)</u>	<u>Matrix Color</u>	<u>Mottles Color or Texture</u>
A	0-6	10YR 2/1	loam
B	6-12+	10YR 3/2	sandy loam

Conclusion: Is soil hydric? ☐ yes ☒ no

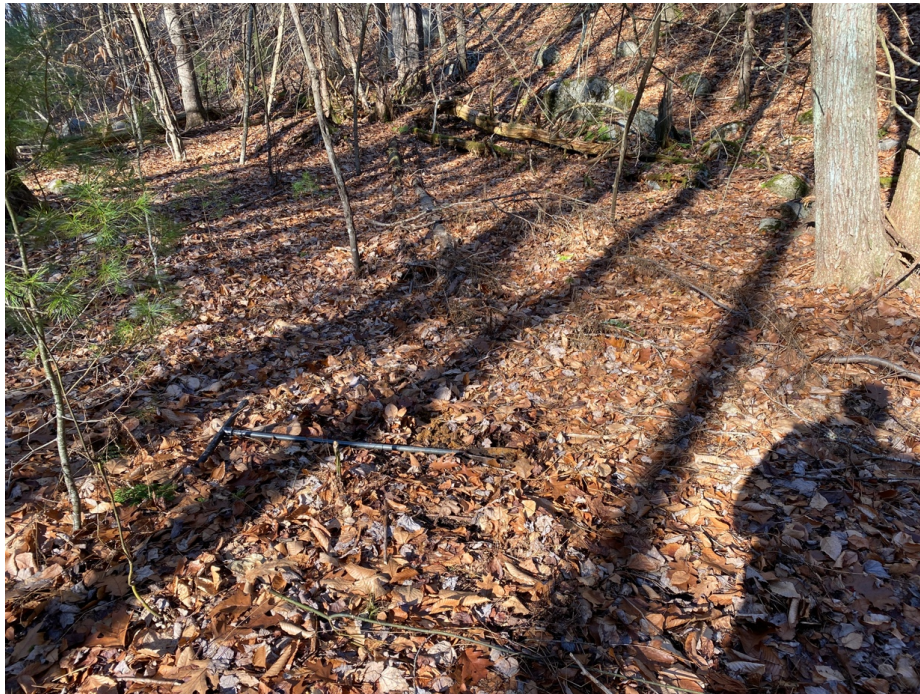
*Photo 3 - TP #3.*

<u>Horizon</u>	<u>Depth (inches)</u>	<u>Matrix Color</u>	<u>Mottles Color or Texture</u>
A	0-4	10YR 2/1	loam
B	4-14+	10YR 3/4	sandy loam

Conclusion: Is soil hydric? ☐ yes ☒ no

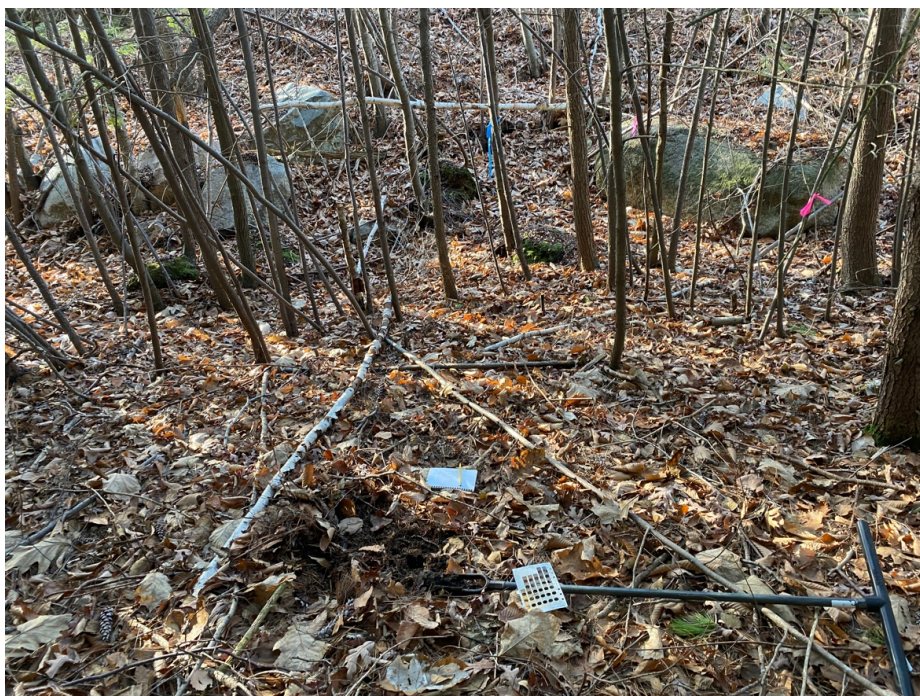
Test Pits 4 and 5 in the C-series confirmed that upland soils are present. Photos 4 and 5 show the locations of these test pits respectively.

*Photo 4 - TP #4.*

<u>Horizon</u>	<u>Depth (inches)</u>	<u>Matrix Color</u>	<u>Mottles Color or Texture</u>
A	0-2	10YR 2/1	loam
B	2-13 (refusal)	10YR 3/4	loamy sand

Remarks: refusal at hard packed gravel  
\_\_\_\_\_  
\_\_\_\_\_  
\_\_\_\_\_

Conclusion: Is soil hydric? ☐ yes ☒ no

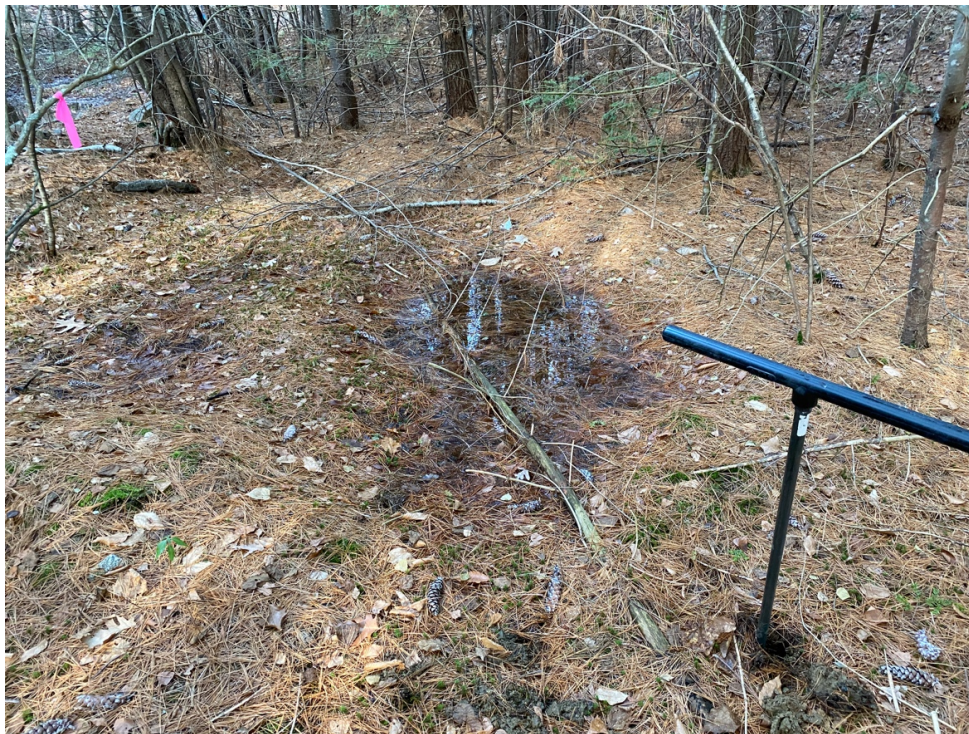
*Photo 5 - TP #5.*

<u>Horizon</u>	<u>Depth (inches)</u>	<u>Matrix Color</u>	<u>Mottles Color or Texture</u>
C	0-13+	10YR 3/4	sand

Conclusion: Is soil hydric? ☐ yes ☒ no

☒ Site inundated: standing water (outside of growing season)

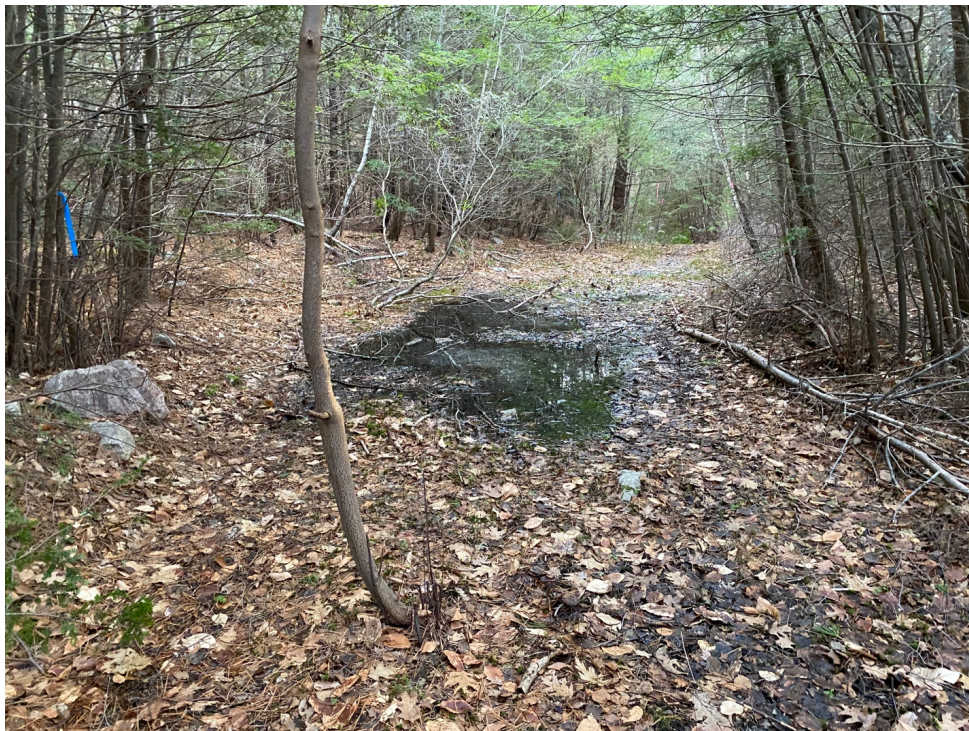
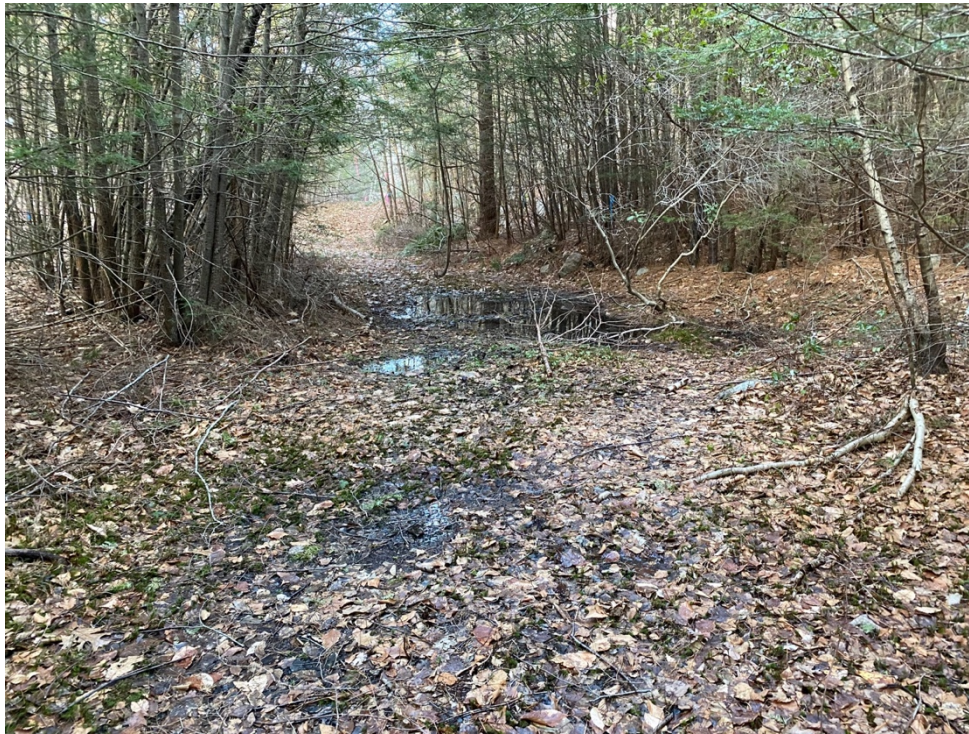
On February 2, 2020 a small area of shallow standing water was present in the northern portions of the cart path, SW of flag #C18, approximately 300 sf in extent (Photos 6 & 7).

*Photo 6 - View of standing water on cart path, facing south, taken 2/2/20.*

*Photo 7 - View of standing water on cart path, facing north, taken 2/2/20.*

In summary, three test pits within the cart path on 2/2/20 and two additional test pits within low spots on either side of the cart path on 12/3/20 confirm the absence of hydric soils from within the C-series. Eastern hemlock is the dominant plant species throughout the C-series, followed by white pine. The US Army Corps of Engineers 2018 National Wetland Plant List, v. 3.4 lists eastern hemlock (*Tsuga canadensis*) as "FACU," which is considered an upland species designation. White pine (*Pinus strobus*) is also listed as FACU. Based on the above observations, I conclude that the area originally flagged as the "C-series" is not a wetland, and therefore is not an area subject to the jurisdiction of the Wetlands Protection Act [M.G.L. c. 131, § 40] or its regulations [310 CMR 10.00].

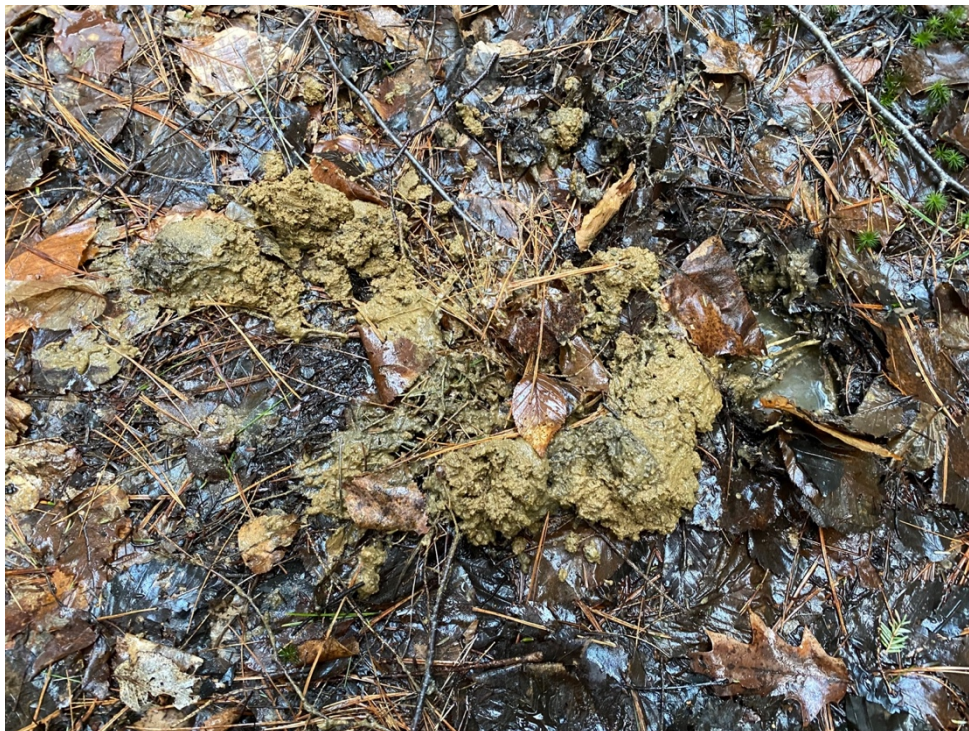
The soils at three separate locations along the cart path (Figure 2) consisted of non-hydric hard-packed sand, with 10YR 4/4 color to a depth of greater than 12 inches (Photo 8).

*Photo 8 - View of soils typical within cart path portion of C-series.*
