PROJECT SUMMARY

SAWMILL BROOK FLOOD MITIGATION AND RESTORATION

SAWMILL BROOK/CENTRAL POND RESTORATION FEASIBILITY STUDY

Manchester-by-the-Sea Town Hall – June 21, 2018

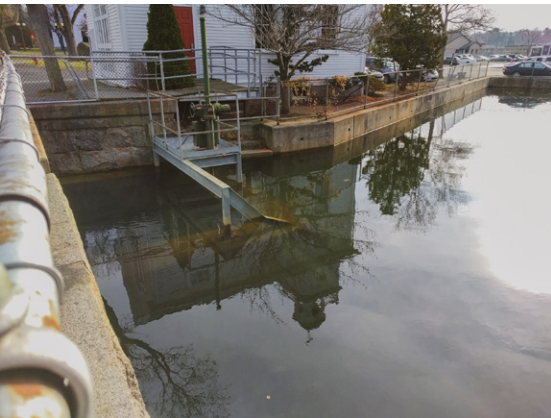
High Tide rising above tide gate - December 3, 2017

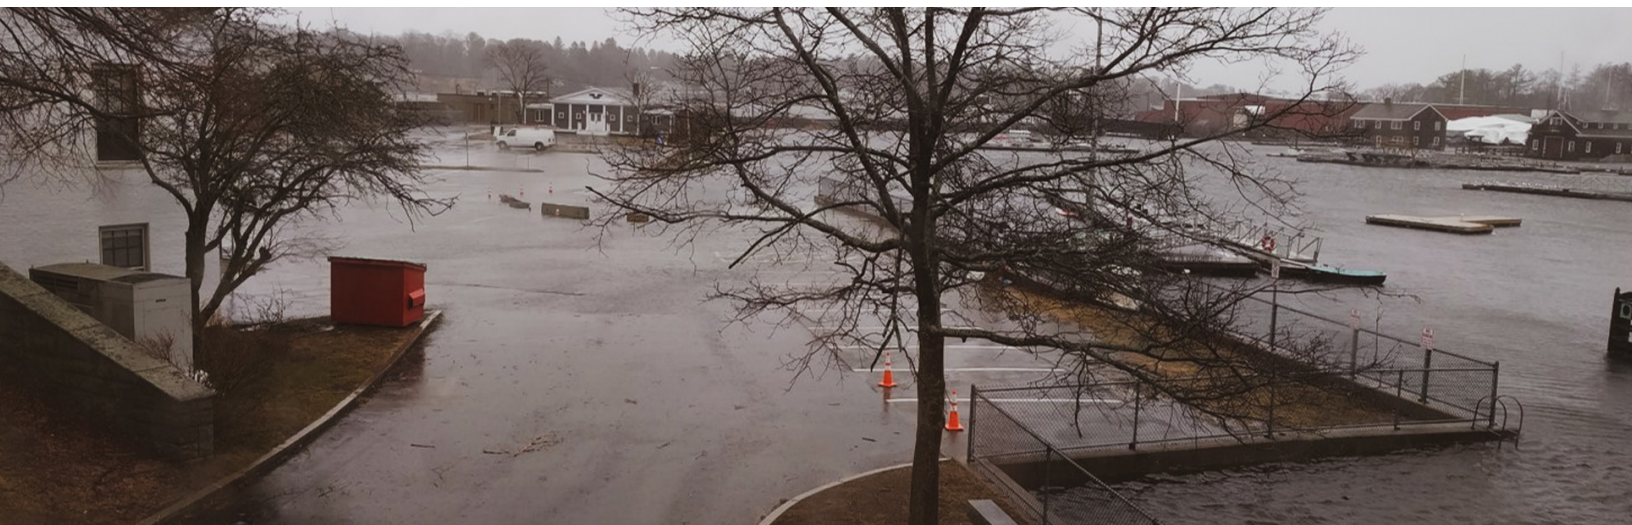
Flooding at the Manchester Town Hall - January 4, 2018

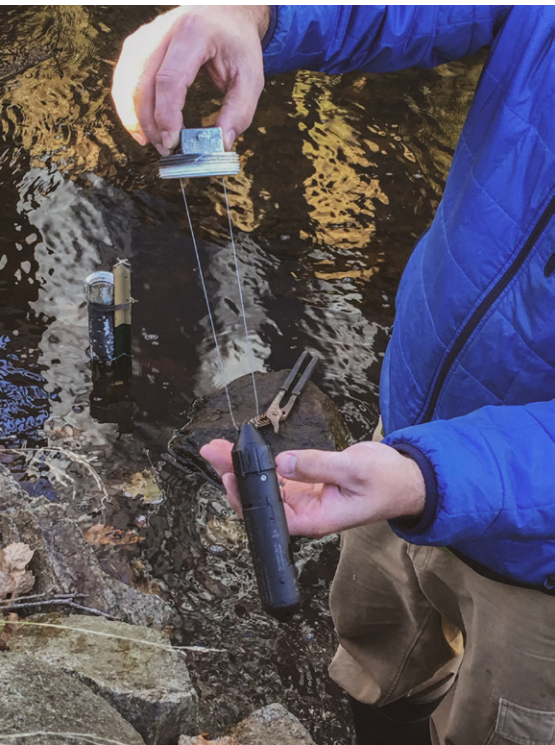
Installing HOB0 water level pressure transducers in stream bed below Norwood Ave.

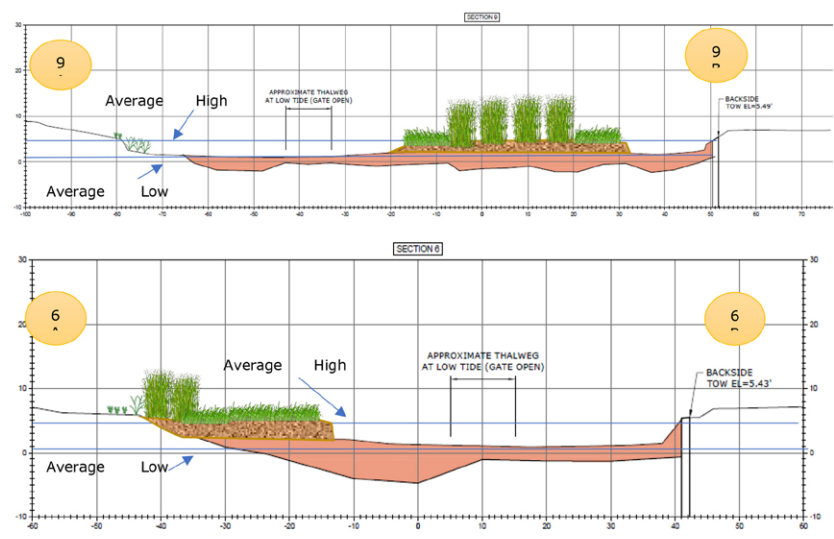
Photo 5
Conceptual Profile for Marsh Restoration- Transect 6 and 9

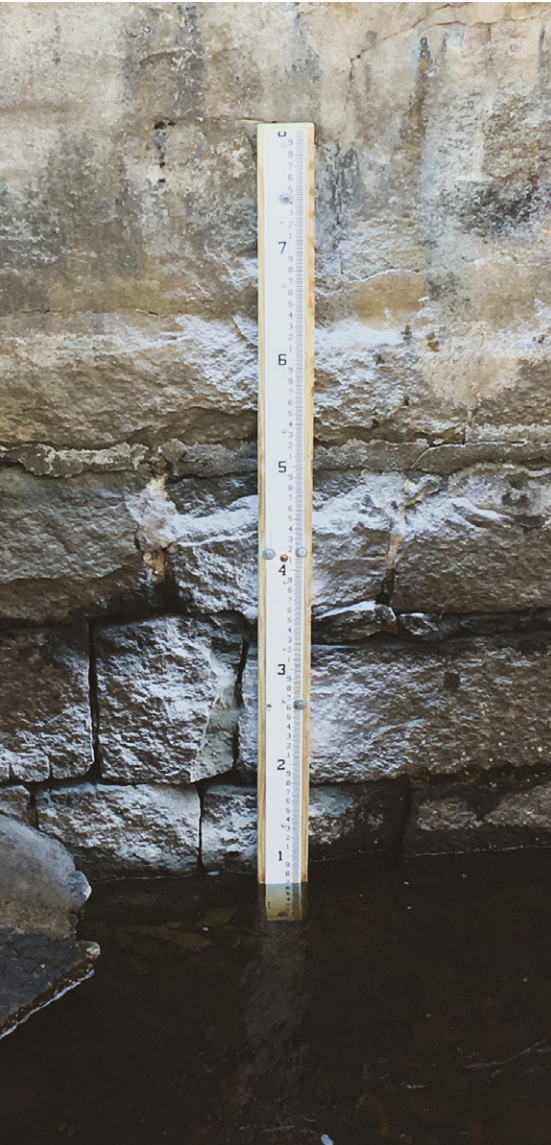
Central Street Bridge Surface Water Level Gauge

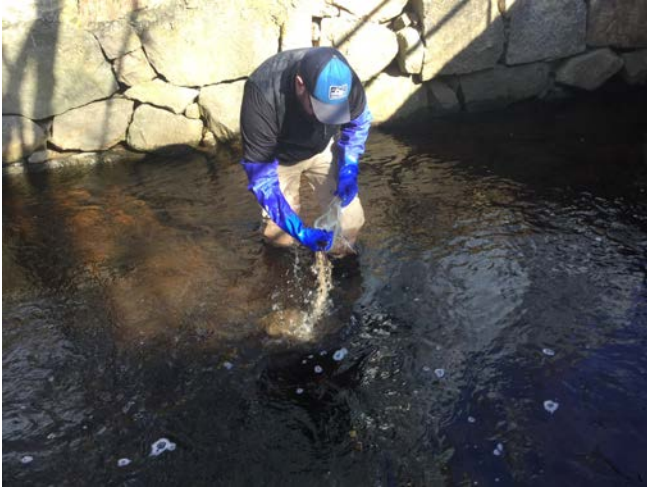
Central Pond

- 5,000 CY of soft sandy sediment
- East bank due to wall erosion
- West bank from stormwater runoff
- Lead, mercury and some petroleum hydrocarbons were found in sediments
- Allowing sediment to naturally flush may be preferred approach to dredging- subject to permitting with state and ACOE

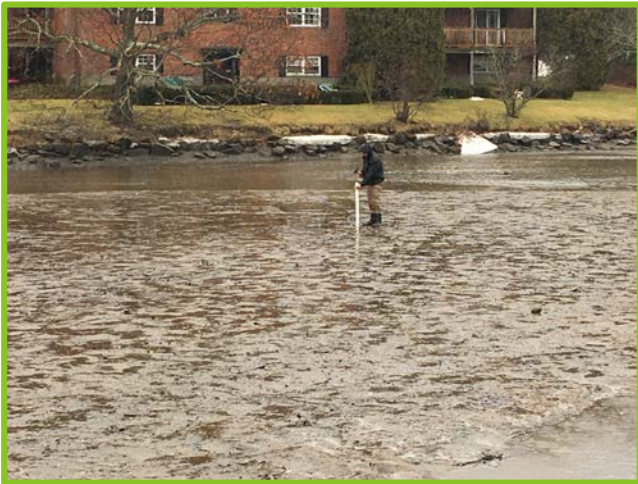
Upstream Channel

- Gravel and sand substrate ideal for fish spawning

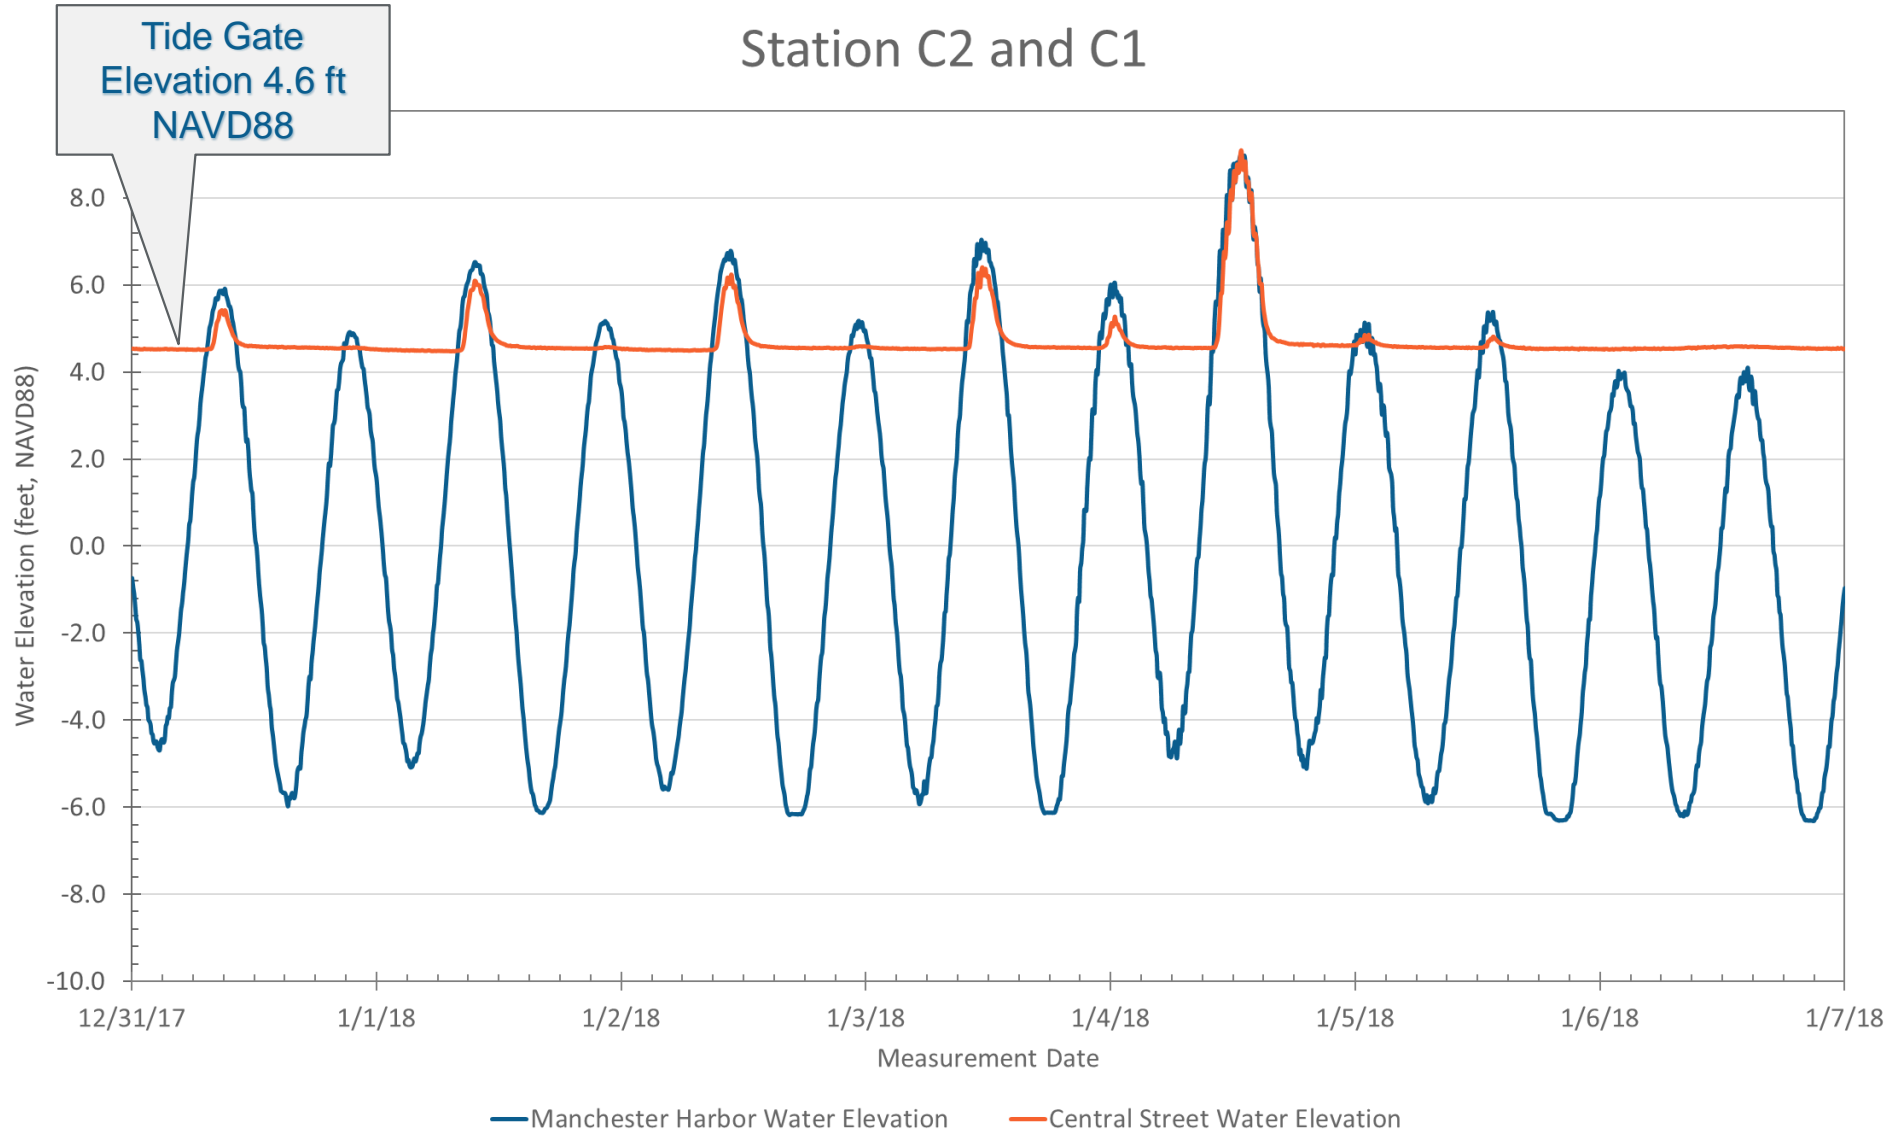
DEC 31, 2017 TO JAN 7, 2018 – TIDE GATE CLOSED

- Gate overtops (4.61 ft) 66% of the time at high tide
- Average water depth fluctuates 0.65 ft from high to low tide
- Tidal backwater to School Street on regular basis and Norwood only once

- Highest water level (Central Pond- 9.08 feet, 12:48 pm on 1/4/18, concurrent with record breaking high tide set in Boston.
- Lowest water level in Central Pond was 0.45 feet.
- Highest Precipitation recorded - 1.9 inches on 4/16/18

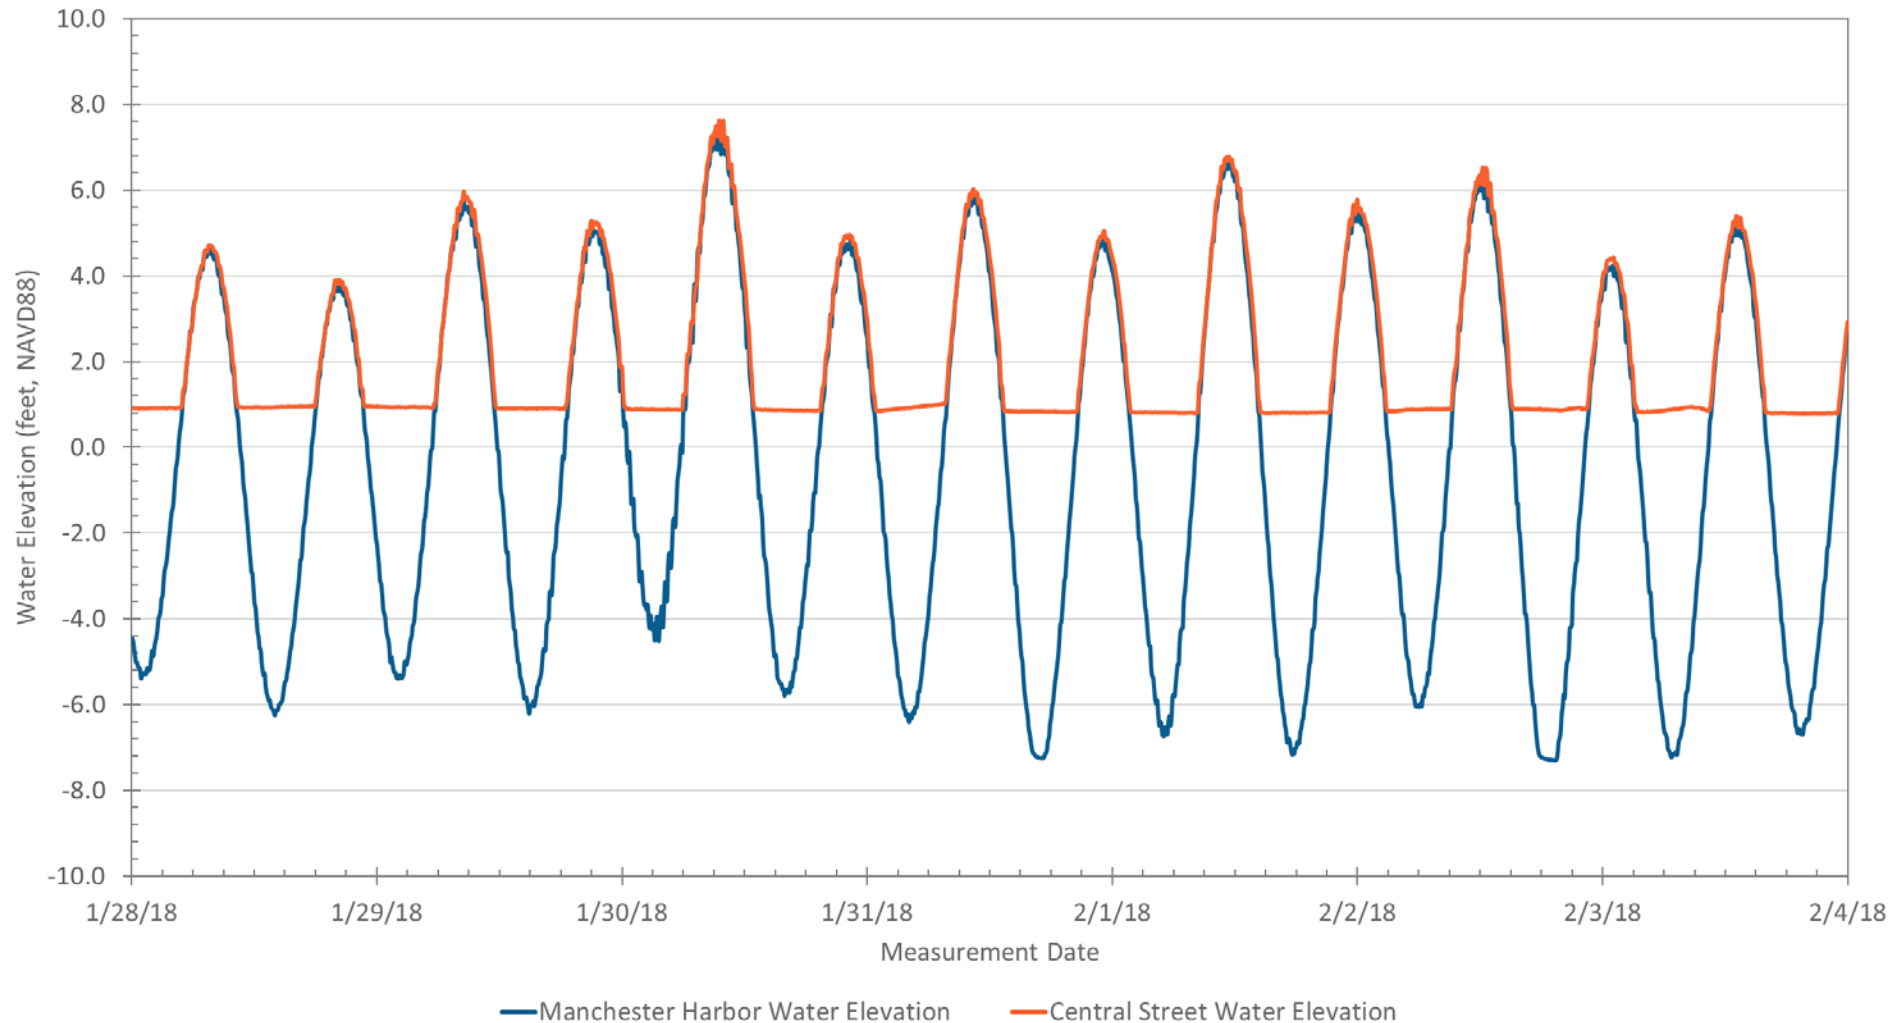
Station C2 and C1

JAN 28, 2018 TO FEB 3, 2018 – TIDE GATE OPEN

- Gate overtops 68% of the time at high tide
- Average water depth fluctuates 4.10 ft from high to low tide
- Tidal backwater only to School Street

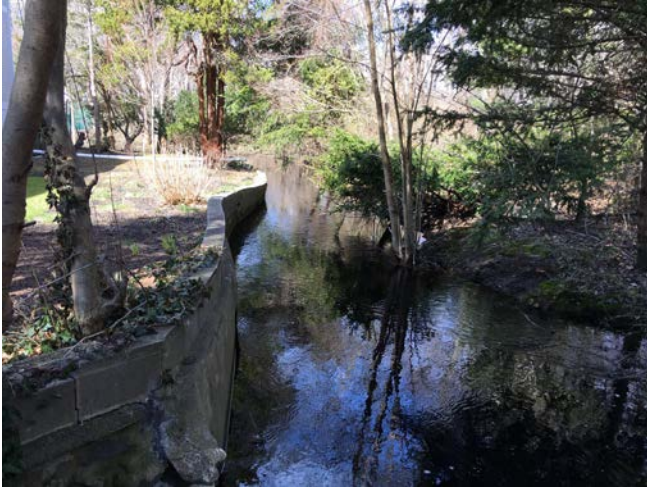
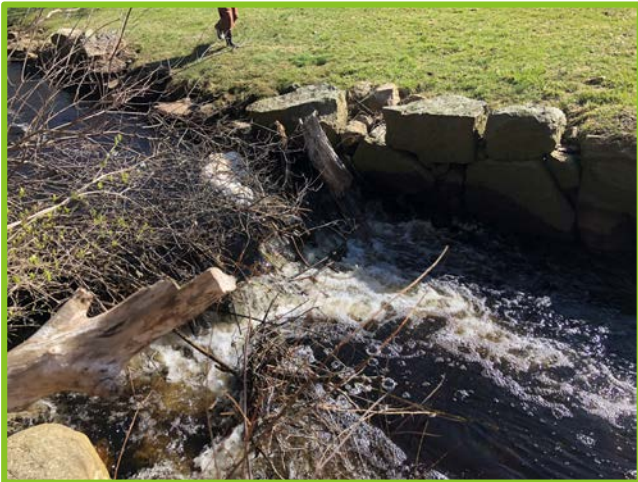
- Granite block, poured concrete, brick, field stone and shale revetment and combinations of the above are the dominant structures found around Central Pond.
- Granite block, field stone and combinations of the above are the dominant structures found along Sawmill Brook.
- Almost 50% of the walls arounds Central Pond are in need of maintenance. Over 60% of the shoreline of Central Pond is privately owned.
- Many locations can benefit from some type of bioengineering to stabilize banks using stone and plantings

Stream bank conditions from Central Street to Norwood Avenue documented areas of stream bank erosion from failed walls, low lying stream bank and stormwater runoff. The majority of the walls are on privately owned property, but around Central Street nearly half are on Town-owned property.

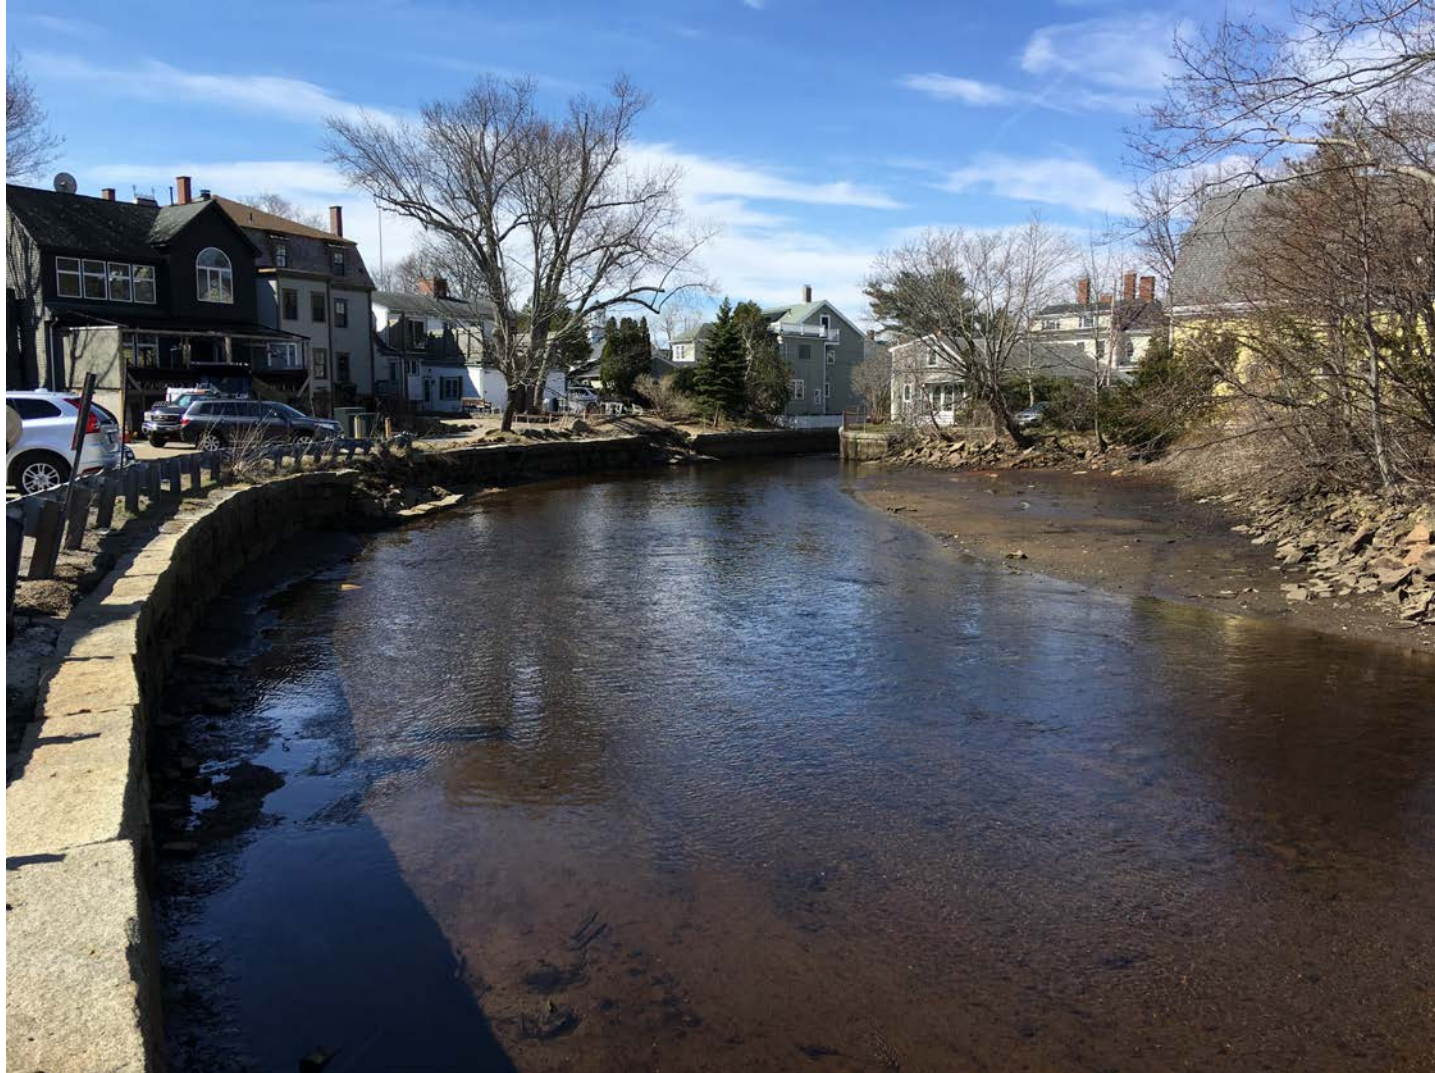
VIEW OF CENTRAL POND LOW TIDE

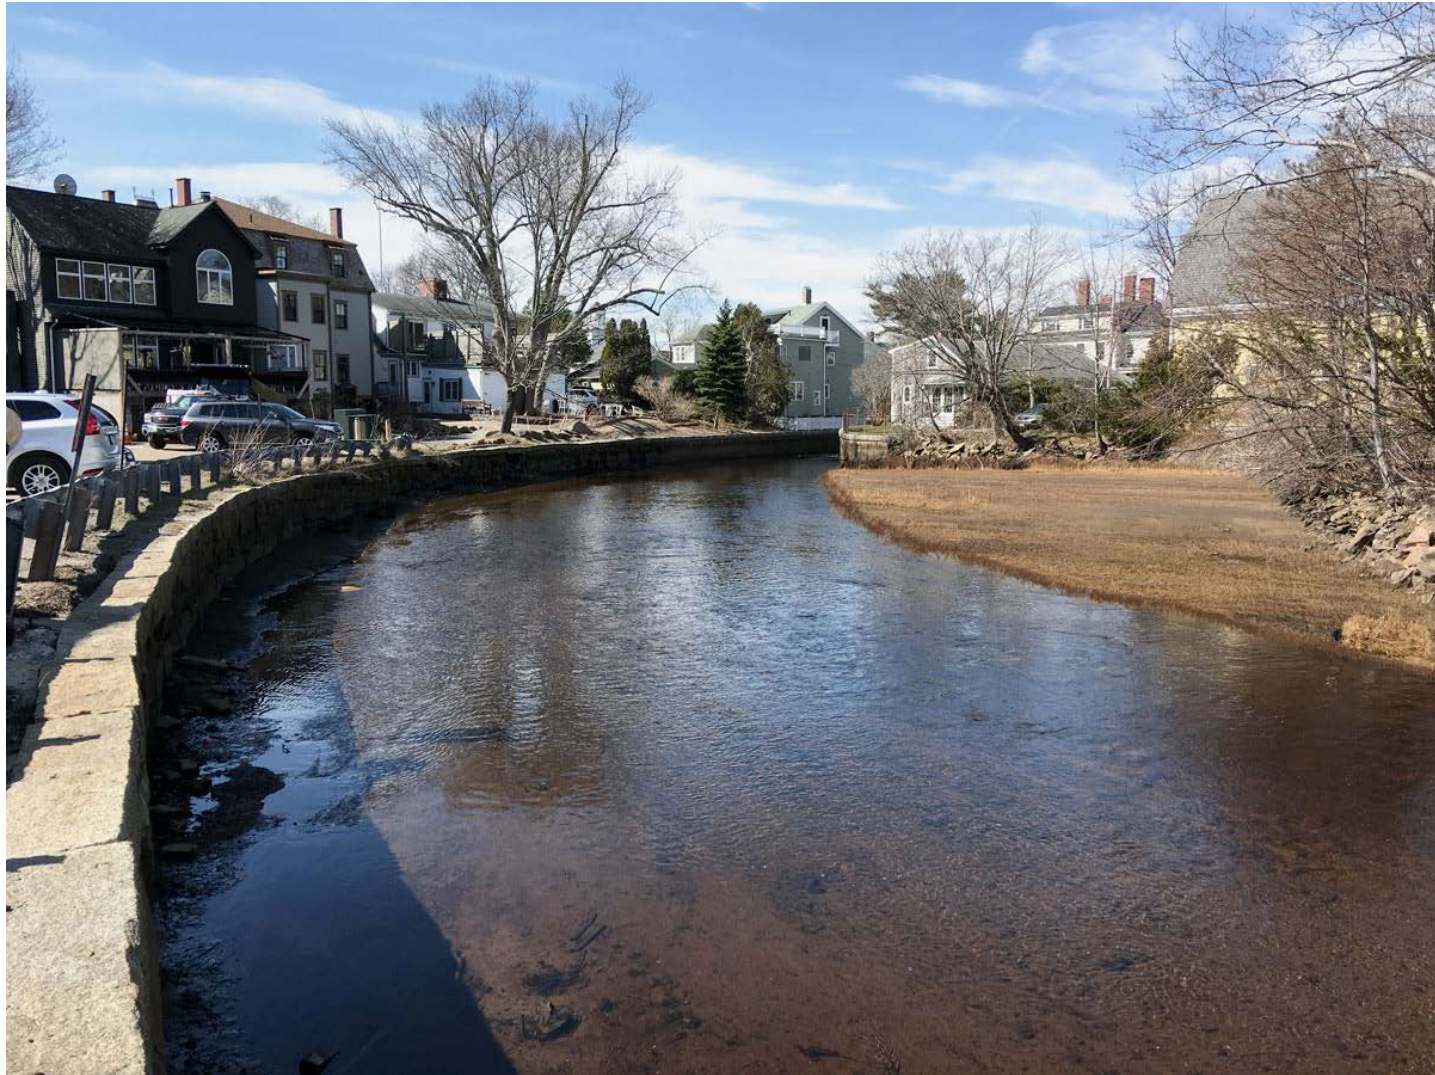
WALL REPAIRS AND BANK STABILIZED

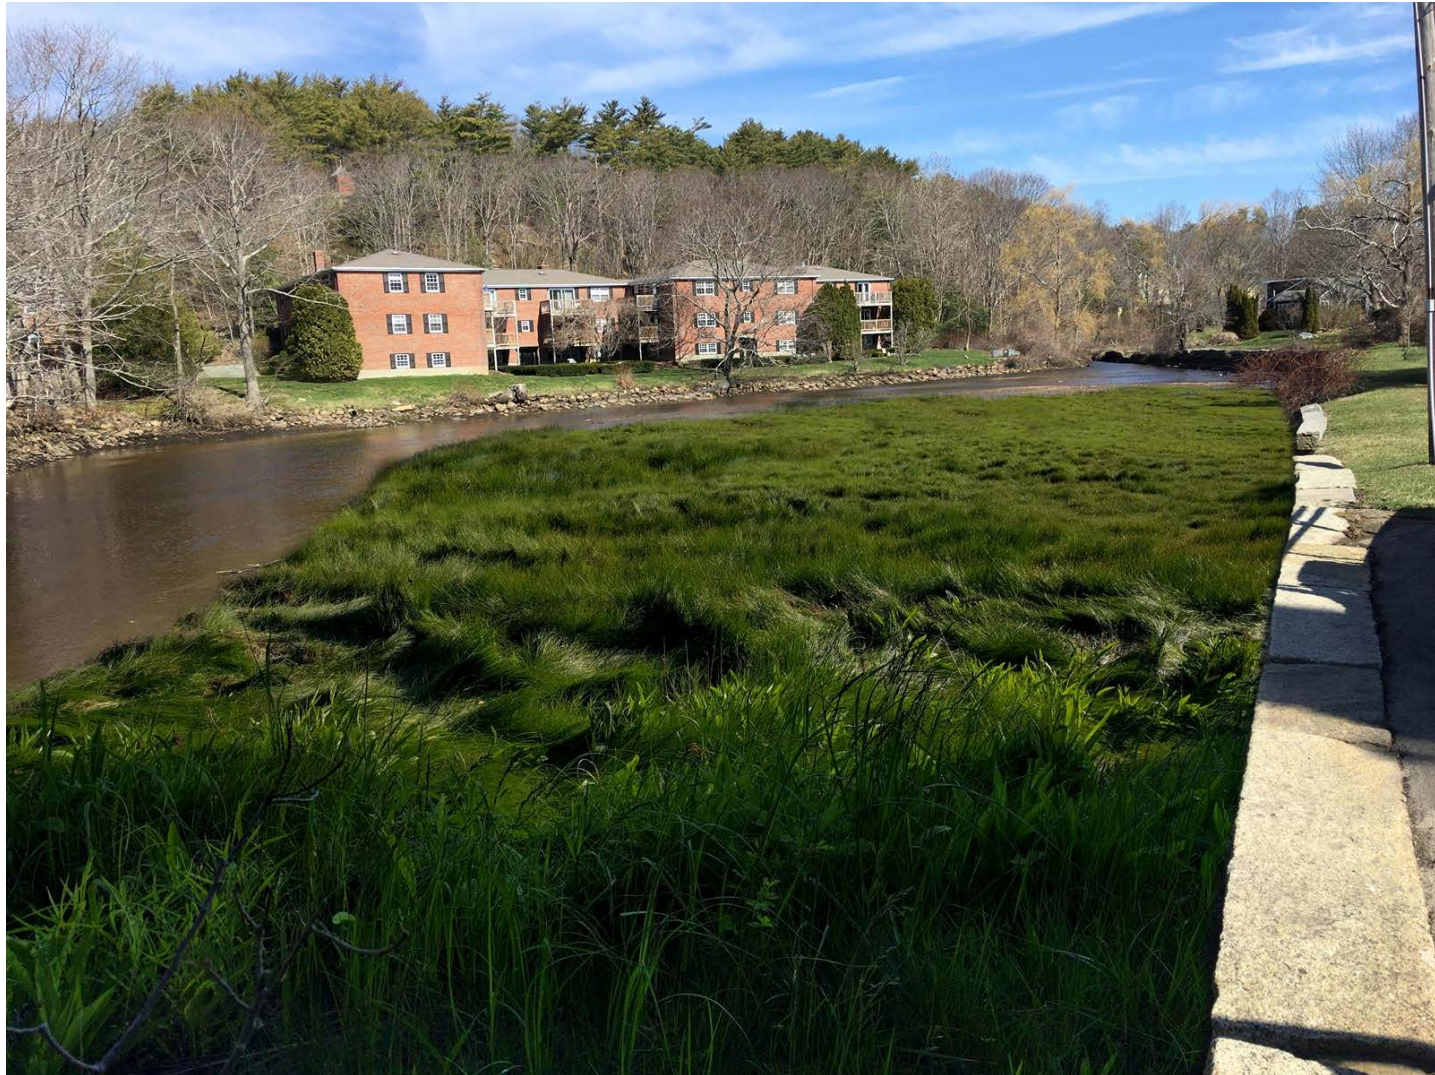
POTENTIAL RESTORATION ALONG EAST BANK AT LOW TIDE
