January 8, 2019

Subject: Harbor Loop Preliminary Design

Field Notes
September 26, 2018
Harbor Loop Sewer Preliminary Design
Manchester-by-the-Sea, MA

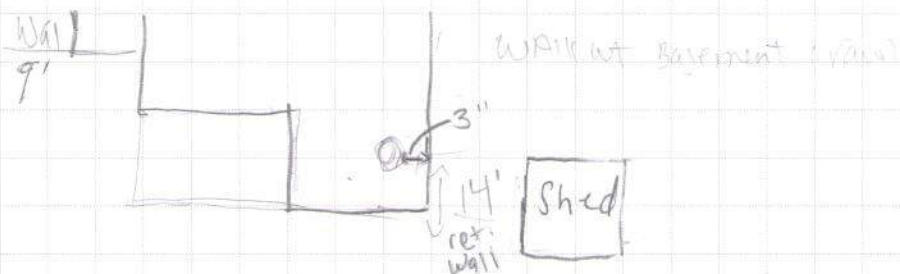
6 BRIDGE STREET

- Unable to locate lateral in home. Basement finished and walk-out.
- Could last see plumbing behind washer in basement. Measured location to where is entered ground behind washer.
- Homeowners have plans to replace fence in the yard but will hold off in case any work is to be done.

Could not see pipe at of house or clean at
location measured where we could see pipe enter
ground in base behind washer ✓

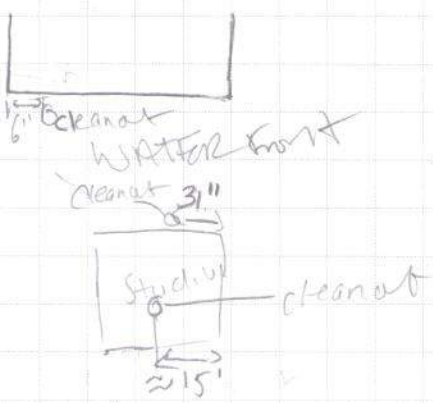
6 Ashland

- Service lateral located in apartment under hatch in closet. Located about halfway mark of building.
- Runs out to line to MH 126A.
- Noted that service cleanout/pipe is in poor condition and should be replaced soon.
- Service was reported to be underwater during high tide.

NOTE: SERVICE CLEANOUT PIPE IN POOR CONDITION
AND UNDERWATER DURING HIGH TIDE

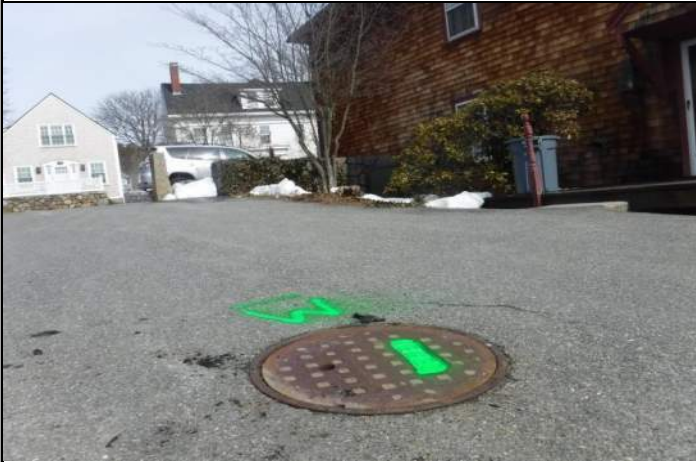
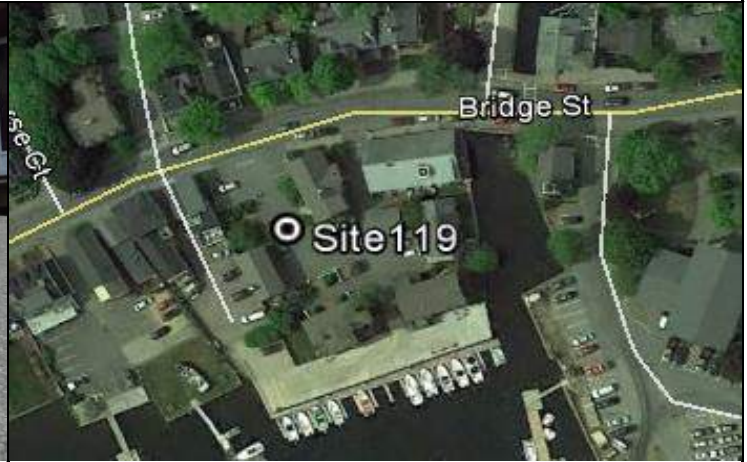
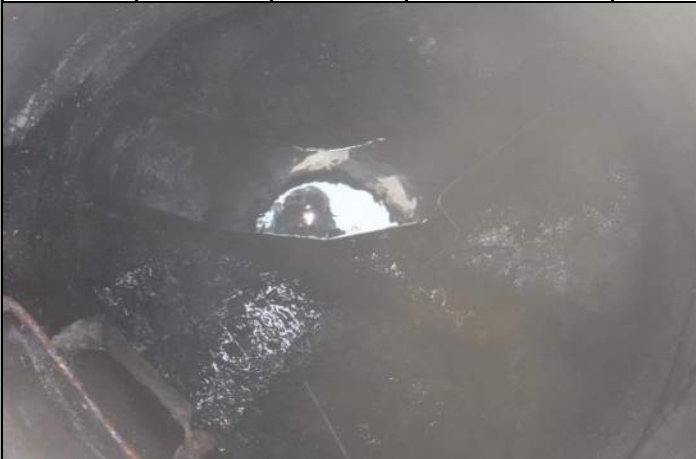
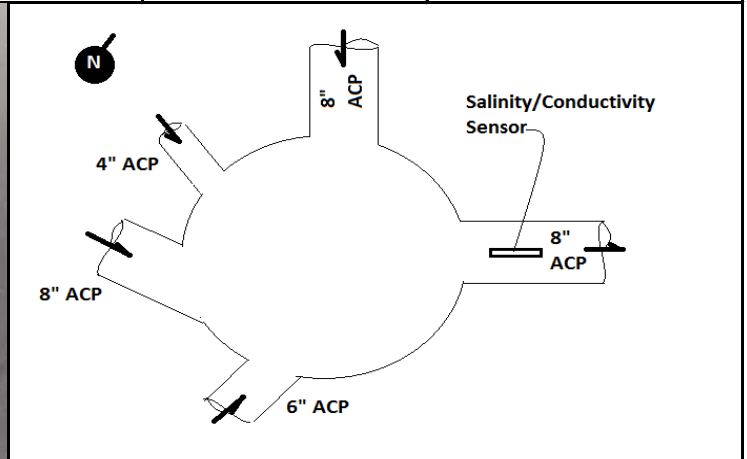
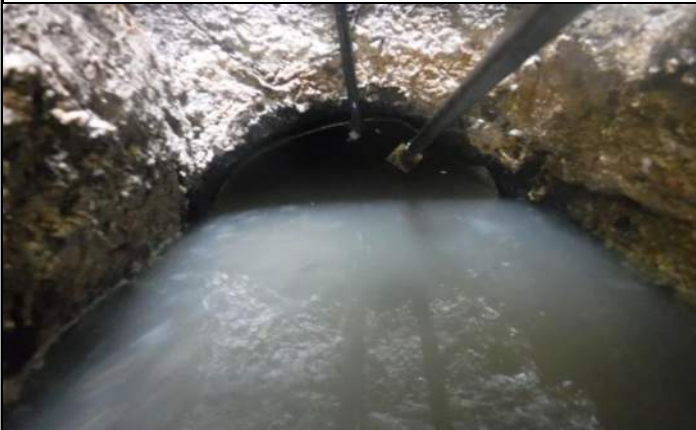
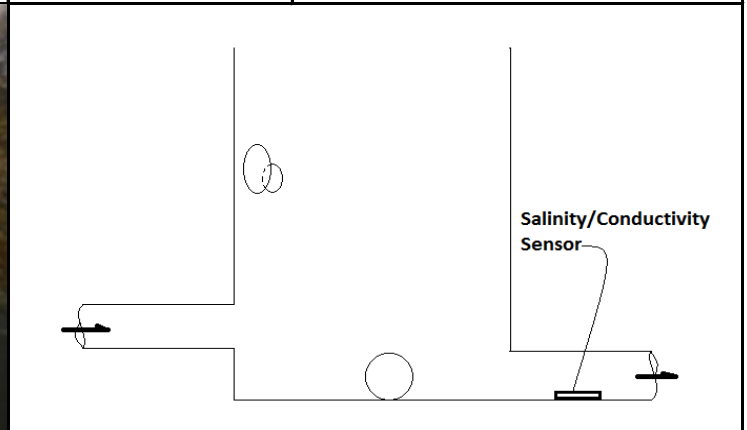
PROJECT: Manchester By the Sea, MA	DATE: March 23, 2018	JOB#: 18039
LOCATION: Peele House Square	MH#: 119	METER SITE: 119
GPS/COMMENTS: 42.574982, -70.773506

Size (")	Material	Flow Depth (")	Debris	Shape	MH Depth
Incoming	8	ACP	3.3	0	Circular	10' 6"
Incoming	6	ACP	0.2	0.5	Circular	9' 7"
Incoming	8	ACP	0.4	0	Circular	4' 7"
Outgoing	8	ACP	3.3	0	Circular	10' 7"

SURCHARGE NONE EVIDENT:	LENGTH:	HEIGHT ABOVE WEIR:
SURCHARGED MARKS TO: 8'	BREADTH:	OVERFLOW OCCURS AT:
SURCHARGE CURRENTLY TO:	LEVEL:

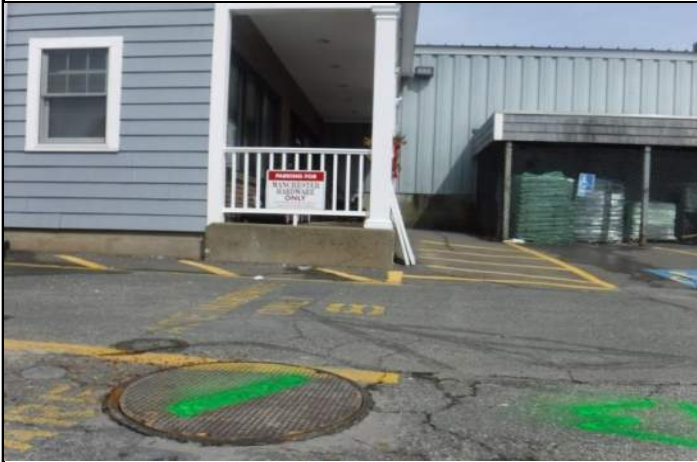
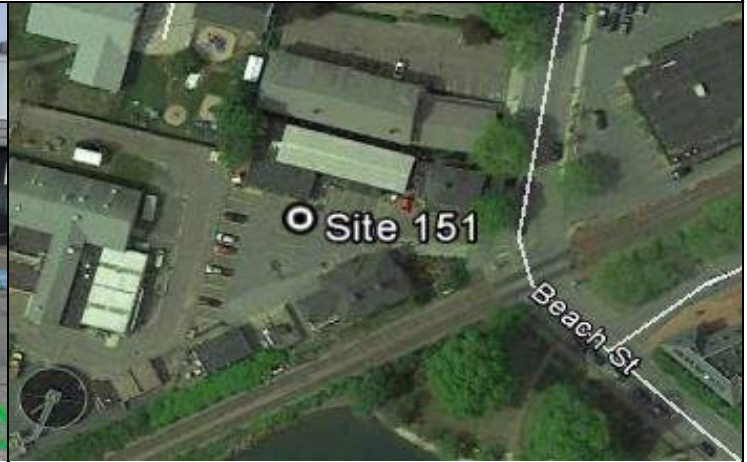
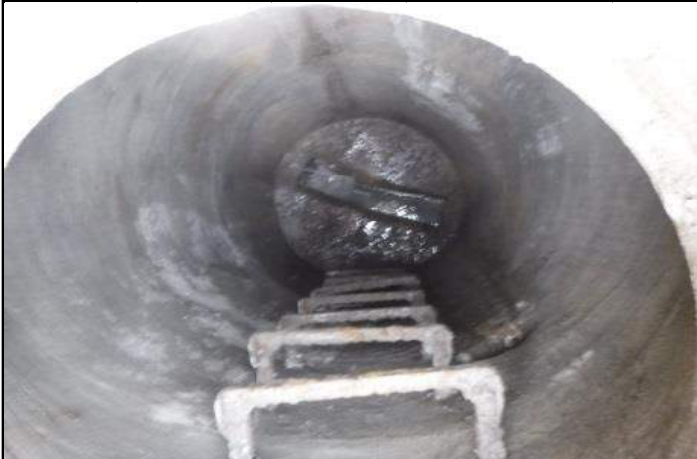
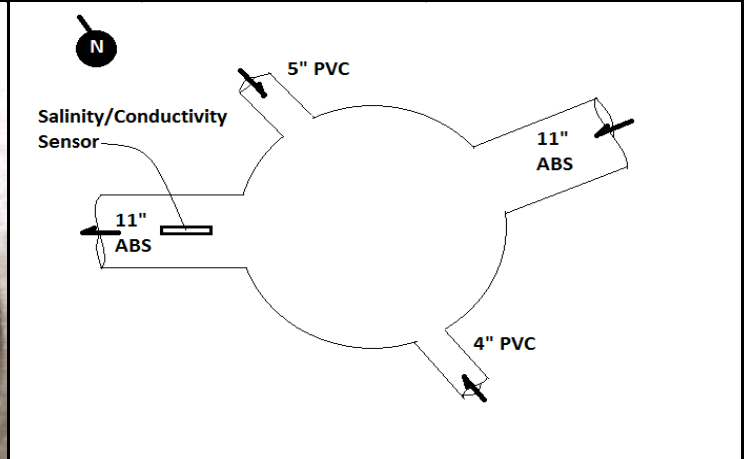
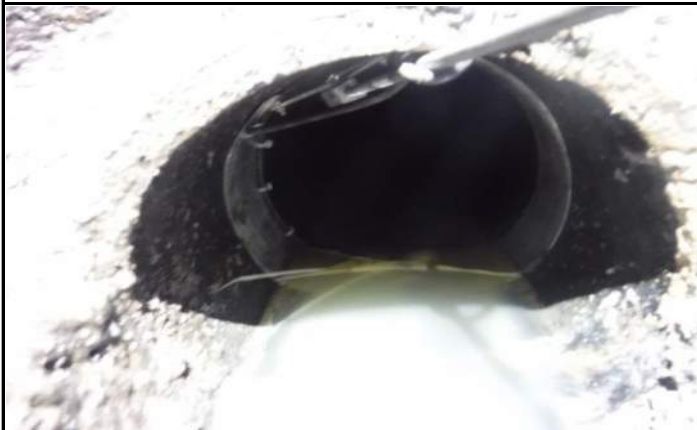
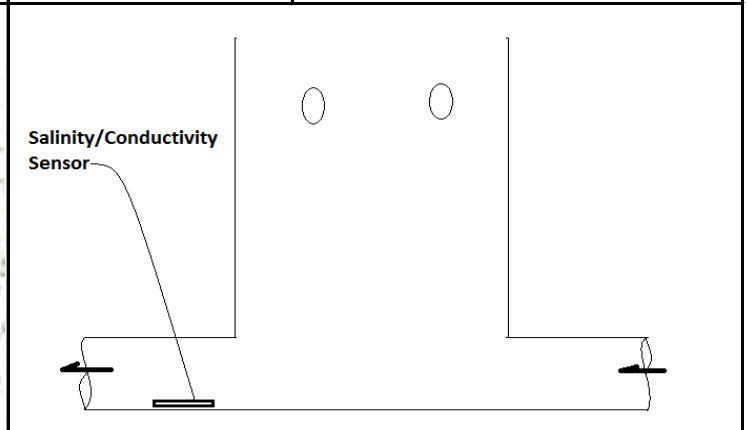
PROJECT: Manchester By the Sea, MA	DATE: March 23, 2018	JOB#: 18039
LOCATION: 35 Beach Street	MH#: 151	METER SITE: 151
GPS/COMMENTS: 42.573750, -70.770922

Size (")	Material	Flow Depth (")	Debris	Shape	MH Depth
Incoming	11	ABS	2	0	Circular	13' 1"
Incoming	4	PVC	0	0	Circular	4' 2"
Incoming	5	PVC	0	0	Circular	4' 5"
Outgoing	11	ABS	2	0	Circular	13' 2"

SURCHARGE NONE EVIDENT: X
SURCHARGED MARKS TO:
SURCHARGE CURRENTLY TO:
