Manchester-by-the-Sea, Massachusetts

Stream Crossing Evaluation, Sawmill Brook Watershed

Stream Crossing Evaluation in Sawmill Brook Watershed

TO: Mary Reilly, Manchester-by-the-Sea Grants Administrator
FROM: Gabrielle C. Belfit, Janet Moonan; Tighe & Bond
COPY: M. Gregory Federspiel, Town Administrator
David A. Murphy, P.E. Vice President, Tighe & Bond
DATE: July 28, 2015

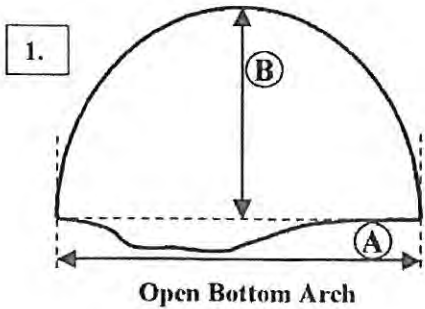
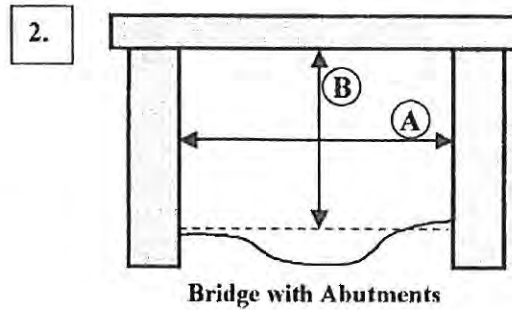
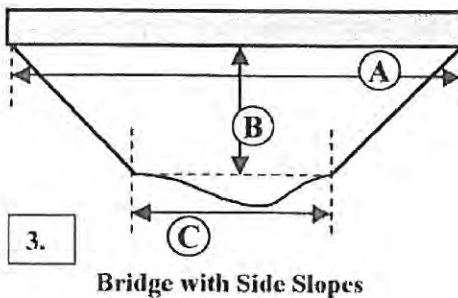
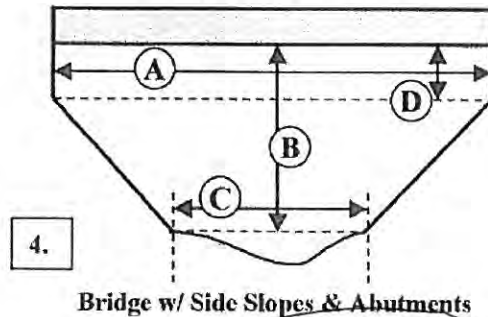
NOTE:
dry stone
masonry
open bottom.
N/ tons of
organic matter

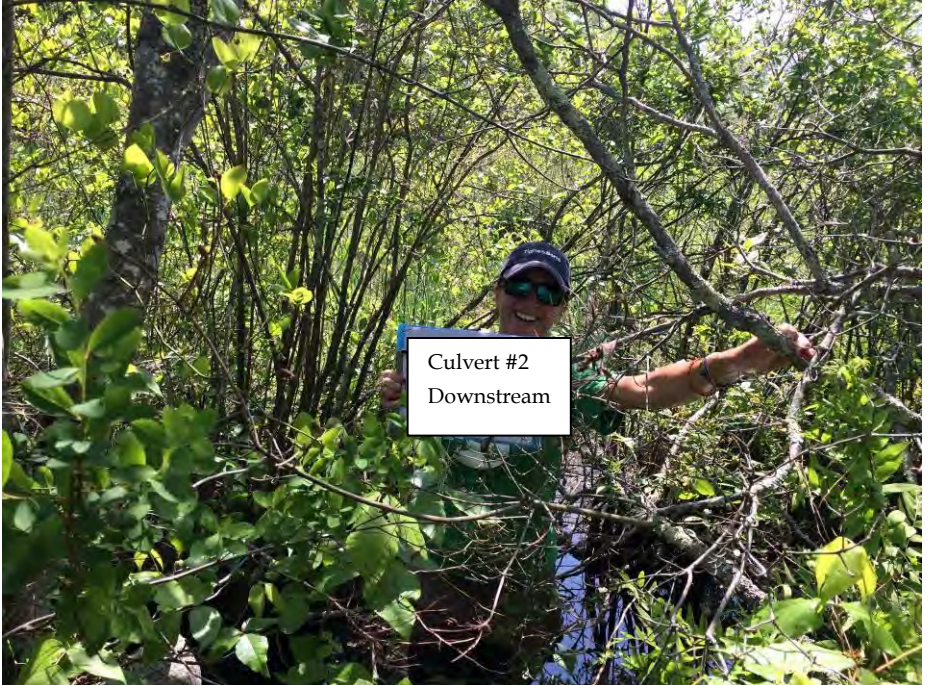
Tighe&Bond		PHOTOGRAPHIC LOG	
Client Name: Manchester-by-the Sea, MA		Site Location: Sawmill Brook Watershed, Old School Street, Culvert #2	Project No. M-1476
Photo No. 1	Date: 5/30/15

Direction Photo Taken: S			
Description: View downstream, in Cedar Swamp.

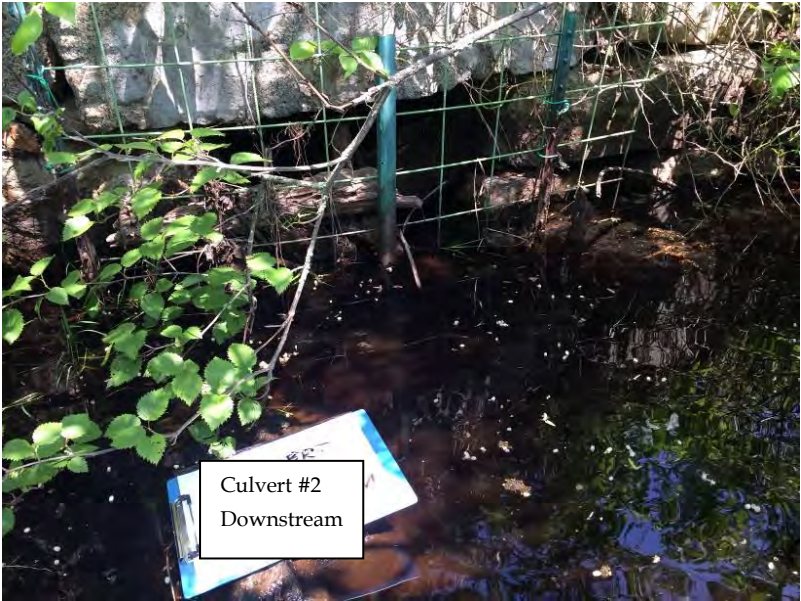
Tighe&Bond		PHOTOGRAPHIC LOG	
Client Name: Manchester-by-the Sea, MA		Site Location: Sawmill Brook Watershed, Old School Street, Culvert #2	Project No. M-1476
Photo No. 2	Date: 5/30/15

Direction Photo Taken: N			
Description: View of culvert outlet, Cedar Swamp

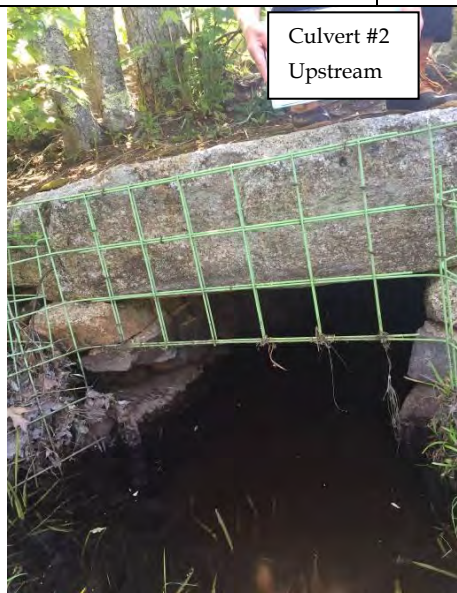
Tighe&Bond		PHOTOGRAPHIC LOG	
Client Name: Manchester-by-the Sea, MA		Site Location: Sawmill Brook Watershed, Old School Street, Culvert #2	Project No. M-1476
Photo No. 4	Date: 5/30/15

Direction Photo Taken: S			
Description: View of culvert inlet, upstream in Cedar Swamp. Beaver guard.

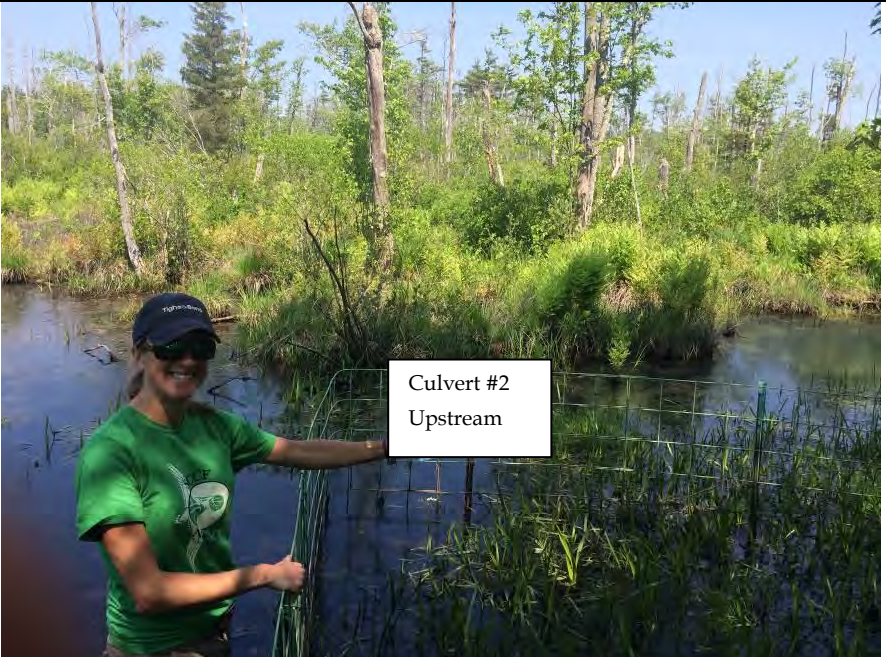
Tighe&Bond		PHOTOGRAPHIC LOG	
Client Name: Manchester-by-the Sea, MA		Site Location: Sawmill Brook Watershed, Old School Street, Culvert #2	Project No. M-1476
Photo No. 5	Date: 5/30/15

Direction Photo Taken: N			
Description: View upstream of culvert looking at Cedar Swamp. Beaver guard.

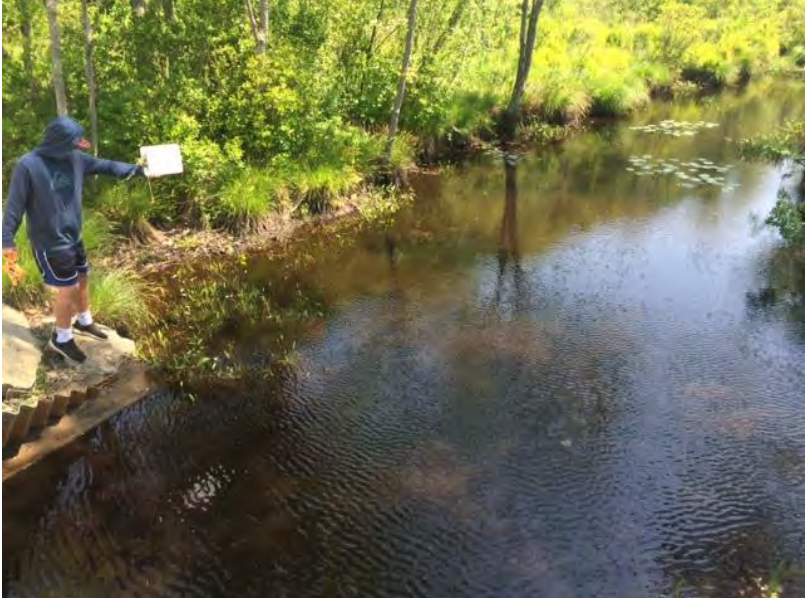
Tighe&Bond		PHOTOGRAPHIC LOG	
Client Name: Manchester-by-the Sea, MA		Site Location: Sawmill Brook Watershed, School St. Culvert #3	Project No. M-1476
Photo No. 3	Date: 5/30/15

Direction Photo Taken: W			
Description: Upstream view from culvert

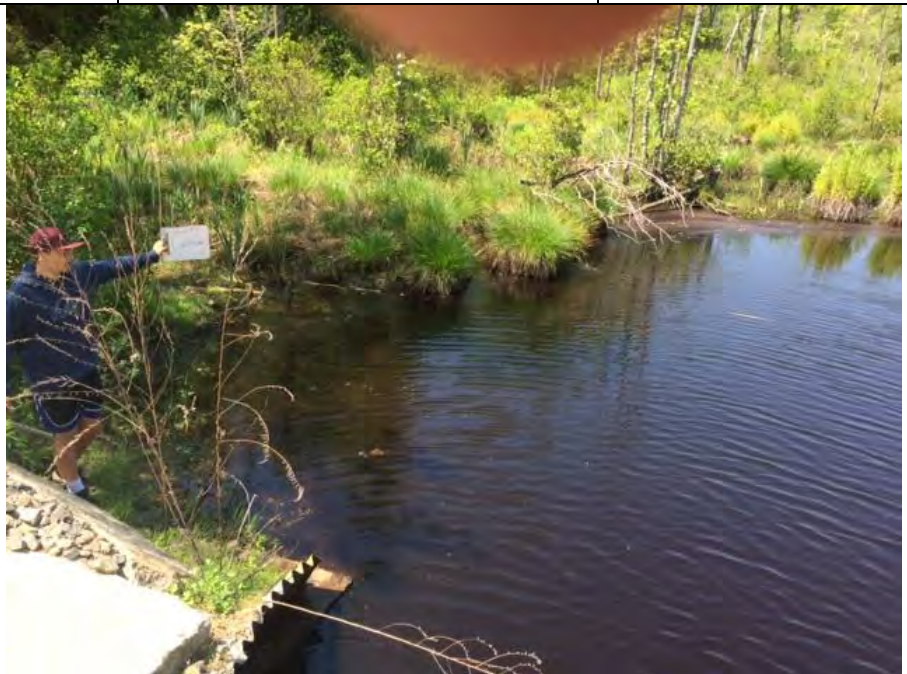
Tighe&Bond		PHOTOGRAPHIC LOG	
Client Name: Manchester-by-the Sea, MA		Site Location: Sawmill Brook Watershed, School St. Culvert #3	Project No. M-1476
Photo No. 4	Date: 5/30/15

Direction Photo Taken: NW			
Description: View upstream from culvert

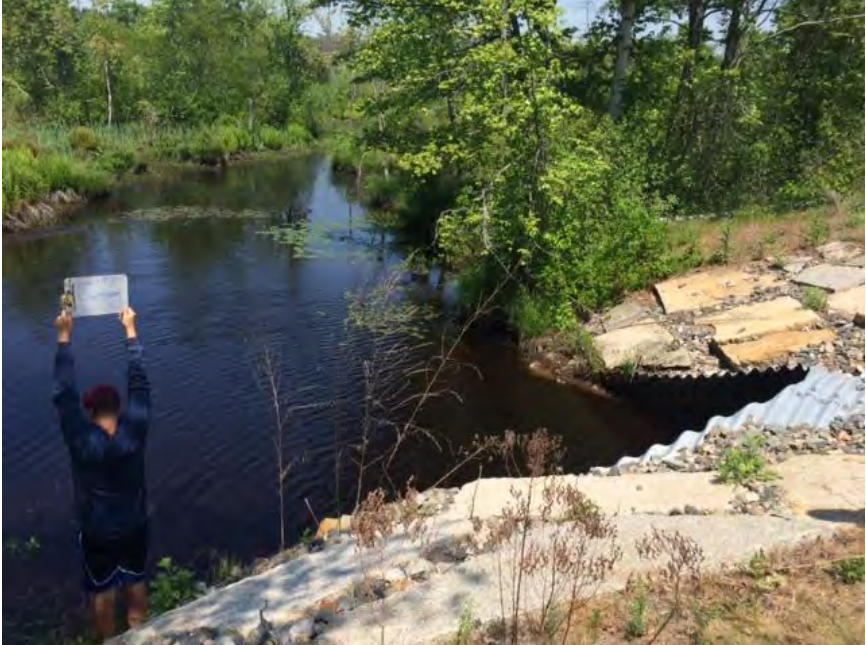
Tighe&Bond		PHOTOGRAPHIC LOG	
Client Name: Manchester-by-the Sea, MA		Site Location: Sawmill Brook Watershed, School St. Culvert #3	Project No. M-1476
Photo No. 5	Date: 5/30/15

Direction Photo Taken: SW			
Description: View Downstream, culvert outlet

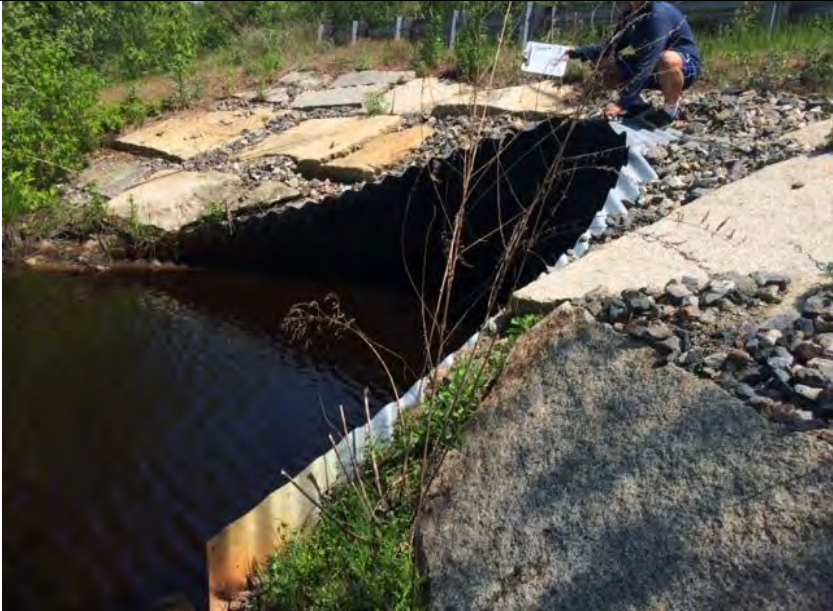
Tighe&Bond		PHOTOGRAPHIC LOG	
Client Name: Manchester-by-the Sea, MA		Site Location: Sawmill Brook Watershed, School St. Culvert #3	Project No. M-1476
Photo No. 6	Date: 5/30/15

Direction Photo Taken: S			
Description: View of culvert outlet, downstream

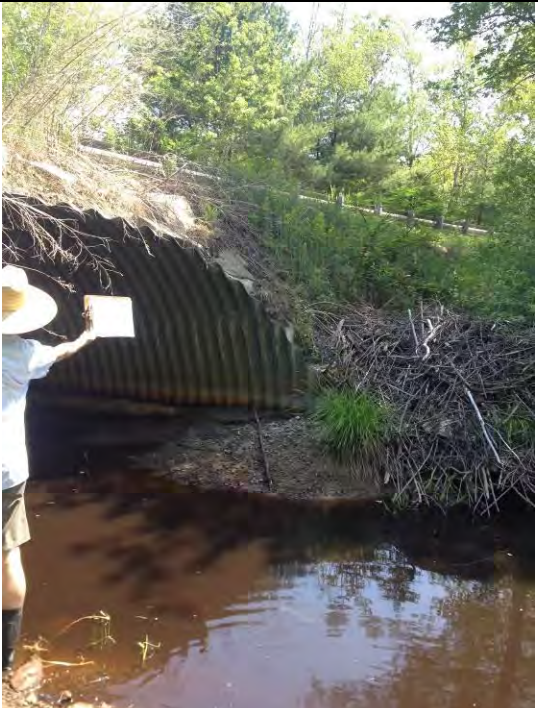
Direction Photo Taken: NW			
Description: Sawmill Brook. View of culvert outlet.

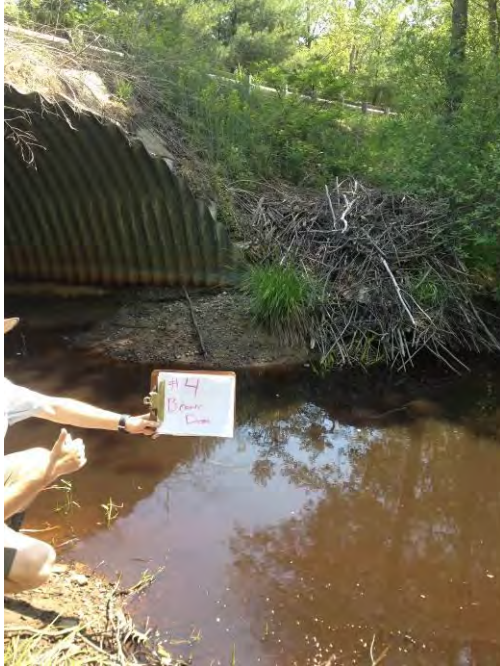
Tighe&Bond		PHOTOGRAPHIC LOG	
Client Name: Manchester-by-the Sea, MA		Site Location: Sawmill Brook Watershed, Atwater Ave. Culvert #4	Project No. M-1476
Photo No. 3	Date: 5/30/15

Direction Photo Taken: NW			
Description: Sawmill Brook. Culvert Outlet, Beaver Dam			
Tighe&Bond		PHOTOGRAPHIC LOG	
Client Name: Manchester-by-the Sea, MA		Site Location: Sawmill Brook Watershed, Atwater Ave. Culvert #4	Project No. M-1476
Photo No. 4	Date: 5/30/15

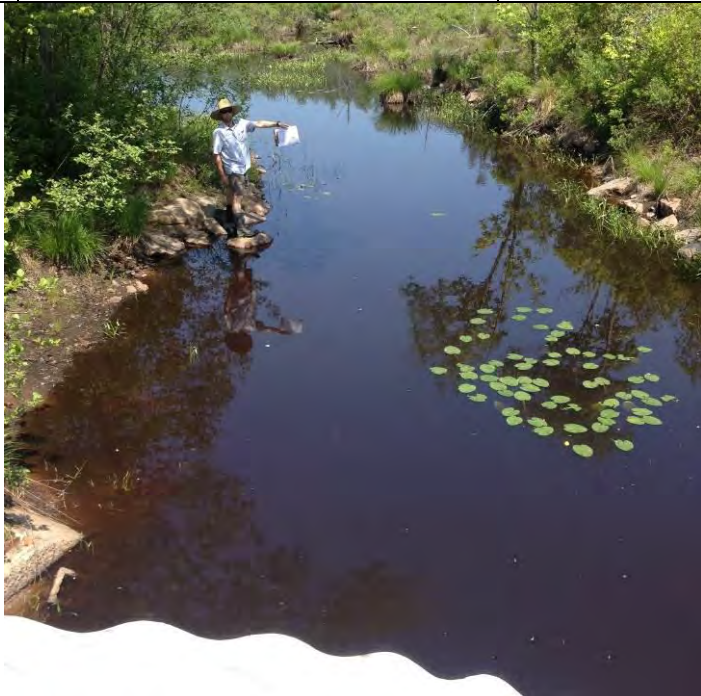
Direction Photo Taken: NW			
Description: Sawmill Brook. View upstream from inlet

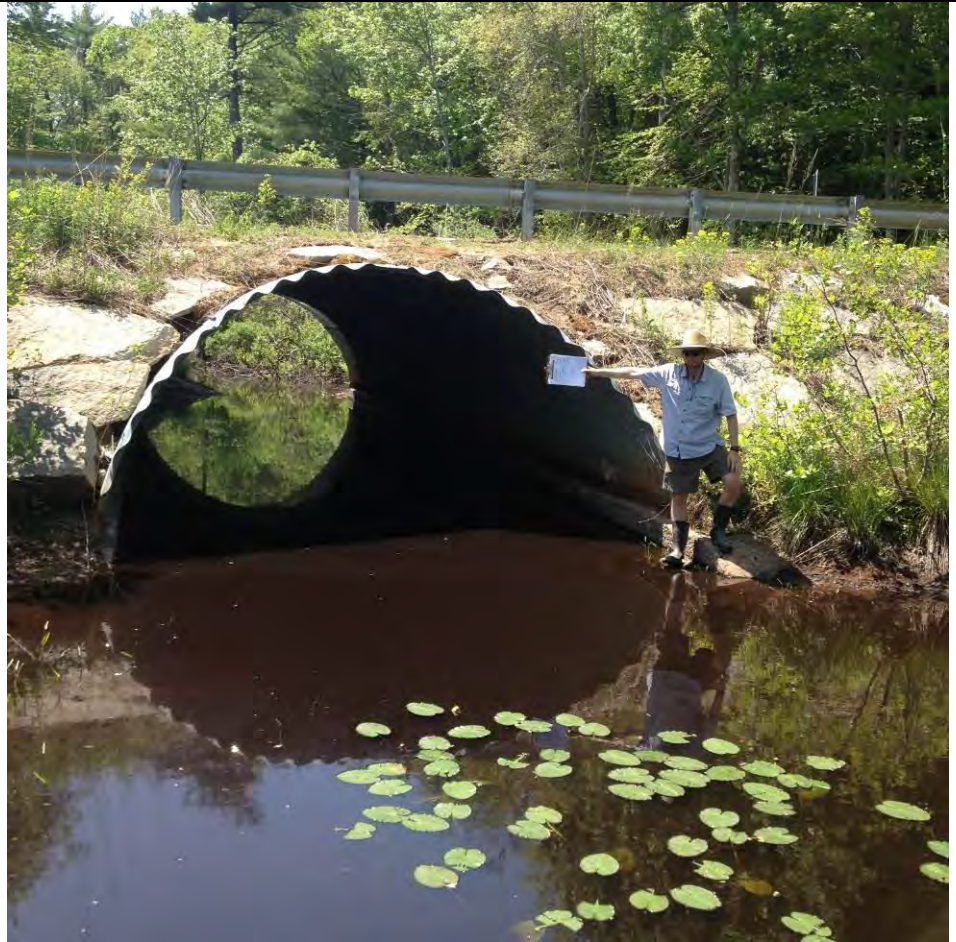
Client Name: Manchester-by-the Sea, MA**Site Location:** Sawmill Brook Watershed, Atwater Ave. Culvert #4**Project No.** M-1476**Photo No.**
5**Date:**
5/30/15**Direction Photo Taken:** SE**Description:**
Sawmill Brook.
Culvert inlet

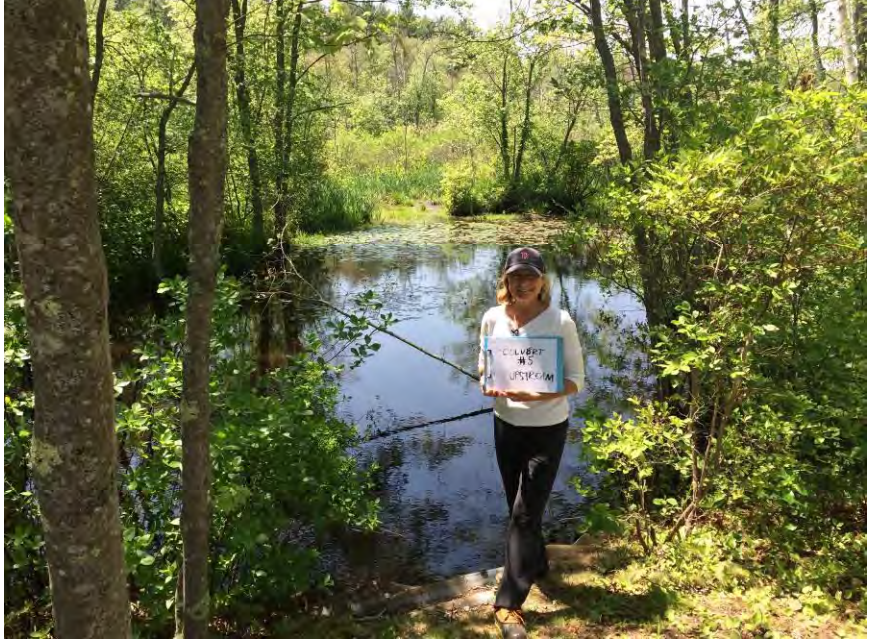
Tighe&Bond		PHOTOGRAPHIC LOG	
Client Name: Manchester-by-the Sea, MA		Site Location: Sawmill Brook Watershed, Old Manchester Rd. Culvert #5	Project No. M-1476
Photo No. 1	Date: 5/30/15

Direction Photo Taken: SW			
Description: Sawmill Brook. View looking upstream from culvert-Cedar Swamp

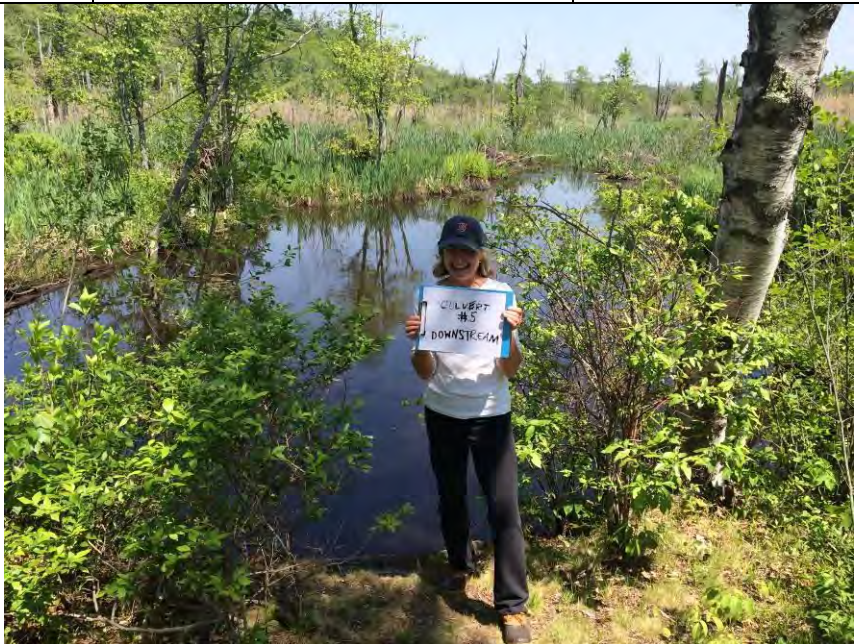
Tighe&Bond		PHOTOGRAPHIC LOG	
Client Name: Manchester-by-the Sea, MA		Site Location: Sawmill Brook Watershed, Old Manchester Rd. Culvert #5	Project No. M-1476
Photo No. 2	Date: 5/30/15

Direction Photo Taken: SW			
Description: Sawmill Brook. View looking downstream from culvert Cedar Swamp

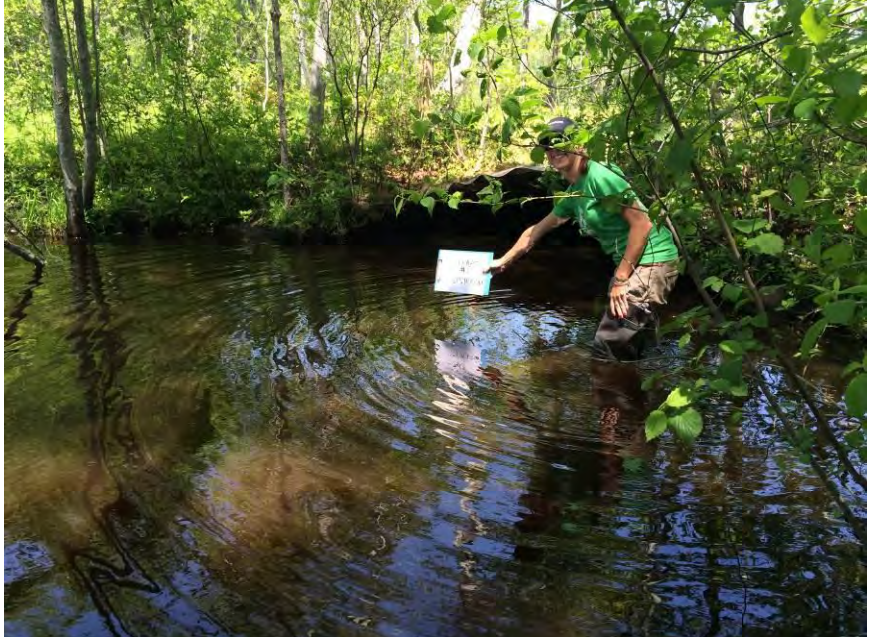
Tighe&Bond		PHOTOGRAPHIC LOG	
Client Name: Manchester-by-the Sea, MA		Site Location: Sawmill Brook Watershed, Old Manchester Rd. Culvert #5	Project No. M-1476
Photo No. 3	Date: 5/30/15

Direction Photo Taken: NE			
Description: Sawmill Brook. View of culvert inlet looking downstream into inlet

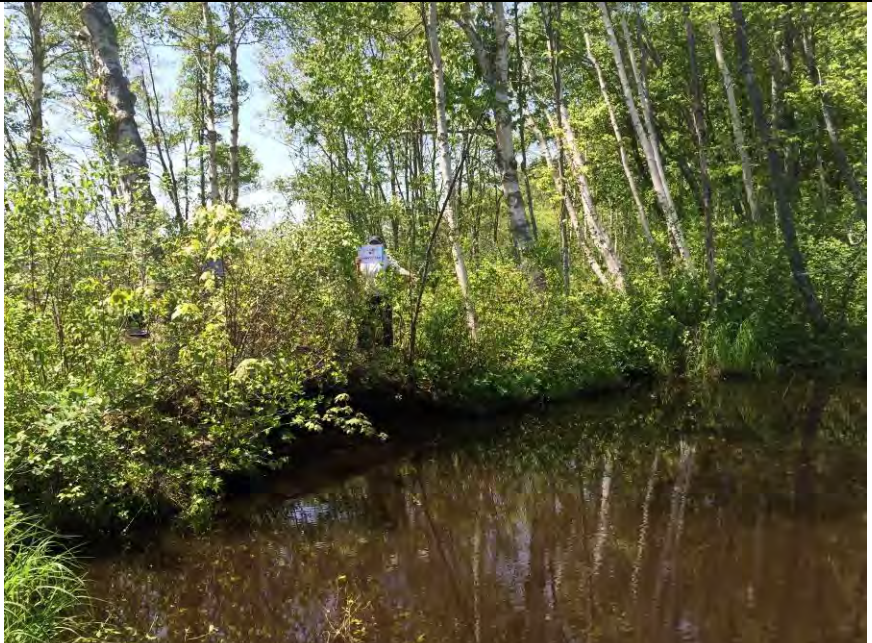
Tighe&Bond		PHOTOGRAPHIC LOG	
Client Name: Manchester-by-the Sea, MA		Site Location: Sawmill Brook Watershed, Old Manchester Rd. Culvert #5	Project No. M-1476
Photo No. 4	Date: 5/30/15

Direction Photo Taken: SW			
Description: Sawmill Brook. View culvert outlet looking upstream.

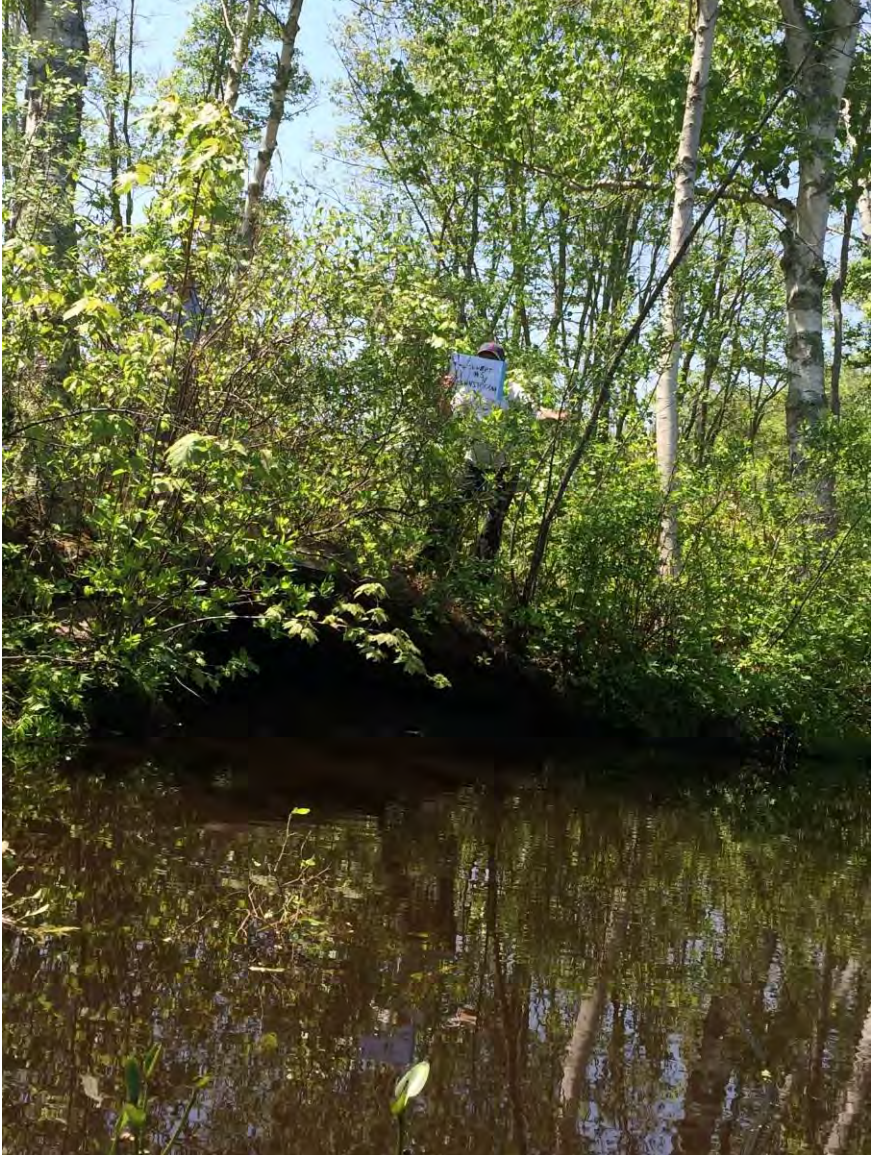
Tighe&Bond		PHOTOGRAPHIC LOG	
Client Name: Manchester-by-the Sea, MA		Site Location: Sawmill Brook Watershed, Old Manchester Rd. Culvert #5	Project No. M-1476
Photo No. 5	Date: 5/30/15

Direction Photo Taken: SW			
Description: Sawmill Brook. View of culvert outlet – looking upstream into culvert.

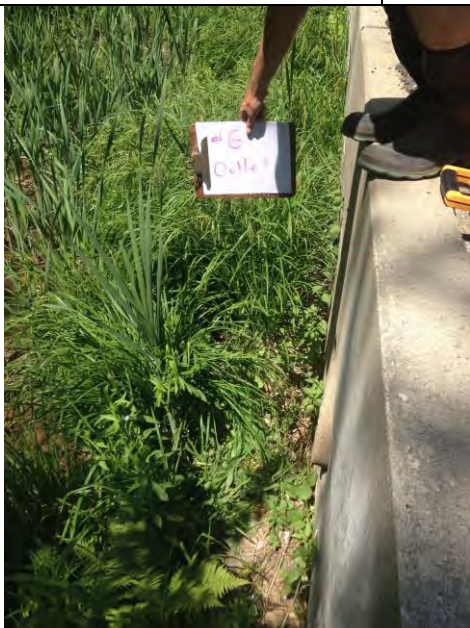
Tighe&Bond		PHOTOGRAPHIC LOG	
Client Name: Manchester-by-the Sea, MA		Site Location: Sawmill Brook Watershed, Kit Glass Dr. Culvert #6	Project No. M-1476
Photo No. 2	Date: 5/30/15

Direction Photo Taken: SW			
Description: Outlet downstream. Culvert is raised in concrete road crossing above base of wetland. Wetland was dry.

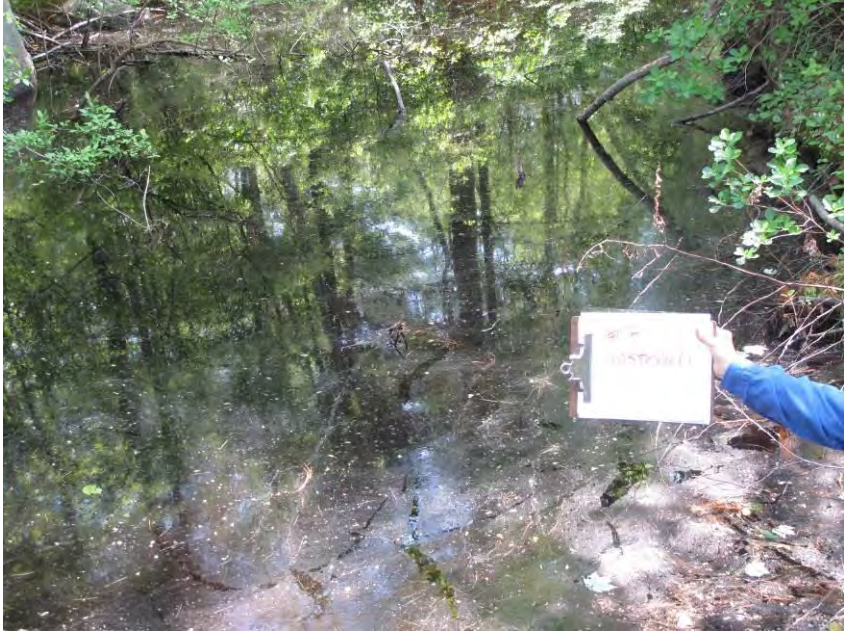
Tighe&Bond		PHOTOGRAPHIC LOG	
Client Name: Manchester-by-the Sea, MA		Site Location: Sawmill Brook Watershed, Forest Lane Culvert #7	Project No. M-1476
Photo No. 1	Date: 5/30/15

Direction Photo Taken: SE			
Description: East Cat Brook. View upstream from culvert. Bacterial film present.

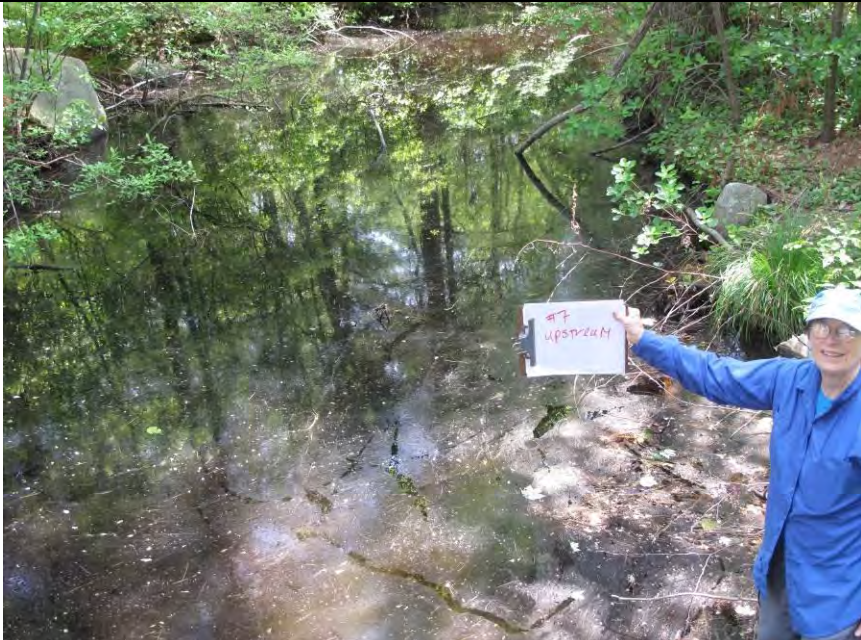
Tighe&Bond		PHOTOGRAPHIC LOG	
Client Name: Manchester-by-the Sea, MA		Site Location: Sawmill Brook Watershed, Forest Lane Culvert #7	Project No. M-1476
Photo No. 2	Date: 5/30/15

Direction Photo Taken: SE			
Description: East Cat Brook. View upstream from culvert.

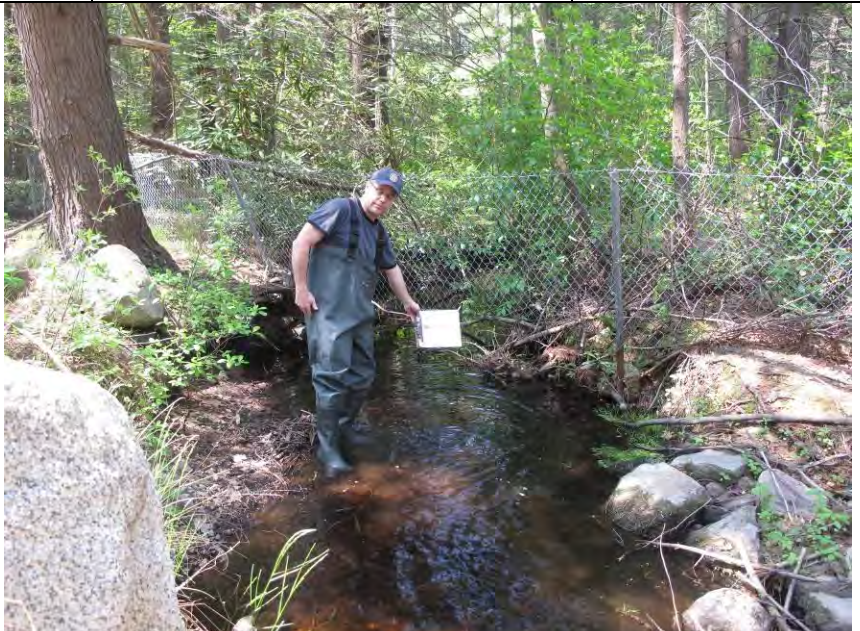
Tighe&Bond		PHOTOGRAPHIC LOG	
Client Name: Manchester-by-the Sea, MA		Site Location: Sawmill Brook Watershed, Forest Lane Culvert #7	Project No. M-1476
Photo No. 4	Date: 5/30/15

Direction Photo Taken: NW			
Description: East Cat Brook. View downstream from culvert outlet

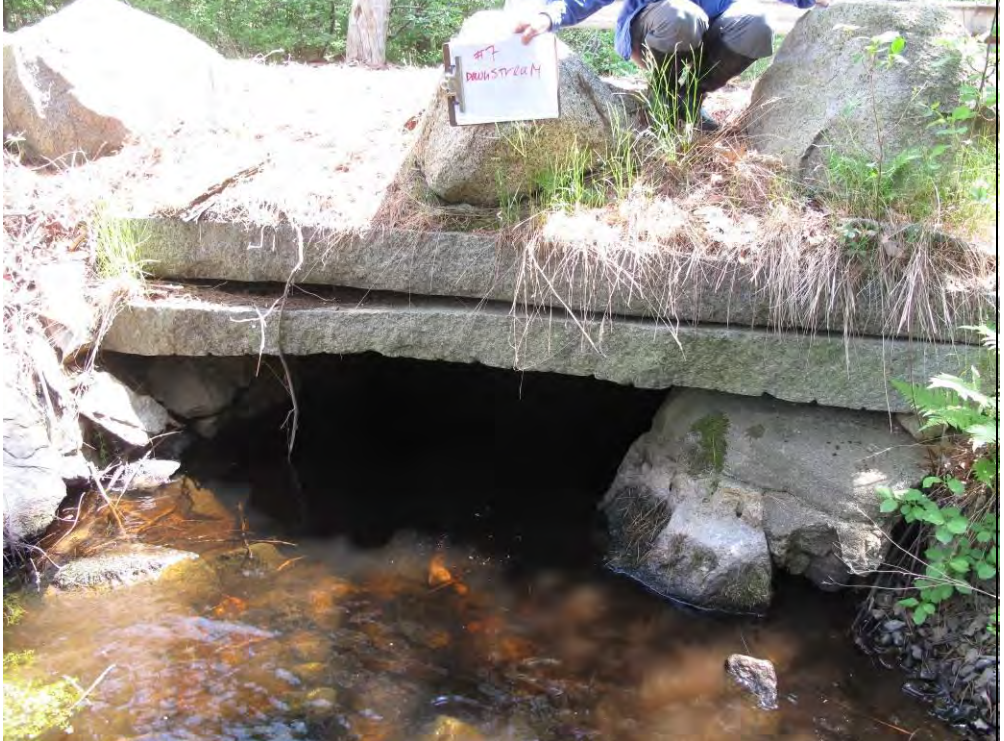
Tighe&Bond		PHOTOGRAPHIC LOG	
Client Name: Manchester-by-the Sea, MA		Site Location: Sawmill Brook Watershed, Forest Lane Culvert #7	Project No. M-1476
Photo No. 5	Date: 5/30/15

Direction Photo Taken: SE			
Description: East Cat Brook, View of the culvert outlet. Looking upstream.

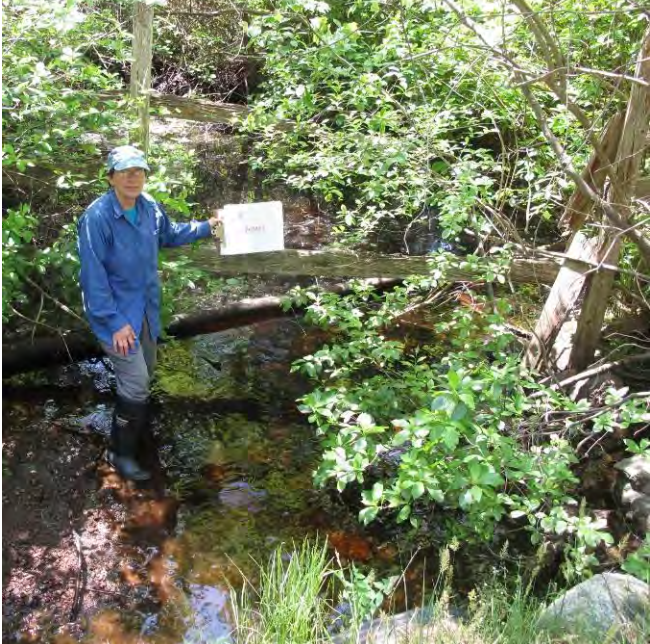
Tighe&Bond		PHOTOGRAPHIC LOG	
Client Name: Manchester-by-the Sea, MA		Site Location: Sawmill Brook Watershed, Loading Place Rd. Culvert #8	Project No. M-1476
Photo No. 1	Date: 5/30/15

Direction Photo Taken: SE			
Description: East Cat Brook. View upstream from culvert inlet.

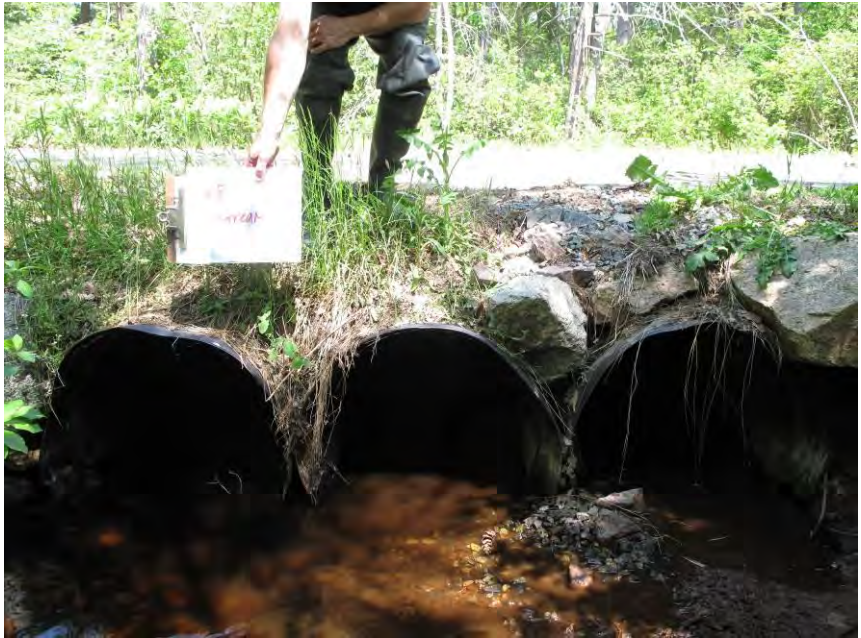
Tighe&Bond		PHOTOGRAPHIC LOG	
Client Name: Manchester-by-the Sea, MA		Site Location: Sawmill Brook Watershed, Loading Place Rd. Culvert #8	Project No. M-1476
Photo No. 2	Date: 5/30/15

Direction Photo Taken: NW			
Description: East Cat Brook. View into culvert inlets, looking downstream.

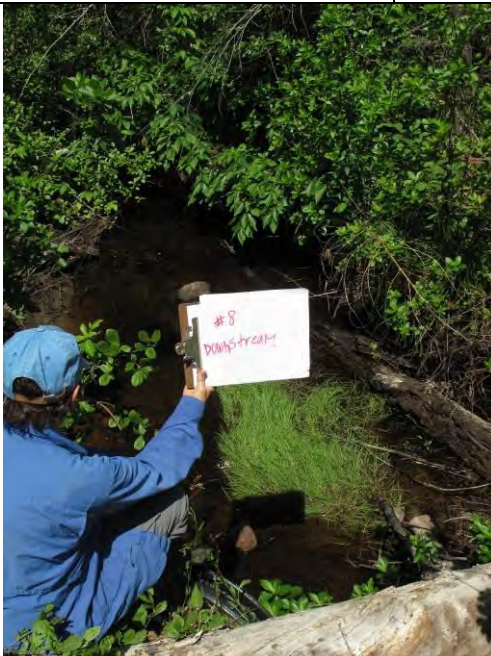
Tighe&Bond		PHOTOGRAPHIC LOG	
Client Name: Manchester-by-the Sea, MA		Site Location: Sawmill Brook Watershed, Loading Place Rd. Culvert #8	Project No. M-1476
Photo No. 4	Date: 5/30/15

Direction Photo Taken: NW			
Description: East Cat Brook. Downstream view from culvert.

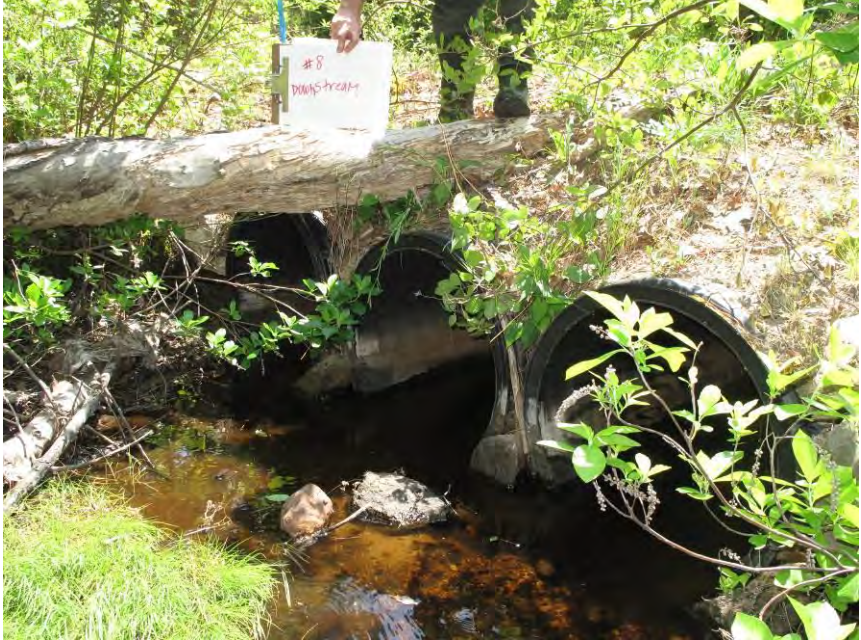
Tighe&Bond		PHOTOGRAPHIC LOG	
Client Name: Manchester-by-the Sea, MA		Site Location: Sawmill Brook Watershed, Loading Place Rd. Culvert #8	Project No. M-1476
Photo No. 5	Date: 5/30/15

Direction Photo Taken: SE			
Description: East Cat Brook. View looking upstream into the culvert outlets.

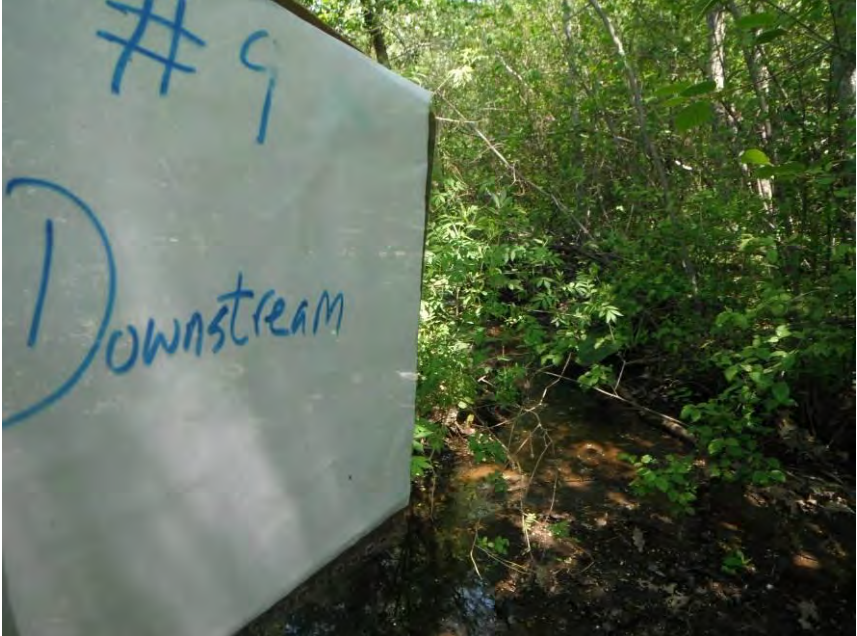
Tighe&Bond		PHOTOGRAPHIC LOG	
Client Name: Manchester-by-the Sea, MA		Site Location: Sawmill Brook Watershed, Pine Street Culvert #9	Project No. M-1476
Photo No. 1	Date: 5/30/15

Direction Photo Taken: N			
Description: Sawmill Brook. Downstream view.

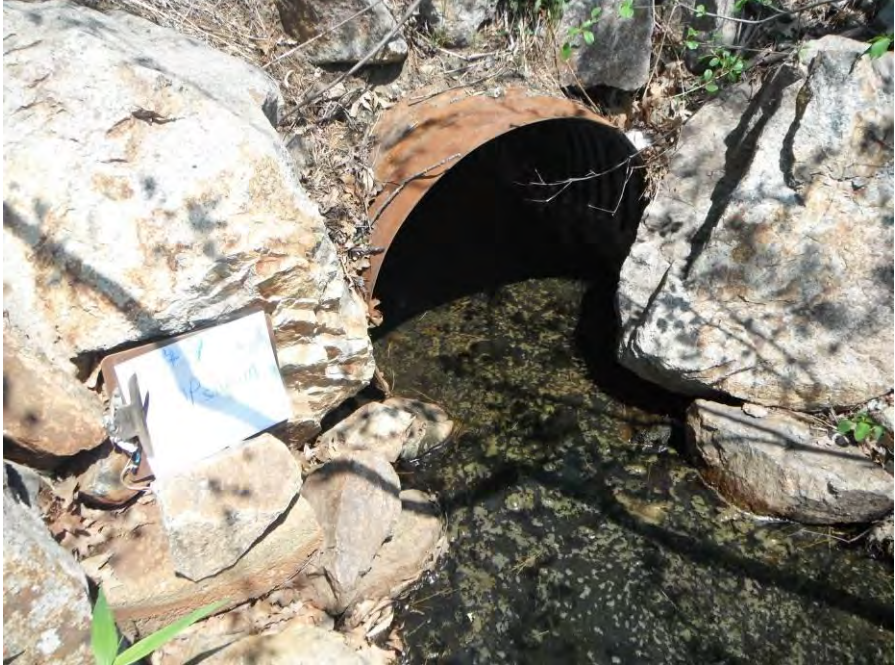
Tighe&Bond		PHOTOGRAPHIC LOG	
Client Name: Manchester-by-the Sea, MA		Site Location: Sawmill Brook Watershed, Pine Street Culvert #9	Project No. M-1476
Photo No. 2	Date: 5/30/15

Direction Photo Taken: N			
Description: Sawmill Brook. Upstream inlet -

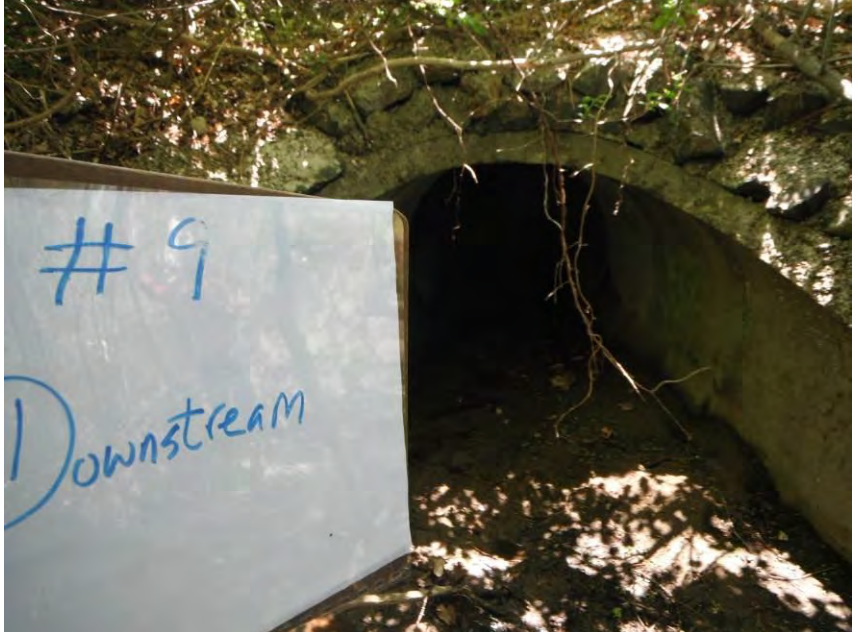
Tighe&Bond		PHOTOGRAPHIC LOG	
Client Name: Manchester-by-the Sea, MA		Site Location: Sawmill Brook Watershed, Pine Street Culvert #9	Project No. M-1476
Photo No. 3	Date: 5/30/15

Direction Photo Taken: S			
Description: Sawmill Brook. View into culvert outlet.

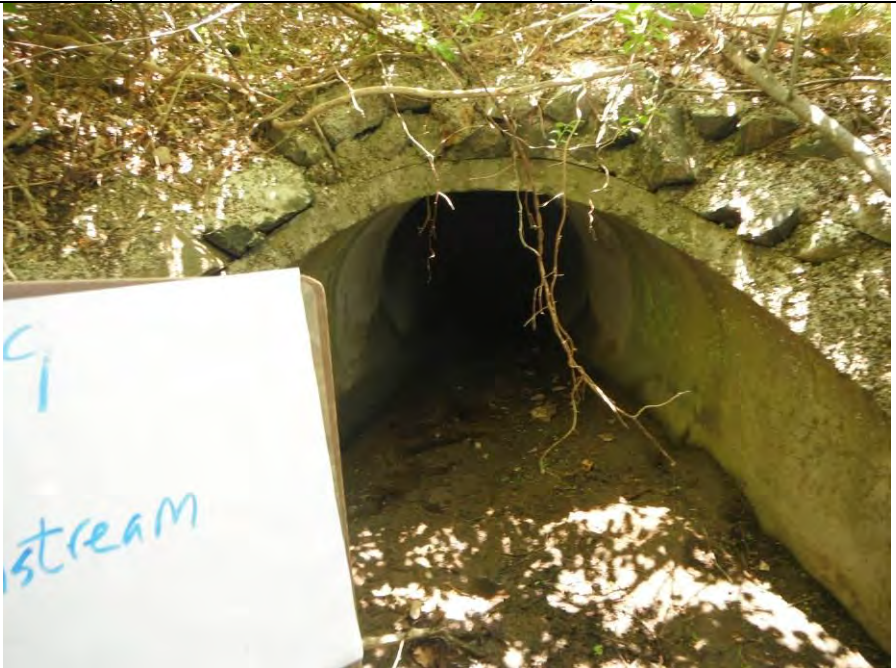
Tighe&Bond		PHOTOGRAPHIC LOG	
Client Name: Manchester-by-the Sea, MA		Site Location: Sawmill Brook Watershed, Pine Street Culvert #9	Project No. M-1476
Photo No. 4	Date: 5/30/15

Direction Photo Taken: S			
Description: Sawmill Brook. View of dry, sediment in first outlet.

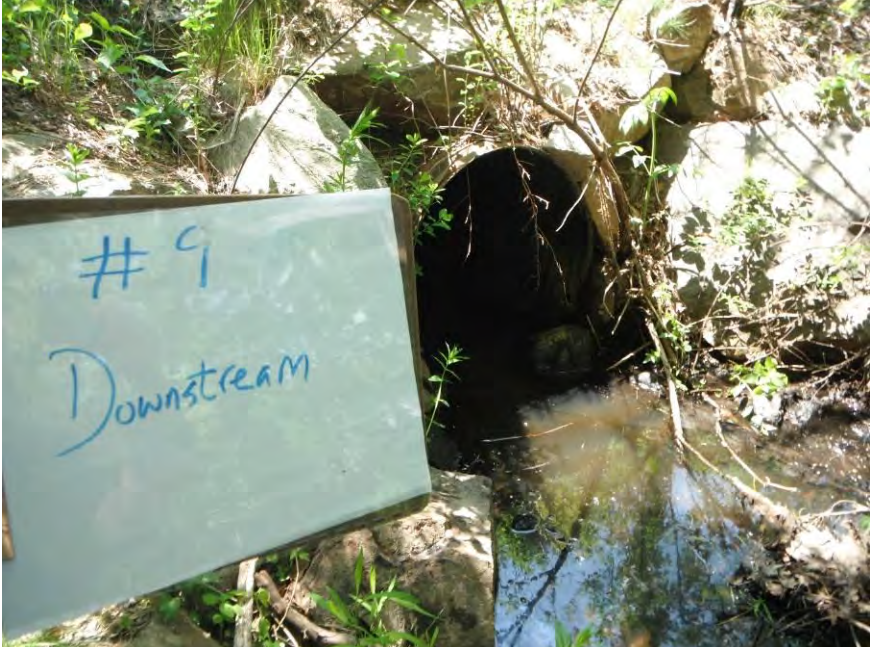
Tighe&Bond		PHOTOGRAPHIC LOG	
Client Name: Manchester-by-the Sea, MA		Site Location: Sawmill Brook Watershed, Pine Street Culvert #9	Project No. M-1476
Photo No. 5	Date: 5/30/15

Direction Photo Taken: S			
Description: View of second outlet. View is looking upstream.

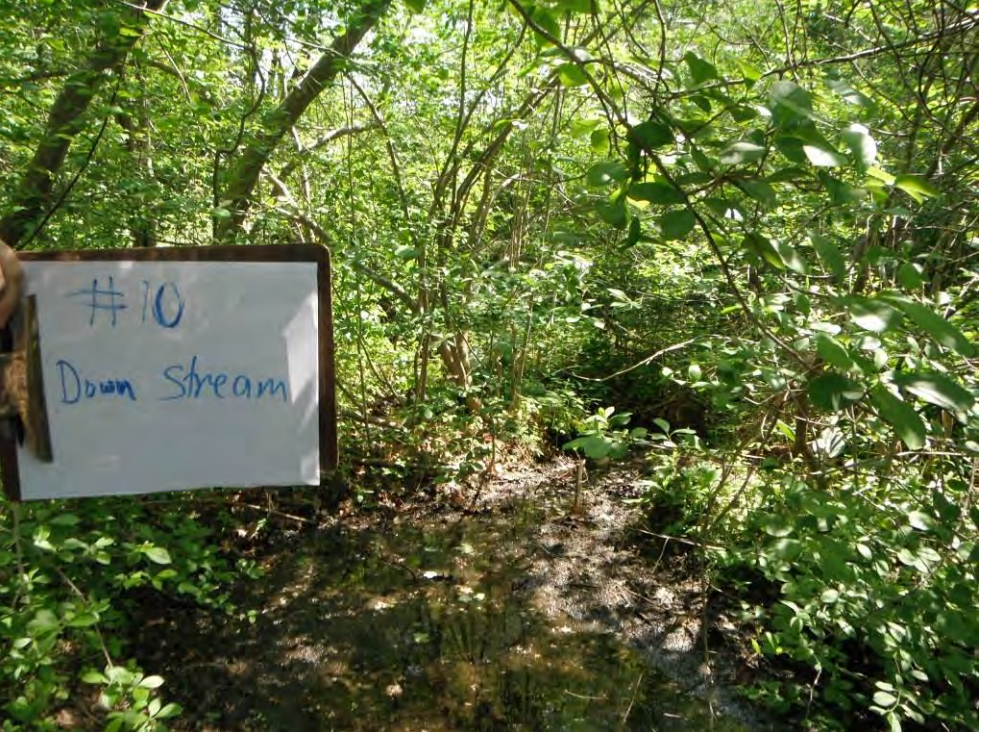
Tighe&Bond		PHOTOGRAPHIC LOG	
Client Name: Manchester-by-the Sea, MA		Site Location: Sawmill Brook Watershed, Rockwood Heights Rd. Culvert #10	Project No. M-1476
Photo No. 1	Date: 5/30/15

Direction Photo Taken: NE			
Description: Sawmill Brook. View downstream.

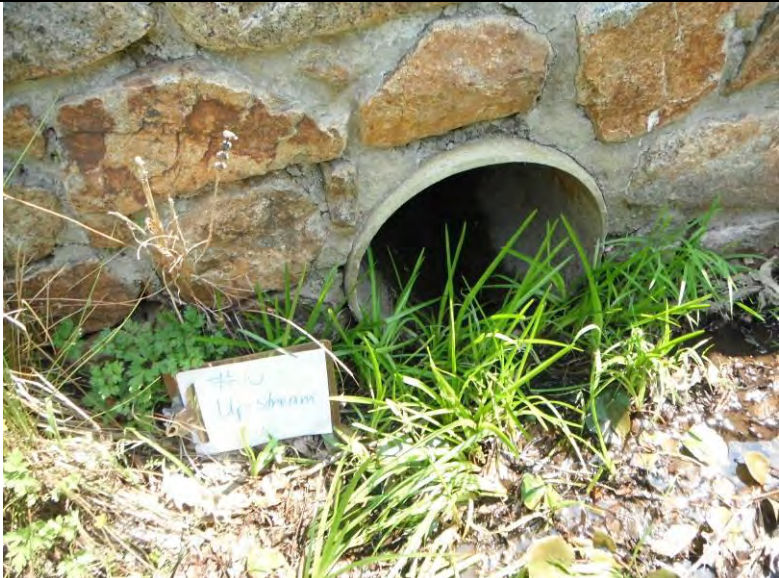
Tighe&Bond		PHOTOGRAPHIC LOG	
Client Name: Manchester-by-the Sea, MA		Site Location: Sawmill Brook Watershed, Rockwood Heights Rd. Culvert #10	Project No. M-1476
Photo No. 2	Date: 5/30/15

Direction Photo Taken: NE			
Description: Sawmill Brook, View of left culvert inlet.

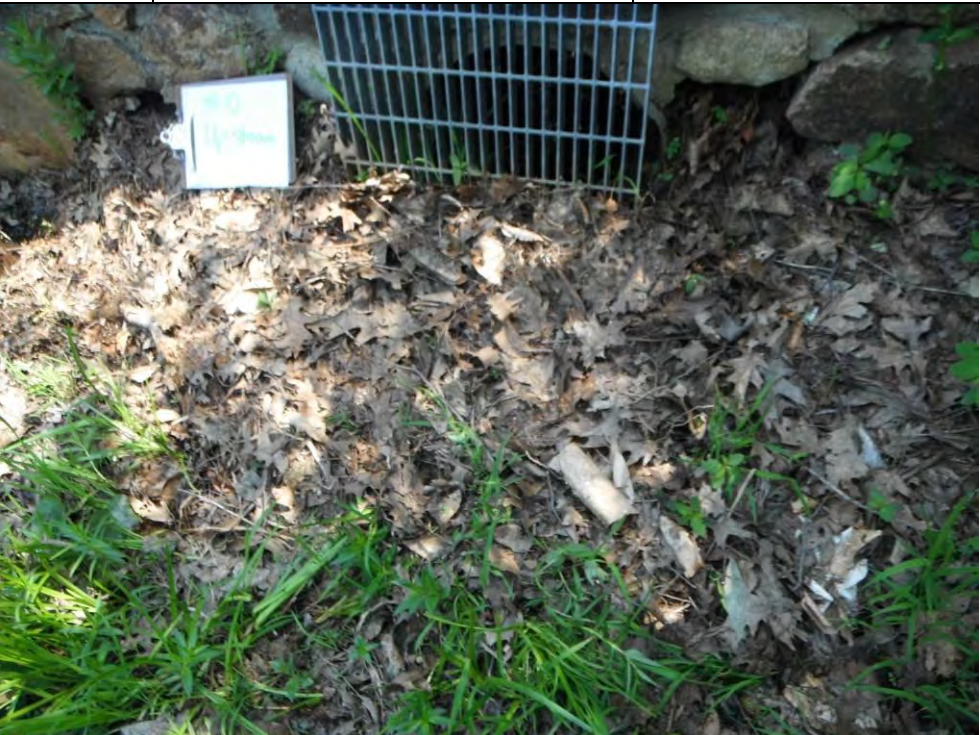
Tighe&Bond		PHOTOGRAPHIC LOG	
Client Name: Manchester-by-the Sea, MA		Site Location: Sawmill Brook Watershed, Rockwood Heights Rd. Culvert #10	Project No. M-1476
Photo No. 3	Date: 5/30/15

Direction Photo Taken: NE			
Description: Sawmill Brook. View of right culvert inlet with beaver guard.

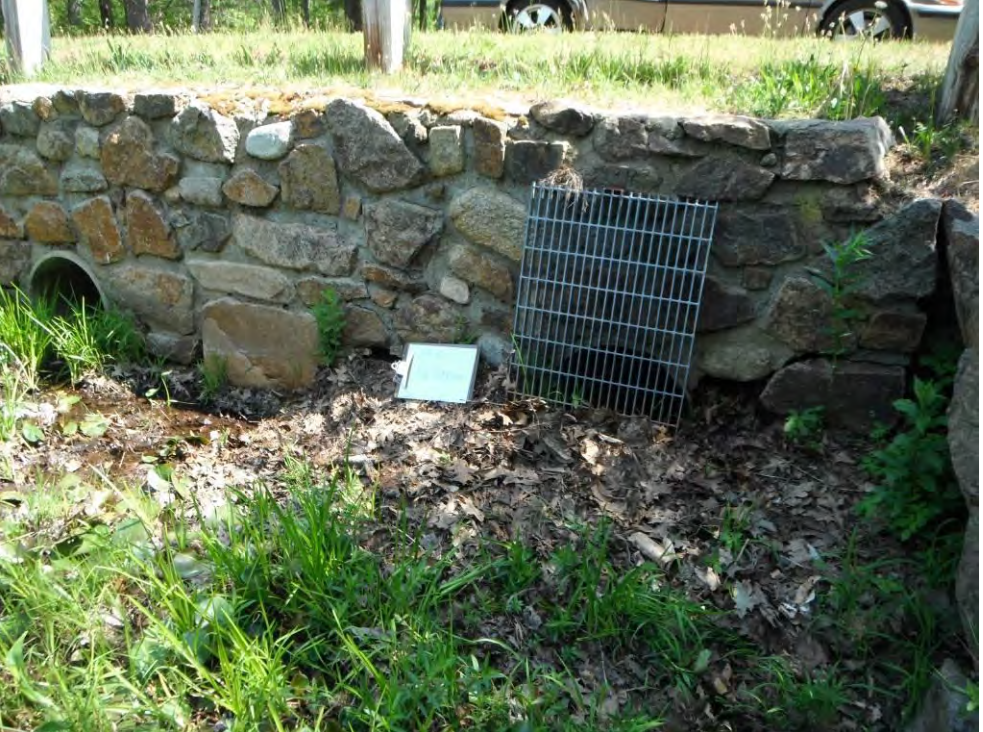
Tighe&Bond		PHOTOGRAPHIC LOG	
Client Name: Manchester-by-the Sea, MA		Site Location: Sawmill Brook Watershed, Rockwood Heights Rd. Culvert #10	Project No. M-1476
Photo No. 5	Date: 5/30/15

Direction Photo Taken: N			
Description: Sawmill Brook. View of both inlets.
