Manchester-by-the-Sea, Massachusetts

Stream Crossing Evaluation, Sawmill Brook Watershed

Stream Crossing Evaluation in Sawmill Brook Watershed

TO: Mary Reilly, Manchester-by-the-Sea Grants Administrator
FROM: Gabrielle C. Belfit, Janet Moonan; Tighe & Bond
COPY: M. Gregory Federspiel, Town Administrator
David A. Murphy, P.E. Vice President, Tighe & Bond
DATE: July 28, 2015

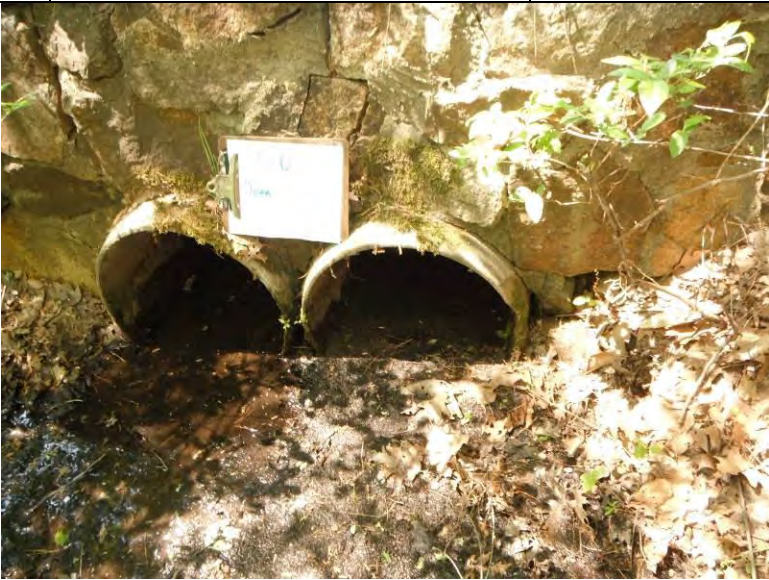
Tighe&Bond		PHOTOGRAPHIC LOG	
Client Name: Manchester-by-the Sea, MA		Site Location: Sawmill Brook Watershed, Rockwood Heights Rd. Culvert #10	Project No. M-1476
Photo No. 6	Date: 5/30/15

Direction Photo Taken: SW			
Description: Sawmill Brook. View of culvert outlets. Looking upstream.

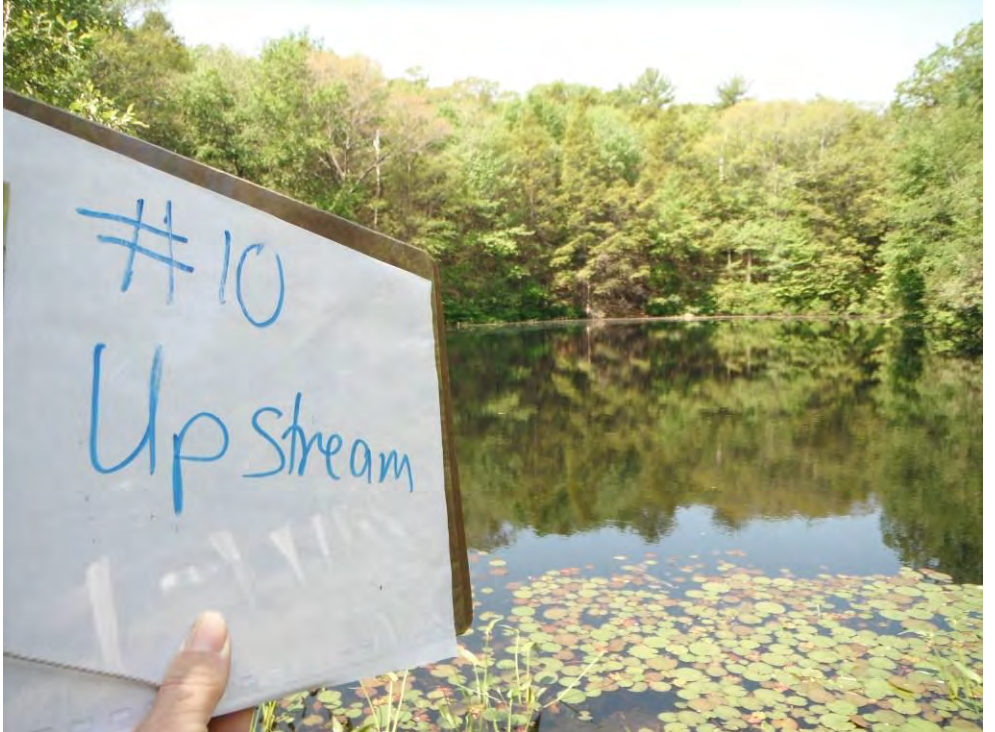
Tighe&Bond		PHOTOGRAPHIC LOG	
Client Name: Manchester-by-the Sea, MA		Site Location: Sawmill Brook Watershed, Rockwood Heights Rd. Culvert #10	Project No. M-1476
Photo No. 7	Date: 5/30/15

Direction Photo Taken: SW			
Description: Sawmill Brook. View upstream.

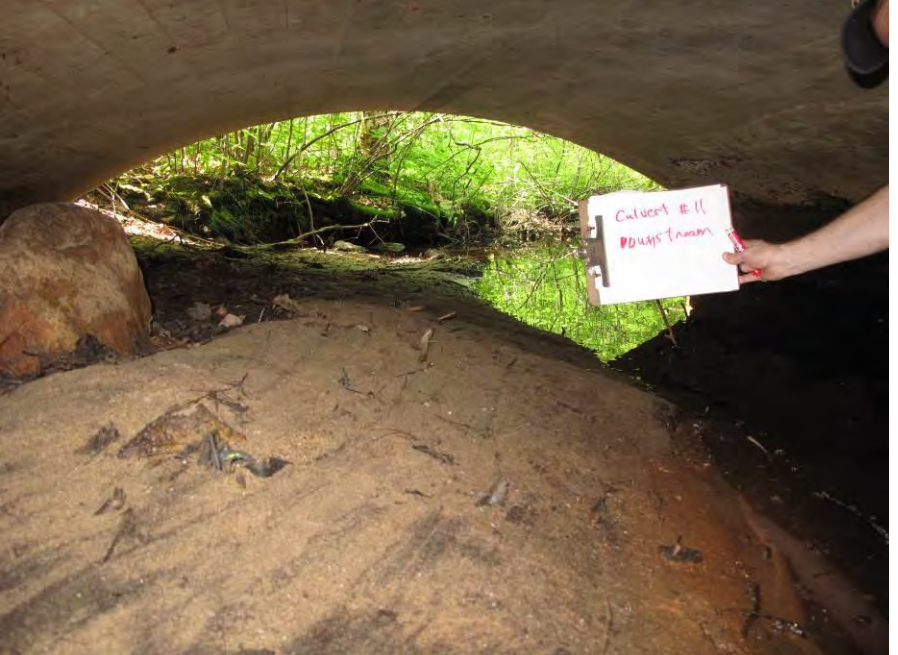
Tighe&Bond		PHOTOGRAPHIC LOG	
Client Name: Manchester-by-the Sea, MA		Site Location: Sawmill Brook Watershed, Mill Street Culvert #11	Project No. M-1476
Photo No. 3	Date: 5/30/15

Direction Photo Taken: SW			
Description: Cat Brook. View inside culvert, looking downstream towards outlet..

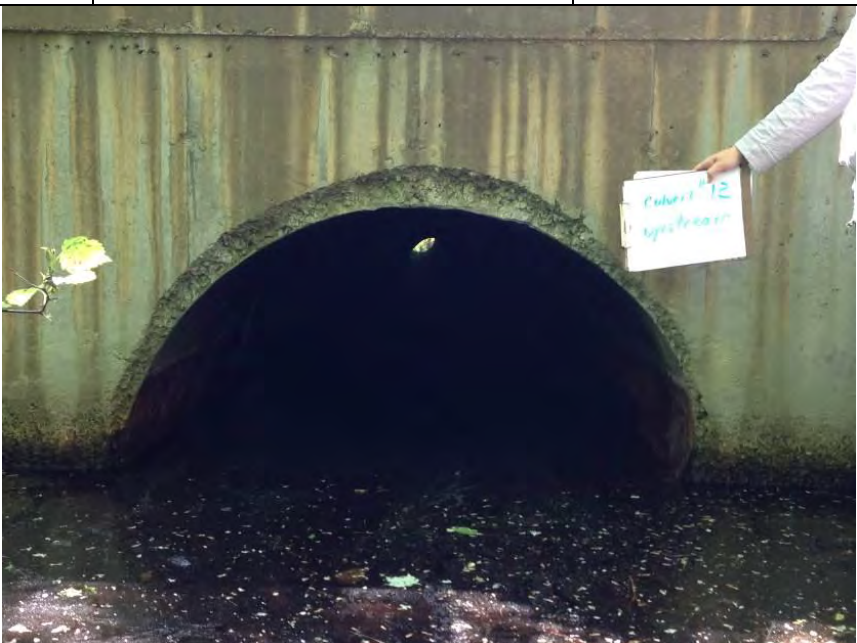
Tighe&Bond		PHOTOGRAPHIC LOG	
Client Name: Manchester-by-the Sea, MA		Site Location: Sawmill Brook Watershed, Millets Ln. Culvert #12	Project No. M-1476
Photo No. 2	Date: 5/30/15

Direction Photo Taken: NW			
Description: Sawmill Brook. View of inlet looking downstream

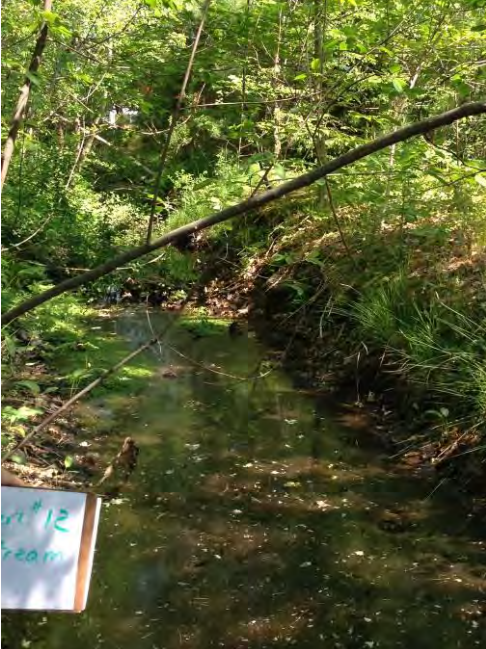
Tighe&Bond		PHOTOGRAPHIC LOG	
Client Name: Manchester-by-the Sea, MA		Site Location: Sawmill Brook Watershed, Millets Ln. Culvert #12	Project No. M-1476
Photo No. 3	Date: 5/30/15

Direction Photo Taken: S			
Description: Sawmill Brook. View upstream

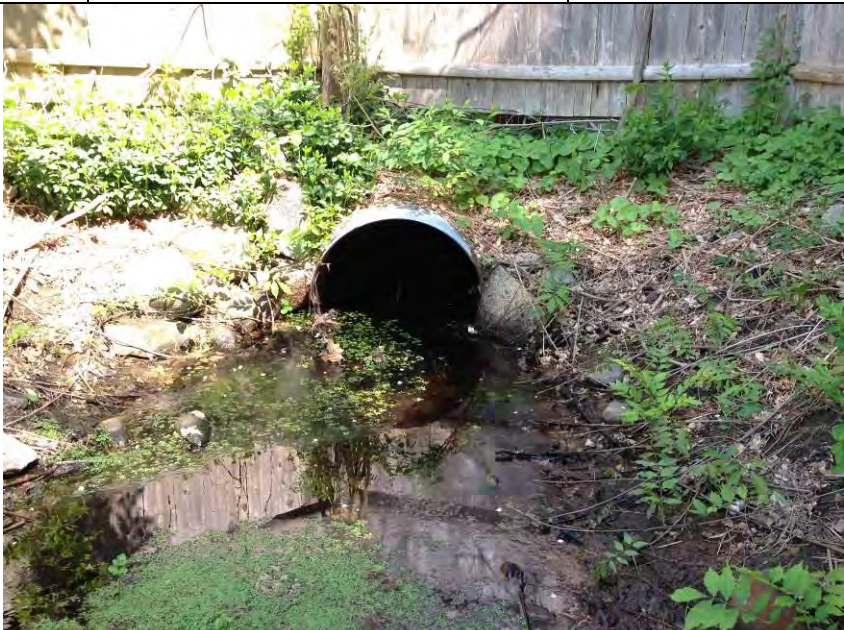
Tighe&Bond		PHOTOGRAPHIC LOG	
Client Name: Manchester-by-the Sea, MA		Site Location: Sawmill Brook Watershed, Millets Ln Culvert #12	Project No. M-1476
Photo No. 6	Date: 5/30/15

Direction Photo Taken: SE			
Description: Sawmill Brook. View of outlet, looking upstream.

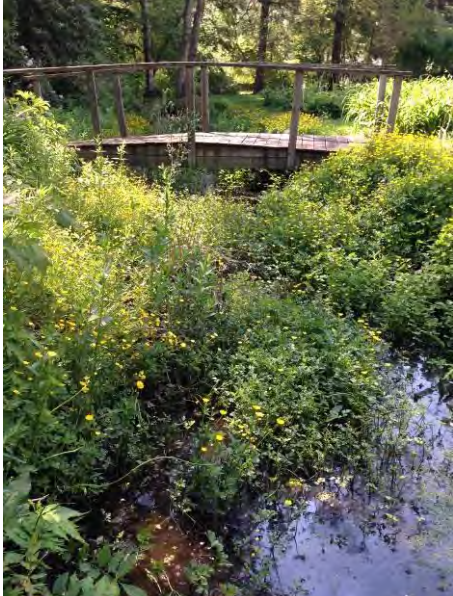
Tighe&Bond		PHOTOGRAPHIC LOG	
Client Name: Manchester-by-the Sea, MA		Site Location: Sawmill Brook Watershed, Millets Ln Culvert #12	Project No. M-1476
Photo No. 7	Date: 5/30/15

Direction Photo Taken: NW			
Description: Sawmill Brook. View downstream

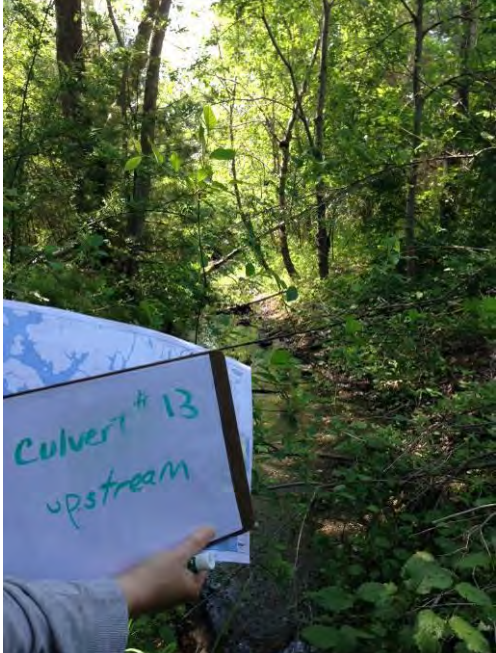
Tighe&Bond		PHOTOGRAPHIC LOG	
Client Name: Manchester-by-the Sea, MA		Site Location: Sawmill Brook Watershed, The Plains Culvert #13	Project No. M-1476
Photo No. 1	Date: 5/30/15

Direction Photo Taken: SE			
Description: Sawmill Brook. View upstream.

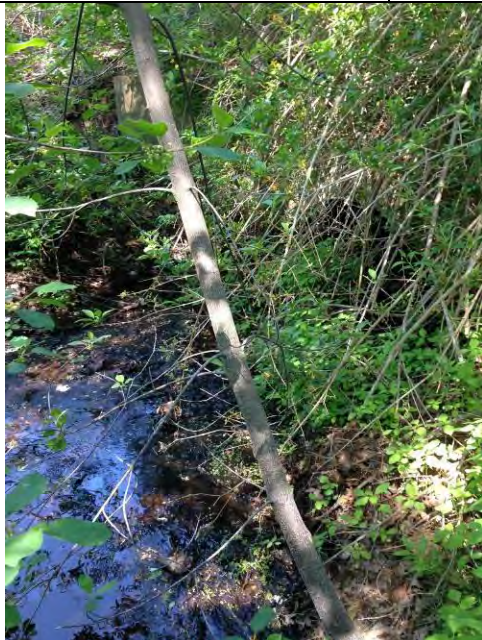
Tighe&Bond		PHOTOGRAPHIC LOG	
Client Name: Manchester-by-the Sea, MA		Site Location: Sawmill Brook Watershed, The Plains Culvert #13	Project No. M-1476
Photo No. 2	Date: 5/30/15

Direction Photo Taken: SE			
Description: Sawmill Brook. View upstream

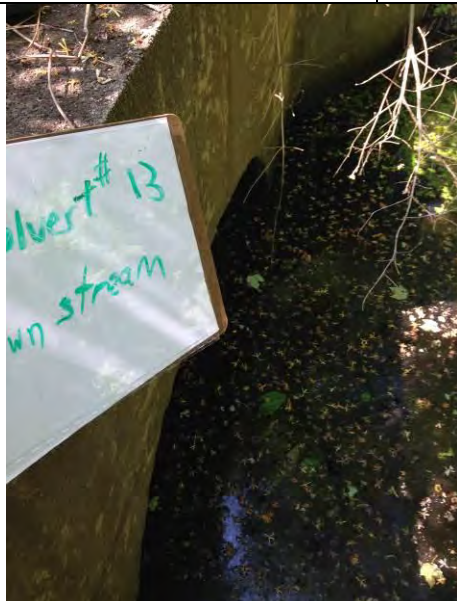
Tighe&Bond		PHOTOGRAPHIC LOG	
Client Name: Manchester-by-the Sea, MA		Site Location: Sawmill Brook Watershed, The Plains Culvert #13	Project No. M-1476
Photo No. 4	Date: 5/30/15

Direction Photo Taken: E			
Description: Sawmill Brook. View of outlet on downstream side.

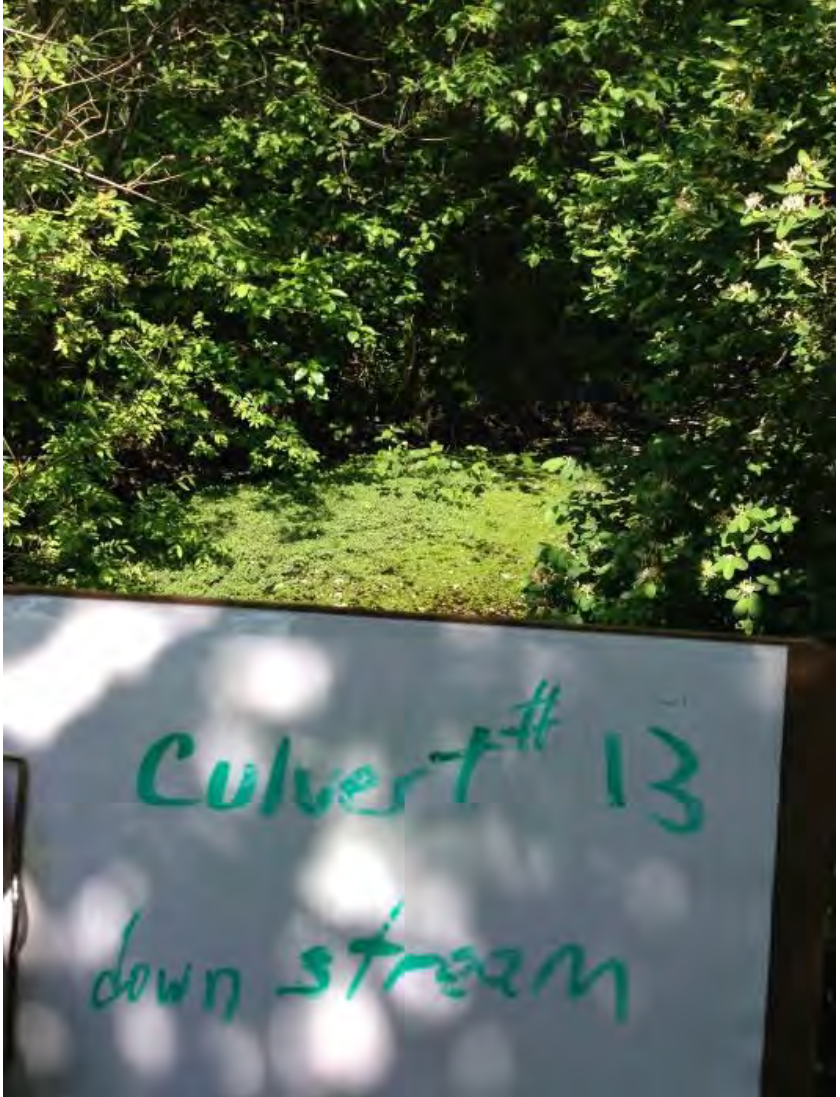
Tighe&Bond		PHOTOGRAPHIC LOG	
Client Name: Manchester-by-the Sea, MA		Site Location: Sawmill Brook Watershed, The Plains Culvert #13	Project No. M-1476
Photo No. 5	Date: 5/30/15

Direction Photo Taken: NW			
Description: Sawmill Brook. View downstream

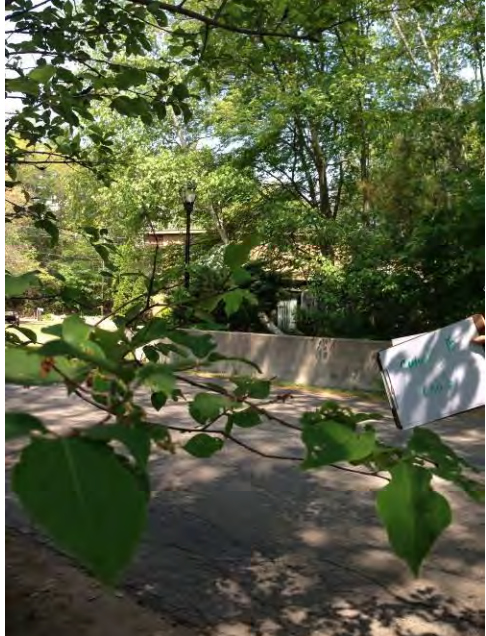
Tighe&Bond		PHOTOGRAPHIC LOG	
Client Name: Manchester-by-the Sea, MA		Site Location: Sawmill Brook Watershed, Blue Heron Ln. Culvert #15	Project No. M-1476
Photo No. 1	Date: 5/30/15

Direction Photo Taken: W			
Description: Blue Heron Lane

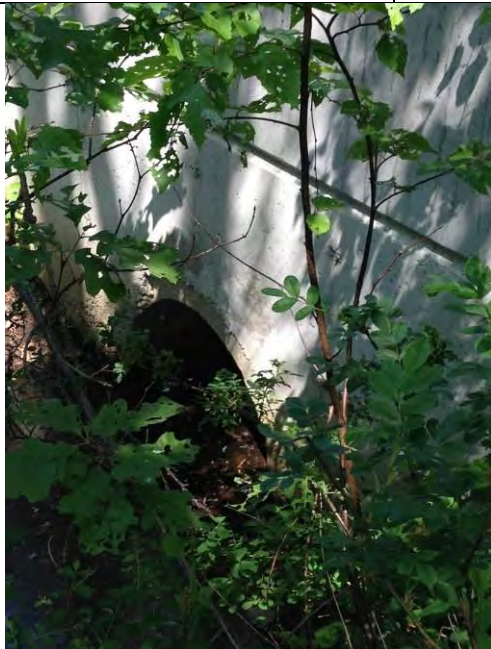
Tighe&Bond		PHOTOGRAPHIC LOG	
Client Name: Manchester-by-the Sea, MA		Site Location: Sawmill Brook Watershed, Blue Heron Ln. Culvert #15	Project No. M-1476
Photo No. 2	Date: 5/30/15

Direction Photo Taken: NE			
Description: Sawmill Brook. View upstream of inlet.

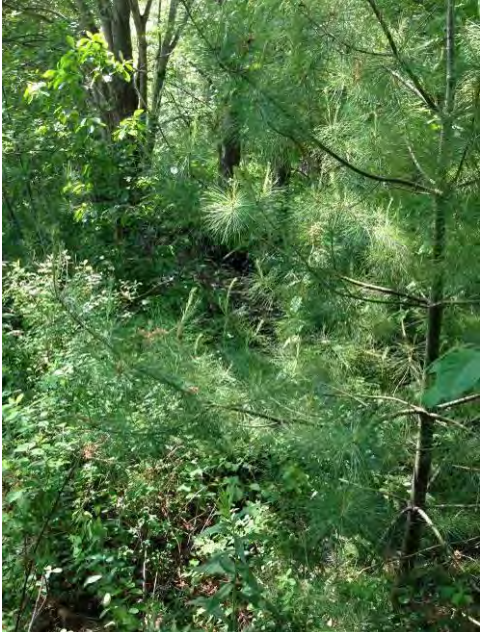
Tighe&Bond		PHOTOGRAPHIC LOG	
Client Name: Manchester-by-the Sea, MA		Site Location: Sawmill Brook Watershed, Blue Heron Ln. Culvert #15	Project No. M-1476
Photo No. 3	Date: 5/30/15

Direction Photo Taken: SE			
Description: Sawmill Brook. View upstream

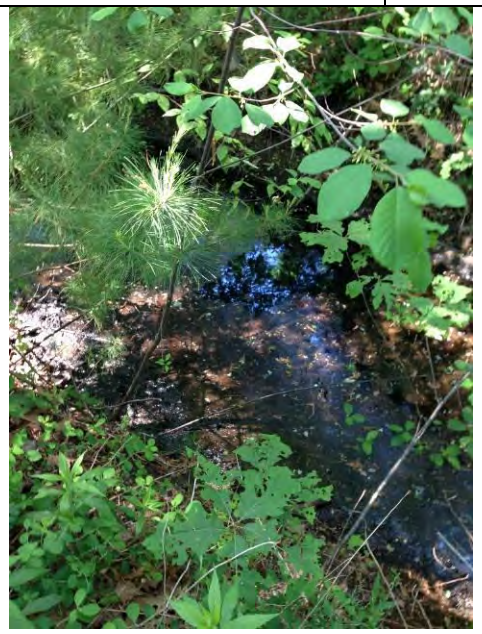
Tighe&Bond		PHOTOGRAPHIC LOG	
Client Name: Manchester-by-the Sea, MA		Site Location: Sawmill Brook Watershed, Blue Heron Ln. Culvert #15	Project No. M-1476
Photo No. 4	Date: 5/30/15

Direction Photo Taken: SE			
Description: Sawmill Brook. View upstream

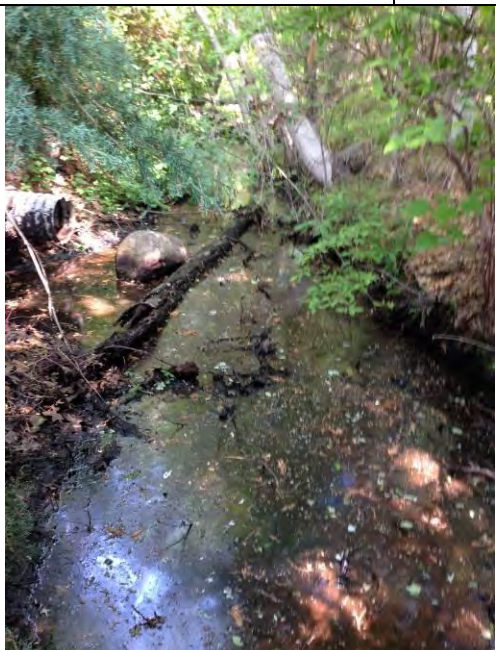
Tighe&Bond		PHOTOGRAPHIC LOG	
Client Name: Manchester-by-the Sea, MA		Site Location: Sawmill Brook Watershed, Blue Heron Ln. Culvert #15	Project No. M-1476
Photo No. 6	Date: 5/30/15

Direction Photo Taken: N			
Description: Sawmill Brook. View downstream.

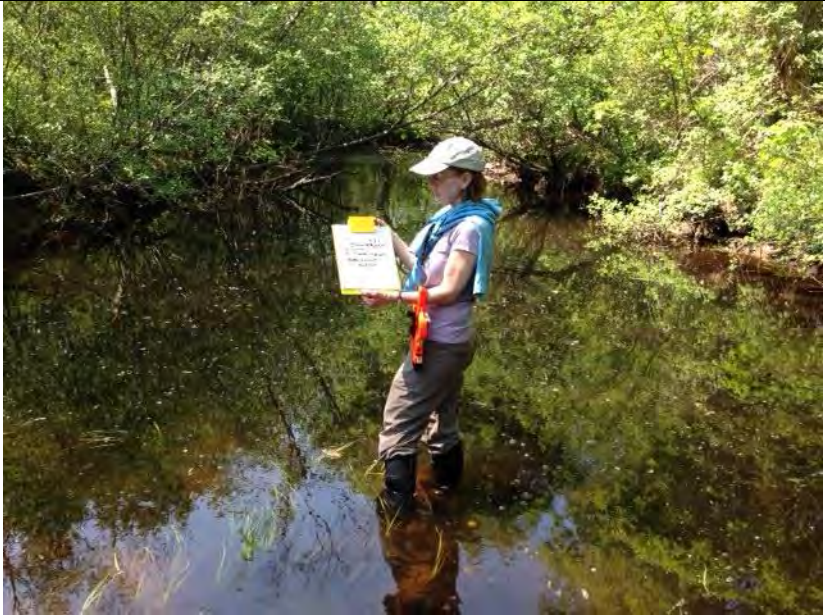
Tighe&Bond		PHOTOGRAPHIC LOG	
Client Name: Manchester-by-the Sea, MA		Site Location: Sawmill Brook Watershed, Lincoln Street Culvert #17	Project No. M-1476
Photo No. 1	Date: 5/30/15

Direction Photo Taken: S			
Description: Sawmill Brook Downstream From Outlet			
Tighe&Bond		PHOTOGRAPHIC LOG	
Client Name: Manchester-by-the Sea, MA		Site Location: Sawmill Brook Watershed, Lincoln Street Culvert #17	Project No. M-1476
Photo No. 2	Date: 5/30/15

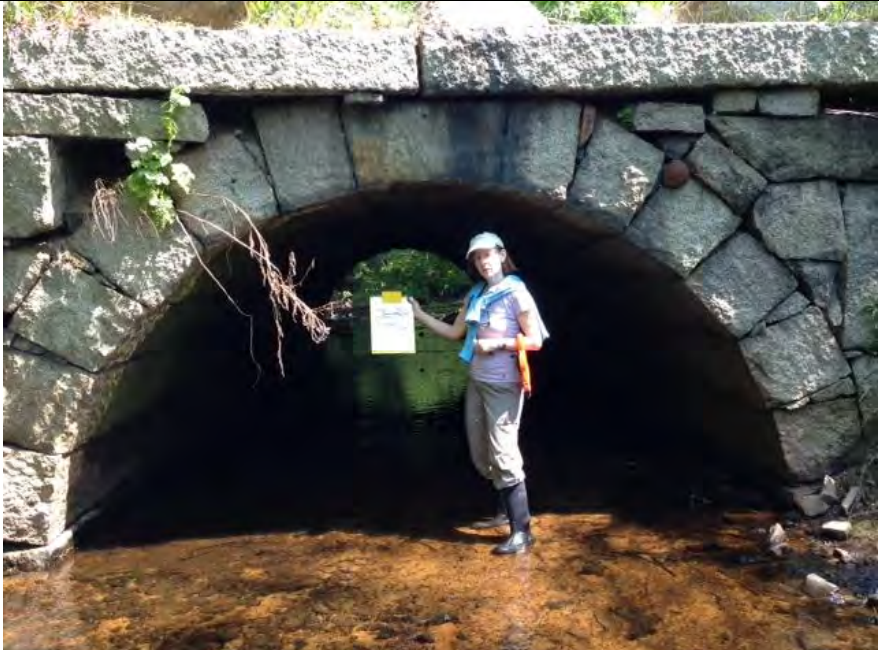
Direction Photo Taken: NE			
Description: Sawmill Brook. View of Culvert outlet looking upstream.

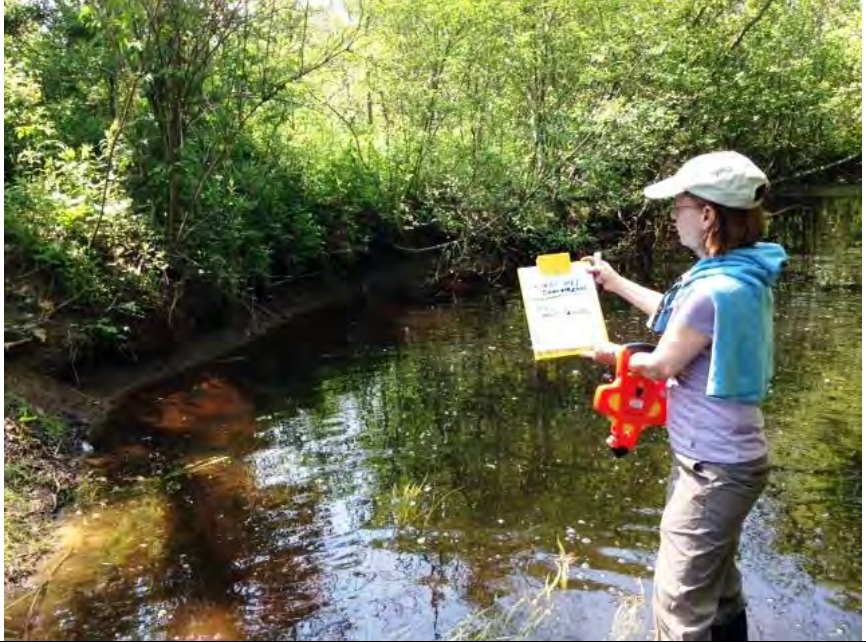
Tighe&Bond		PHOTOGRAPHIC LOG	
Client Name: Manchester-by-the Sea, MA		Site Location: Sawmill Brook Watershed, Lincoln Street Culvert #17	Project No. M-1476
Photo No. 3	Date: 5/30/15

Direction Photo Taken: SE			
Description: Sawmill Brook. Downstream bank undercut.			
Tighe&Bond		PHOTOGRAPHIC LOG	
Client Name: Manchester-by-the Sea, MA		Site Location: Sawmill Brook Watershed, Lincoln Street Culvert #17	Project No. M-1476
Photo No. 4	Date: 5/30/15

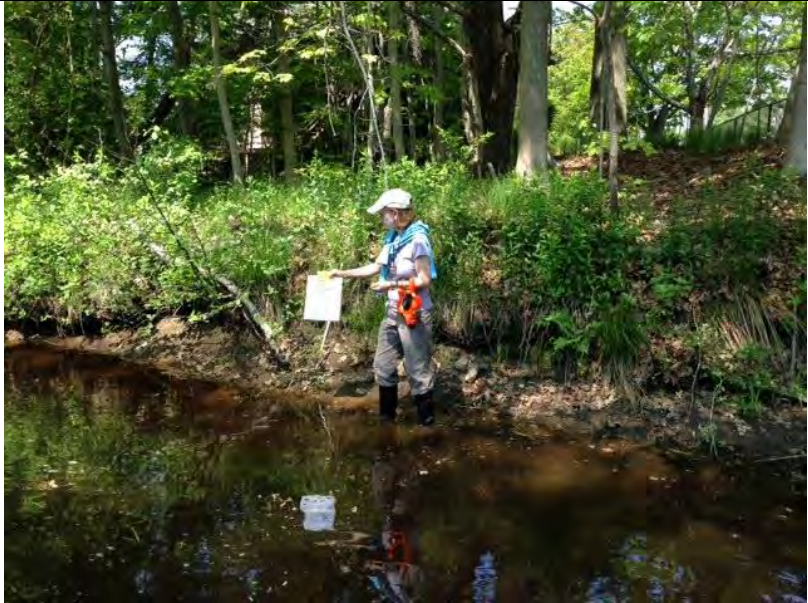
Direction Photo Taken: SE			
Description: Sawmill Brook. Downstream bank erosion.

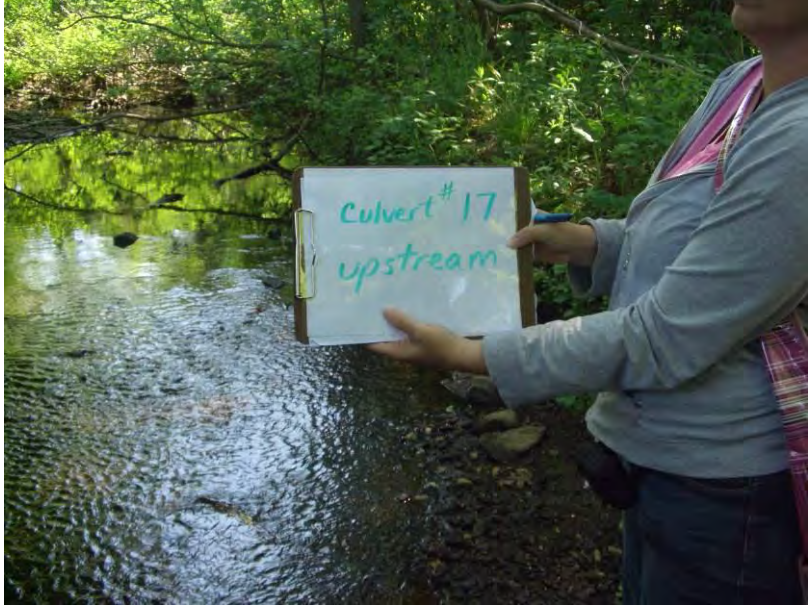
Tighe&Bond		PHOTOGRAPHIC LOG	
Client Name: Manchester-by-the Sea, MA		Site Location: Sawmill Brook Watershed, Lincoln Street Culvert #17	Project No. M-1476
Photo No. 5	Date: 5/30/15

Direction Photo Taken: NE			
Description: Sawmill Brook. View upstream.			
Tighe&Bond		PHOTOGRAPHIC LOG	
Client Name: Manchester-by-the Sea, MA		Site Location: Sawmill Brook Watershed, Lincoln Street Culvert #17	Project No. M-1476
Photo No. 6	Date: 5/30/15

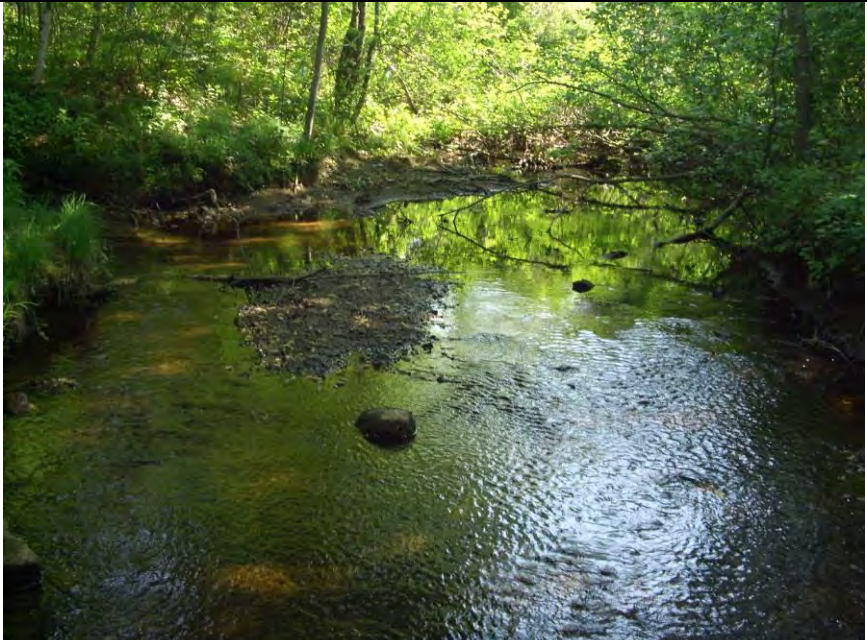
Direction Photo Taken: NE			
Description: Sawmill Brook. View upstream.

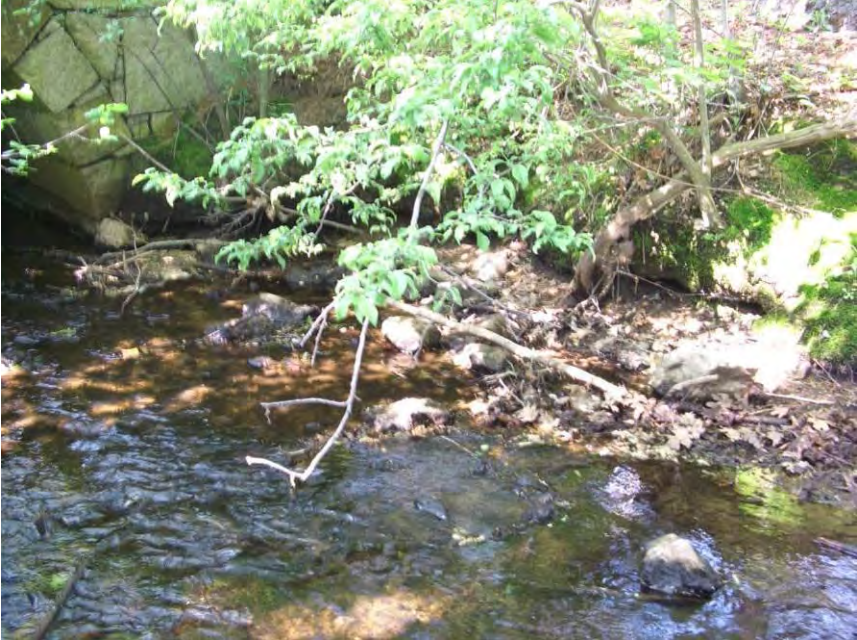
Tighe&Bond		PHOTOGRAPHIC LOG	
Client Name: Manchester-by-the Sea, MA		Site Location: Sawmill Brook Watershed, Lincoln Street Culvert #17	Project No. M-1476
Photo No. 7	Date: 5/30/15

Direction Photo Taken: SW			
Description: Sawmill brook Upstream. View of undercut bank.			
Tighe&Bond		PHOTOGRAPHIC LOG	
Client Name: Manchester-by-the Sea, MA		Site Location: Sawmill Brook Watershed, Lincoln Street Culvert #17	Project No. M-1476
Photo No. 8	Date: 5/30/15

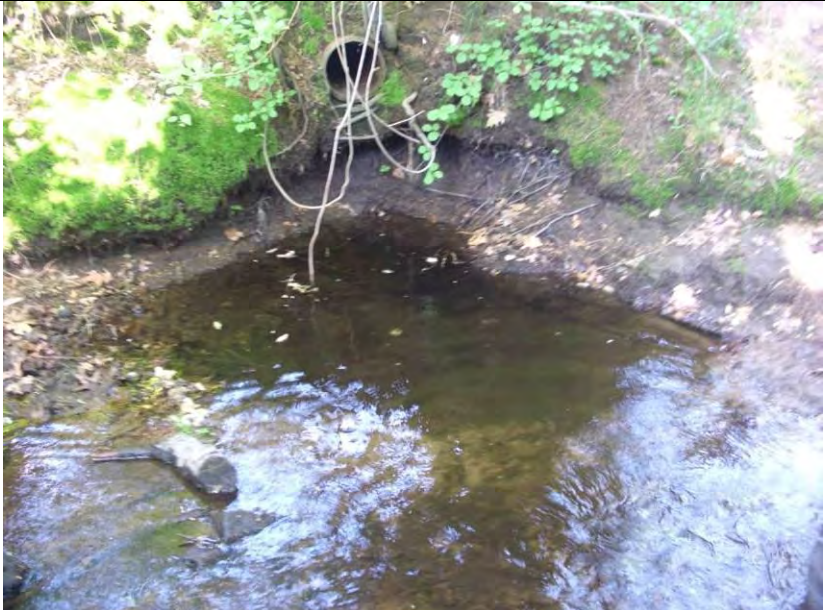
Direction Photo Taken: SW			
Description: Sawmill Brook. Upstream outfall scour and bank undercut

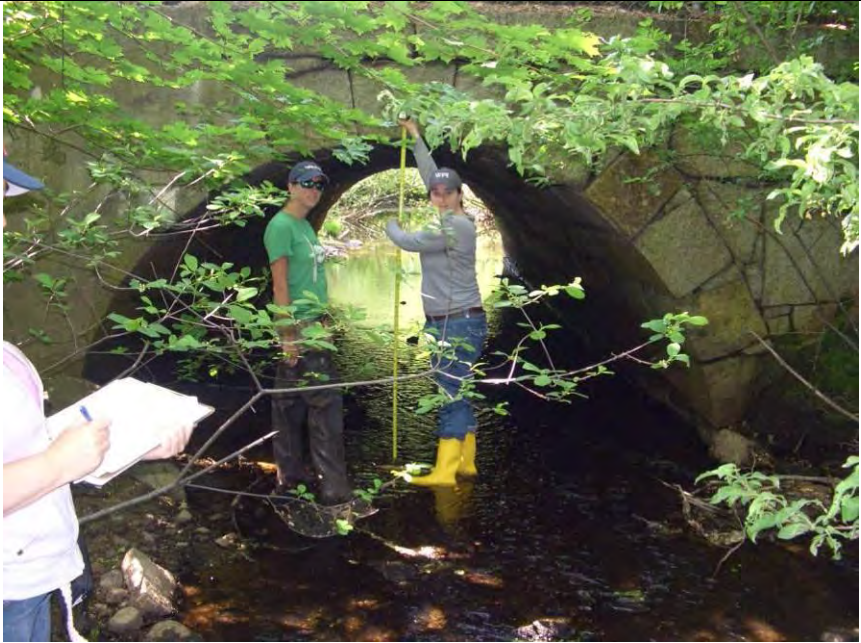
Tighe&Bond		PHOTOGRAPHIC LOG	
Client Name: Manchester-by-the Sea, MA		Site Location: Sawmill Brook Watershed, Lincoln Street Culvert #17	Project No. M-1476
Photo No. 9	Date: 5/30/15

Direction Photo Taken: SW			
Description: Sawmill Brook. View of culvert inlet.			
Tighe&Bond		PHOTOGRAPHIC LOG	
Client Name: Manchester-by-the Sea, MA		Site Location: Sawmill Brook Watershed, Lincoln Street Culvert #17	Project No. M-1476
Photo No. 10	Date: 5/30/15

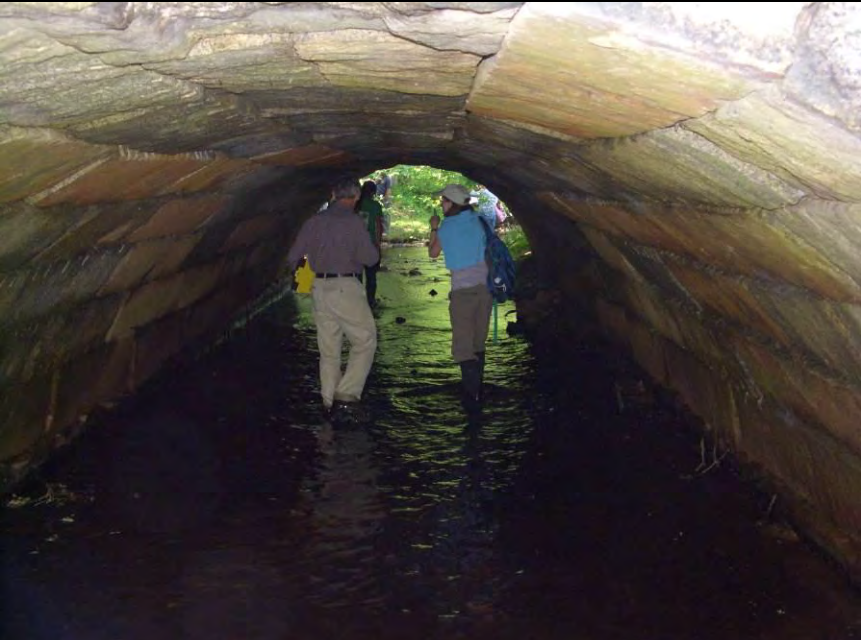
Direction Photo Taken: SW			
Description: Sawmill Brook. Inside culvert. View looking downstream. Stone construction.

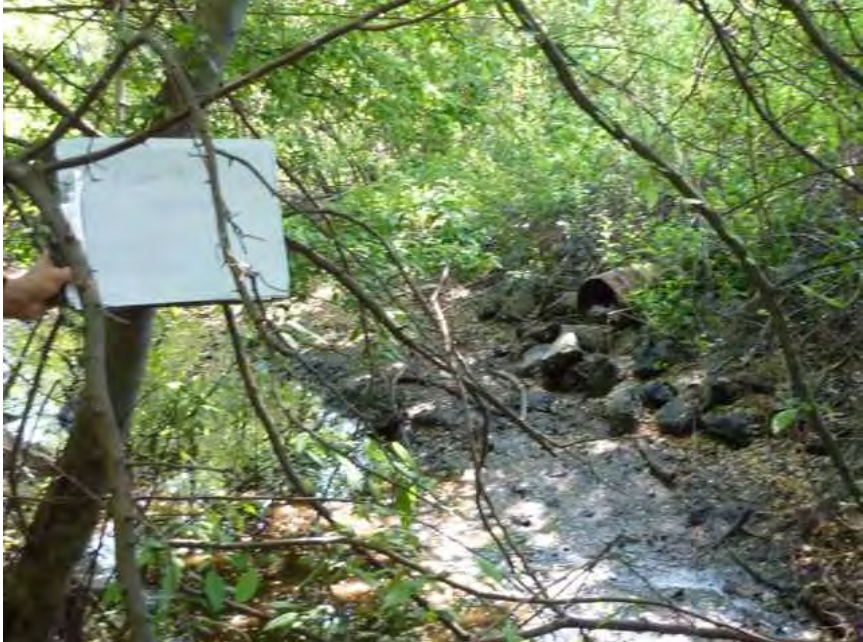
Tighe&Bond		PHOTOGRAPHIC LOG	
Client Name: Manchester-by-the Sea, MA		Site Location: Sawmill Brook Watershed, Lincoln St. Culvert #18	Project No. M-1476
Photo No. 1	Date: 5/30/15

Direction Photo Taken: E			
Description: Causeway Brook View upstream from inlet.

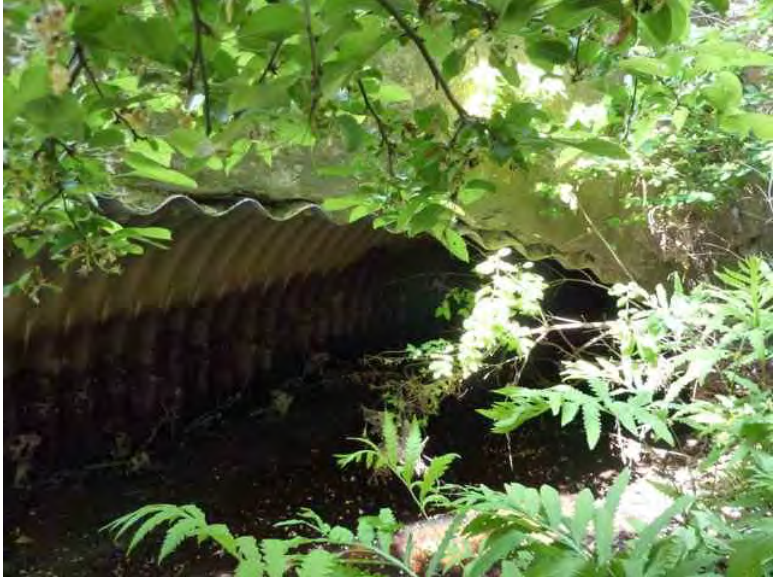
Tighe&Bond		PHOTOGRAPHIC LOG	
Client Name: Manchester-by-the Sea, MA		Site Location: Sawmill Brook Watershed, Lincoln St. Culvert #18	Project No. M-1476
Photo No. 3	Date: 5/30/15

Direction Photo Taken: W			
Description: Causeway Brook Closeup of culvert inlet

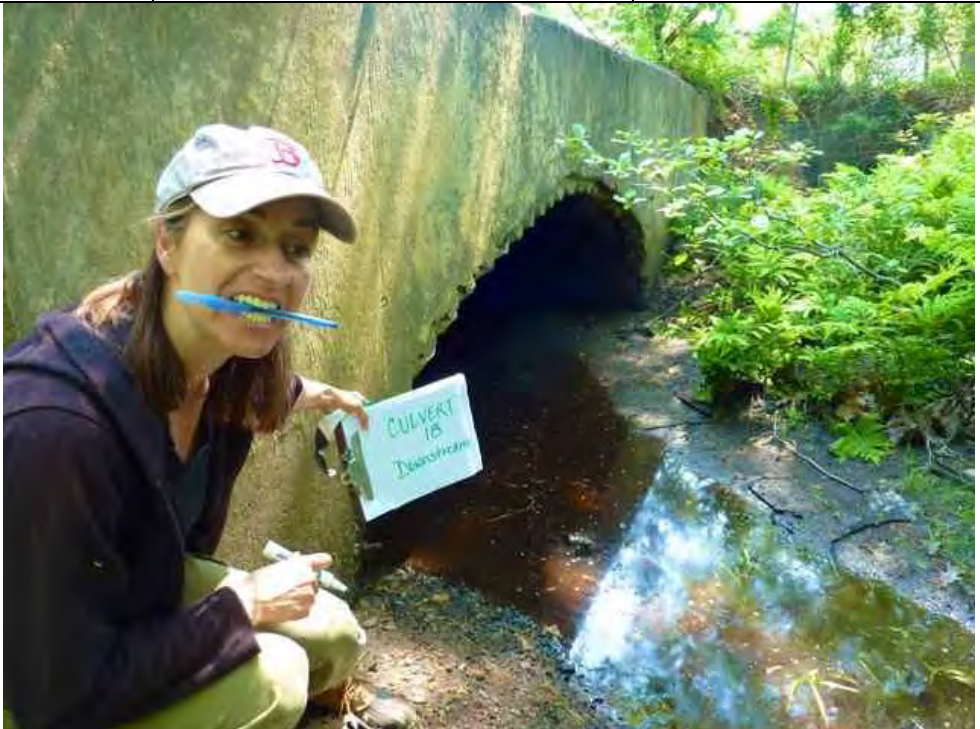
Tighe&Bond		PHOTOGRAPHIC LOG	
Client Name: Manchester-by-the Sea, MA		Site Location: Sawmill Brook Watershed, Lincoln St. Culvert #18	Project No. M-1476
Photo No. 4	Date: 5/30/15

Direction Photo Taken: SE			
Description: Causeway Brook Downstream view of outlet.

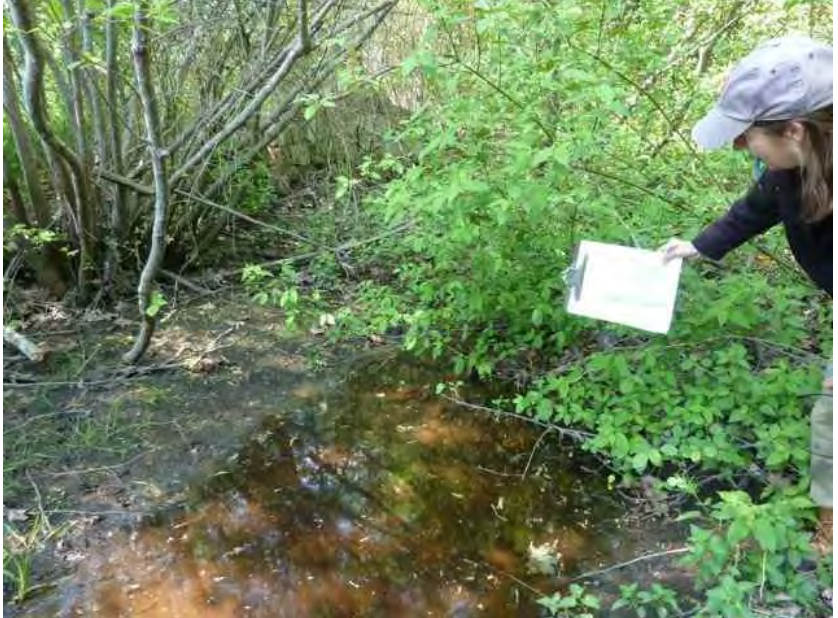
Tighe&Bond		PHOTOGRAPHIC LOG	
Client Name: Manchester-by-the Sea, MA		Site Location: Sawmill Brook Watershed, Lincoln St. Culvert #18	Project No. M-1476
Photo No. 5	Date: 5/30/15

Direction Photo Taken: SW			
Description: Causeway Brook View downstream.

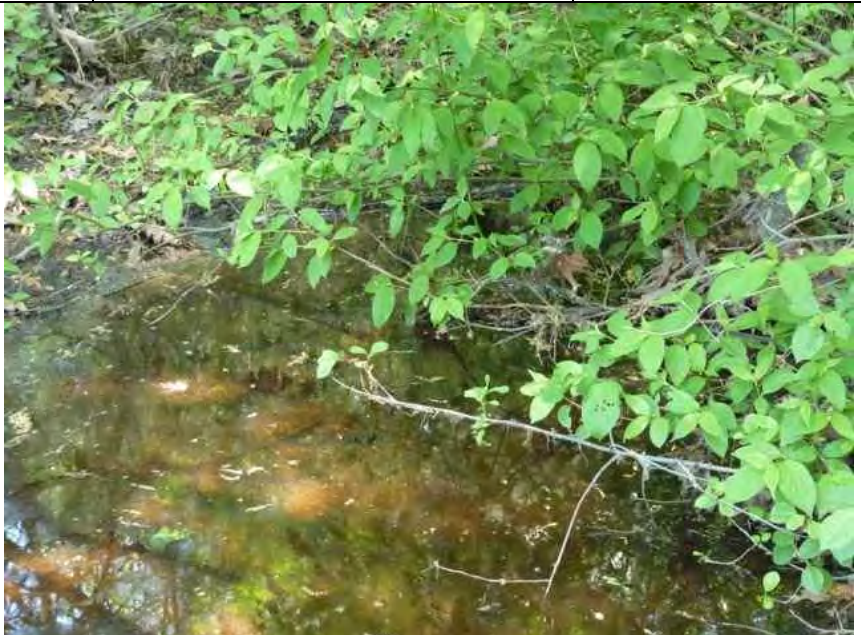
Tighe&Bond		PHOTOGRAPHIC LOG	
Client Name: Manchester-by-the Sea, MA		Site Location: Sawmill Brook Watershed, Lincoln St. Culvert #18	Project No. M-1476
Photo No. 6	Date: 5/30/15

Direction Photo Taken: SW			
Description: Causeway Brook View downstream.

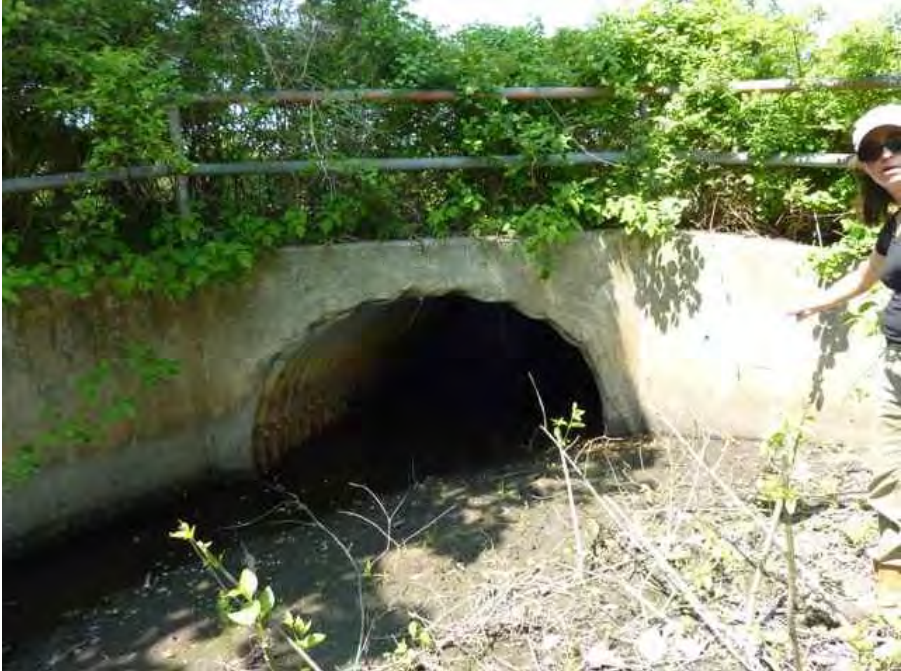
Tighe&Bond		PHOTOGRAPHIC LOG	
Client Name: Manchester-by-the Sea, MA		Site Location: Sawmill Brook Watershed, 153 School St/Golf Course Culvert #19	Project No. M-1476
Photo No. 2	Date: 5/30/15

Direction Photo Taken: SW			
Description: Causeway Brook. View of inlet looking downstream.

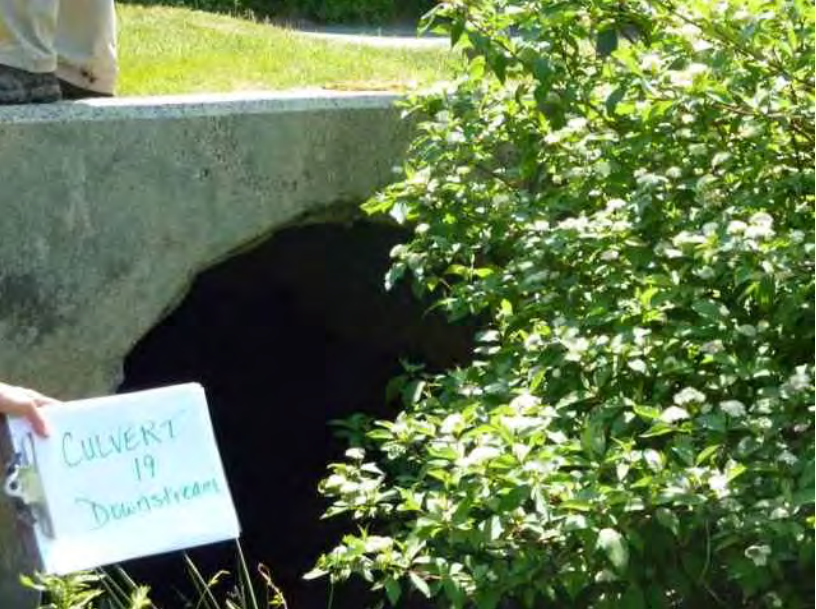
Tighe&Bond		PHOTOGRAPHIC LOG	
Client Name: Manchester-by-the Sea, MA		Site Location: Sawmill Brook Watershed, 153 School St/Golf Course Culvert #19	Project No. M-1476
Photo No. 3	Date: 5/30/15

Direction Photo Taken: NE			
Description: Causeway Brook View of culvert outlet

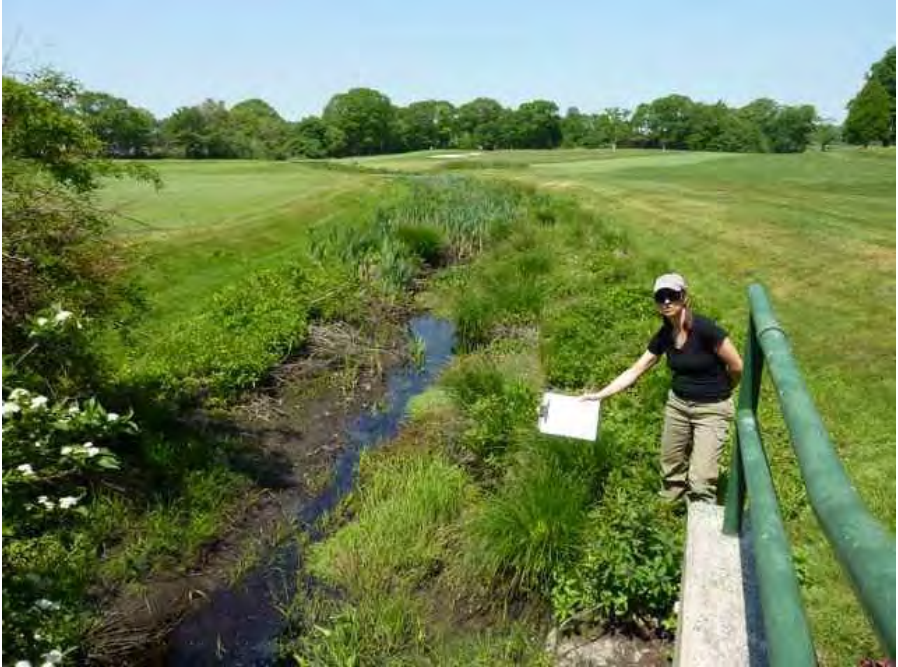
Tighe&Bond		PHOTOGRAPHIC LOG	
Client Name: Manchester-by-the Sea, MA		Site Location: Sawmill Brook Watershed, 153 School St/Golf Course Culvert #19	Project No. M-1476
Photo No. 4	Date: 5/30/15

Direction Photo Taken: W			
Description: Causeway Brook View Downstream

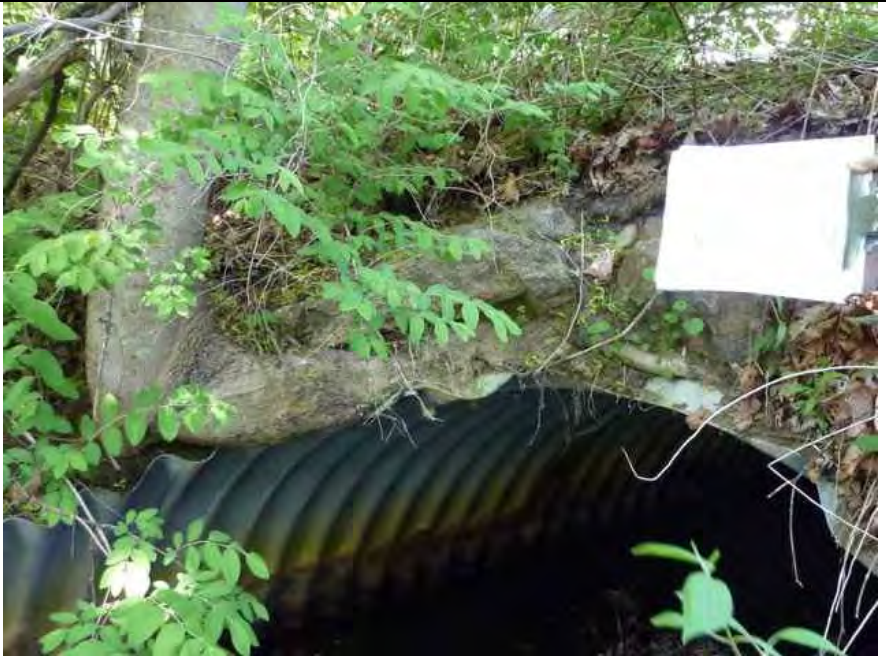
Tighe&Bond		PHOTOGRAPHIC LOG	
Client Name: Manchester-by-the Sea, MA		Site Location: Sawmill Brook Watershed, Summer St. Culvert #20	Project No. M-1476
Photo No. 2	Date: 5/30/15

Direction Photo Taken: NW			
Description: Causeway Brook View of culvert inlet, looking downstream.

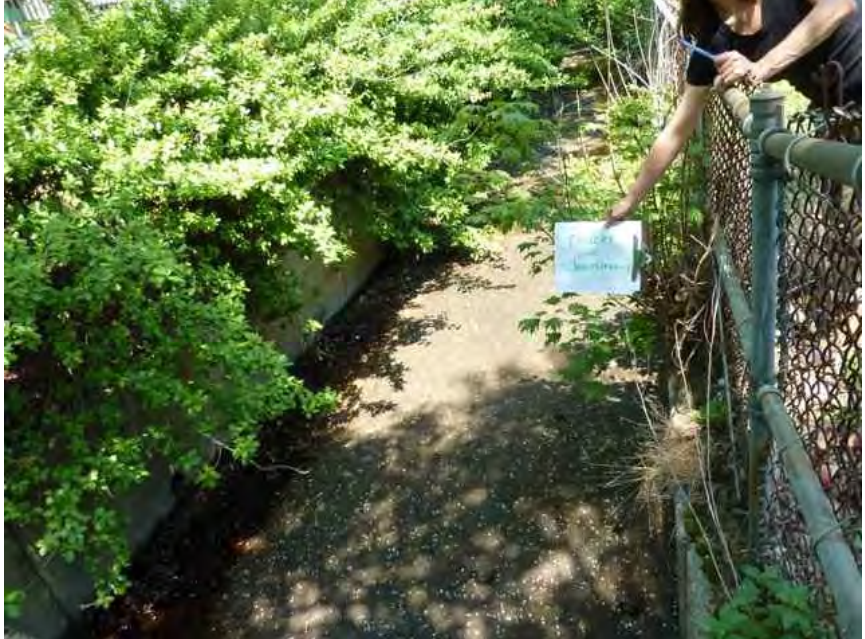
Tighe&Bond		PHOTOGRAPHIC LOG	
Client Name: Manchester-by-the Sea, MA		Site Location: Sawmill Brook Watershed, Summer St. Culvert #20	Project No. M-1476
Photo No. 5	Date: 5/30/15

Direction Photo Taken: NW			
Description: Causeway Brook. View downstream.

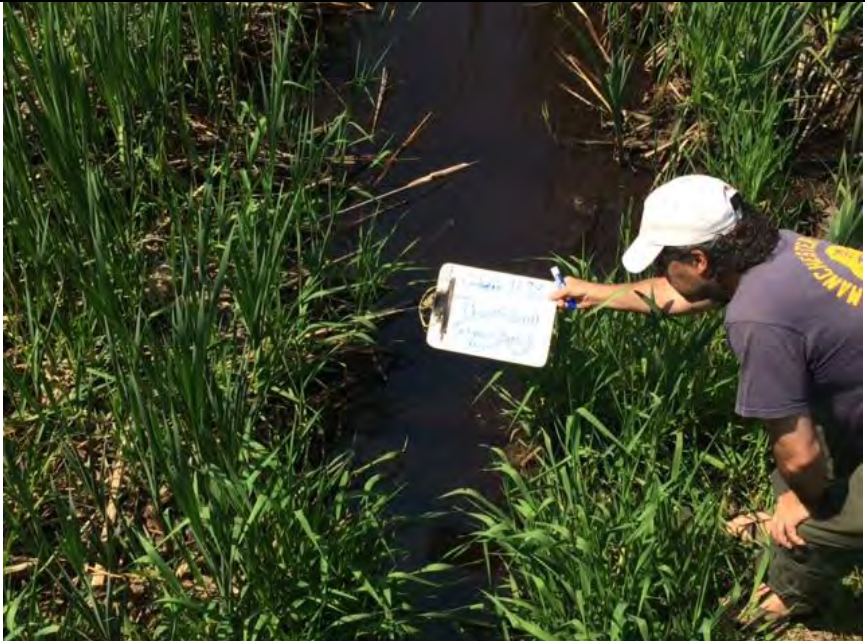
Tighe&Bond		PHOTOGRAPHIC LOG	
Client Name: Manchester-by-the Sea, MA		Site Location: Sawmill Brook Watershed, Summer St. Culvert #21	Project No. M-1476
Photo No. 2	Date: 5/30/15

Direction Photo Taken: SW			
Description: Causeway Brook View downstream.

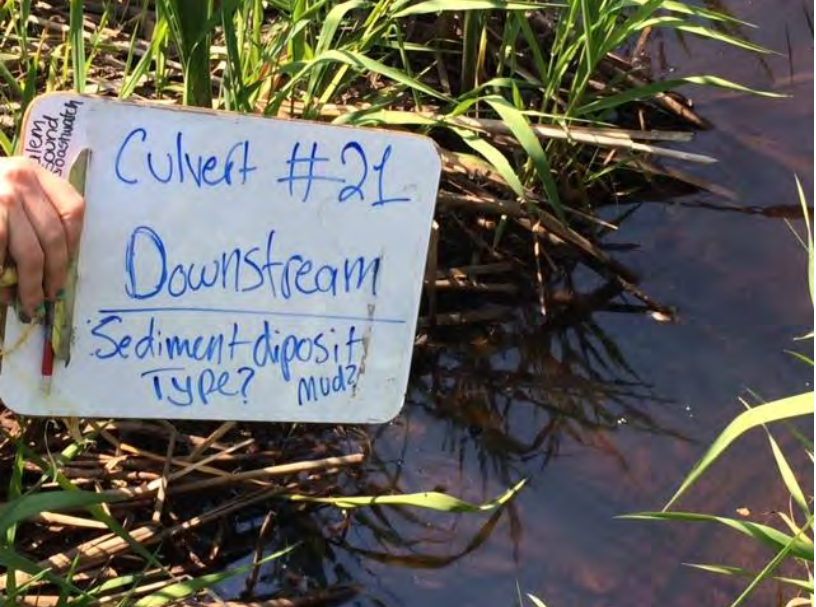
Tighe&Bond		PHOTOGRAPHIC LOG	
Client Name: Manchester-by-the Sea, MA		Site Location: Sawmill Brook Watershed, Summer St. Culvert #21	Project No. M-1476
Photo No. 3	Date: 5/30/15

Direction Photo Taken: SW			
Description: Causeway Brook View downstream.

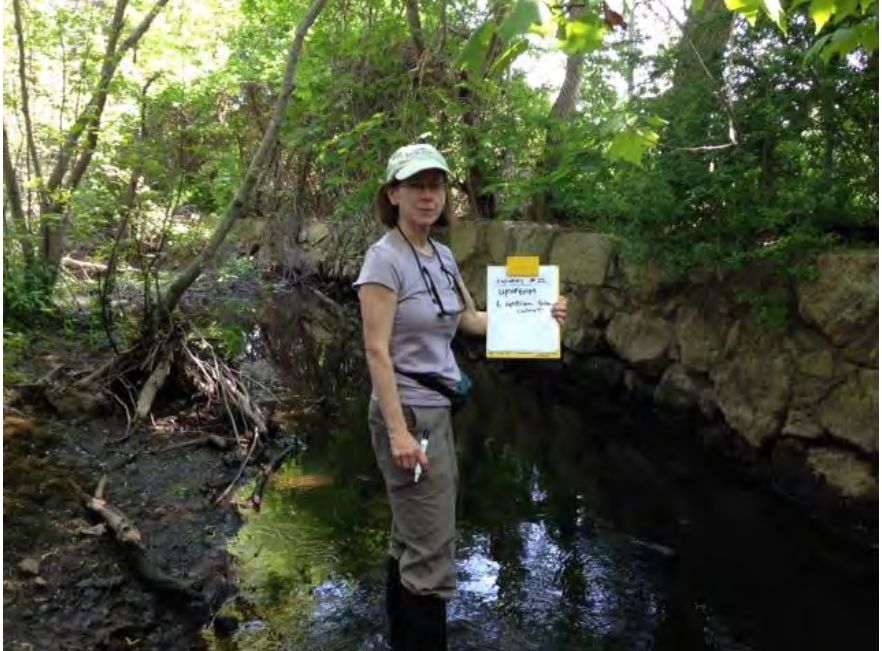
Tighe&Bond		PHOTOGRAPHIC LOG	
Client Name: Manchester-by-the Sea, MA		Site Location: Sawmill Brook Watershed, Norwood Ave Culvert #22	Project No. M-1476
Photo No. 1	Date: 5/30/15

Direction Photo Taken: NE			
Description: Sawmill Brook. Looking upstream from inlet.

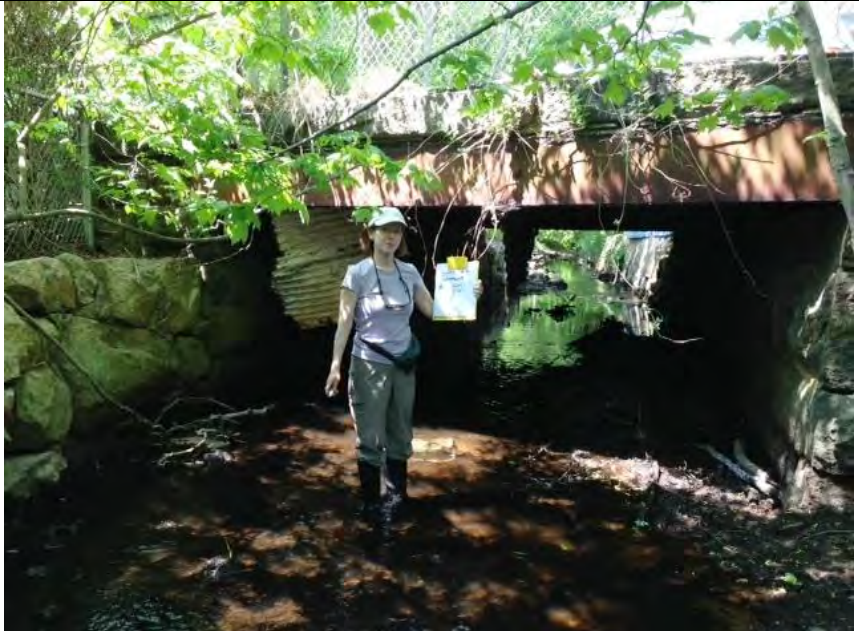
Tighe&Bond		PHOTOGRAPHIC LOG	
Client Name: Manchester-by-the Sea, MA		Site Location: Sawmill Brook Watershed, Norwood Ave Culvert #22	Project No. M-1476
Photo No. 2	Date: 5/30/15

Direction Photo Taken: SW			
Description: Sawmill Brook Upstream inlet, looking downstream.
