Manchester-by-the-Sea, Massachusetts

Stream Crossing Evaluation, Sawmill Brook Watershed

Stream Crossing Evaluation in Sawmill Brook Watershed

TO: Mary Reilly, Manchester-by-the-Sea Grants Administrator
FROM: Gabrielle C. Belfit, Janet Moonan; Tighe & Bond
COPY: M. Gregory Federspiel, Town Administrator
David A. Murphy, P.E. Vice President, Tighe & Bond
DATE: July 28, 2015

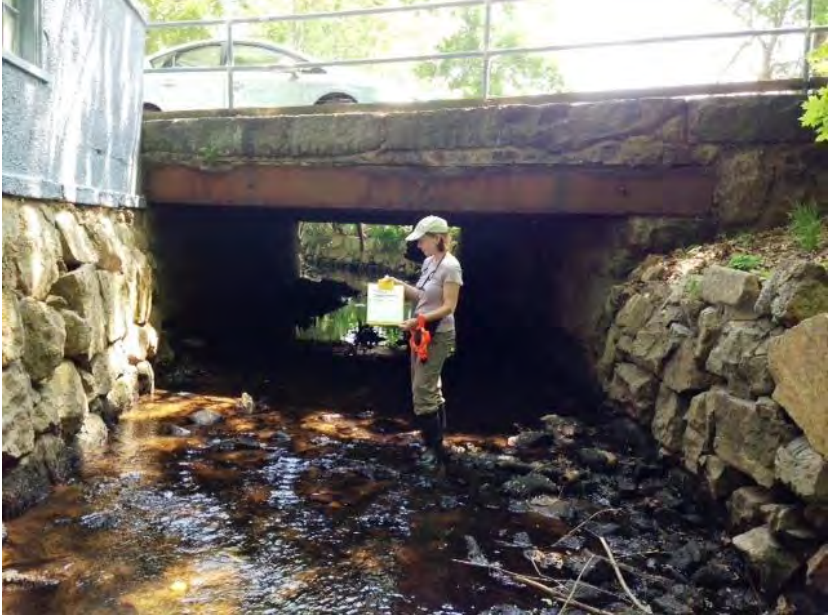
Tighe&Bond		PHOTOGRAPHIC LOG	
Client Name: Manchester-by-the Sea, MA		Site Location: Sawmill Brook Watershed, Norwood Ave Culvert #22	Project No. M-1476
Photo No. 3	Date: 5/30/15

Direction Photo Taken: NE			
Description: Sawmill Brook Outlet, looking upstream.

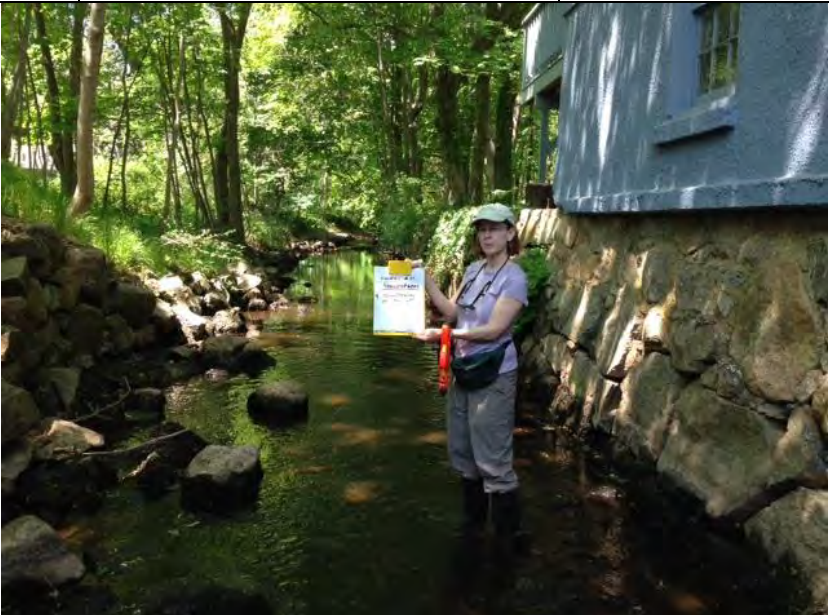
Tighe&Bond		PHOTOGRAPHIC LOG	
Client Name: Manchester-by-the Sea, MA		Site Location: Sawmill Brook Watershed, Norwood Ave Culvert #22	Project No. M-1476
Photo No. 4	Date: 5/30/15

Direction Photo Taken: SW			
Description: Sawmill Brook View downstream from outlet.

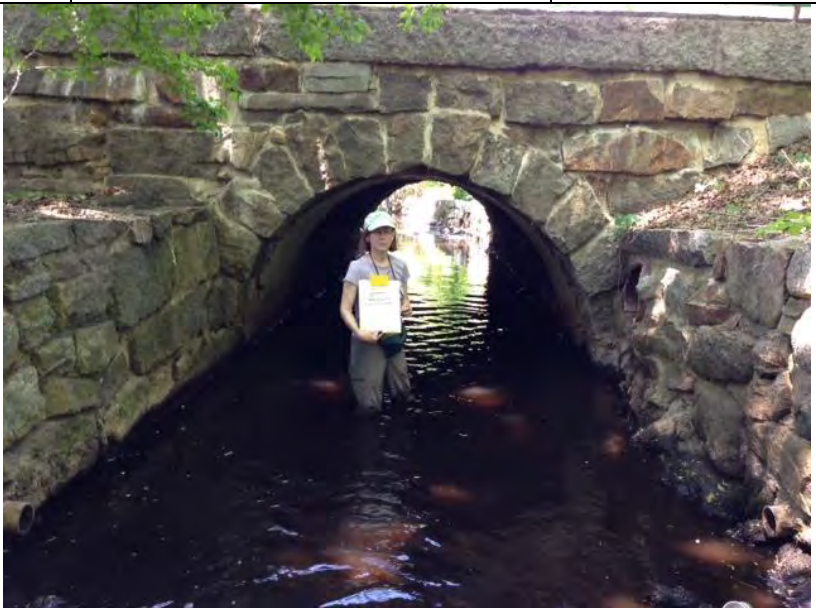
Tighe&Bond		PHOTOGRAPHIC LOG	
Client Name: Manchester-by-the Sea, MA		Site Location: Sawmill Brook Watershed, School St. Culvert #23	Project No. M-1476
Photo No. 2	Date: 5/30/15

Direction Photo Taken: W			
Description: Sawmill Brook. Upstream Inlet, view looking downstream.

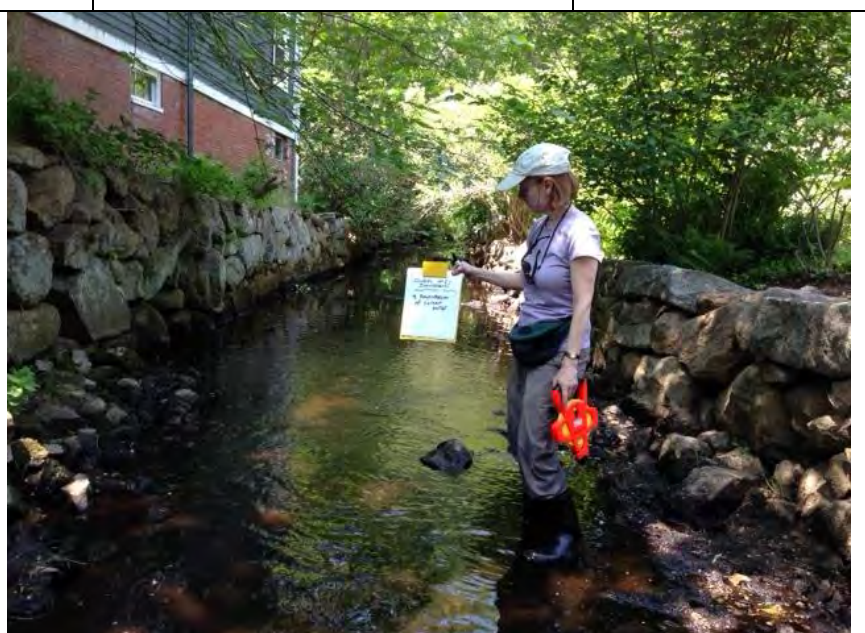
Tighe&Bond		PHOTOGRAPHIC LOG	
Client Name: Manchester-by-the Sea, MA		Site Location: Sawmill Brook Watershed, School St. Culvert #23	Project No. M-1476
Photo No. 4	Date: 5/30/15

Direction Photo Taken: W			
Description: Sawmill Brook. Downstream view from outlet.

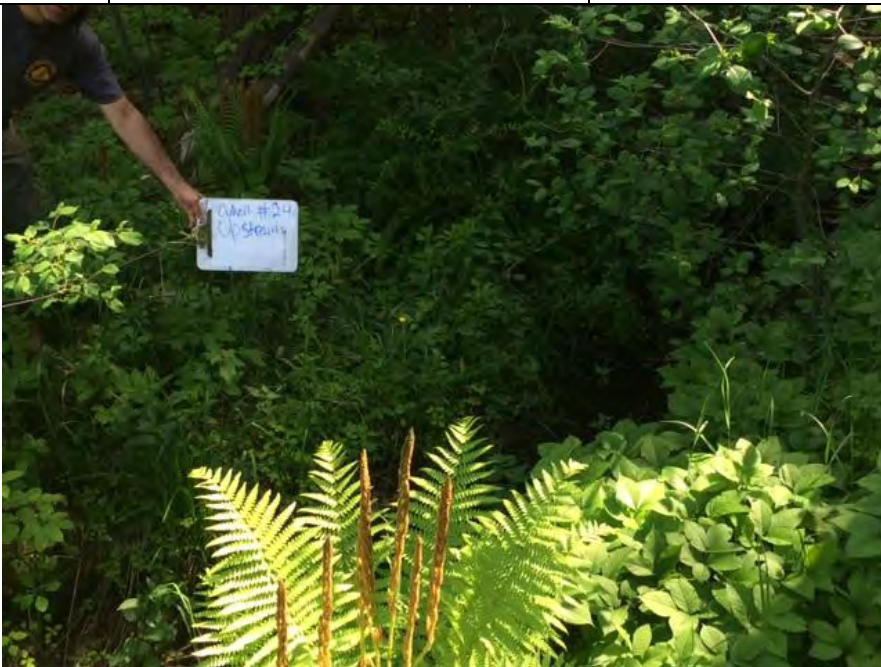
Tighe&Bond		PHOTOGRAPHIC LOG	
Client Name: Manchester-by-the Sea, MA		Site Location: Sawmill Brook Watershed, 185 Summer St. Culvert #24	Project No. M-1476
Photo No. 2	Date: 5/30/15

Direction Photo Taken: NE			
Description: Causeway Brook. Looking upstream.

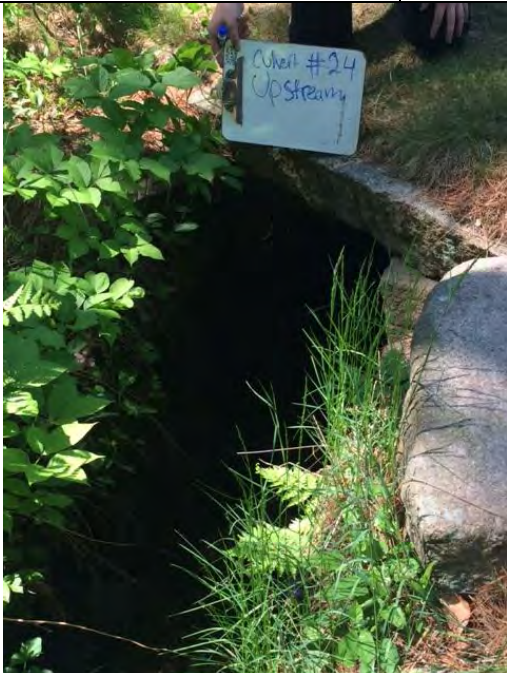
Tighe&Bond		PHOTOGRAPHIC LOG	
Client Name: Manchester-by-the Sea, MA		Site Location: Sawmill Brook Watershed, 185 Summer St. Culvert #24	Project No. M-1476
Photo No. 3	Date: 5/30/15

Direction Photo Taken: SW			
Description: Causeway Brook. View of inlet.

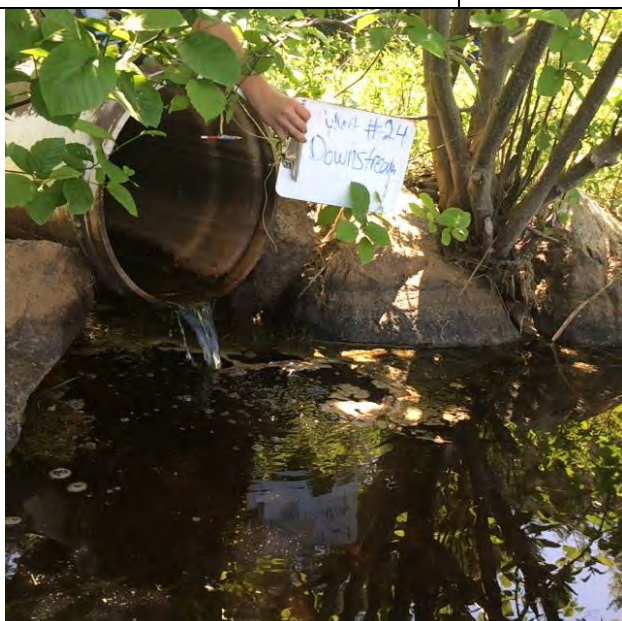
Tighe&Bond		PHOTOGRAPHIC LOG	
Client Name: Manchester-by-the Sea, MA		Site Location: Sawmill Brook Watershed, 185 Summer St. Culvert #24	Project No. M-1476
Photo No. 6	Date: 5/30/15

Direction Photo Taken: E			
Description: Causeway Brook. Downstream outlet.

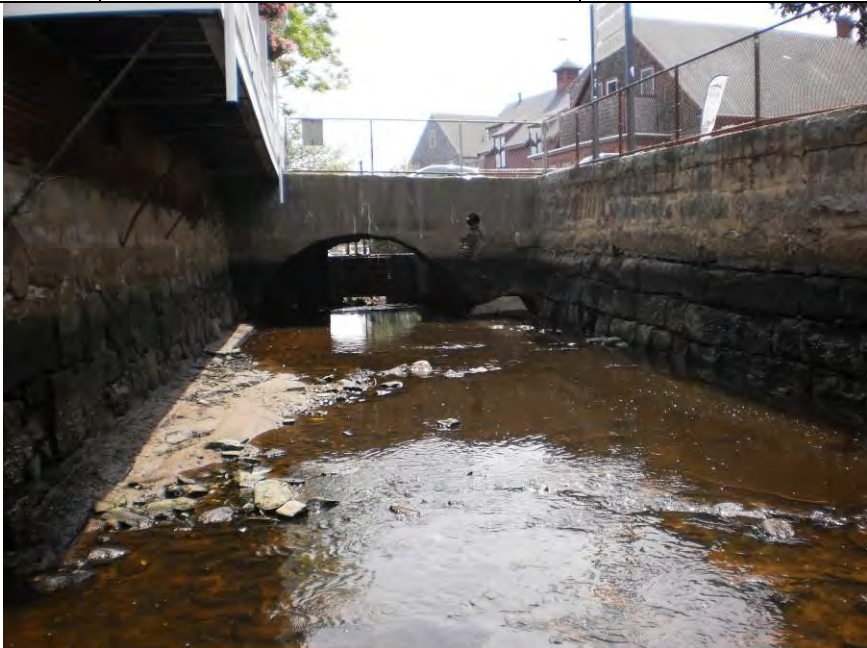
Tighe&Bond		PHOTOGRAPHIC LOG	
Client Name: Manchester-by-the Sea, MA		Site Location: Sawmill Brook Watershed, Sawmill Brook Tide Gate Culvert	Project No. M-1476
Photo No. 1	Date: 6/11/15

Direction Photo Taken: S			
Description: Arch culvert looking downstream

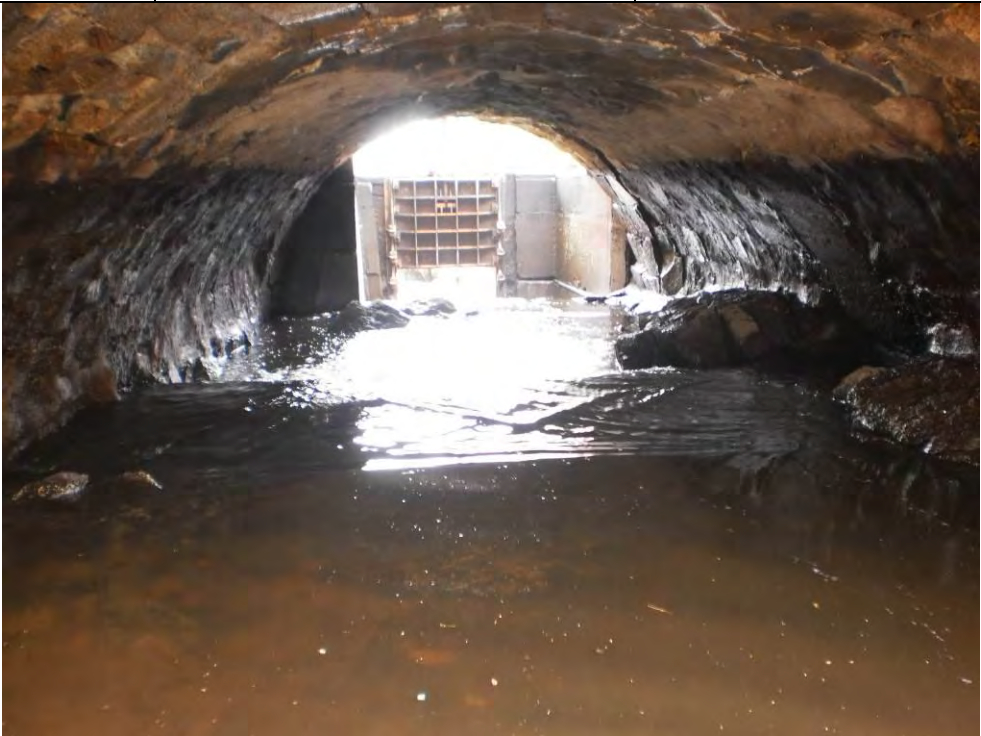
Tighe&Bond		PHOTOGRAPHIC LOG	
Client Name: Manchester-by-the Sea, MA		Site Location: Sawmill Brook Watershed, Sawmill Brook Tide Gate Culvert	Project No. M-1476
Photo No. 2	Date: 6/11/15

Direction Photo Taken: S			
Description: Inside culvert looking toward tide gate

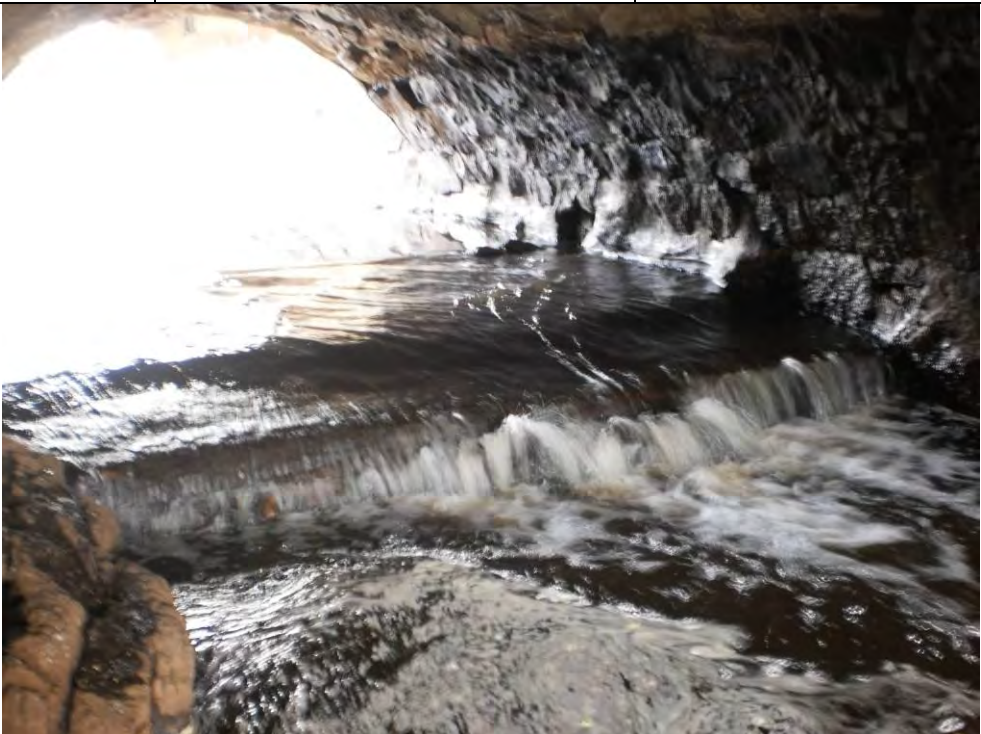
Tighe&Bond		PHOTOGRAPHIC LOG	
Client Name: Manchester-by-the Sea, MA		Site Location: Sawmill Brook Watershed, Sawmill Brook Tide Gate Culvert	Project No. M-1476
Photo No. 3	Date: 6/11/15

Direction Photo Taken: NE			
Description: Upper weir, bedrock left

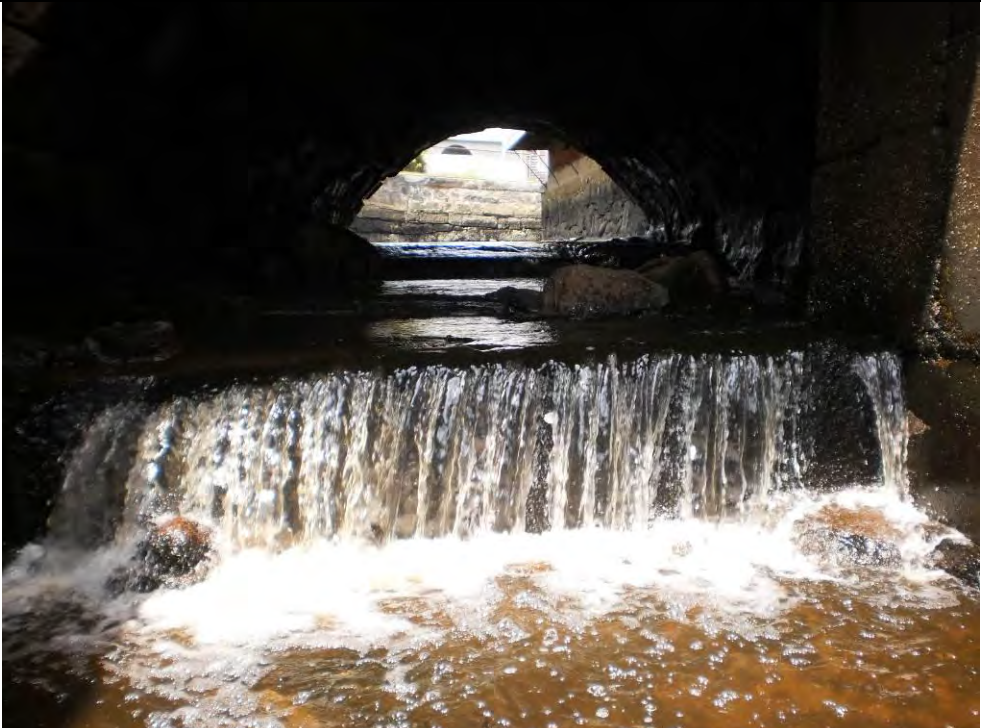
Tighe&Bond		PHOTOGRAPHIC LOG	
Client Name: Manchester-by-the Sea, MA		Site Location: Sawmill Brook Watershed, Sawmill Brook Tide Gate Culvert	Project No. M-1476
Photo No. 4	Date: 6/11/15

Direction Photo Taken: N			
Description: Lower weir, concrete facing on apparent rock filled timber cribs

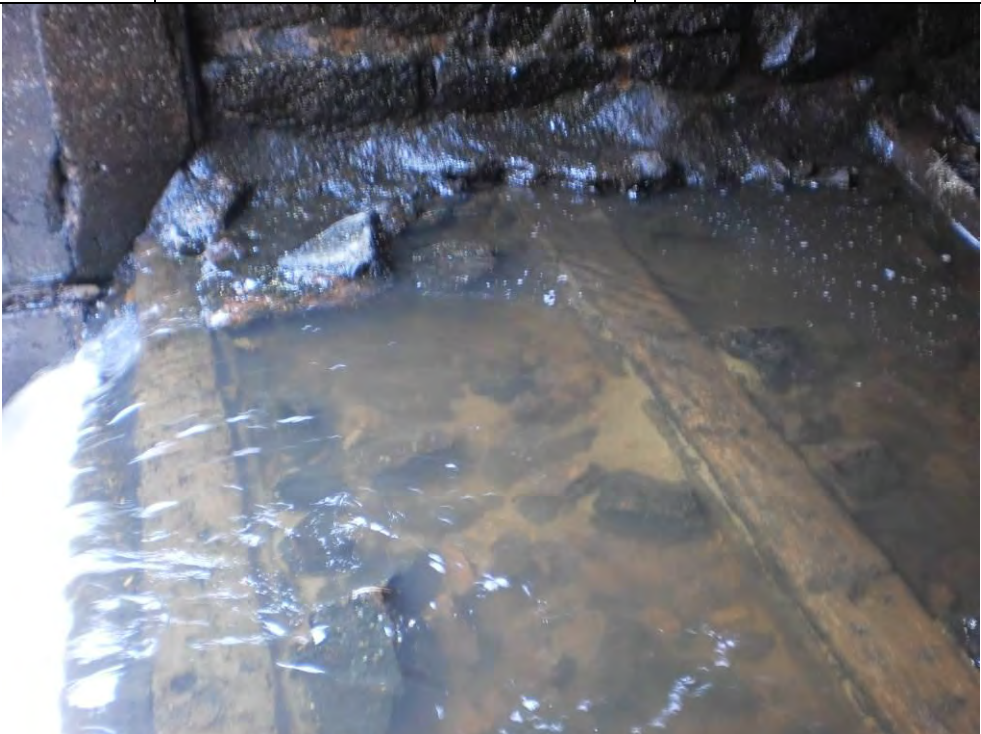
Tighe&Bond		PHOTOGRAPHIC LOG	
Client Name: Manchester-by-the Sea, MA		Site Location: Sawmill Brook Watershed, Sawmill Brook Tide Gate Culvert	Project No. M-1476
Photo No. 5	Date: 6/11/15

Direction Photo Taken: W			
Description: Apparent rock filled timber cribs at lower weir

Proceeding upstream inside the culvert from the south weir is several feet of boulder rock riffles with horizontal transverse timbers that may be rock filled timber cribs (Photo 6). It is not known if these cribs support the arch culvert, or if they are inside the culvert from an earlier dam, or perhaps stream bed scour protection.

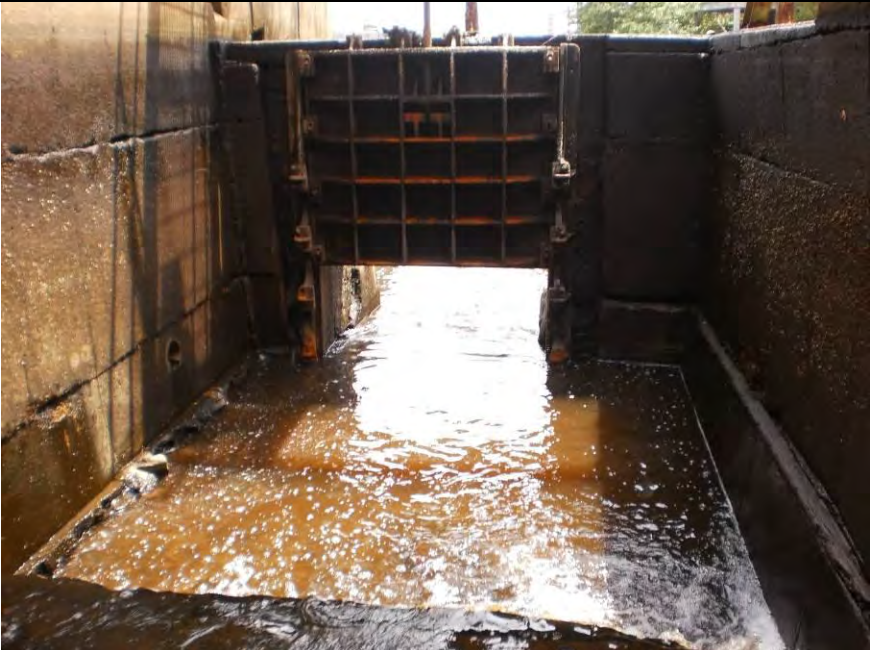
Tighe&Bond		PHOTOGRAPHIC LOG	
Client Name: Manchester-by-the Sea, MA		Site Location: Sawmill Brook Watershed, Sawmill Brook Tide Gate Culvert	Project No. M-1476
Photo No. 6	Date: 6/11/15

Direction Photo Taken: S			
Description: View of tide gate from lower weir

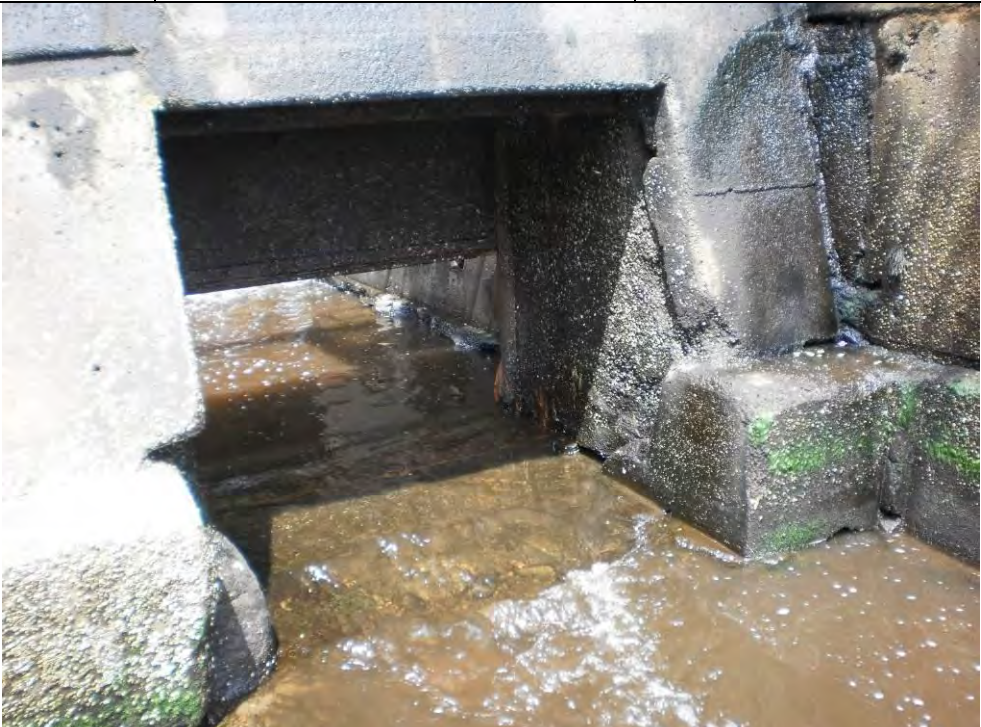
Tighe&Bond		PHOTOGRAPHIC LOG	
Client Name: Manchester-by-the Sea, MA		Site Location: Sawmill Brook Watershed, Sawmill Brook Tide Gate Culvert	Project No. M-1476
Photo No. 8	Date: 6/11/15

Direction Photo Taken: N			
Description: Tide gate invert

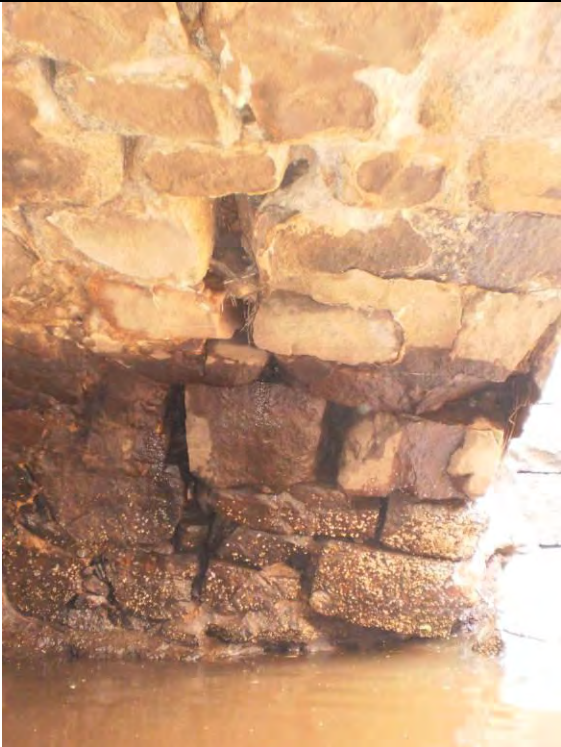
Tighe&Bond		PHOTOGRAPHIC LOG	
Client Name: Manchester-by-the Sea, MA		Site Location: Sawmill Brook Watershed, Sawmill Brook Tide Gate Culvert	Project No. M-1476
Photo No. 11	Date: 6/11/15

Direction Photo Taken: W			
Description: Arch culvert stone separation approximately 4 feet inside upstream end

Direction Photo Taken: S			
Description: Upstream west entrance corner of stone arch culvert showing unsupported culvert stonework, possibly caused by scour or loss of footing stones – apparent cause of separation in photo 11

The stone arch culvert was observed to have two transverse open stone joints. The straight transverse joint about 6 feet inside from the south end appears to be a culvert extension, perhaps associated with a past road widening. The transverse joint 4 feet inside from the north end is not completely straight and appears to have been caused by movement of the outer 4 feet of culvert stonework resulting in separations between adjacent stones (Photo 8). The northwestern corner of the stone arch culvert is missing foundation support, likely caused by stream scour, and the stones above appear to be settling and separating.

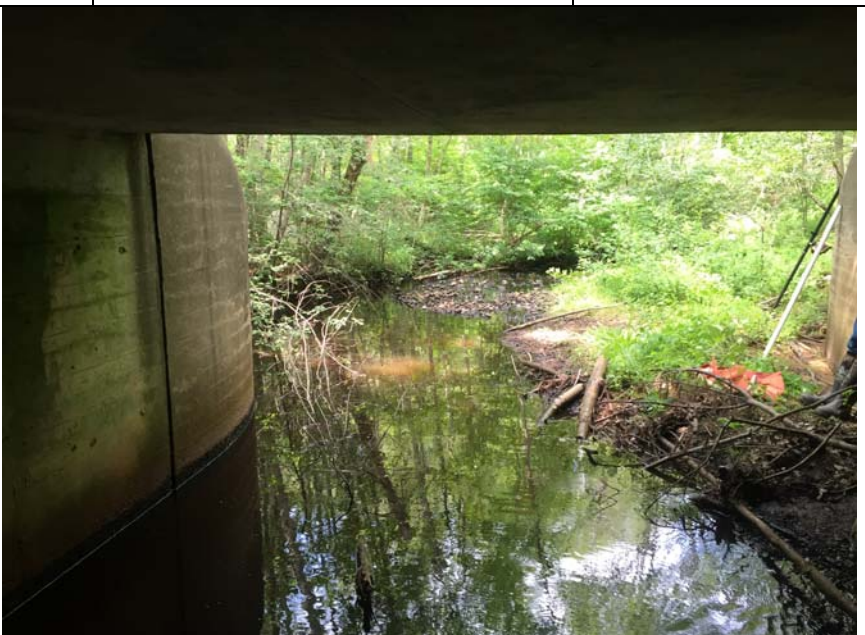
Tighe&Bond		PHOTOGRAPHIC LOG	
Client Name: Manchester-by-the Sea, MA		Site Location: Sawmill Brook Watershed, Culvert #26	Project No. M-1476
Photo No. 2	Date: 7/21/15

Direction Photo Taken: North			
Description: View of upstream from inside Culvert #26, owned by MassDOT

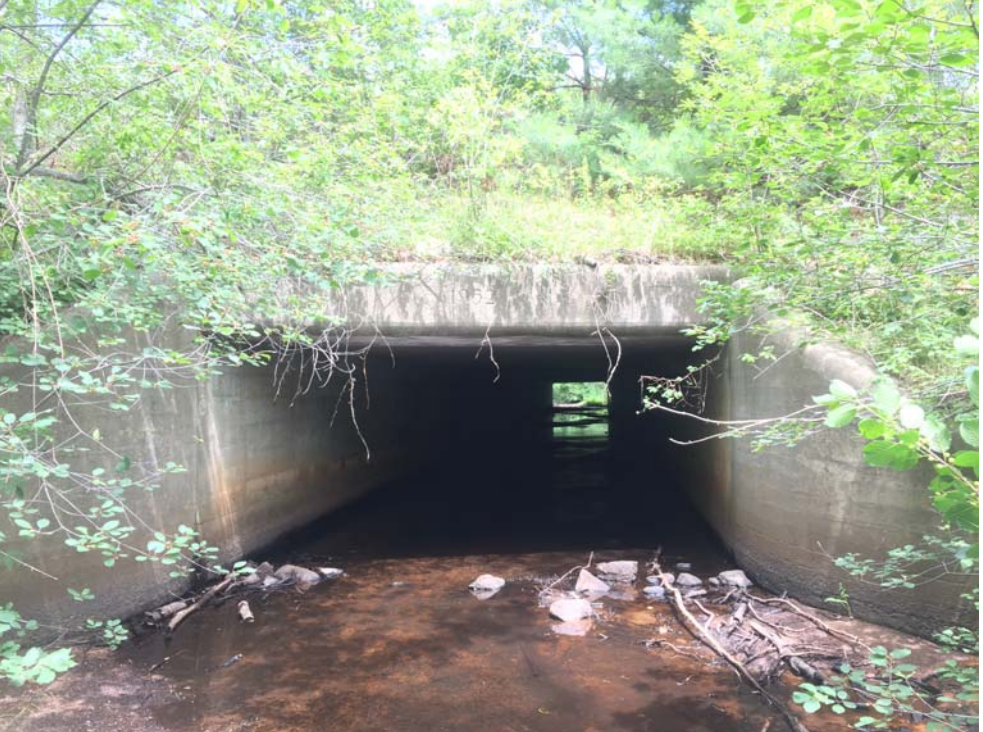
Tighe&Bond		PHOTOGRAPHIC LOG	
Client Name: Manchester-by-the Sea, MA		Site Location: Sawmill Brook Watershed, Culvert #26	Project No. M-1476
Photo No. 3	Date: 7/21/15

Direction Photo Taken: North			
Description: Downstream side of Culvert #26, owned by MassDOT

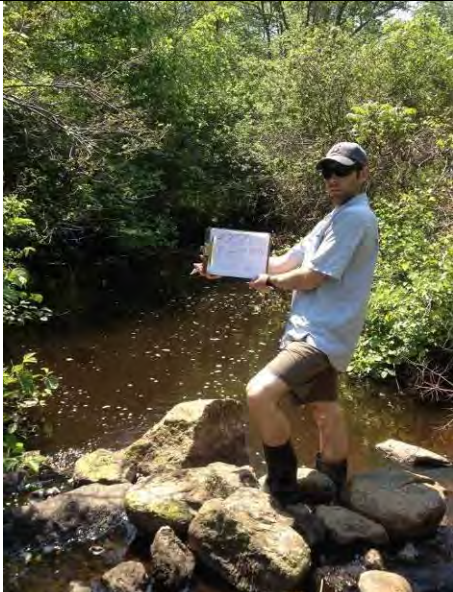
Tighe&Bond		PHOTOGRAPHIC LOG	
Client Name: Manchester-by-the Sea, MA		Site Location: Sawmill Brook Watershed, Mill Street Culvert #27	Project No. M-1476
Photo No. 1	Date: 5/30/15

Direction Photo Taken: N			
Description: Sawmill Brook. View upstream.

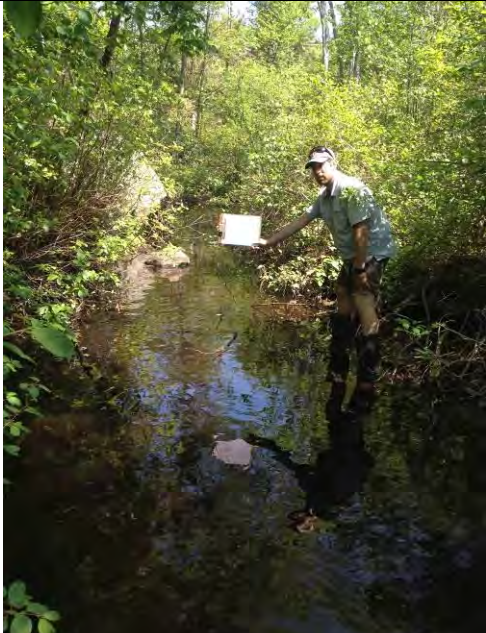
Tighe&Bond		PHOTOGRAPHIC LOG	
Client Name: Manchester-by-the Sea, MA		Site Location: Sawmill Brook Watershed, Mill Street Culvert #27	Project No. M-1476
Photo No. 4	Date: 5/30/15

Direction Photo Taken: S			
Description: Sawmill Brook. Below outlet, looking downstream.

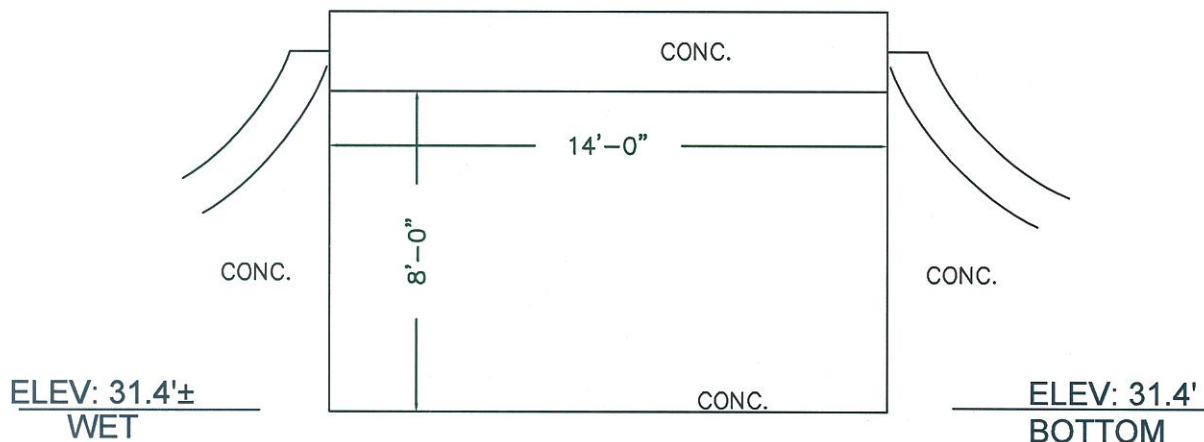
NO SEDIMENT OBSERVED

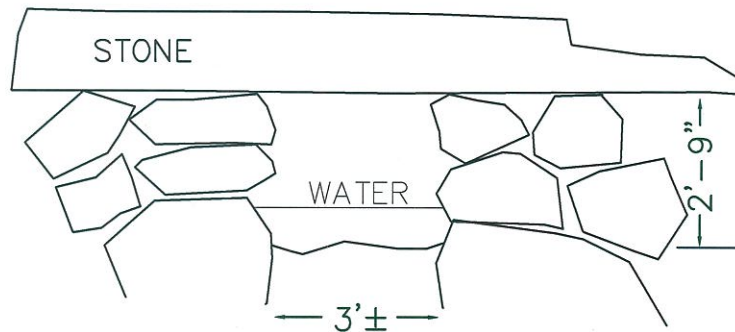
WATER DEPTH: 8"

OBSERVED SEDIMENT DEPTH: 8"±

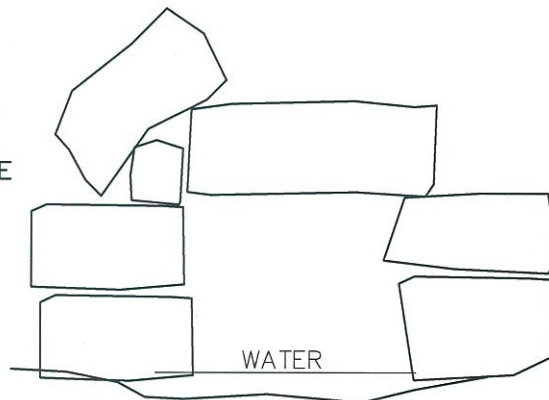
OBSERVED SEDIMENT DEPTH: UNABLE TO DETERMINE

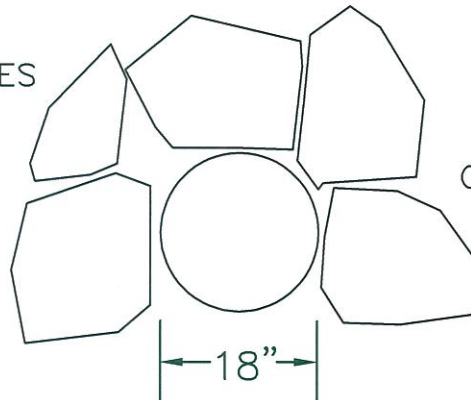
WATER DEPTH: DRY

OBSERVED SEDIMENT DEPTH: PIPE PARTLY
OBSTRUCTED

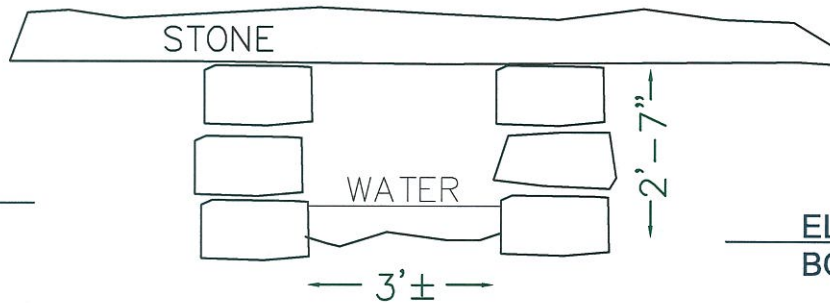
WATER DEPTH: 6"

UNABLE TO DETERMINE SEDIMENT

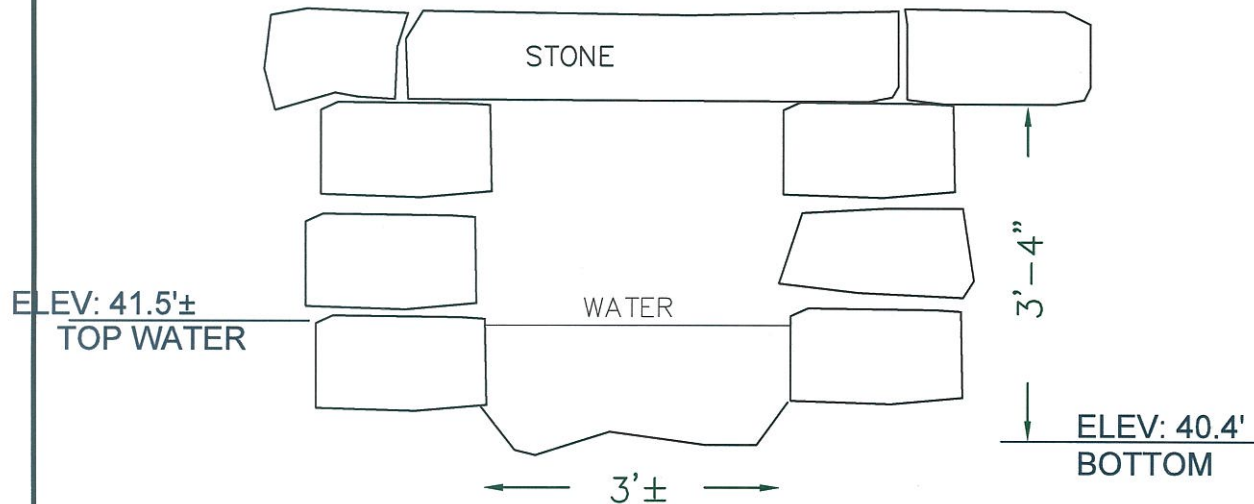
WATER DEPTH: 6"

UNABLE TO DETERMINE SEDIMENT

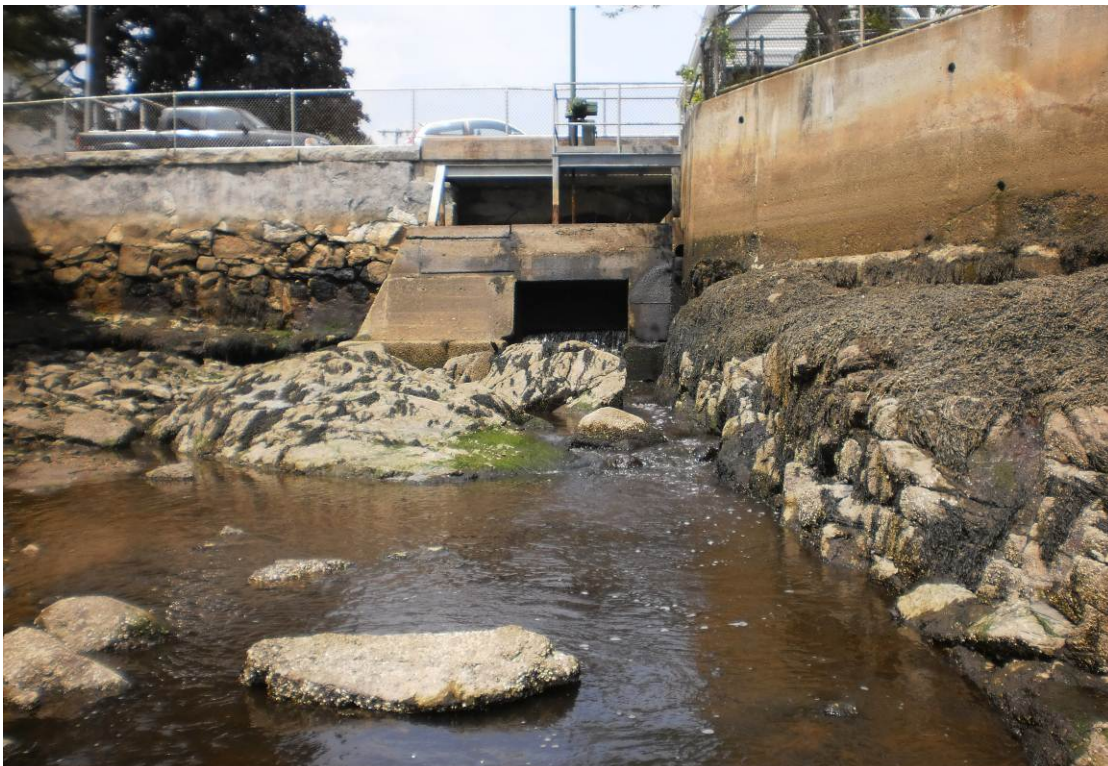
Fish coming from the harbor at low tide will encounter rock riffles and bedrock below the tide gate structure (Photo 1). As the tide rises these natural impediments will become submerged and no longer hinder fish passage at a water level about 2 feet above Mean Low Water (MLW), (CLE, 2000. Existing Conditions and Proposed Repairs to Tide Gate and Seawall).

Photo 1 Looking upstream (low tide) toward tide gate and Central St culvert

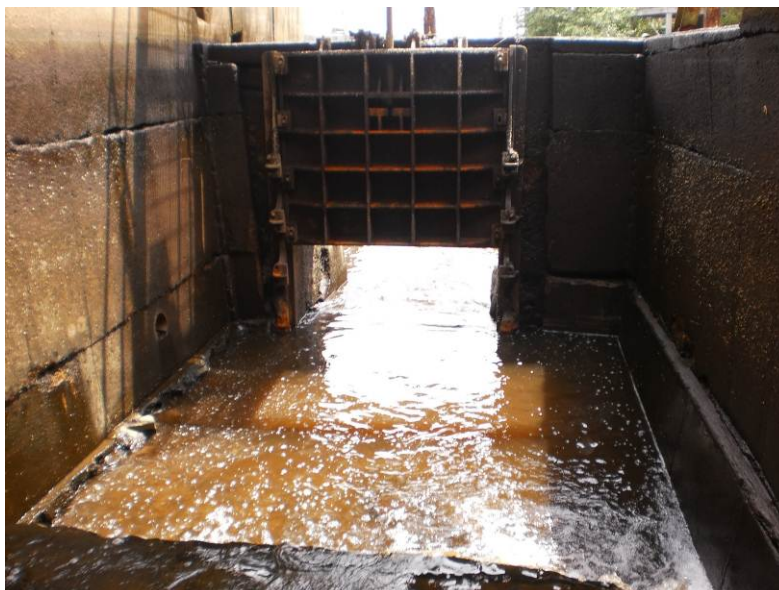
The concrete walls of the tide gate structure appear to be gravity walls with indications of prior concrete repair and overlays, including the repairs circa 2000 (Photo3).

Photo 3 View of tide gate from inside culvert

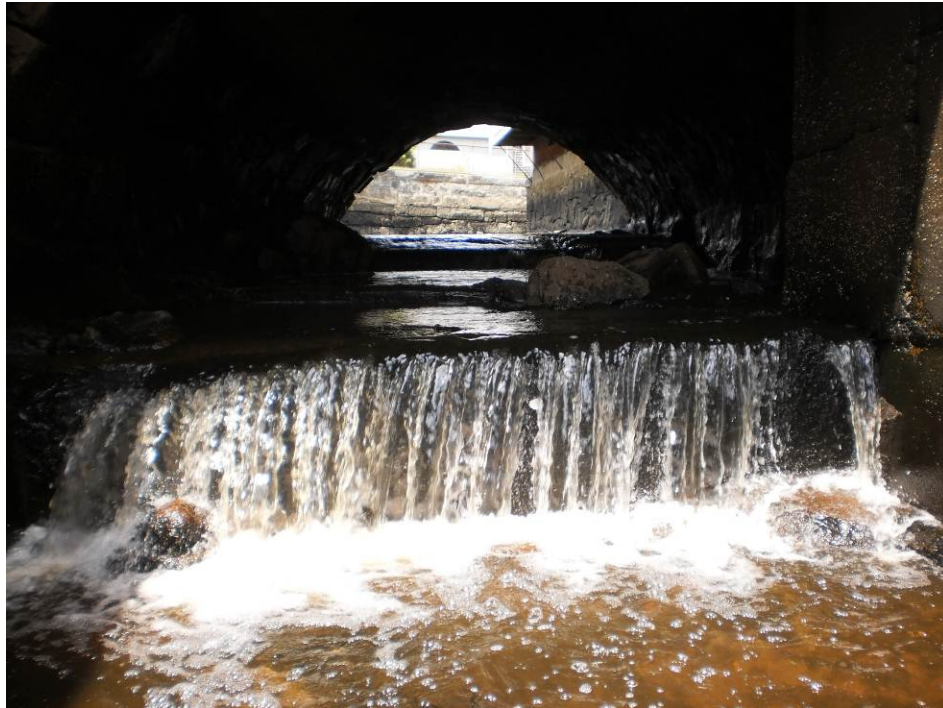
The downstream end of the stone arch culvert is about 5 feet upstream from the south edge of the sidewalk. At this point there is a weir 2.7 feet high rising from the bedrock stream bed (Photo 5). This weir has a concrete face, but it appears to be just an overlay on rock filled timber cribs behind. The east side seawall from the harbor to the culvert has had a concrete overlay repair that restricts the culvert opening by about 2 feet on the eastern side at this weir, but it does not continue inside the arch culvert more than 2 to 3 feet. The typical base width of the stone arch culvert is about 16 feet.

Photo 5 Downstream culvert weir looking upstream

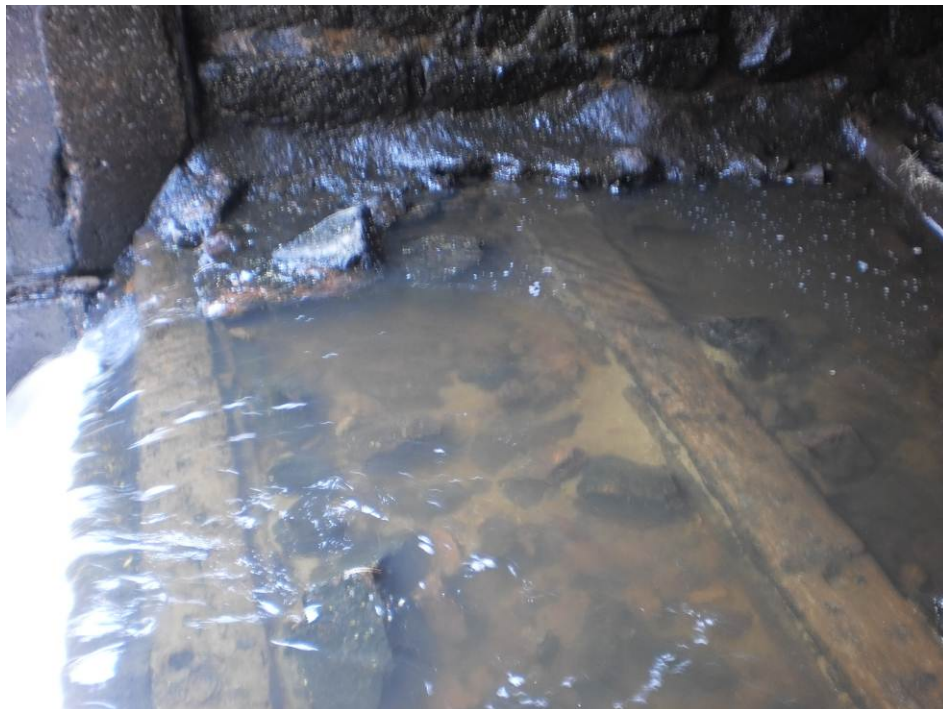
Photo 6 Apparent rock filled timber cribs forming stream bed at south end of arch culvert

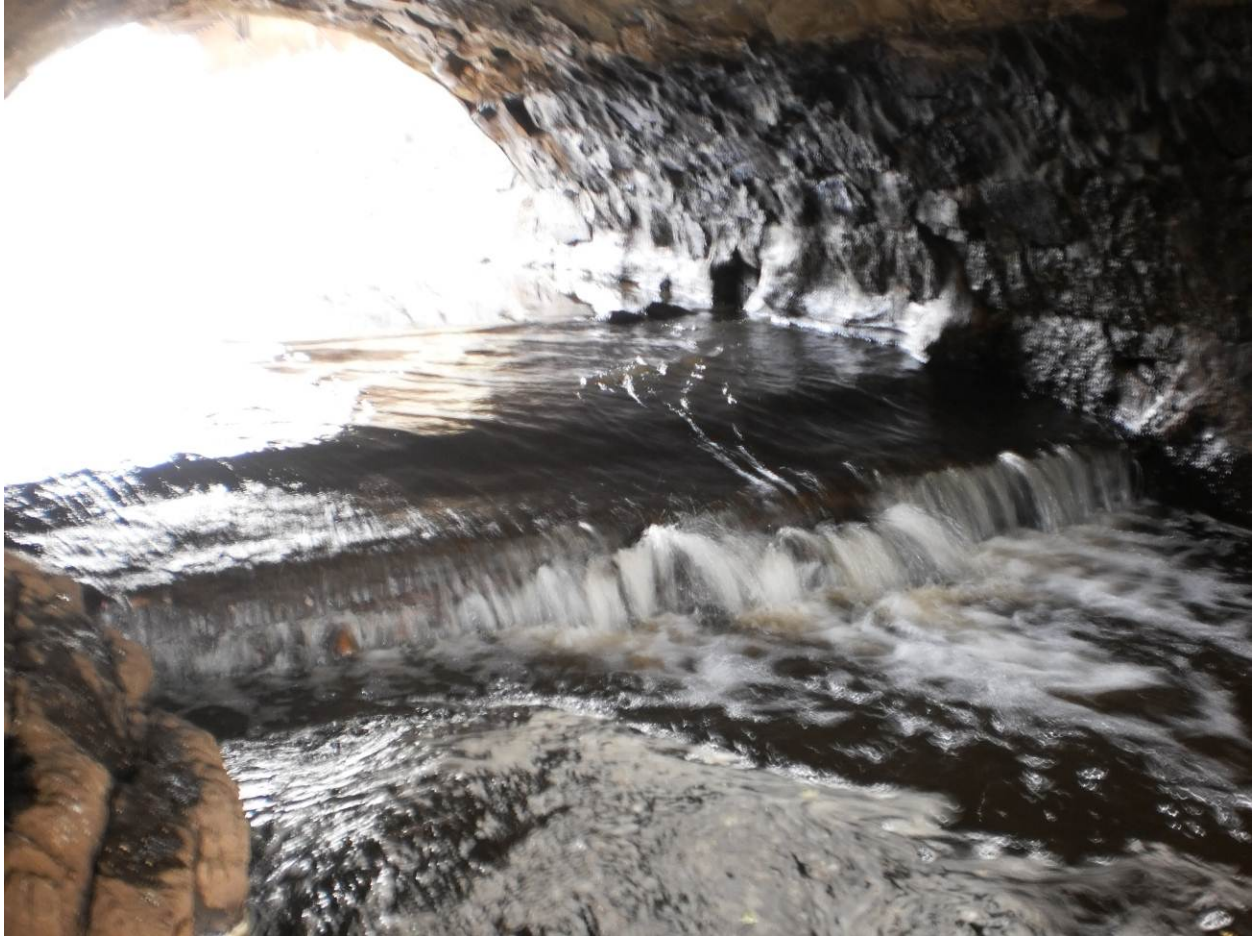
At about half distance inside the arch culvert is a second weir with apparent bedrock outcrop at the western side of the culvert (Photo 7). This weir has a total height of about 4 feet (pool below) causing about a 17 inch rise in water level at the weir. The weir has a broad partially sloping crest of concrete (6.1 feet down from top of arch), which might be armor over a buried water and/or sewer main.

Photo 7 Mid length weir inside culvert, bedrock left
