Town of Manchester-By-The-Sea Facility Condition Assessment

Town Of Manchester-By-The-Sea

April 02, 2021

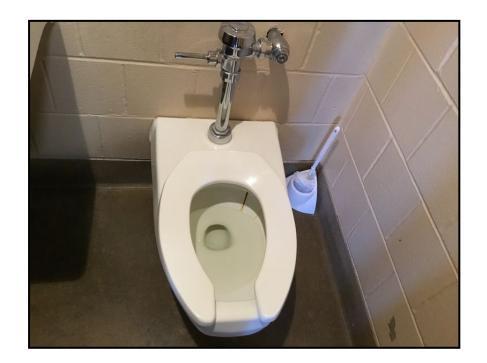
Plumbing

The manual and porcelain plumbing fixtures were in fair condition due to observed rust. The domestic water distribution system is beyond its recommended useful life. The sanitary waste system is beyond its recommended useful life.

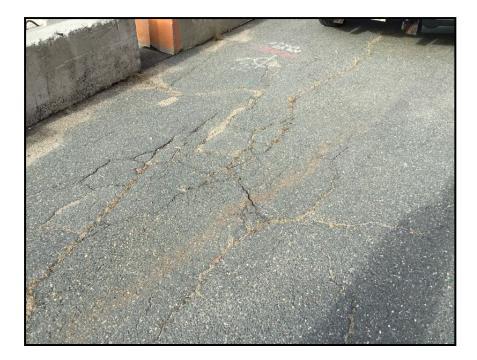
Site Infrastructure

The asphalt pavements were in poor condition and in need of resurfacing as longitudinal cracking, transverse cracking, and degradation were observed throughout the pavement.

Asset Description	Corrective Action	Notes	Priority	Current Needs	Year
Vehicular Pavements	Resurface Asphalt Pavements	3800 SF @ \$3.5 Per SF	Low	\$13,300	2021
			Total 2021 Needs	\$13,300

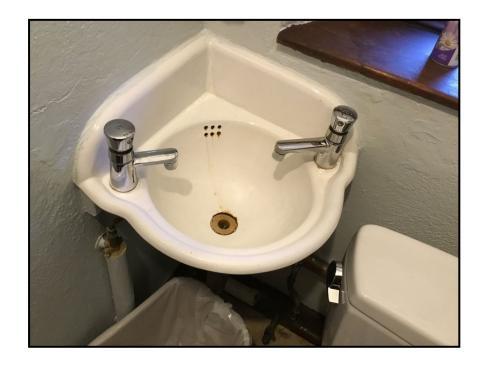
Plumbing

The manual and porcelain plumbing fixtures were in good condition. The domestic water distribution system is beyond its recommended useful life. The sanitary waste system is beyond its recommended useful life.

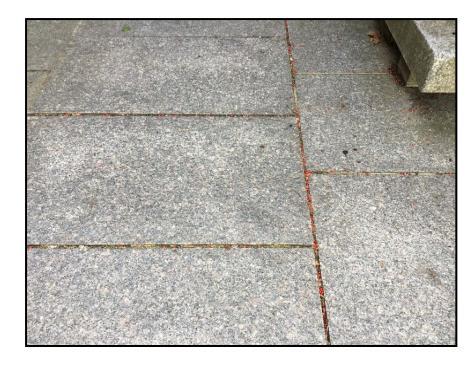
Site Infrastructure

Replacement of the sealant in the expansion joints as part of routine maintenance would extend the overall life of the concrete pedestrian walkways.
SEASIDE 1

Asset Description	Corrective Action	Notes	Priority	Current Needs	Year
Pedestrian Pavements	Replace Caulking in Concrete Pavements	500 SF @ \$0.65 Per SF	Medium	\$325	2021
			Total 2021 Needs	\$325

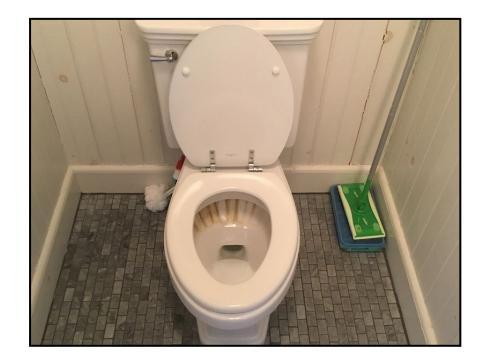
Plumbing

The manual and porcelain plumbing fixtures were in good condition; however, a portion of the fixtures were in fair condition due to observed mineral build-up. The domestic water distribution system is beyond its recommended useful life. The sanitary waste system is beyond its recommended useful life.

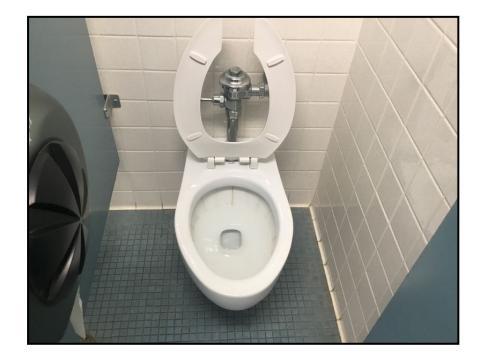
Plumbing

The manual and porcelain plumbing fixtures were in fair condition due to observed rust and malfunctioning hardware that cause the fixtures to continuously flush. The domestic water distribution system is beyond its recommended useful life. The sanitary waste system is beyond its recommended useful life. Table 46. Current and Forecasted Needs Summarized by System (Current + 5 years): Town Hall/ Police Dept

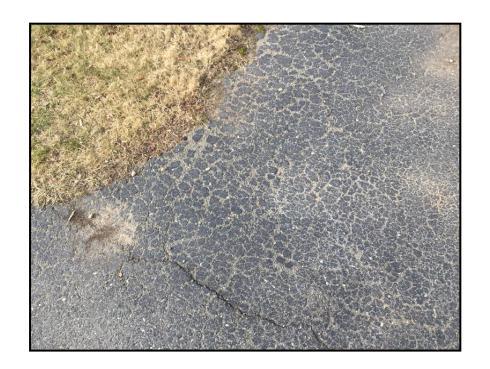
Site Infrastructure

The asphalt sidewalks were in poor condition and in need of resurfacing as longitudinal cracking, transverse cracking, and degradation were observed throughout the pavement.

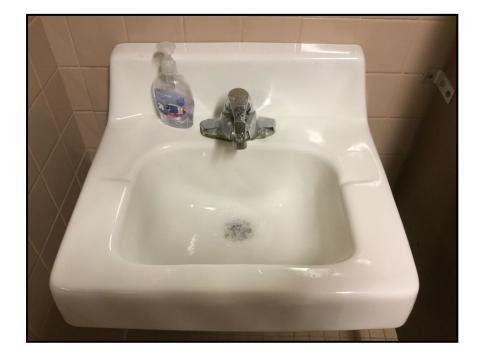
Plumbing

The manual and manual and automatic plumbing fixtures were in poor condition due to observed mineral build-up. The domestic water distribution system is within its recommended useful life. The sanitary waste system is within its recommended useful life.

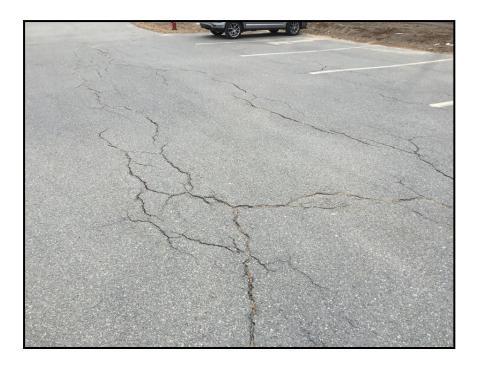
Site Infrastructure

The asphalt pavements were in poor condition and in need of resealing as longitudinal and transverse cracking were observed throughout the pavement.

Asset Description	Corrective Action	Notes	Priority	Current Needs	Year
Vehicular Pavements	Crack Fill, Seal Coat, and Restripe Asphalt Pavements	20000 SF @ \$1.2 Per SF	Low	\$24,000	2021
			Total 2021 Needs	\$24,000

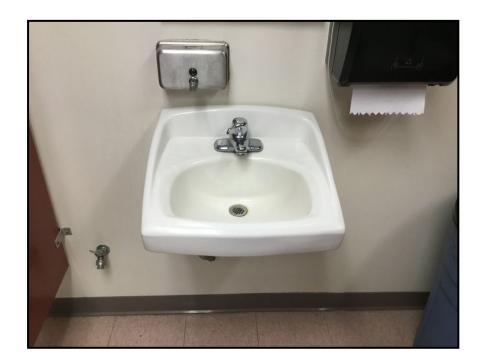
Plumbing

The manual and porcelain plumbing fixtures were in good condition. The domestic water distribution system is within its recommended useful life. The sanitary waste system is within its recommended useful life.
