# Condition Assessment Report

## Manchester-by-the-Sea Public Library

15 Union Street - Manchester-by-the-Sea - MA 01944

May 25 2024

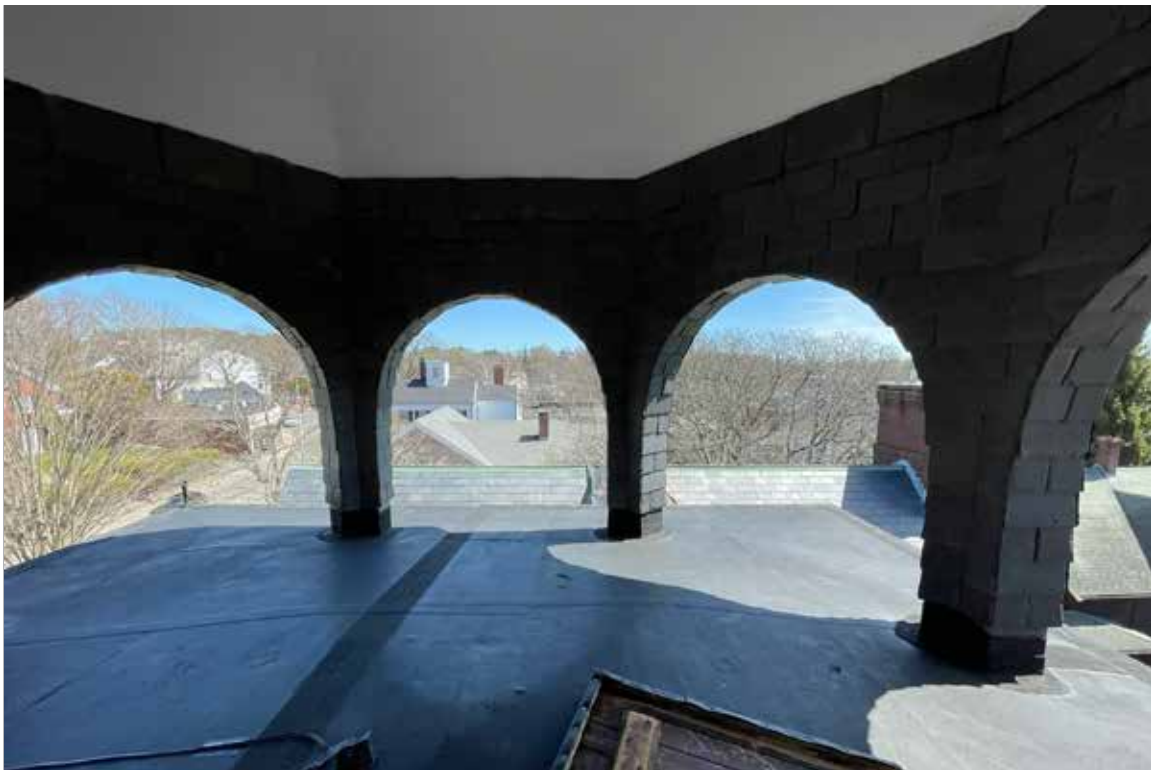
FIGURE 1.02 - Tower flat roof under cupola - View from west looking east.

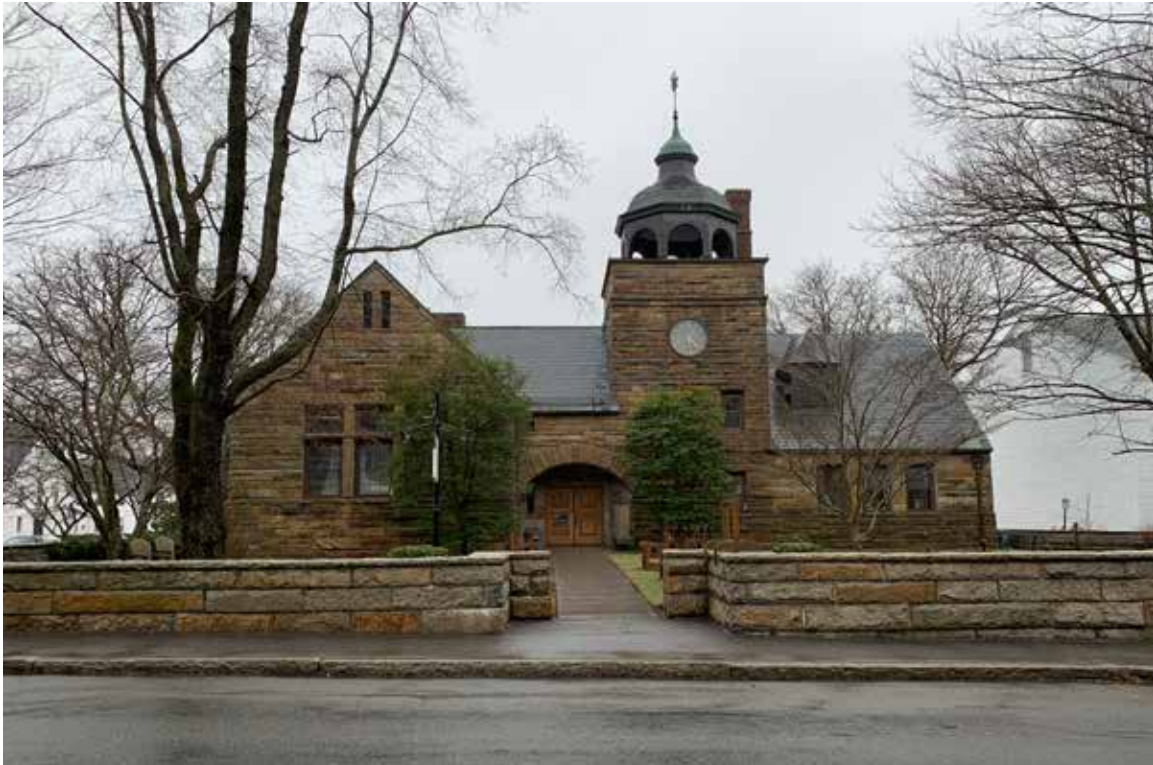
FIGURE 3.2 - North perimeter wall - view from Union Street looking south.

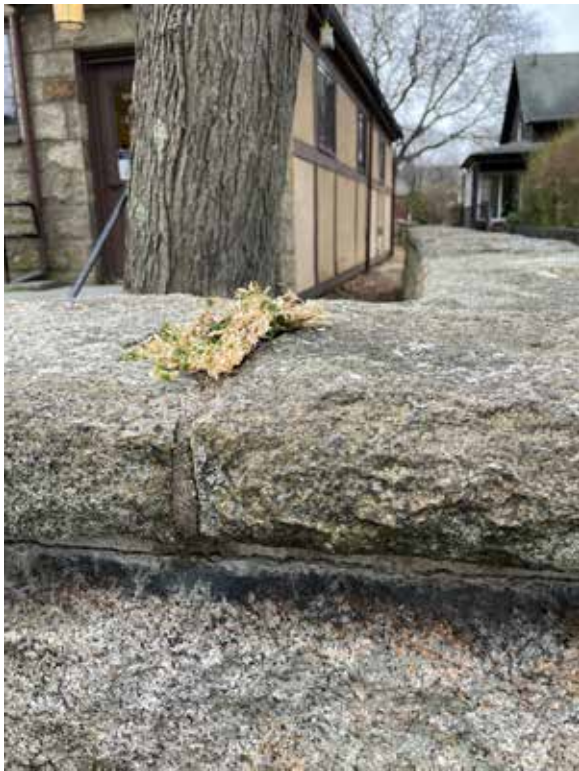
Figure 3.05 Perimeter wall - vegetation growth

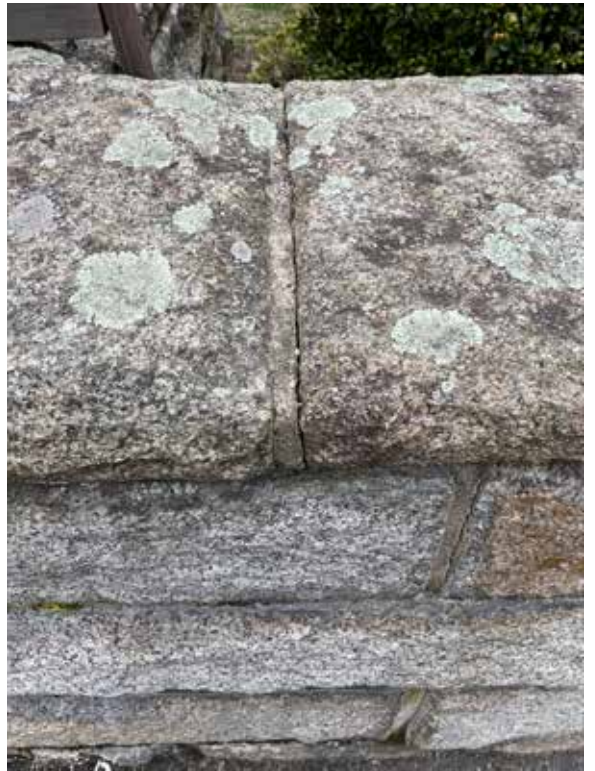
Figure 3.06 Perimeter wall - biological growth.

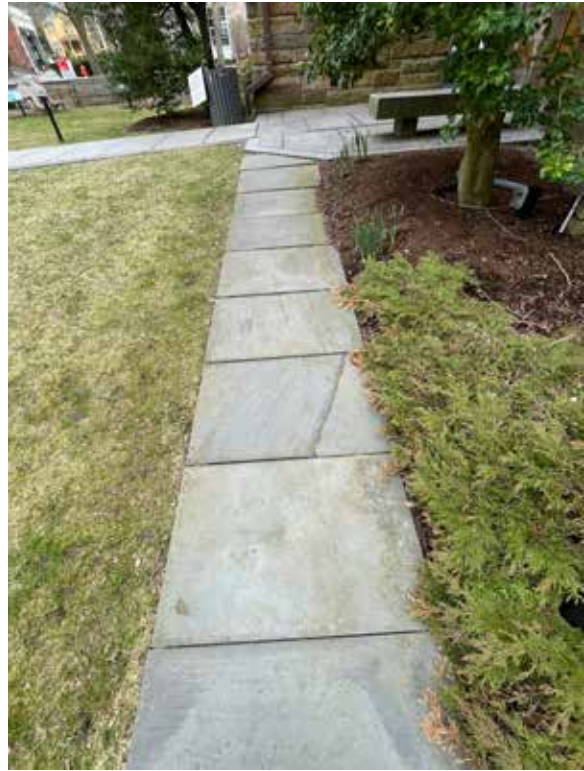
Figure 3.08 Bluestone paving and concrete paving beyond - north elevation.

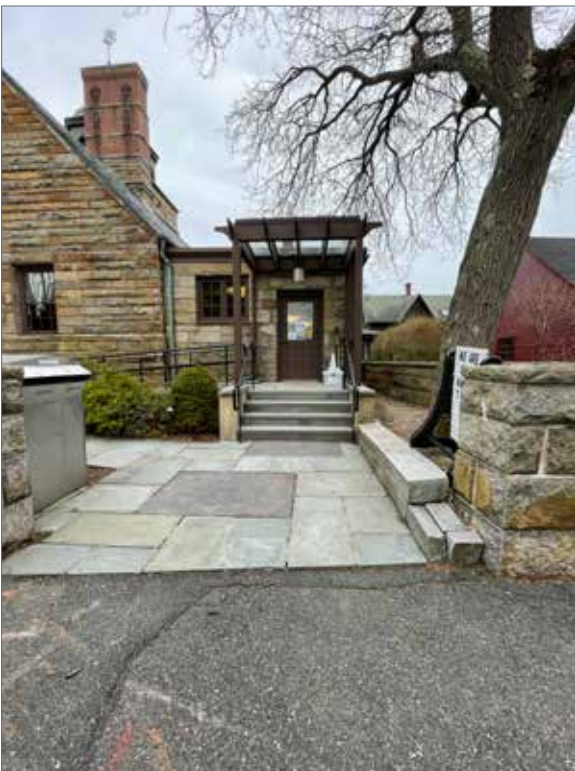
Figure 3.09 Bluestone paving and displaced retaining wall at west entrance

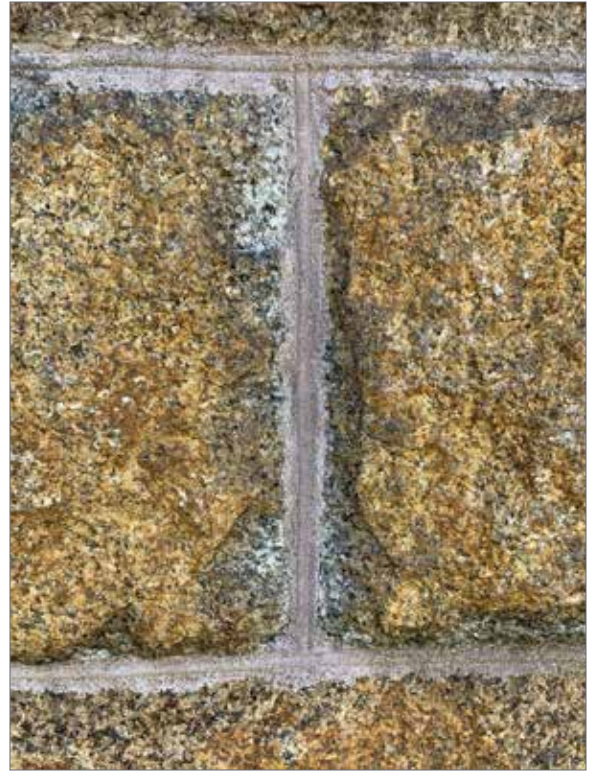
Figure 3.19 - Granite masonry mortar joints."

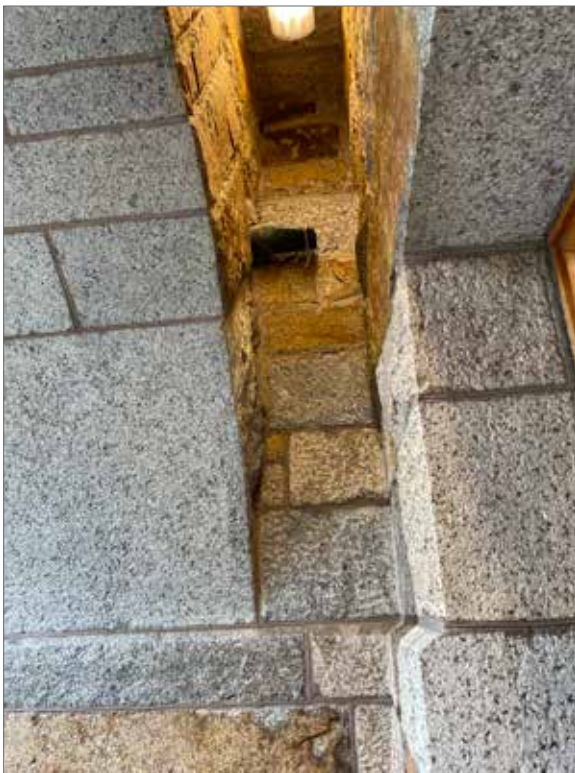
Figure 3.20 Lighting slot at arched main entrance.

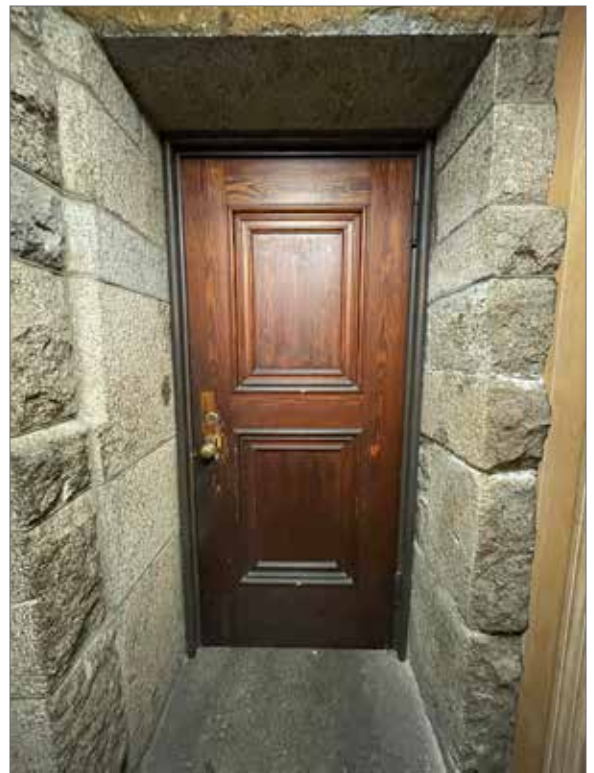
Figure 3.21 Masonry opening - Staff Restroom.

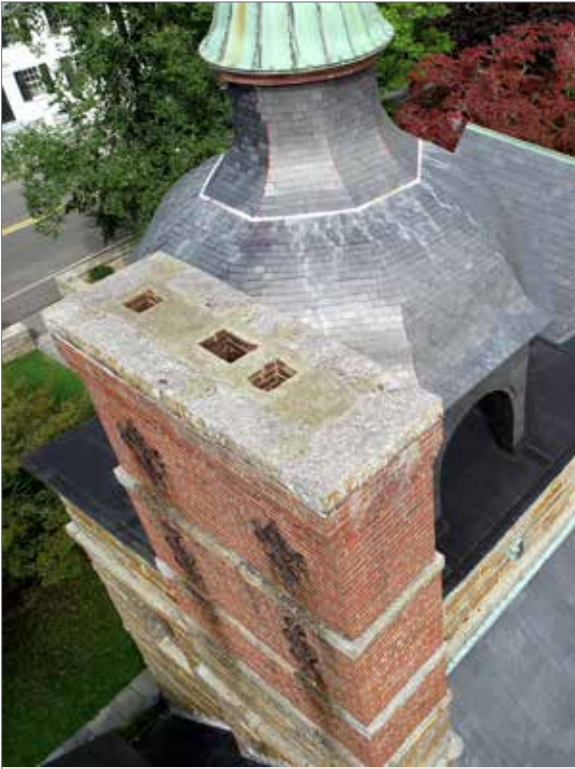
Figure 3.22 West chimney - aerial view from southwest looking northeast.

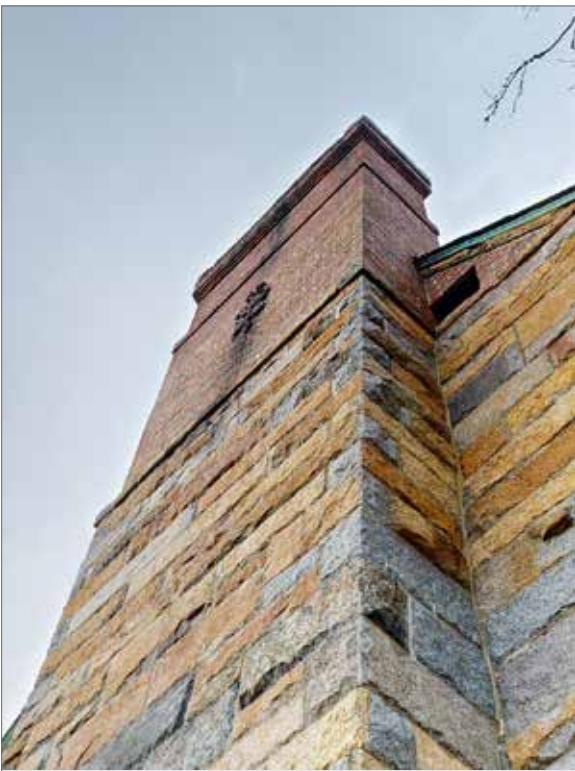
Figure 3.24 South chimney - view from southeast looking northwest.

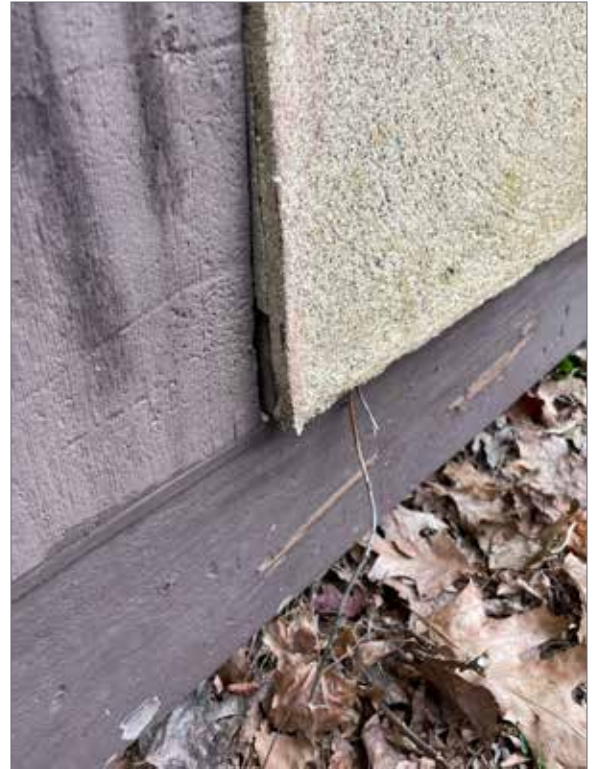
Figure 3.27 South elevation - stucco panel displacement.

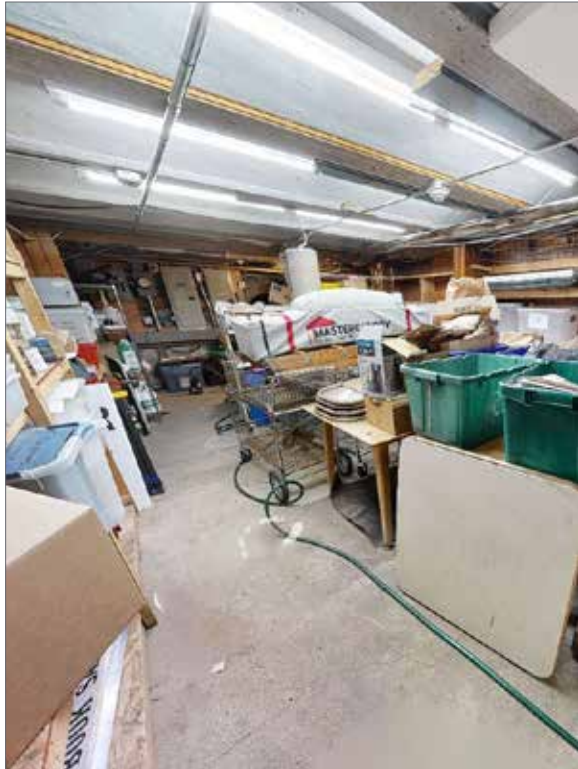
The Memorial Hall/Circulation Room floor is constructed with brick arches, typically topped with unreinforced concrete, spanning between steel purlins spaced at approximately 40-inches on center. The rise of the brick arch was measured as approximately 5-inches, the steel purlins were measured at 5 3/4-inch-wide flanges and approximately 10-inches deep. The framing is supported by foundation walls. Central hall basement floor has a concrete slab on grade.

Figure 3.30 Basement under Memorial Hall/Circulation Room - Brick arches and steel purlins

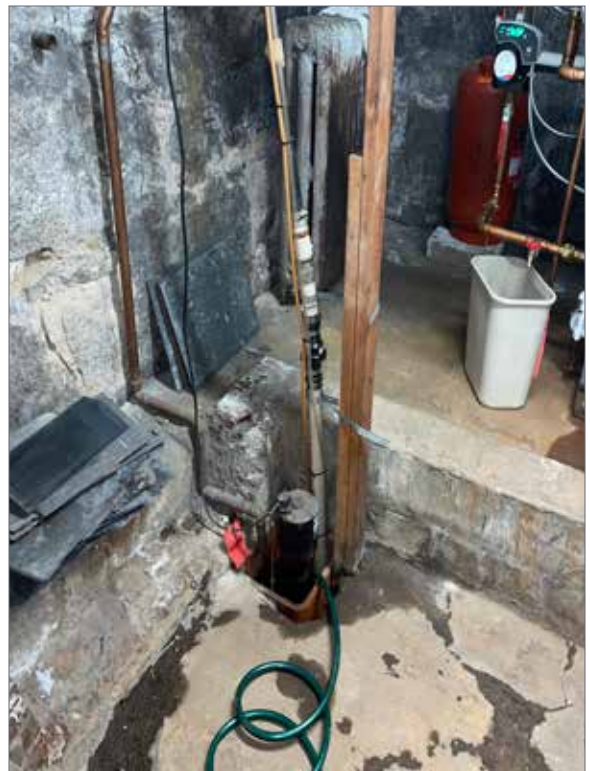
Figure 3.33 Basement - Stone foundation walls in boiler room.

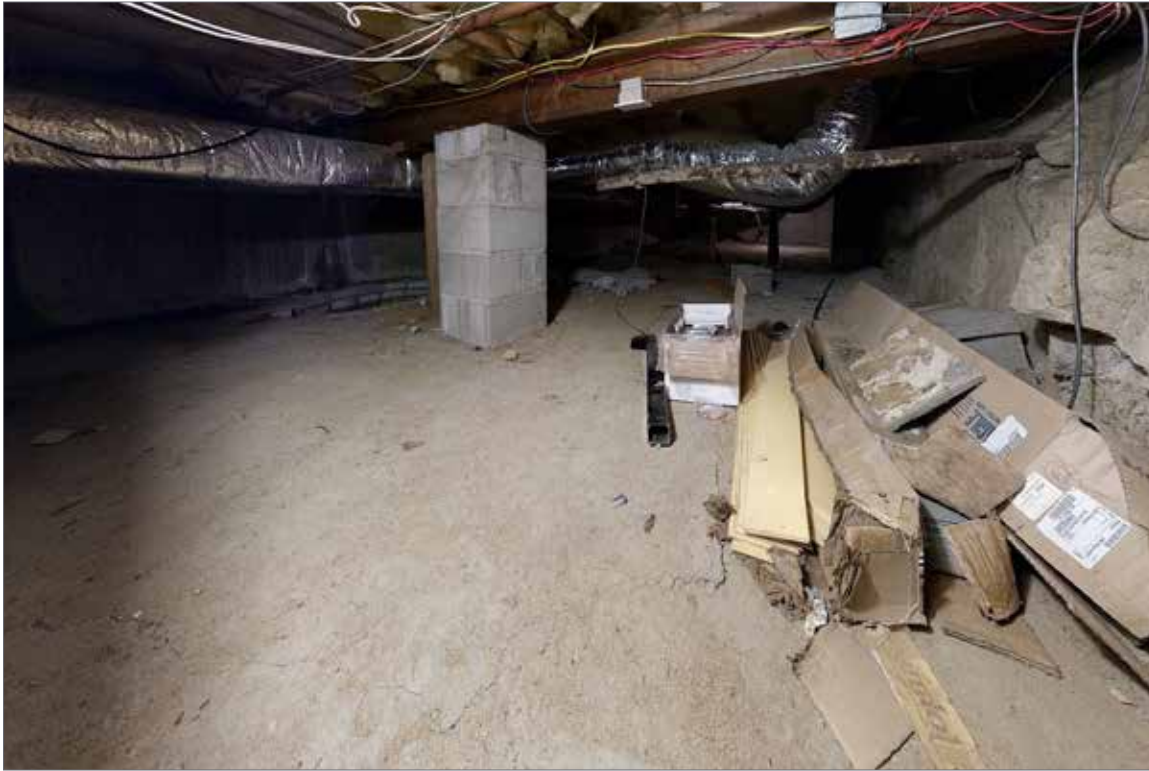
Figure 3.34 - View of Children's Room Addition crawlspace, looking west.

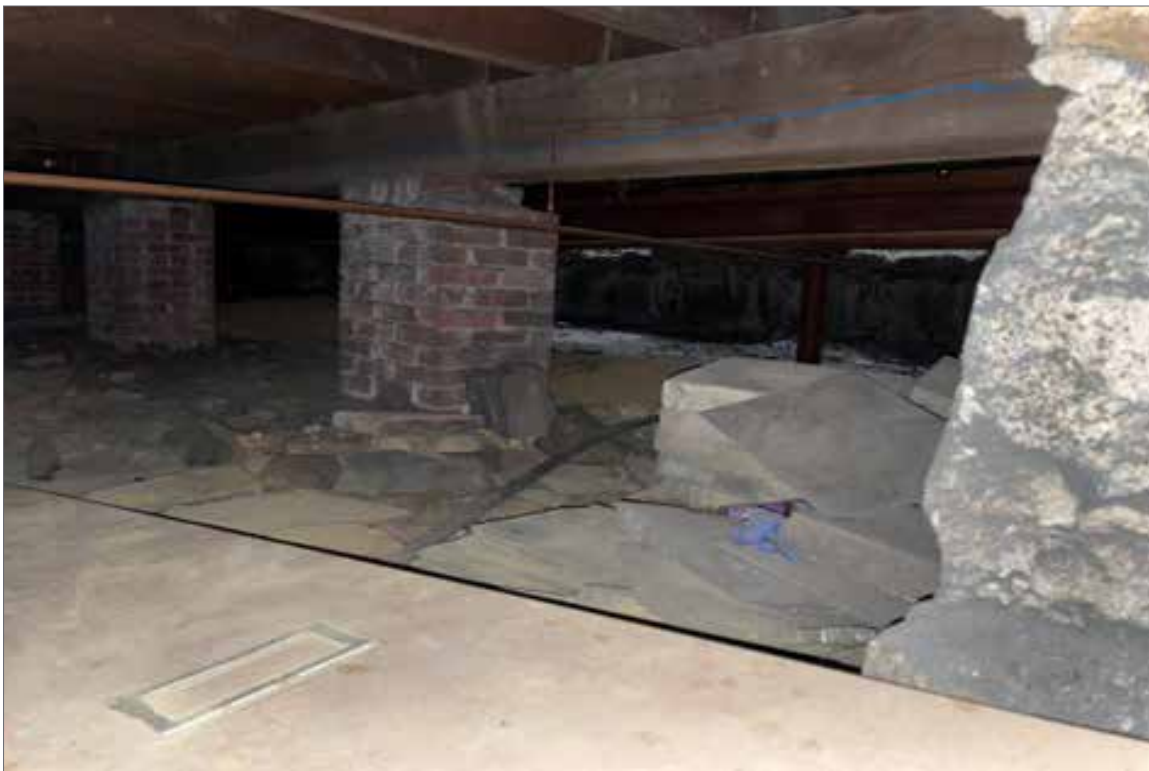
Figure 3.35B - Brick piers and first floor wood framing under GAR Hall/Reference Room crawlspace - typical conditions

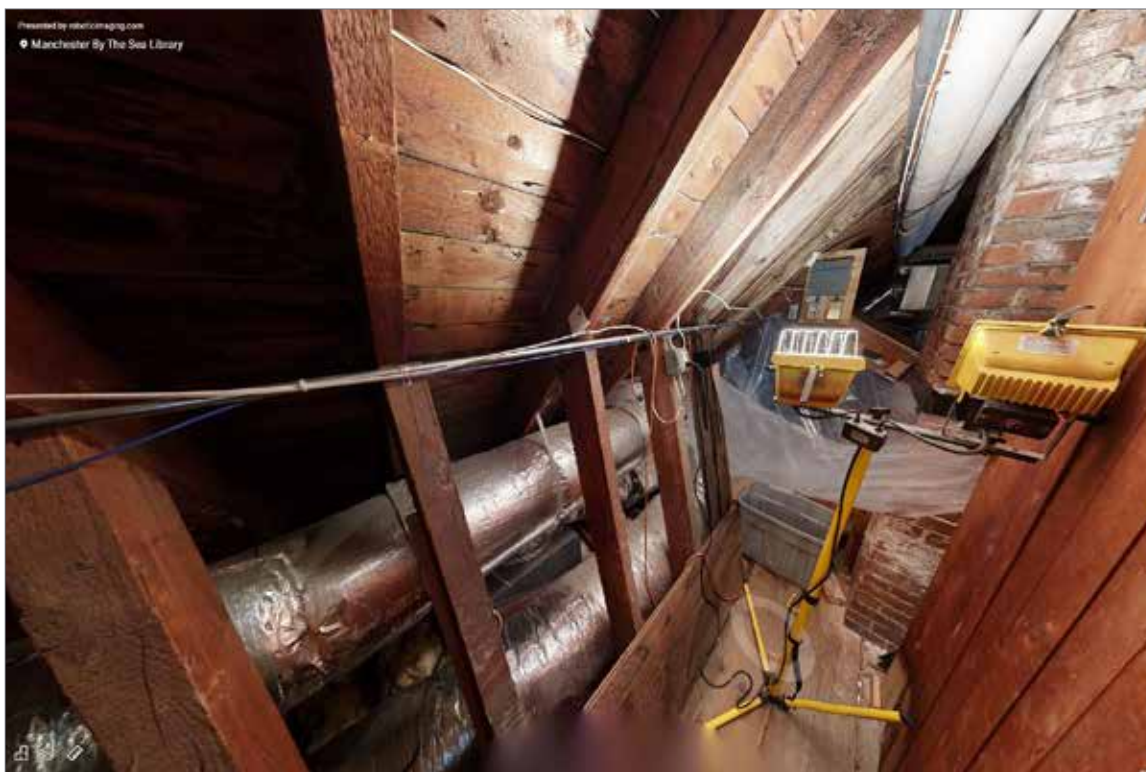
Figure 3.35A - Attic - Roof framing - Looking west towards GAR Hall/ Reference Room."

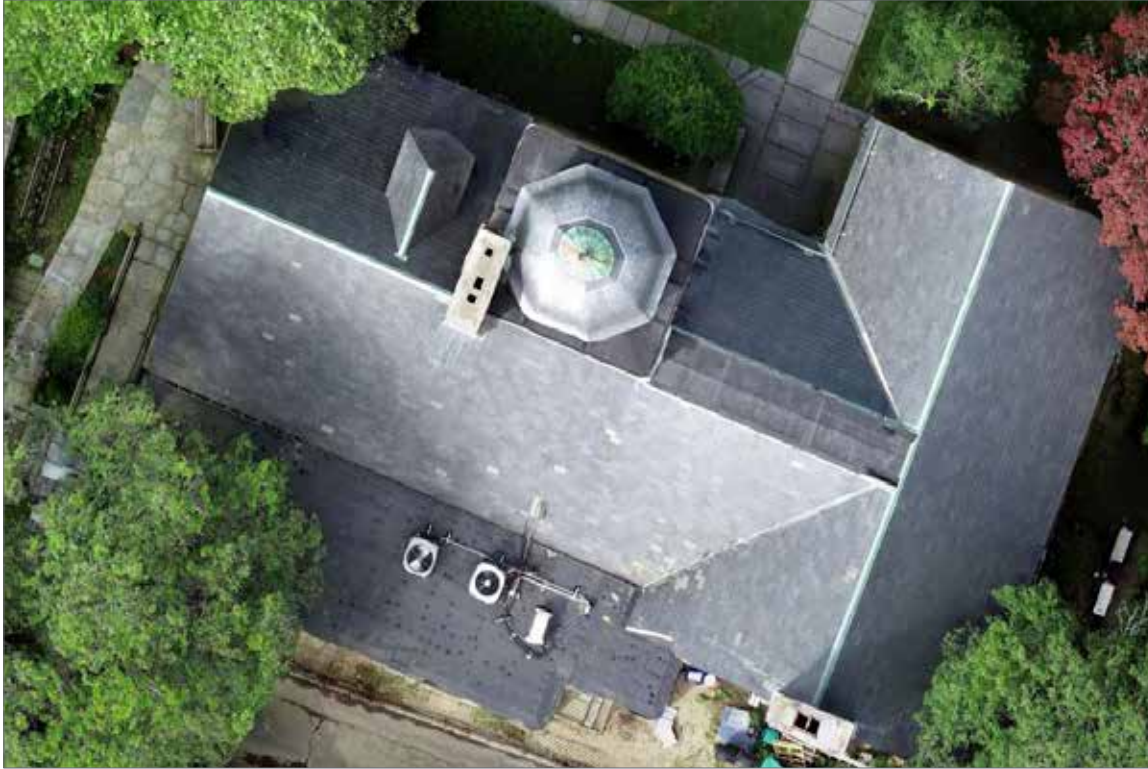
Figure 3.36 - Roof overview - aerial view - Note flat rectangular area to the right of side gable roof, between tower and intersection of end gable roof; this was the location of the skylight which was removed in the 1970s.

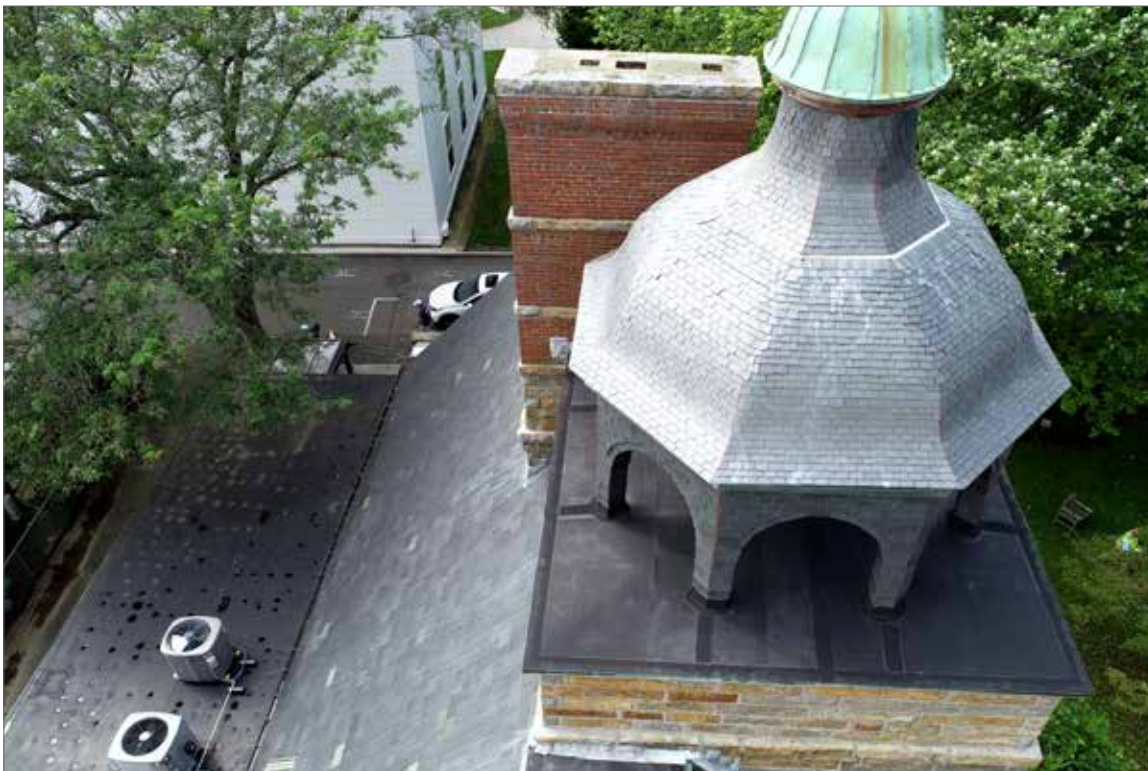
Figure 3.37 - Tower, cupola, west chimney, reference room side-gabled roof at GAR Hall/Reference Room and Children's Room Addition flat roof. Aerial view from east looking west.

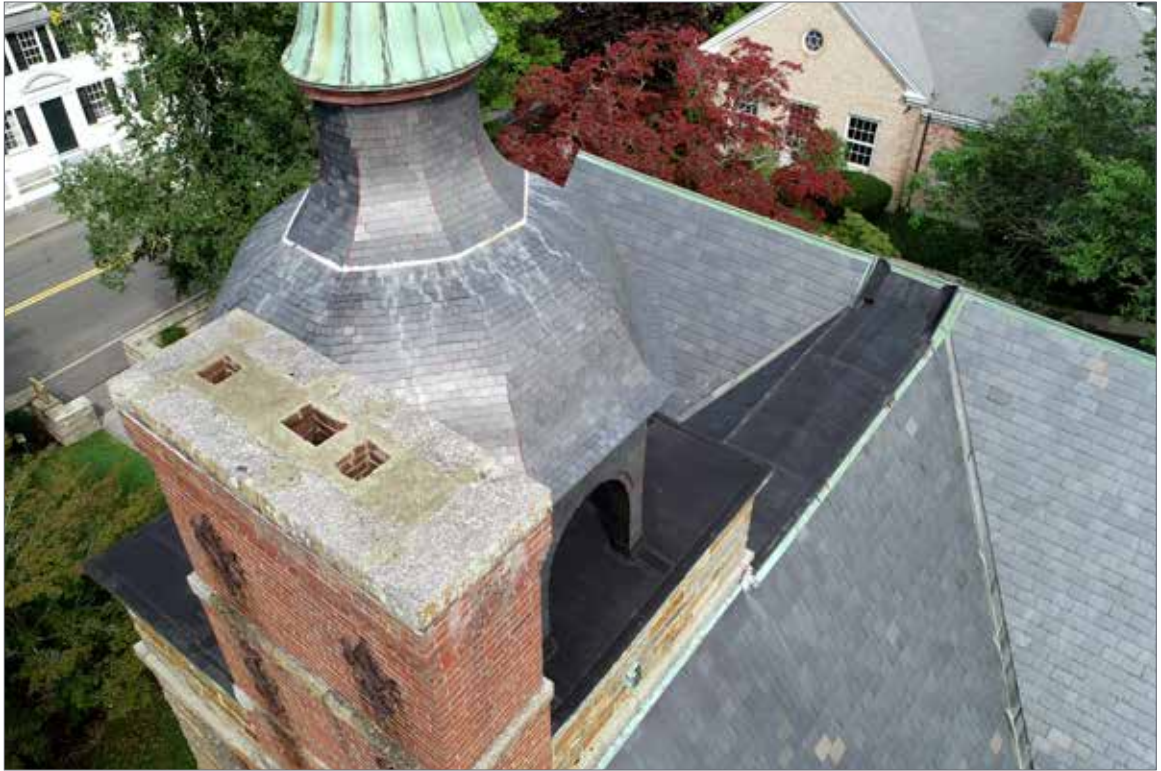
*Figure 3.38 - West chimney (forefront), cupola, intersection of end gable and side gable roof, and membrane roofing at flat area where skylight used to be located. Aerial view from west looking east.."*

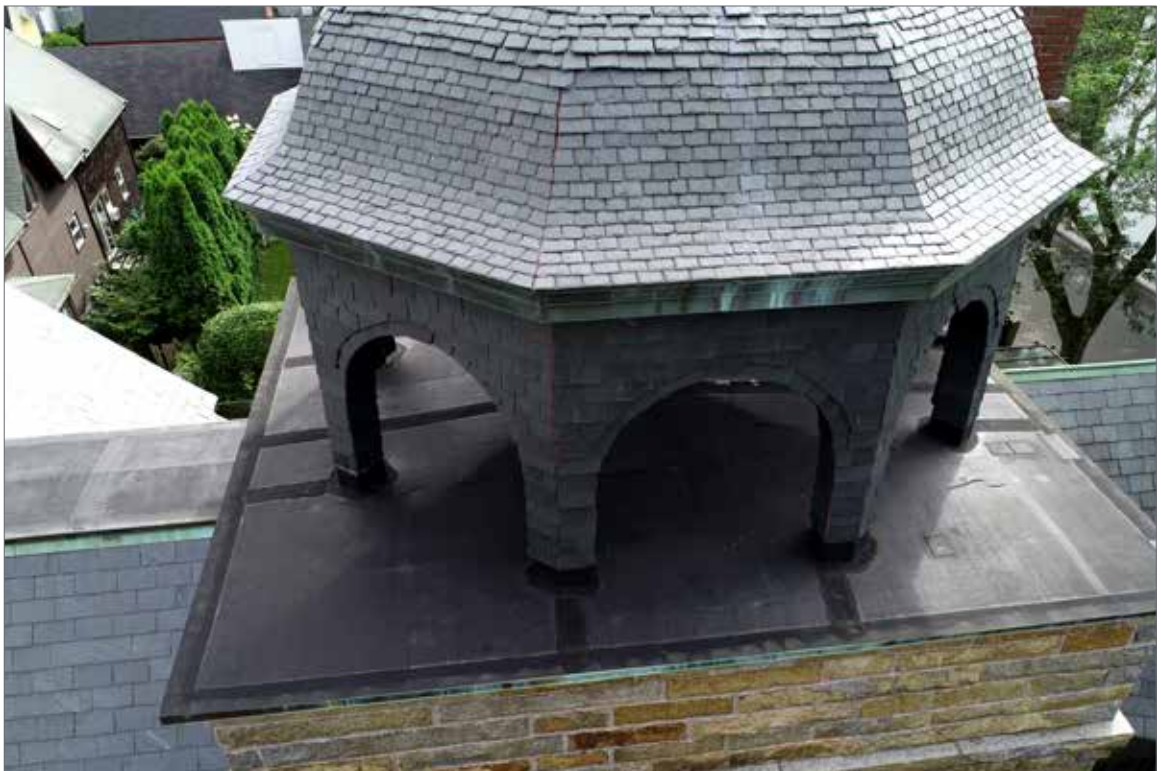
*Figure 3.39 - Tower flat roof and slate clad cupola roof - aerial view from north looking south.*

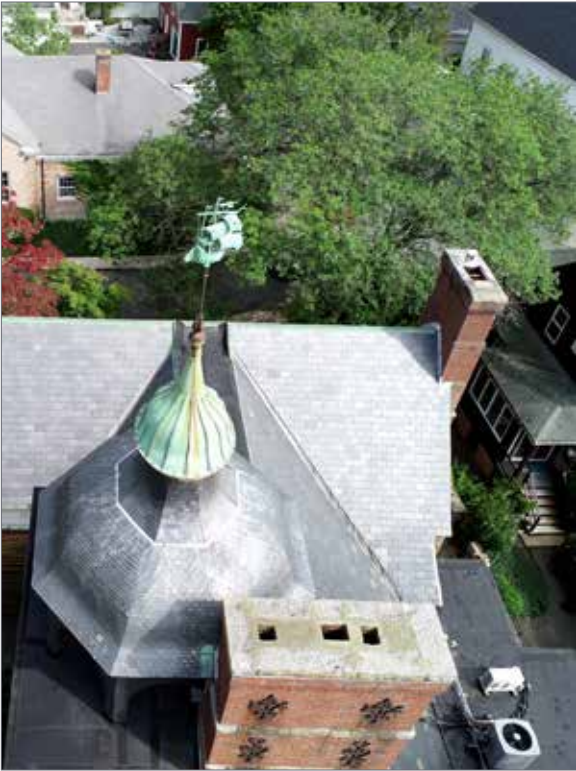
- There were a few cracks indicated in concrete piers.
- Chimney cap is missing, allowing water infiltration into the wall and building.

Figure 3.40 Chimney caps and weather vane.

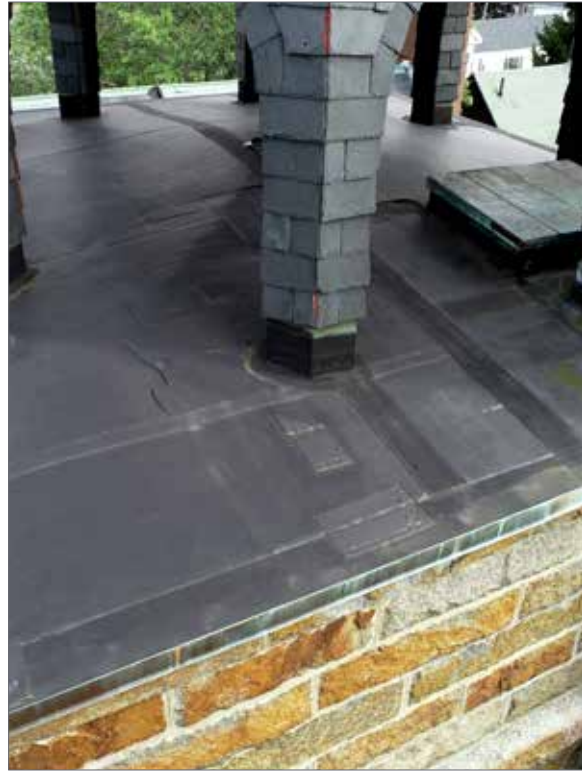
Figure 3.41 Membrane roofing at tower flat roof, sheet copper clad cap at access panel beyond.

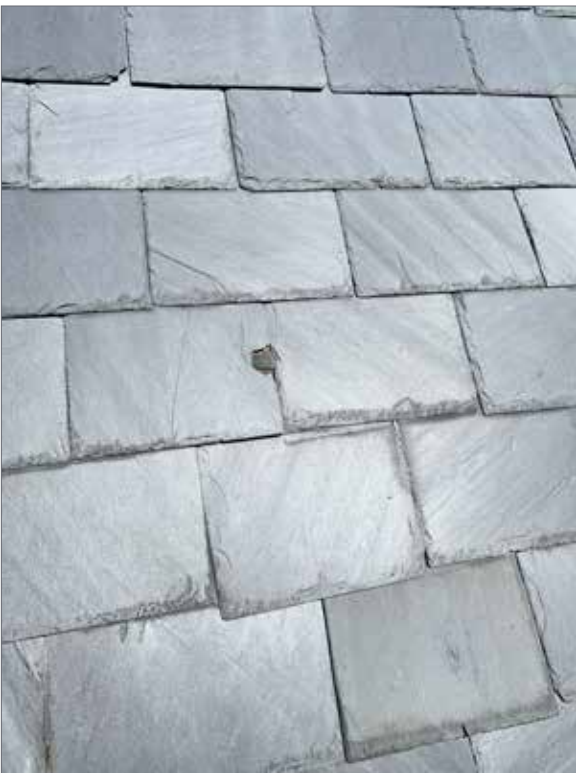
- The main roof slate roofing is in fair condition for its age. Cracked slates, slipped slates, and slates continue to fall off the roof.
- The pipe snow-guards are in good to fair condition.

Figure 3.42 Slate roofing - field at end gable roof.

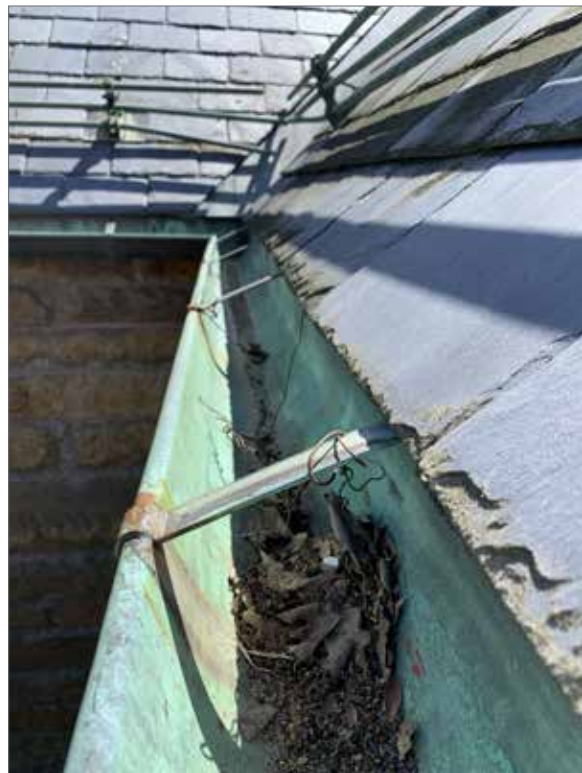
Figure 3.43 Original copper high-back gutter and pipe snow-guard at main entrance.

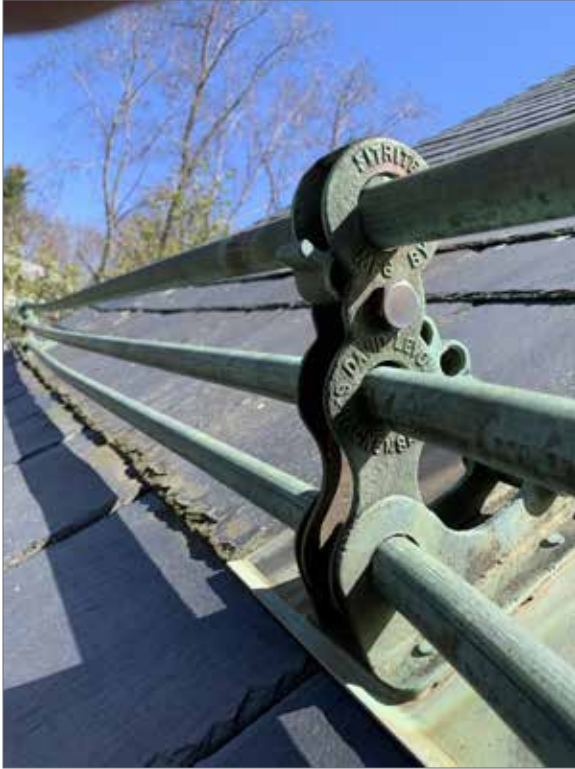
Figure 3.44 Original pipe snow-guard - detail.

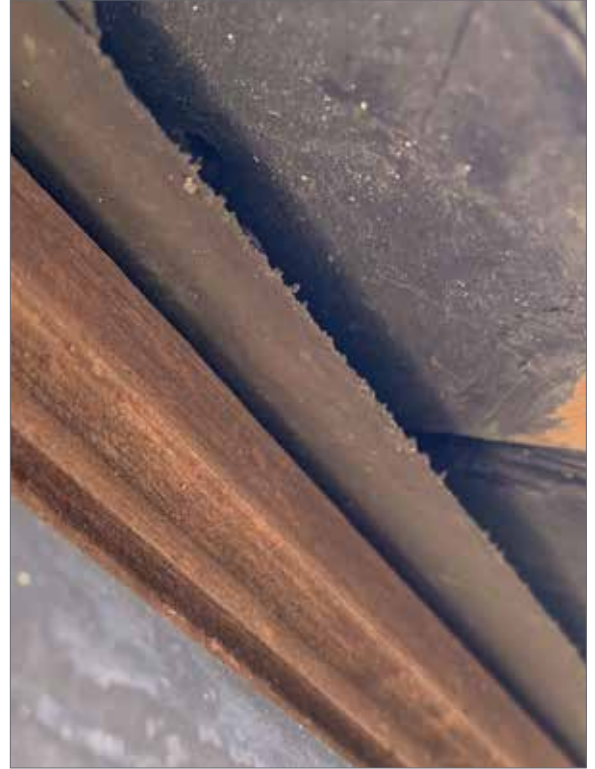
Figure 3.45 Edge of cut original high-back gutter under starter slate - east elevation of library roof.

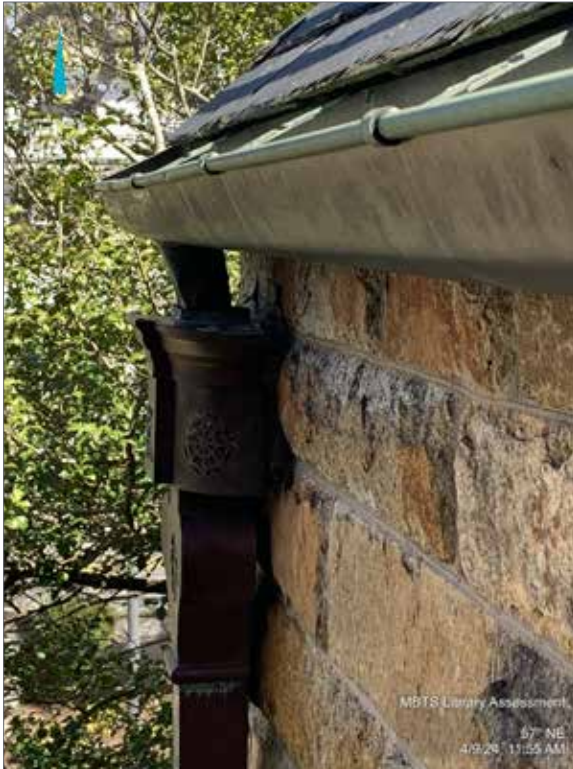
Figure 3.53 Rainwater conductor head and downspout, southeast corner of end gable (library) roof.

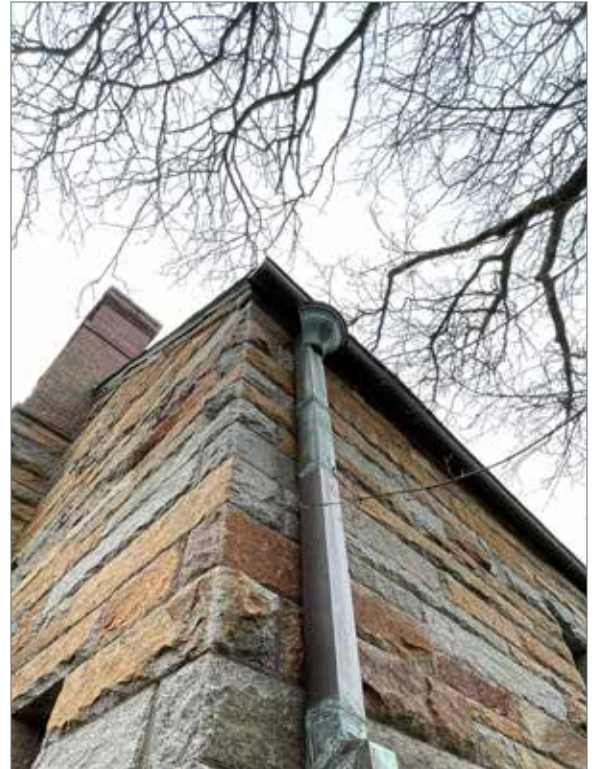
- Downspouts are in good to fair condition; some attachments to the masonry are failing. Boots to underground drainage vary and are in fair to poor condition.
- In the summer of 2023, underground drainage was revised in the south alley behind the Children's Room Addition. Downspouts were tied into the new piping and discharge directed to a leaching catch basin installed in the south east corner of the lot adjacent to Chapel Lane.
- The condition of the underground piping to sewer discharge is unknown.

Figure 3.54 Downspout to grade

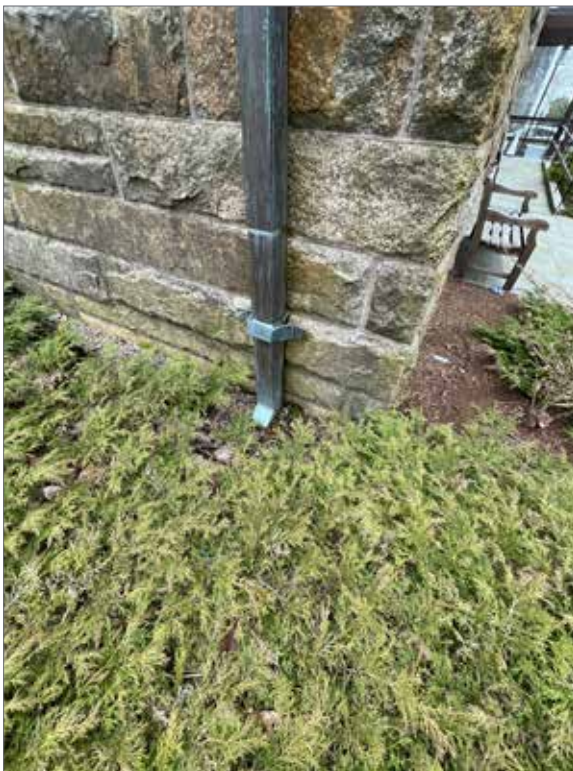
Figure 3.55 Downspout to grade.

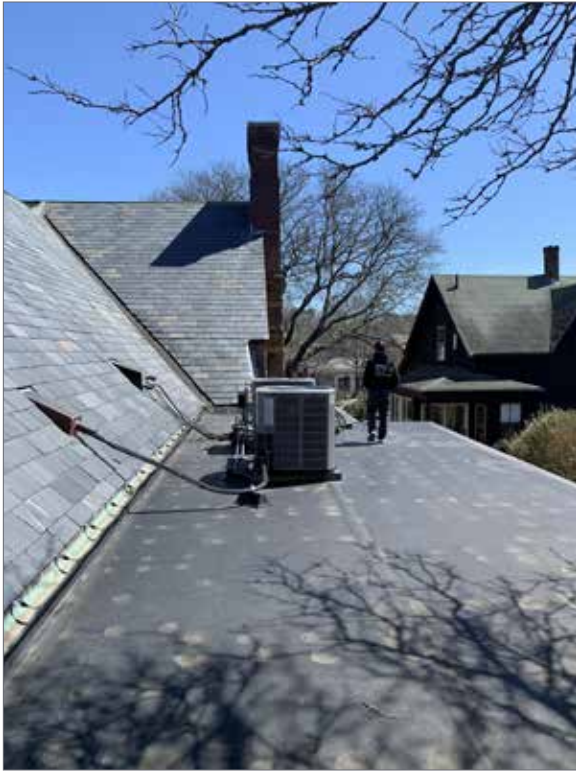
Figure 3.56 Children's Room Addition flat roof membrane roofing, view from east looking west.

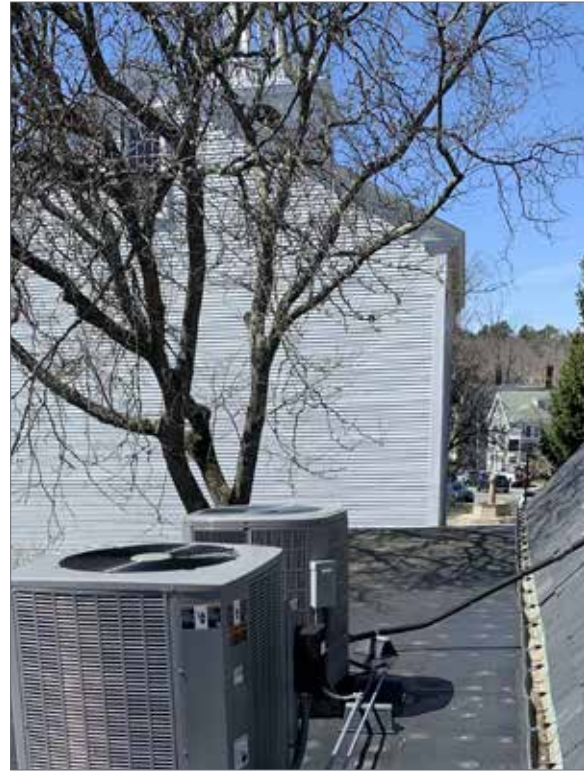
Figure 3.57 Children's Room Addition flat roof downspout - west elevation.

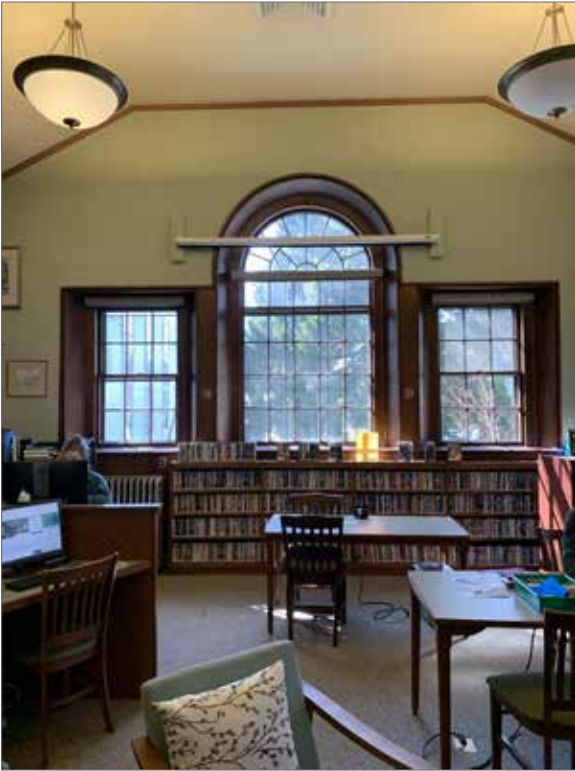
Figure 3.59 Triple single hung operable window, with central arched fixed transom - typical interior finishes

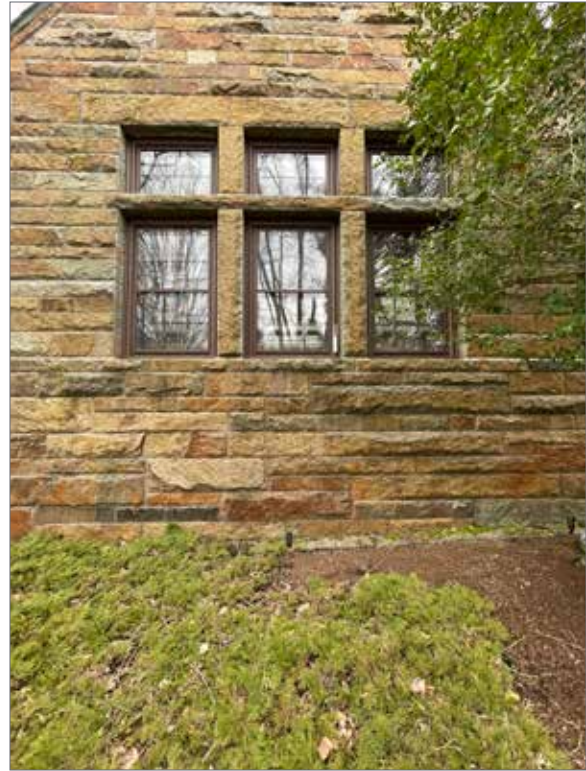
Figure 3.60 Triple single-hung operable windows with fixed rectangular transoms - typical exterior window finishes.

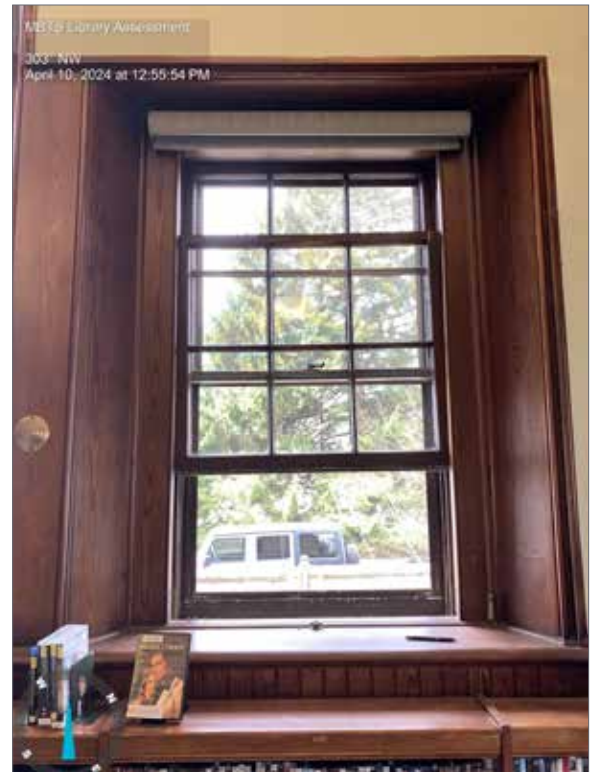
Figure 3.64-Typical single-hung window - interior

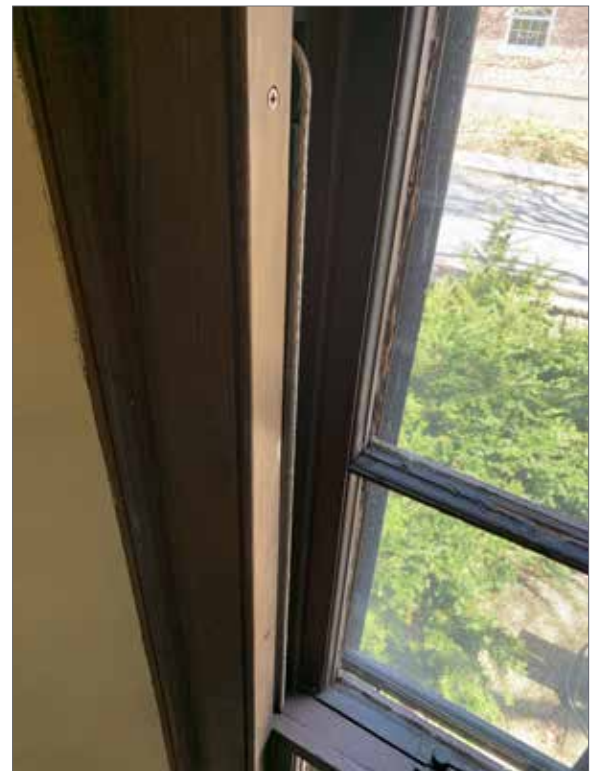
Figure 3.66 Typical single-hung window cable and pulley operating hardware.

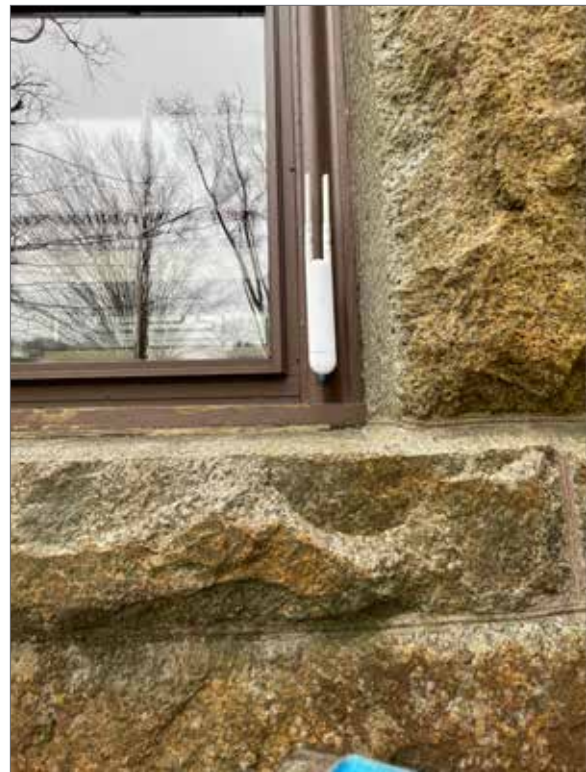
Figure 3.68 Typical exterior storm window frame.

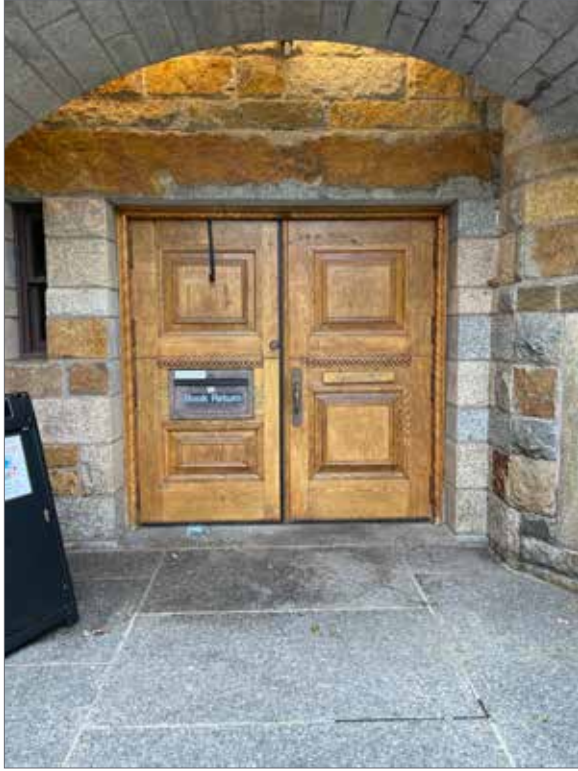
Figure 3.71 Front door - exterior..

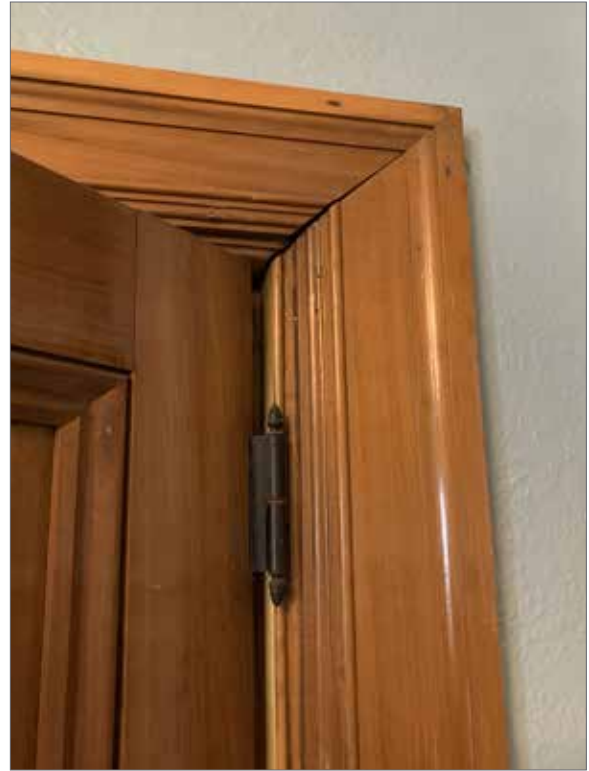
Figure 3.76 Original door hinges and trim

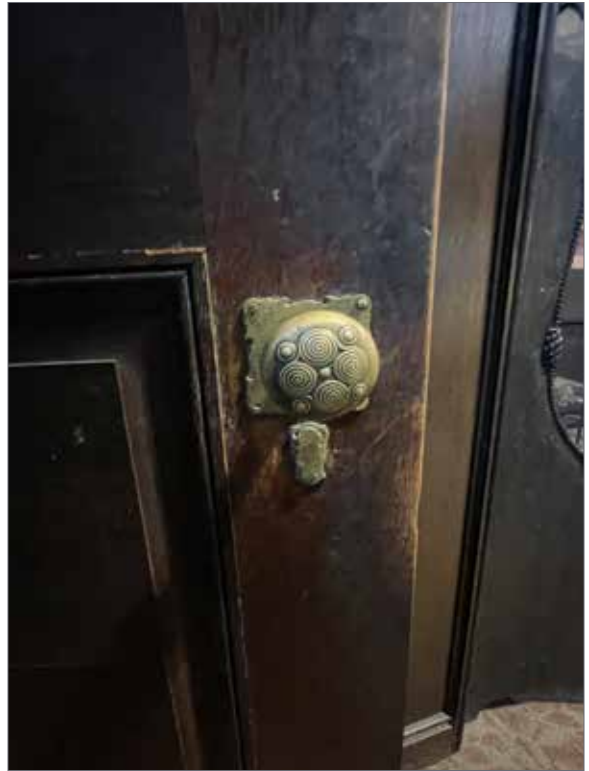
Figure 3.78 Original door to restroom off library/reading room - Hardware.
