# Condition Assessment Report

## Manchester-by-the-Sea Public Library

15 Union Street - Manchester-by-the-Sea - MA 01944

May 25 2024

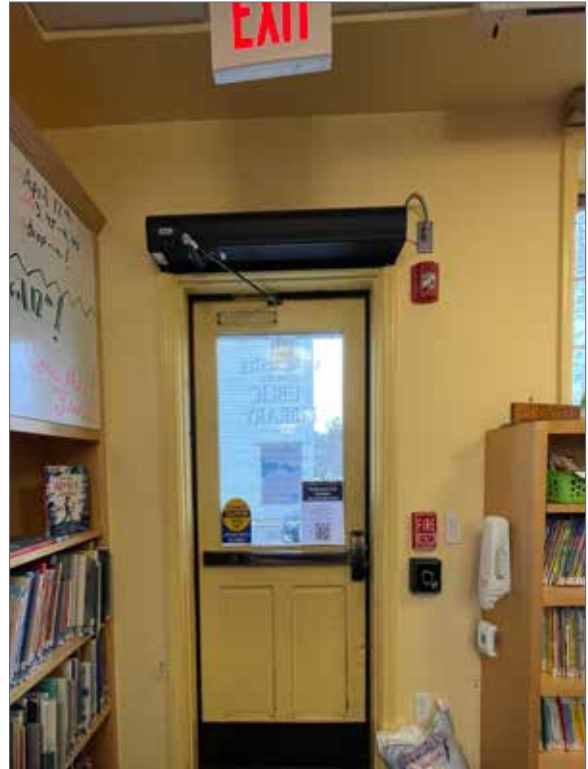
Figure 3.80 West entrance to Children's Room Addition - interior. Panic bar and barrier free access hardware..

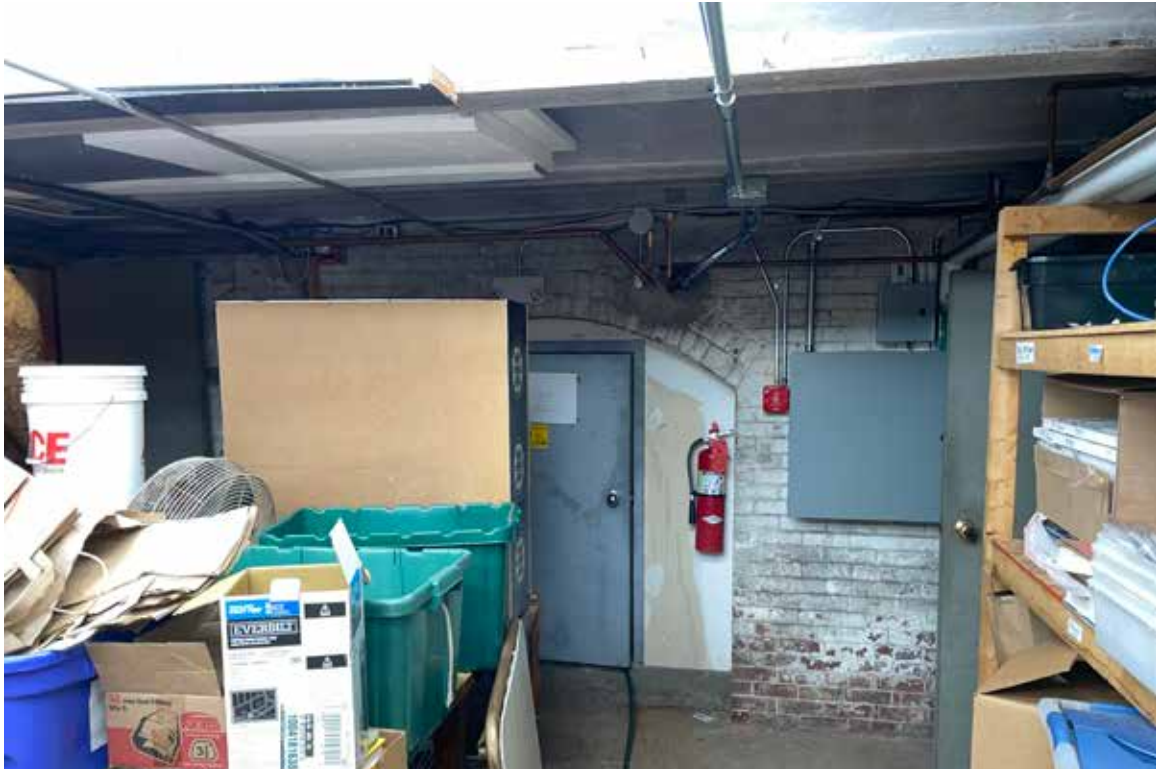
Basement: The exterior walls in the basement are original rubble stone covered with white paint. Interior partition walls are original brick, also painted white. Coatings are in fair to poor condition. The north and south walls are partially covered with wood beadboard, also in fair condition. A gypsum wall partition was built into the arch to the boiler room to accommodate a new door; the drywall is unfinished.

Basement ceiling finishes include coated steel framing and cementitious finish at brick arches. Coatings are in poor condition. Boiler room ceiling is coated in a textured, painted cementitious parge. The parge and coating are in good to fair condition.

Basement floor finish consists of concrete slab. Slab exhibits cracks and areas of previous repair. Basement concrete flooring is considered to be in fair condition; flooring in boiler room is considered to be in poor condition. There have been two recent instances of significant flooding (approximately 4"). The source has yet to be determined (rising damp through small cracks in the concrete flooring was noted, but is not the primary cause of the extensive flooding).

Figure 3.83 - Basement finishes, typical.

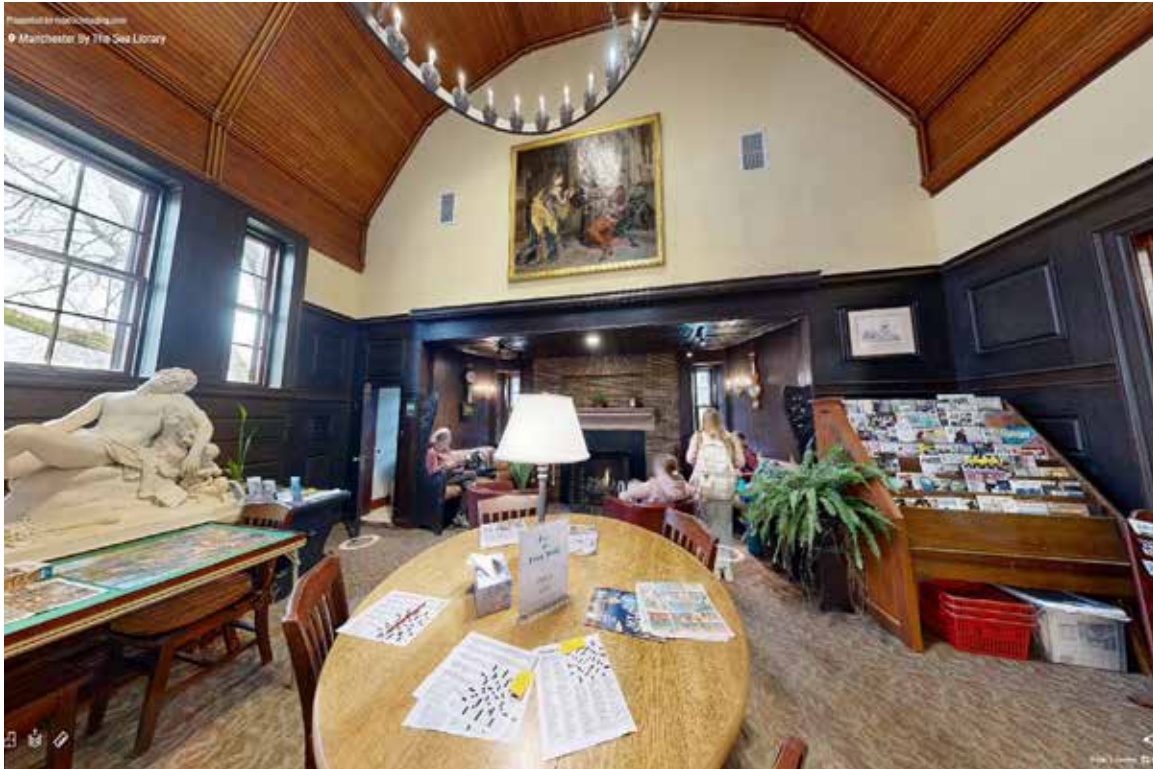
The large fireplace and ornate wood paneling surround in the Reading Room are in good condition.

Figure 3.87 - Library/Reading Room - view looking south..

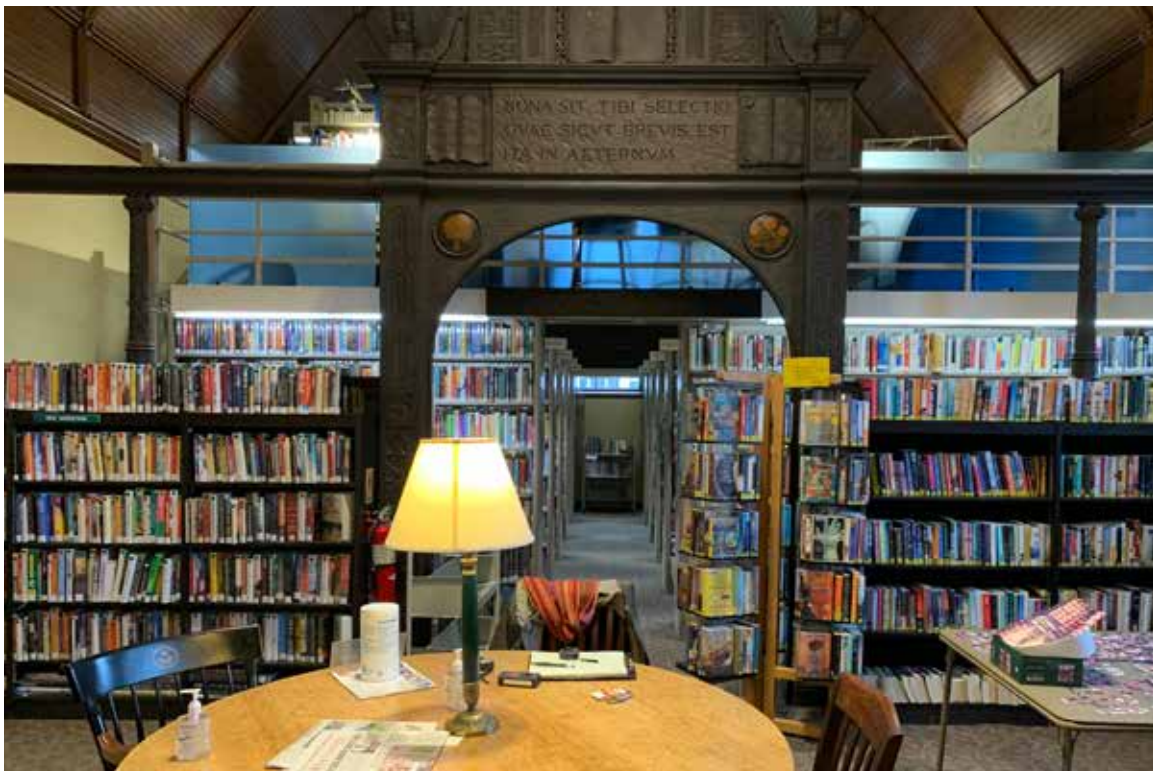
The carved wood screen separating the stacks from the reading room in the original Library is in good condition.

Figure 3.88 - .Library Stacks - view from reading room looking north..

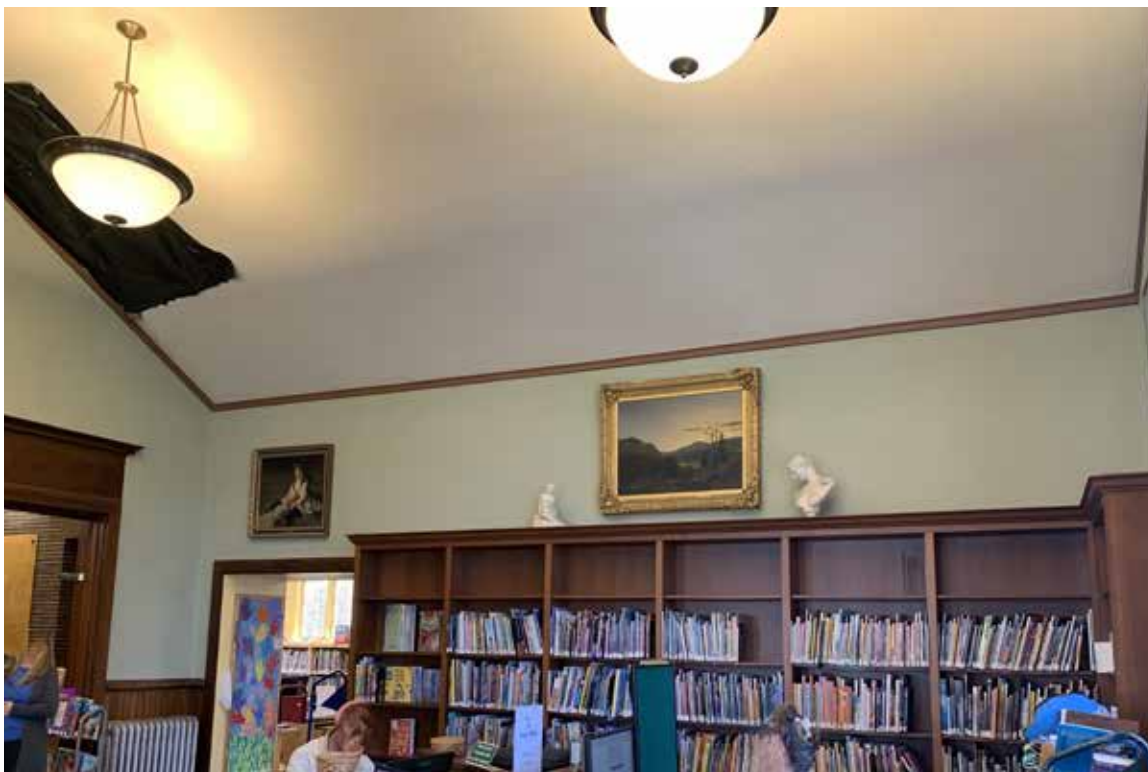
- Oak paneled vaulted ceiling (original Library), in good condition.
- Painted plaster, in overall good condition except for water damaged area, and localized cracks along the south wall in the GAR Hall/Reading Room.
- Wood trim, in good condition.
- Beadboard in the clock tower and clock room, in good condition.
- Acoustical tile ceiling in the Children's Room Addition, in good condition.
- Metal panels in stacks lower level.

Figure 3.89 - GAR Hall/Reference Room - view from northwest looking southeast.

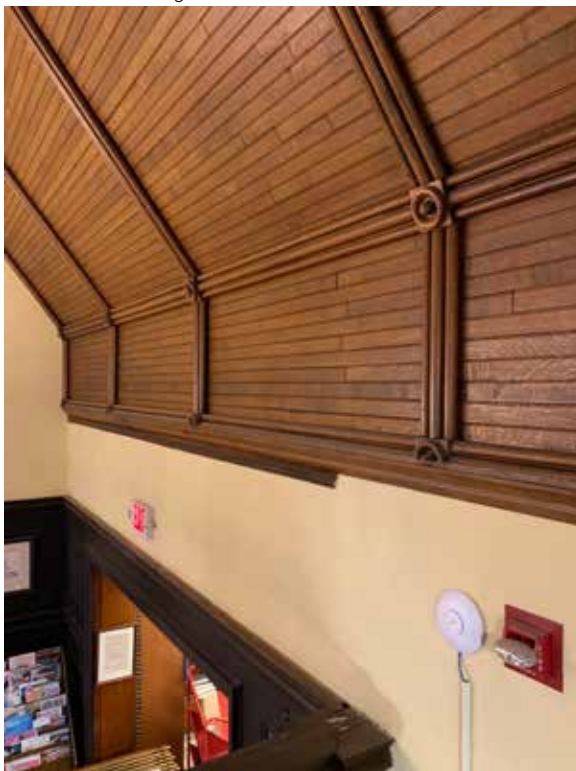
Figure 3.101 Original oak paneled vaulted ceiling. Library/Reading Room, view from upper stacks Teen Loft.

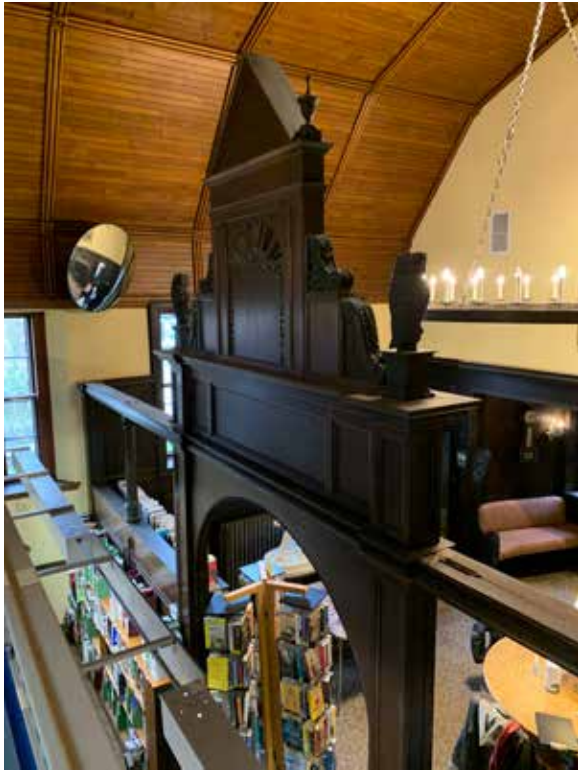
Straight run metal stairs are part of the two-story stack and mezzanine assembly. The open riser metal stairs are in good condition, coating is in fair condition. Glass and metal mezzanine railing is in good condition.

Figure 3.103 Teen Loft metal railing and ornamental screen beyond. View from Teen Loft looking southeast.

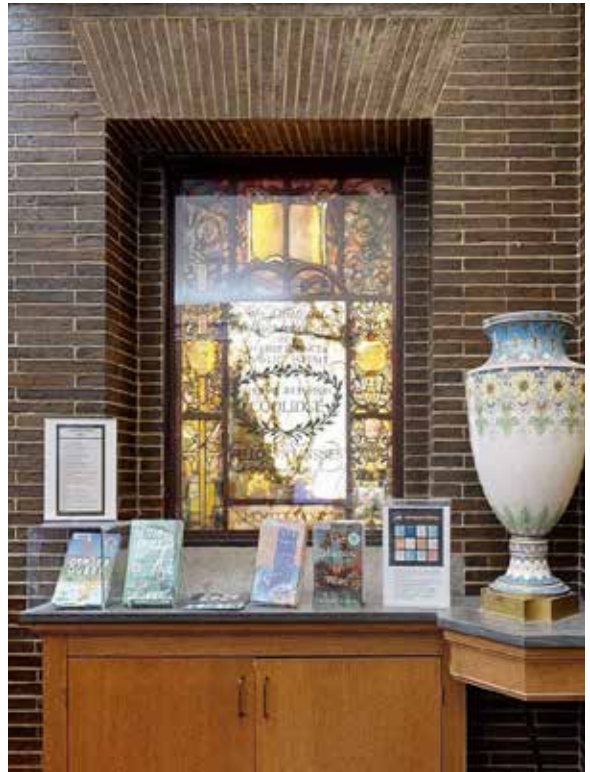
The small stained glass window in the southwest corner of the Circulation Room is in good condition.

Figure 3.104 Stained glass window in southwest corner of Memorial Hall/Circulation Room..

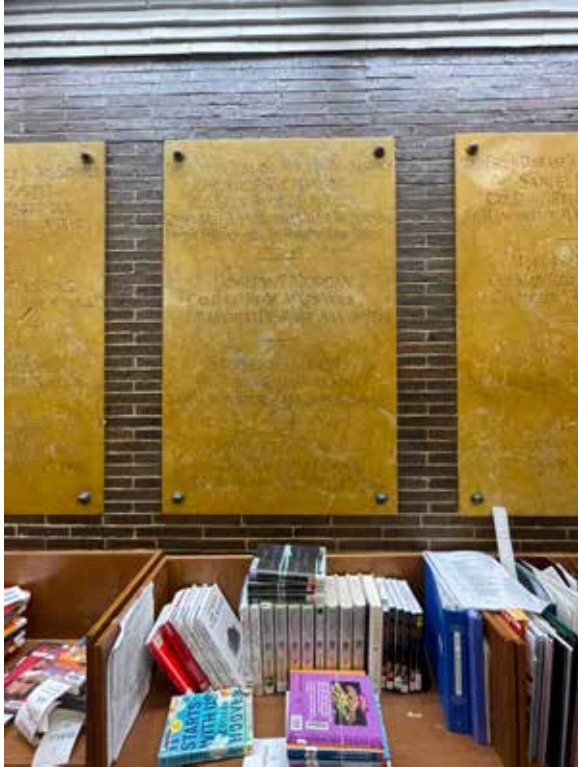
Rectangular memorial tablets and two bronze plaques in the Circulation Room are in good condition.

Figure 3.105 Decorative marble commemorative tablets - Memorial Hall/Circulation Room south wall.

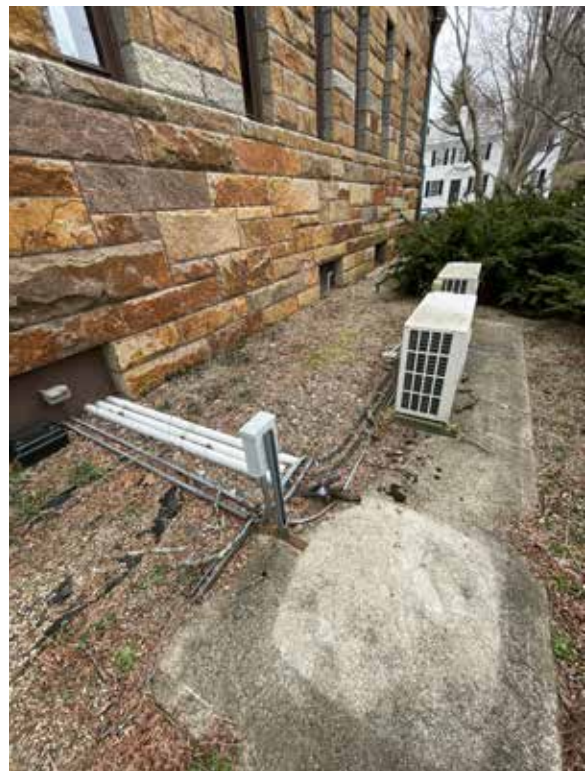
Mini-splits provide conditioning to the Director's office and the back of the stacks on the main level, and the Archives Room on the tower 2<sup>nd</sup> level. Two heat pump units are located at ground level along the east elevation; a third heat pump unit is located on the Children's Room addition roof. Neither heat pumps nor mini-splits are operational.

Figure 3.113 Decommissioned exterior units.

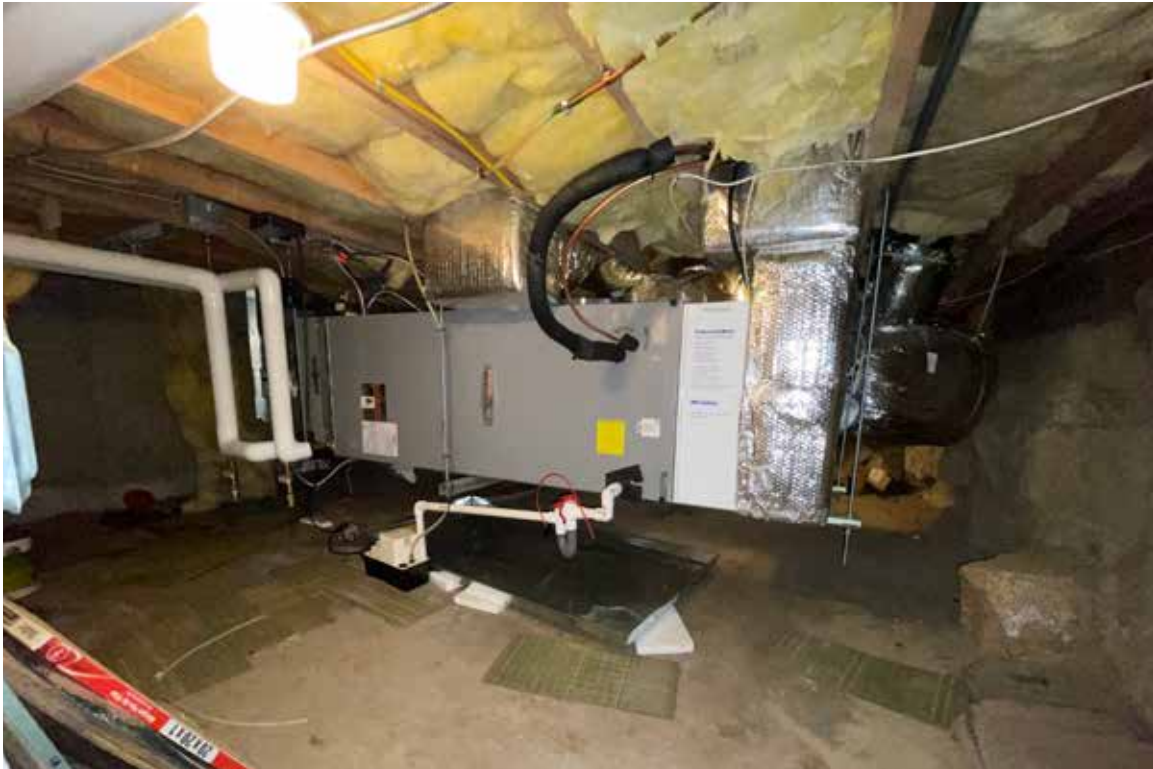
The Children's Room Addition has a rooftop 3.5 ton Armstrong Air heat pump – R410a, an Armstrong Pro 3.5 ton variable speed air handler equipped with a Solaris SLX1024 UV ION filtration system (located in the addition crawl space) and hydronic heating coil for second stage heating/backup. The boilers provides supplemental heat when the heat pump cannot keep up. The crawl space air handling unit and the rooftop heat pump were installed in 2021 and are considered to be in good condition.

FIGURE 3.114 - Children's Room Addition - unit in crawlspace.

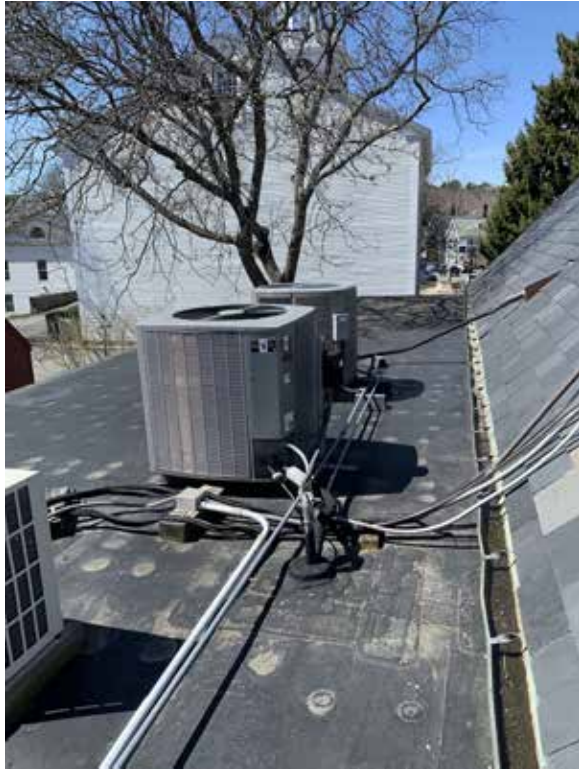
Figure 3.115 Children's Room Addition - rooftop units.

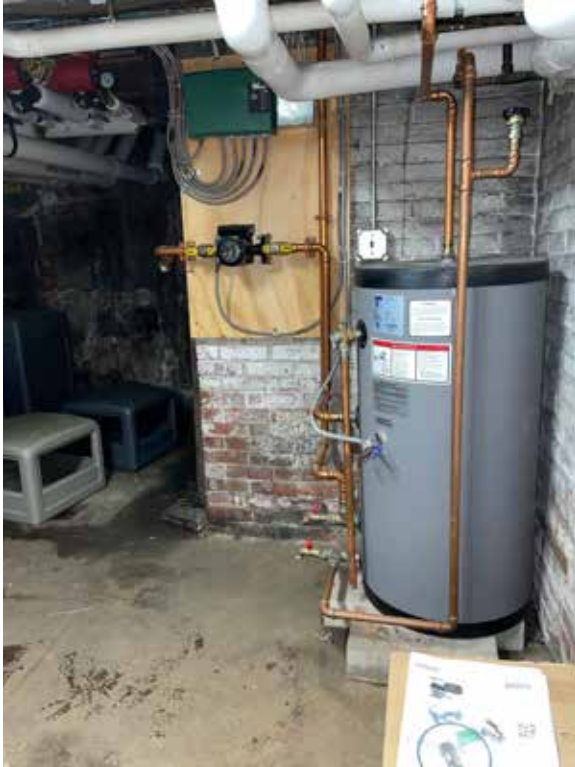
The gas water heater is located in the basement boiler room. It is a Lochinvar model SIT030, serial number 1637103414052, 91-105 MBH and is in good condition

Figure 3.117 Basement boiler room - hot water heater.

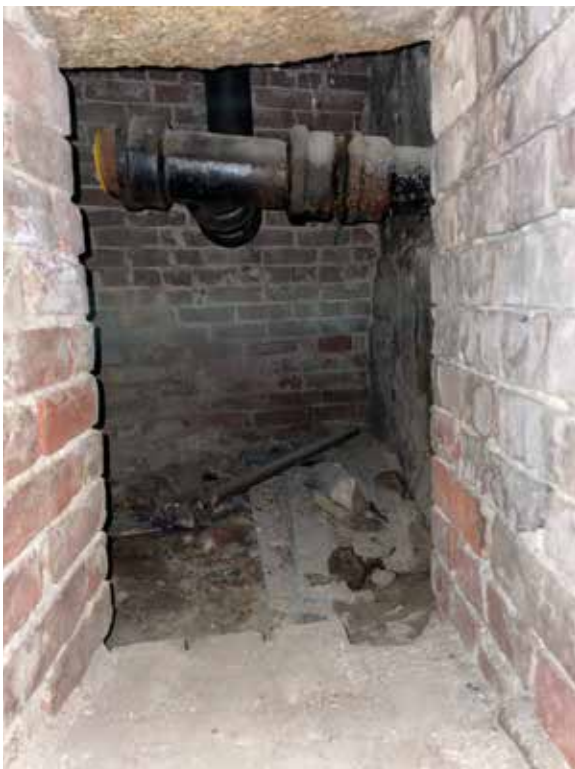
Sanitary piping consists of cast iron piping visible from an access hatch under the staff restroom. Video inspection of sanitary piping was not included in the scope of this assessment, however staff has noted occasional issues with clogging or slow flow. It can be assumed that the old cast iron pipe is tuberculated and should be replaced.

Figure 3.119 Cast-iron piping at original public restroom.

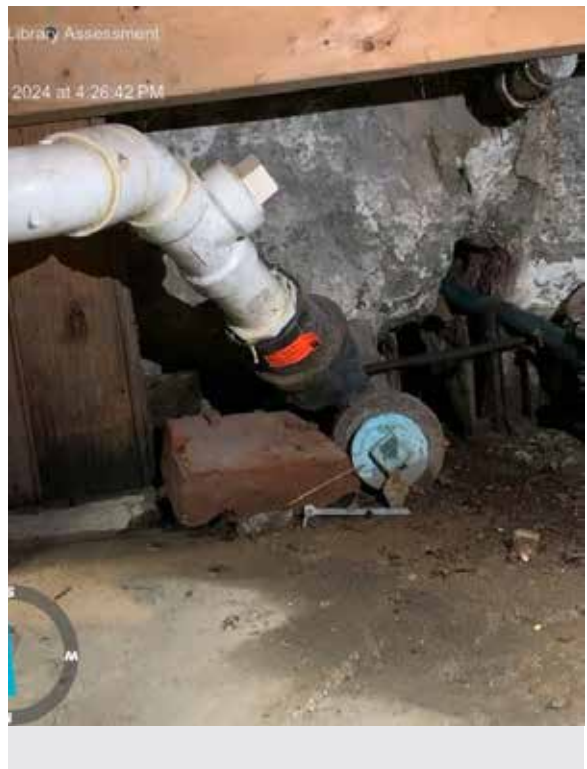
Figure 3.120 Cast-iron and new PVC piping at basement utility sink.

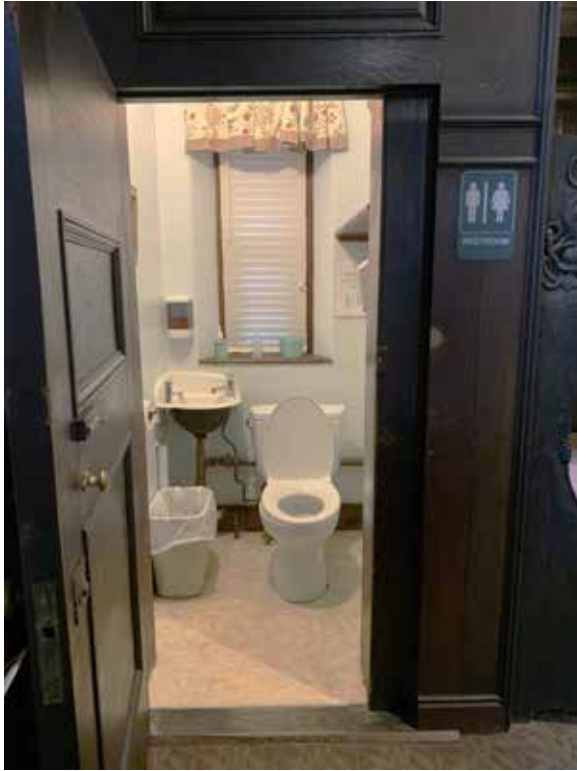
The restroom fixtures consist of a flush tank water closet and manual handle lavatory. Fixtures are in fair condition but do not meet efficiency requirements. The utility sink located in the basement is in fair condition.

Figure 3.121 Fixtures in public restroom (accessed from reading room).

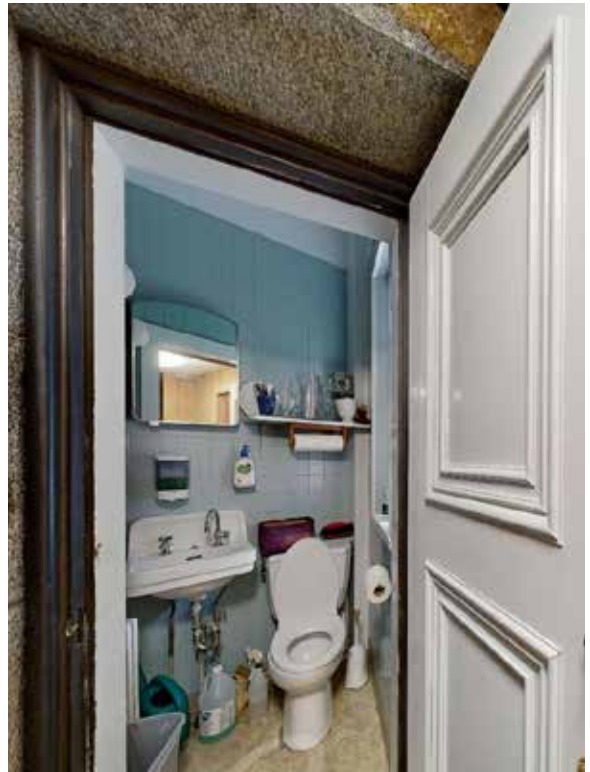
Figure 3.121 Fixtures in staff restroom, accessed from Circulation Room.

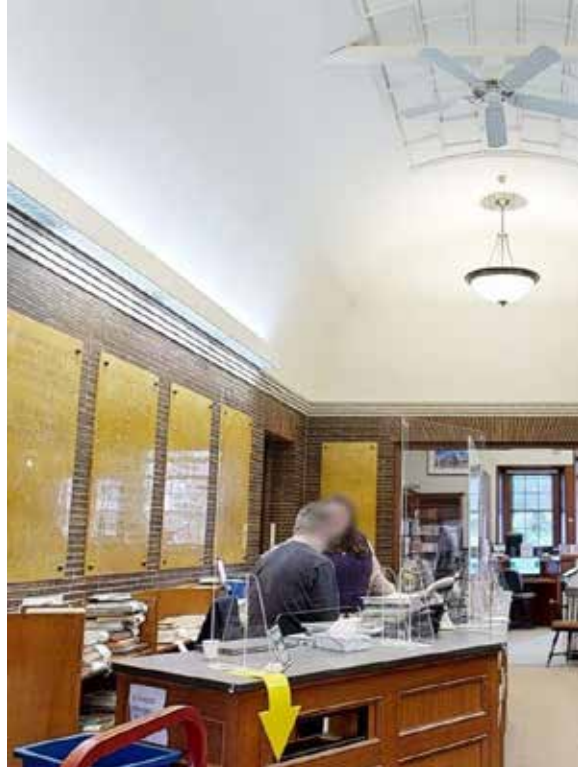
Figure 3.136 Chandelier and wall sconce - Reference Room.

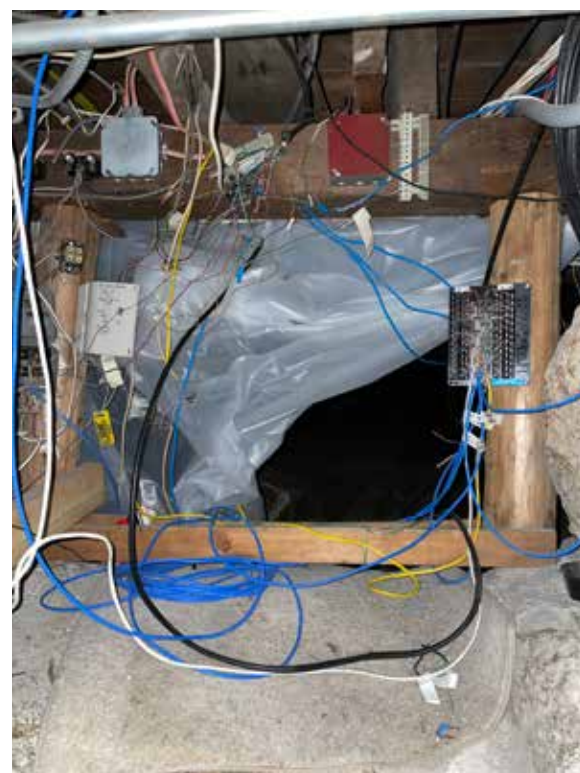
Figure 3.140 IT equipment - basement..

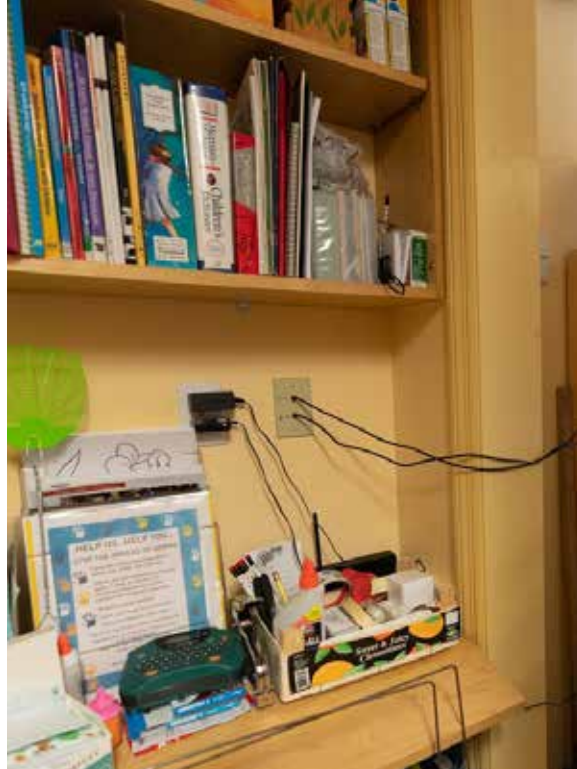
Figure 3.142 IT distribution labeling

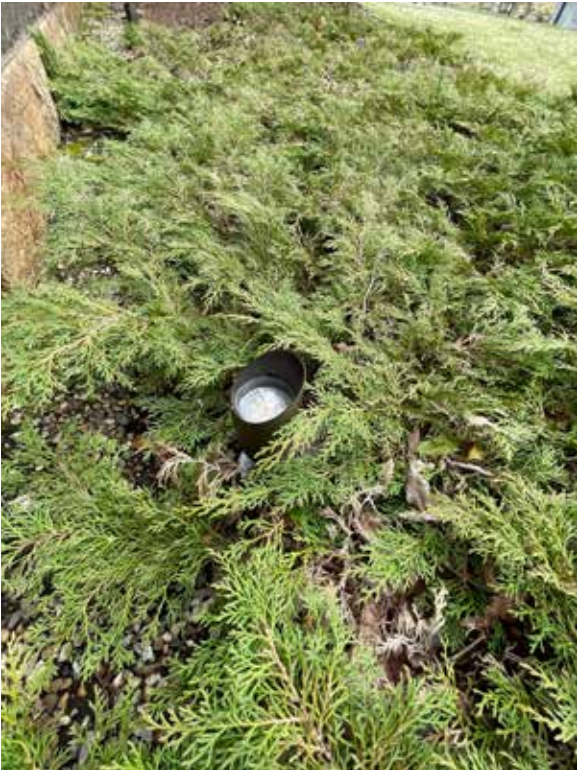
Figure 3.146 Exterior uplighting fixture - north elevation.

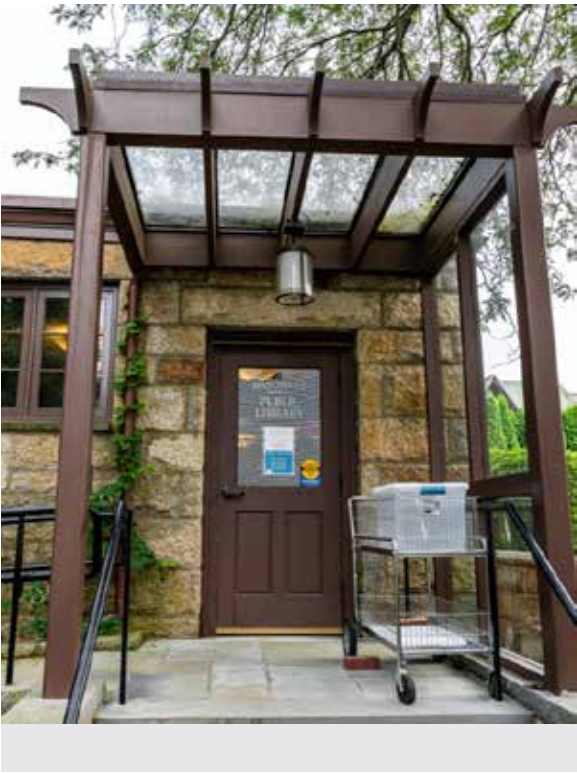
Figure 3.148 Exterior - Indirect lighting at main entrance.
